## ATTACHMENT C: Photograph Log

### Cypress Pit

Bama Concrete Products Company, Inc.  
dba Davis Sand and Gravel

Cypress, Alabama  
April 26-27, 2023

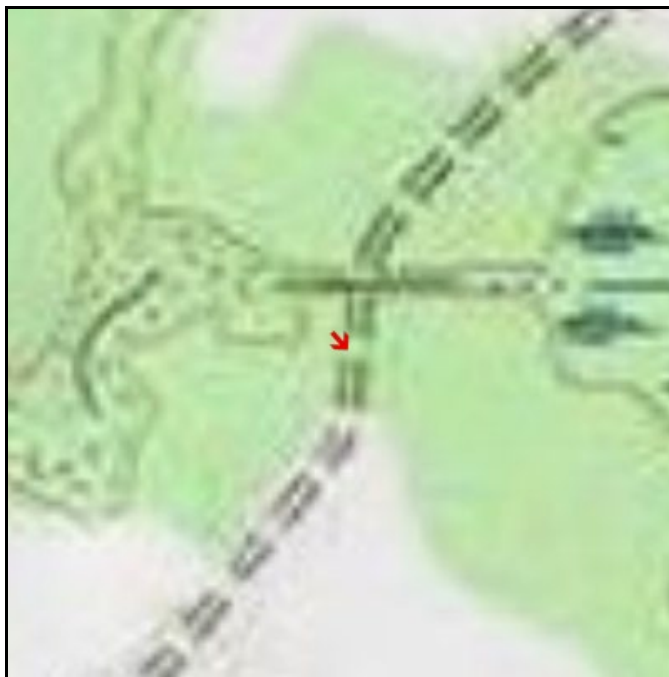
| Title | Photo 2 |

| Description | Striking southeast; upstream. Outfall per the NPDES permit. Skimmer in the bottom righthand corner of image. Red arrow in top photo indicates direction of flow. |
