**SUBJECT:** CLEAN AIR ACT INSPECTION REPORT  
Waste Connections Seabreeze Environmental Landfill, Angleton, TX

**Facility Name:** Seabreeze Environmental Landfill

**Date of Inspection:** On Site Inspection: March 16, 2023  
Virtual Conference: April 21, 2023

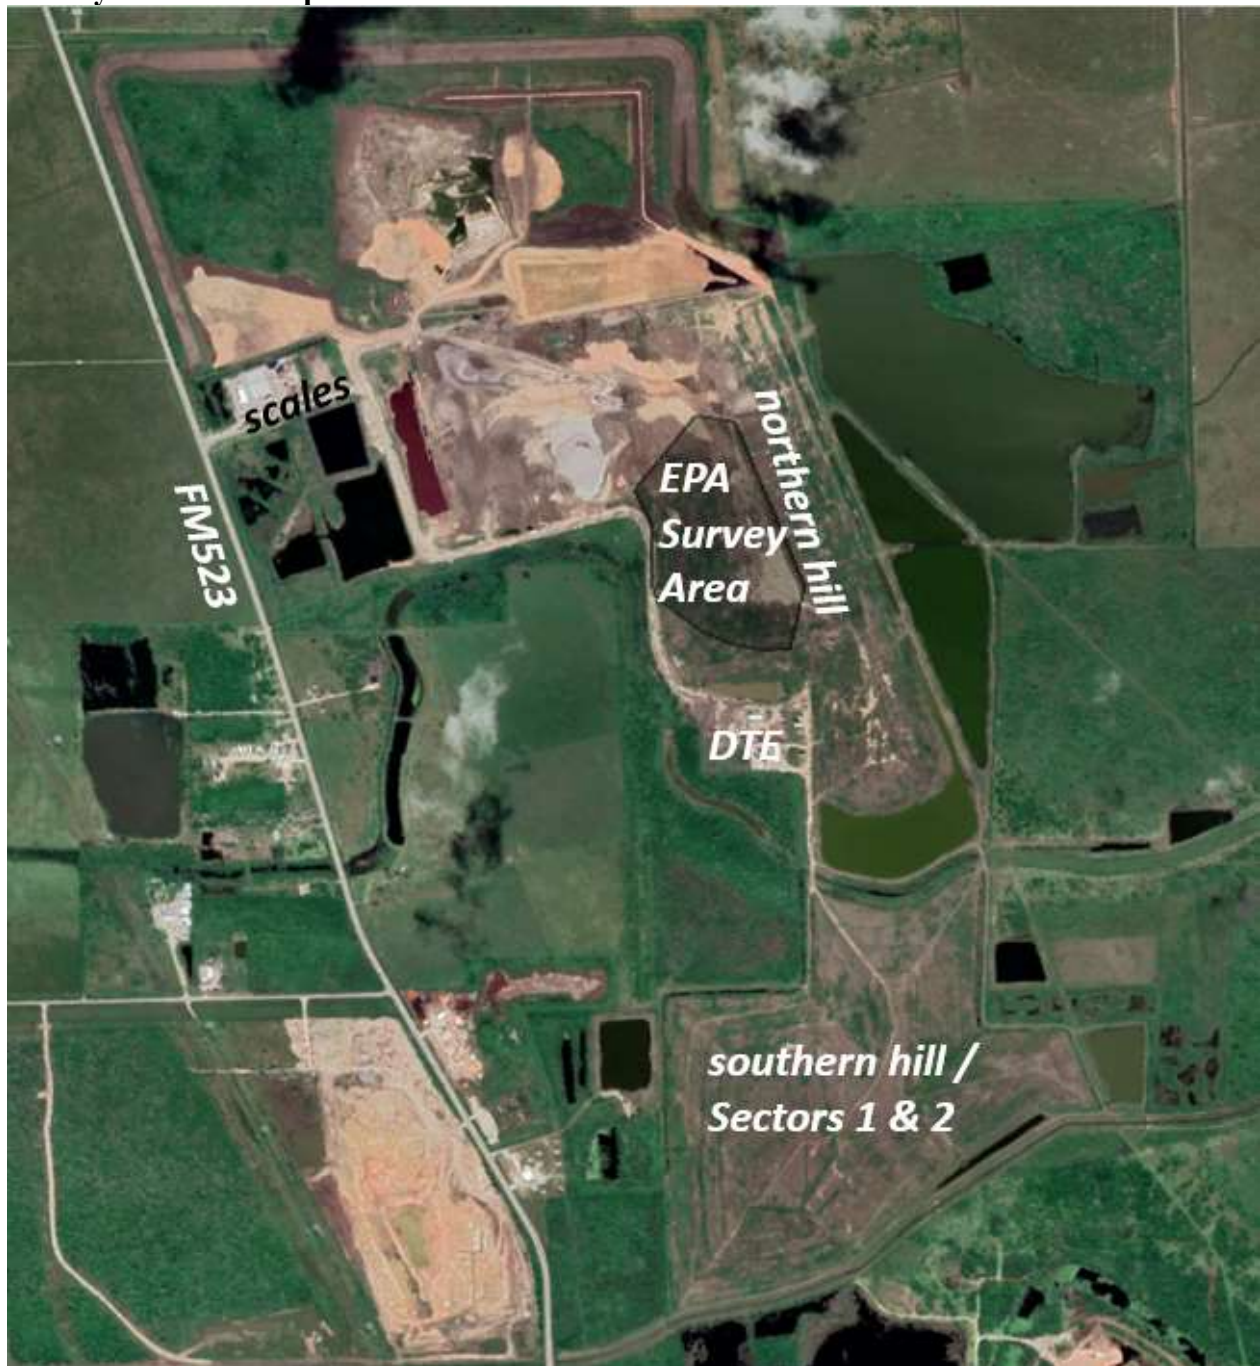
## Facility Overview Map

EPA annotations over Google Earth imagery dated 4/26/2022. Image is ~1.7 miles wide with north oriented up.
