**U.S. Environmental Protection Agency  
Region 5**

**Purpose:** Clean Water Act National Pollutant Discharge Elimination System Compliance Evaluation Inspection

**Facility:** Cleveland-Cliffs Inc. – Empire Mine  
County Road PEE  
Ishpeming, Michigan 49849

**Inspection Date:** September 13 - 15, 2022

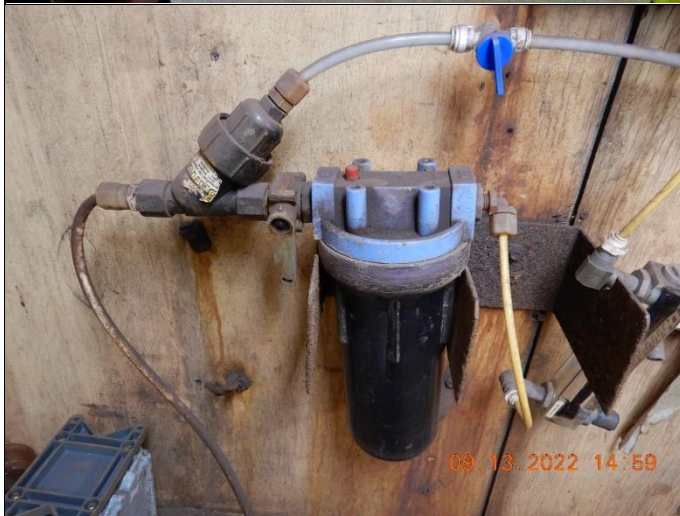
2: DSCN0961.JPG

Description: Filter on the water line with the continuous chlorine analyzer at the Tilden sewage treatment system.

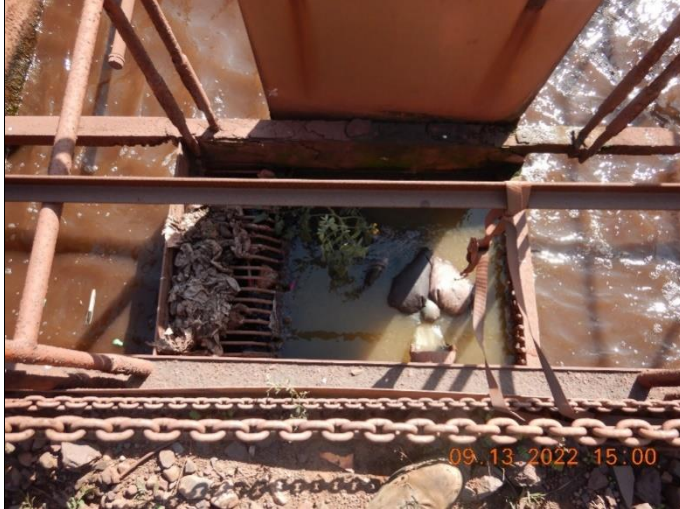
4: DSCN0963.JPG

Description: Tilden sewage treatment.

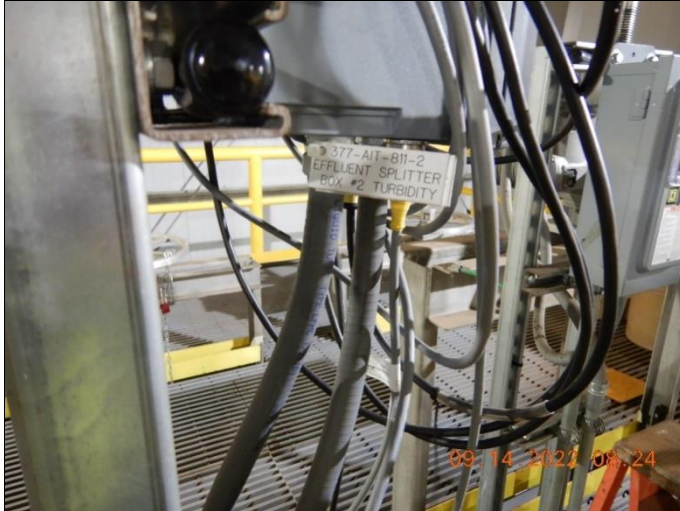
10: DSCN0969.JPG

Location: Tilden and Empire Mine  
Photographer: Jonathan Moody  
Date/Time: 9/14/2022 8:24 AM  
Description: At the Tilden mine treatment plant for the discharge from the Tilden tailings basin.

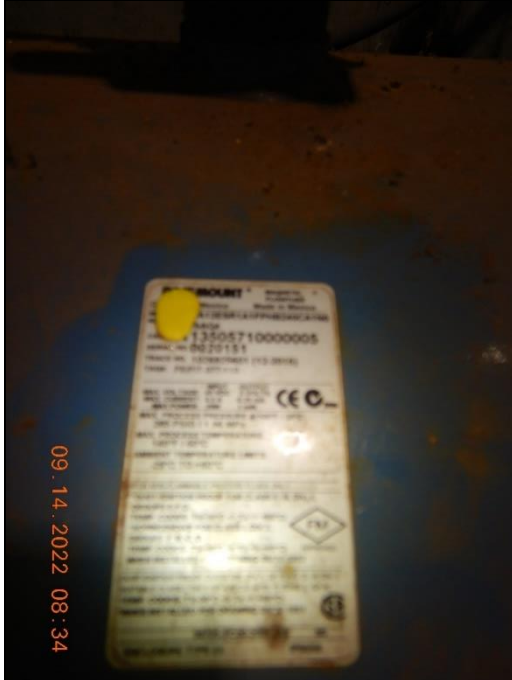
13: DSCN0972.JPG

Description: Label for the Rosemount flow meter at the influent to the treatment facility used for the Tilden mine tailings basin discharge.

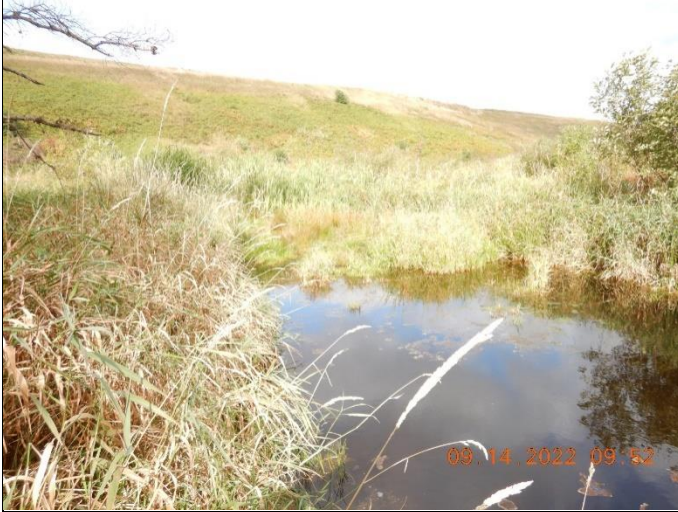
23: DSCN0987.JPG

- USEPA observed and conducted field monitoring on flowing water originating from a location near the toe of the outslope of the east side of the Tilden tailings basin, at a location north of the Gribben Clarification Facility. The waterway is shown in photos 19 through 24, including a video of the flowing water. This location is a possible daylighted seep, which is not monitored as an NPDES outfall, stormwater monitoring location, nor an SSMP location. USEPA field monitoring at this location showed a conductivity of greater than 1,000  $\mu\text{S}/\text{cm}$ , which is above the background values.

Location: Tilden and Empire Mine  
Photographer: Jonathan Moody  
Date/Time: 9/14/2022 9:52 AM  
Description: Location of possible daylighted seep at the east side of the tailings basin. The water had an iridescent sheen. Camera is looking upstream at the outslope of the tailings basin.

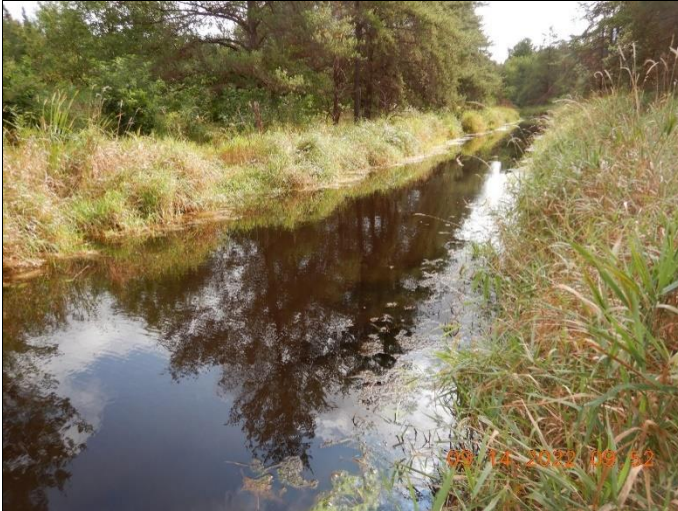
24: DSCN0988.JPG

Location: Tilden and Empire Mine  
Photographer: Jonathan Moody  
Date/Time: 9/14/2022 9:52 AM  
Description: Location of possible daylighted seep at the east side of the tailings basin. Camera is facing downstream. Location of monitoring point 04. Camera is facing downstream.

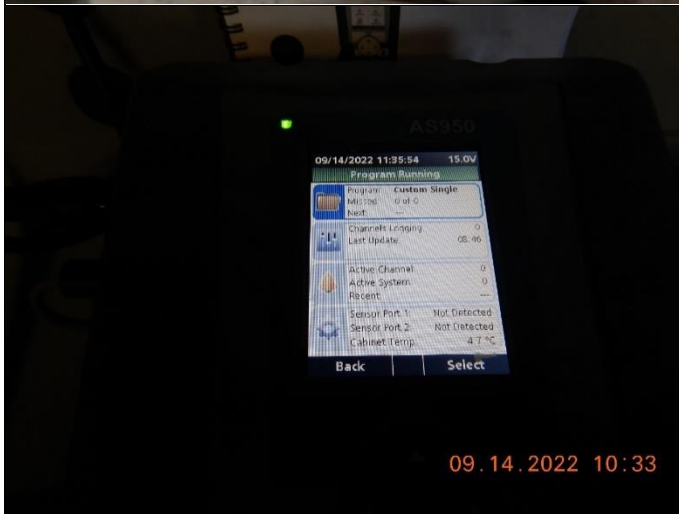
28: DSCN0992.JPG

Location: Tilden and Empire Mine  
Photographer: Jonathan Moody  
Date/Time: 9/14/2022 10:45 AM  
Description: At Empire outfall 001.

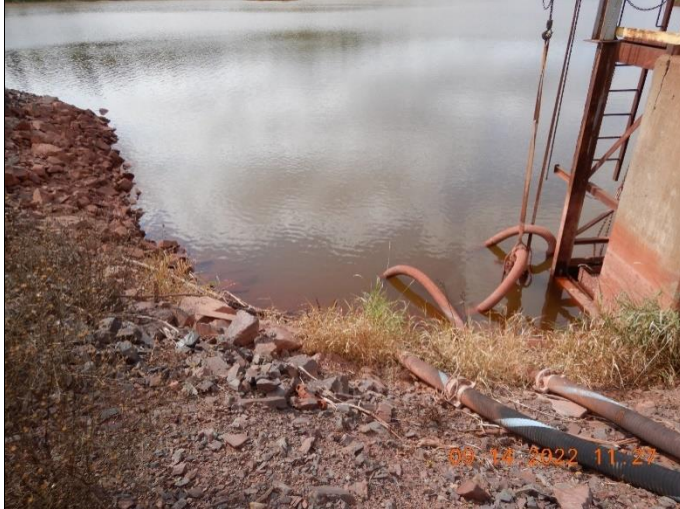
34: DSCN0998.JPG

Location: Tilden and Empire Mine  
Photographer: Jonathan Moody  
Date/Time: 9/14/2022 11:27 AM  
Description: Hoover pond at the control structure at the upstream end of the culvert shown in photo 29. Monitoring point 08.

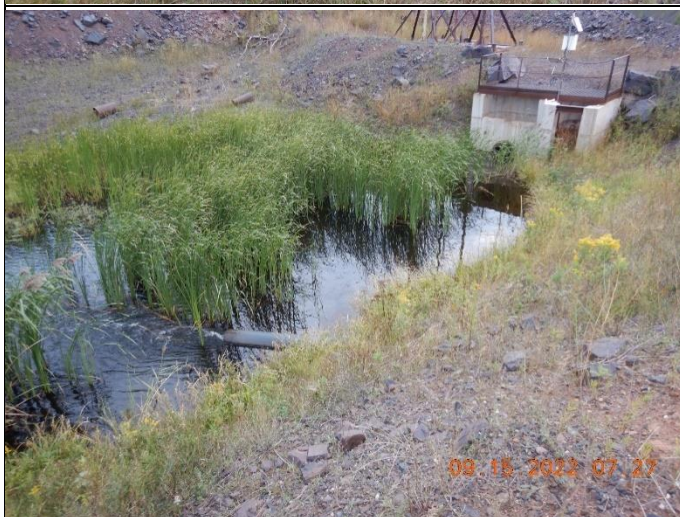
38: DSCN1002.JPG

- During the inspection, USEPA observed waste material from mining operations adjacent to a waterway known as Partridge Creek. Runoff from the slopes of the waste material would drain into a waterway flowing through a historic outfall 003. This is shown in Photos 37 through 42. The Facility representatives stated that NPDES compliance monitoring was no longer being conducted at this location because the discharge was not considered a wastewater. A copy of a cover letter from Michigan Department of Environmental Quality (now EGLE) on June 29, 2017, transmitting the compliance evaluation inspection notes from an April 27, 2017, visit at the Empire Mine (MI0000094) was given to EPA. The June 29, 2017 cover letter was provided as the record of the approval from EGLE. The June 29, 2017, letter references a low selenium concentration and no active mine pit dewatering as justification for changing the NPDES permit, which had expired in 2016.

Location: Tilden and Empire Mine  
Photographer: Jonathan Moody  
Date/Time: 9/15/2022 7:27 AM  
Description: At the historic Empire outfall 003, the pipe in the foreground is replenishment water.

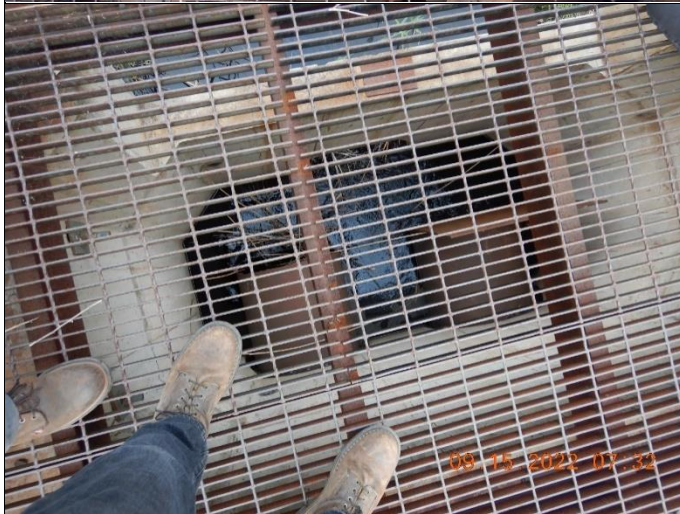
40: DSCN1004.JPG

Location: Tilden and Empire Mine  
Photographer: Jonathan Moody  
Date/Time: 9/15/2022 7:32 AM  
Description: Control structure at the historic Empire Outfall 003.

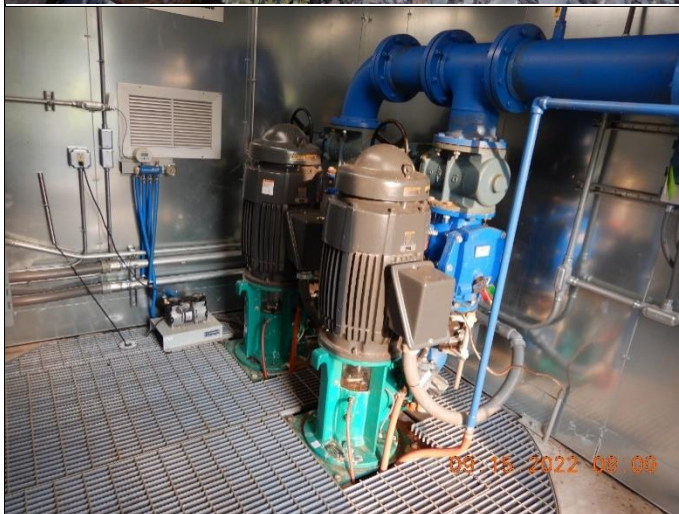
47: DSCN1011.JPG

Location: Tilden and Empire Mine  
Photographer: Jonathan Moody  
Date/Time: 9/15/2022 8:09 AM  
Description: Inside collection system pump house at CC-95.

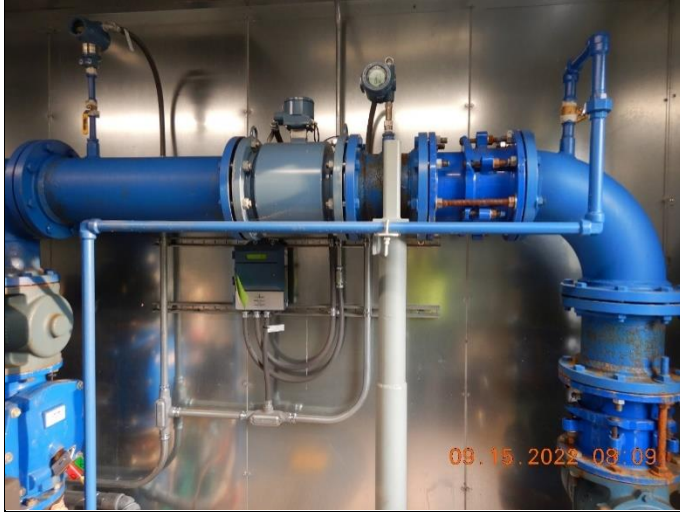
48: DSCN1012.JPG

Location: Tilden and Empire Mine  
Photographer: Jonathan Moody  
Date/Time: 9/15/2022 8:09 AM  
Description: Inside collection system pump house at CC-95. Flow meter shown in this photo.

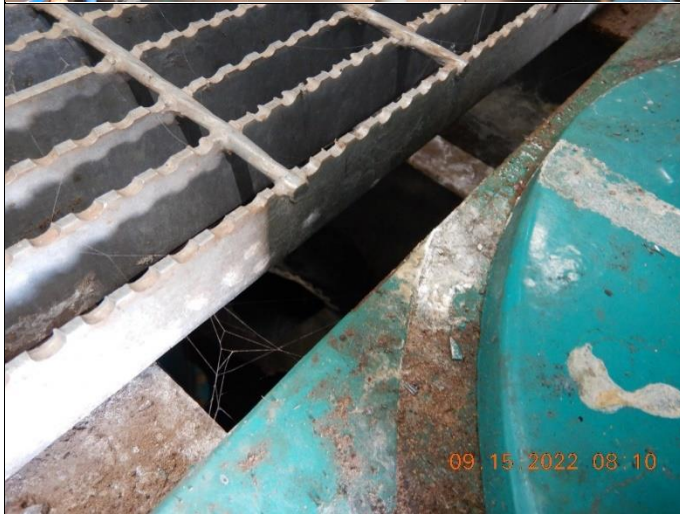
49: DSCN1013.JPG

Location: Tilden and Empire Mine  
Photographer: Jonathan Moody  
Date/Time: 9/15/2022 8:10 AM  
Description: An overflow weir could be seen under the grating in the pump house for location CC-95. The water level in the wet well for this pump station was below the overflow weir elevation. If the water level in the wet well exceeds the weir it will discharge out the structure shown in photo 45.

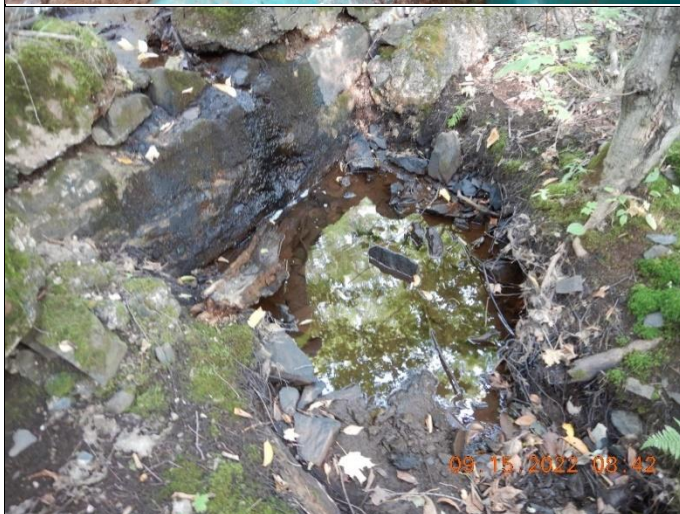
50: DSCN1014.JPG

Location: Tilden and Empire Mine  
Photographer: Jonathan Moody  
Date/Time: 9/15/2022 8:42 AM  
Description: At stormwater monitoring location '12' or CC-175. Stormwater is monitored at the location shown in this photo, as the water flows over the end of a small stone bridge. EPA monitoring location 13.

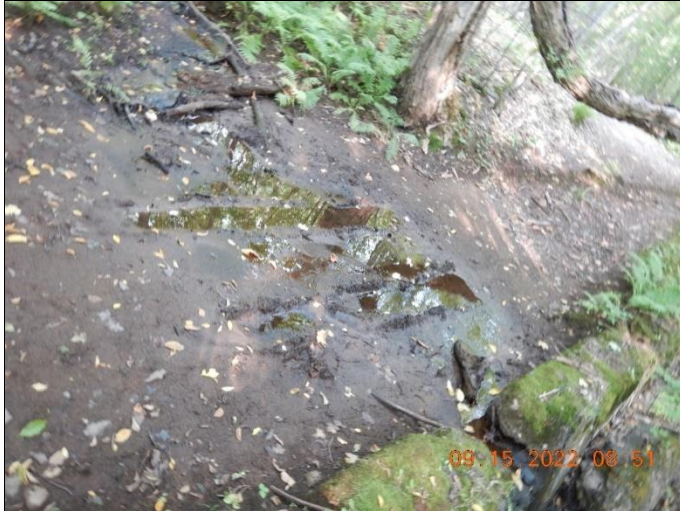
51: DSCN1015.JPG

Location: Tilden and Empire Mine  
Photographer: Jonathan Moody  
Date/Time: 9/15/2022 8:42 AM  
Description: At stormwater monitoring location '12' or CC-175. Looking downstream from where stormwater monitoring occurs.

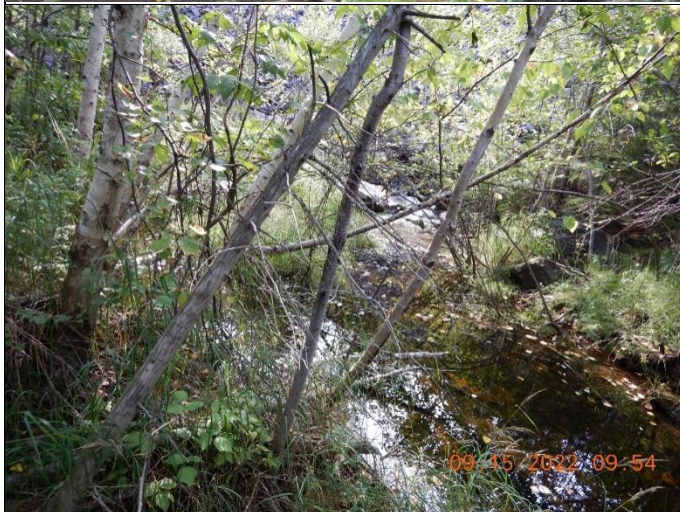
52: DSCN1016.JPG

Location: Tilden and Empire Mine  
Photographer: Jonathan Moody  
Date/Time: 9/15/2022 8:51 AM  
Description: At stormwater monitoring location '12' or CC-175. Location where stormwater flows across the top of a bridge for a rough pathway upstream of where stormwater monitoring occurs.

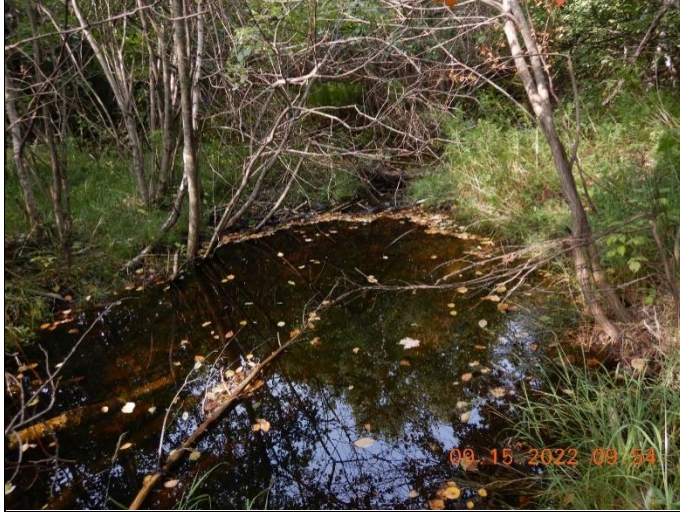
53: DSCN1017.JPG

Location: Tilden and Empire Mine  
Photographer: Jonathan Moody  
Date/Time: 9/15/2022 9:54 AM  
Description: At stormwater monitoring location '12' or CC-175. Looking upstream of where stormwater monitoring occurs.

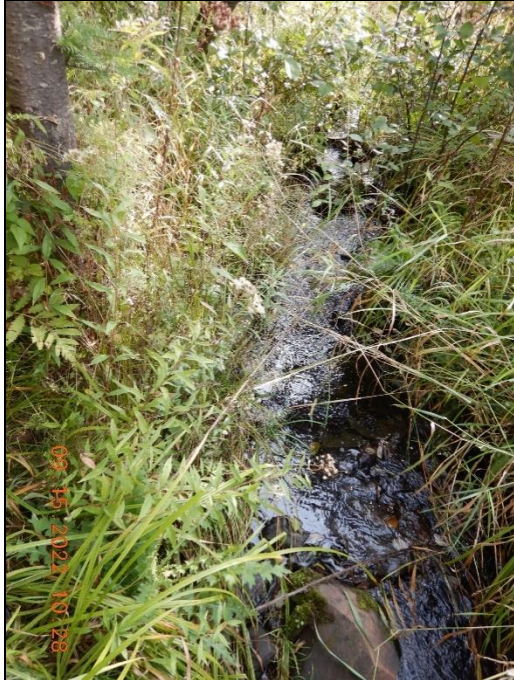
54: DSCN1018.JPG

Location: Tilden and Empire Mine  
Photographer: Jonathan Moody  
Date/Time: 9/15/2022 9:54 AM  
Description: At stormwater monitoring location '12' or CC-175. Looking upstream of where stormwater monitoring occurs.

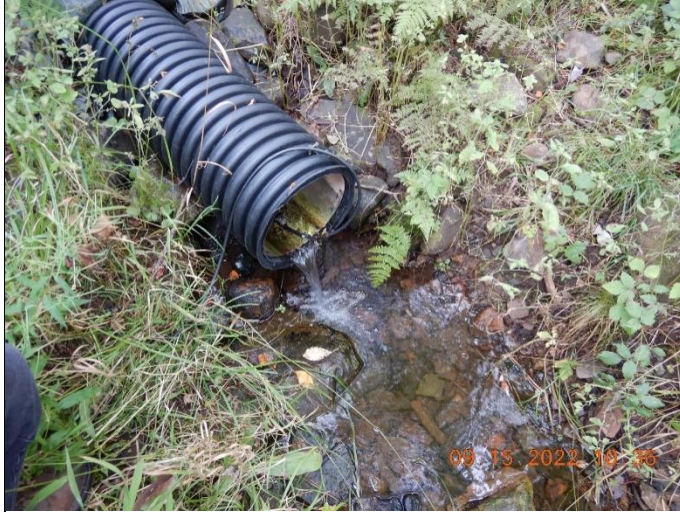
56: DSCN1020.JPG

- Locations CC-291 and CC-292 were not in the current version of the SWPPP available during the inspection, and are not associated with an NPDES outfall. USEPA field monitoring during the inspection showed a specific conductivity of 623  $\mu\text{S}/\text{cm}$  and 439  $\mu\text{S}/\text{cm}$  respectively. At the time of the inspection, these monitoring locations were flowing despite dry weather conditions.
- During the inspection, USEPA observed unvegetated rock piles in the tributary for the water flowing to the control structure for the historic Empire outfall E003.
- Several on-site water bodies present with dark orange coloring, suggesting high levels of iron and conductivity within the water.
  - Stormwater monitoring location '13' or CC-179, was visited during the inspection. The water at this location had an unnatural red color and is shown in photo 63.

Location: Tilden and Empire Mine  
Photographer: Jonathan Moody  
Date/Time: 9/15/2022 10:28 AM  
Description: At the location of stormwater monitoring location CC-292. At the time of the inspection, the depth of the water at this location was several inches. EPA monitoring location 15.

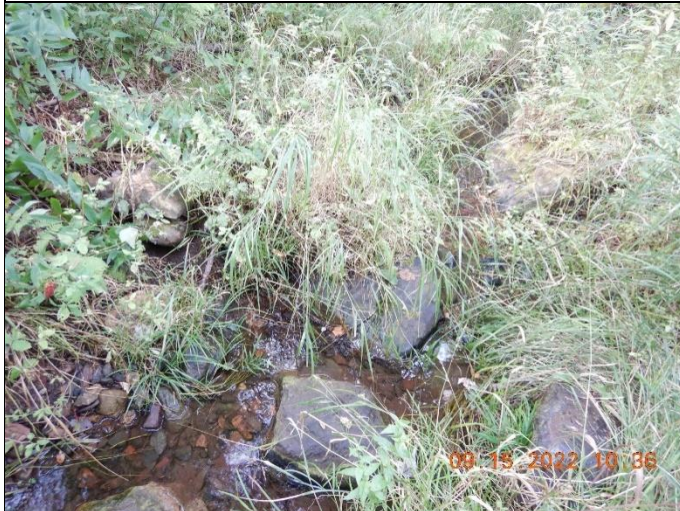
57: DSCN1021.JPG

Location: Tilden and Empire Mine  
Photographer: Jonathan Moody  
Date/Time: 9/15/2022 10:36 AM  
Description: At the location of the selenium monitoring location CC-291. EPA monitoring location 16.

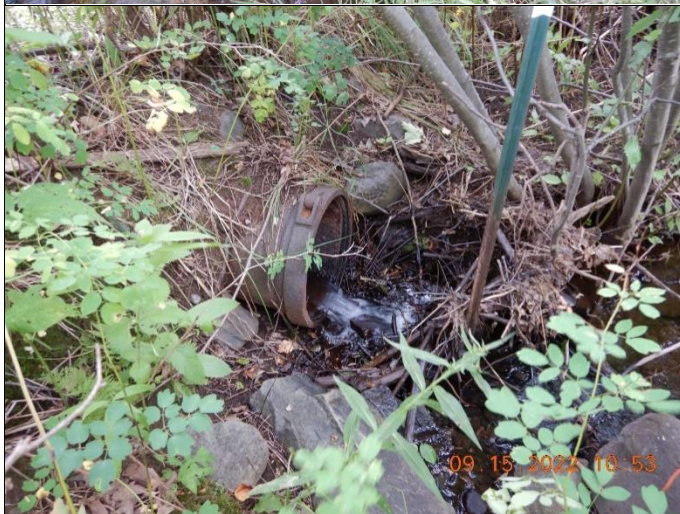
58: DSCN1022.JPG

Location: Tilden and Empire Mine  
Photographer: Jonathan Moody  
Date/Time: 9/15/2022 10:36 AM  
Description: Downstream of the location of the selenium monitoring location CC-291.

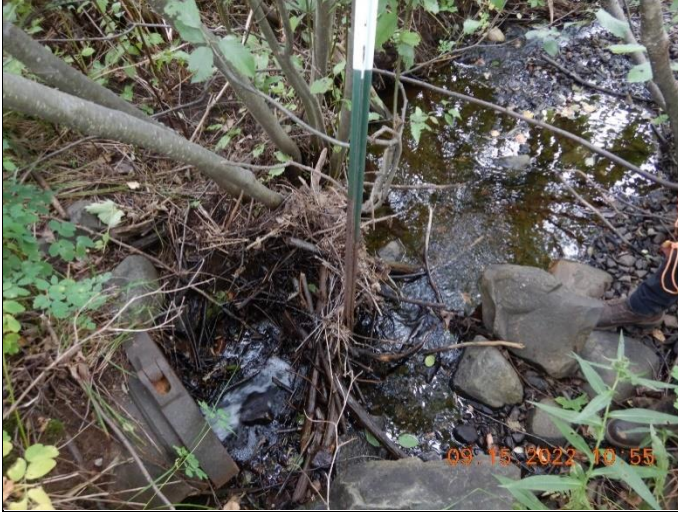
59: DSCN1023.JPG

- Stormwater monitoring location 'M' or CC-93: the SWPPP shows that the rock stockpiles are a source of exposure in the tributary to this location. Field monitoring conducted by USEPA showed a conductivity of 585  $\mu\text{S}/\text{cm}$  , which is above the background values. At the time of the inspection, this stormwater monitoring location was flowing despite dry weather conditions.

Location: Tilden and Empire Mine  
Photographer: Jonathan Moody  
Date/Time: 9/15/2022 10:53 AM  
Description: At the location of the stormwater monitoring location 'M' or CC-93.

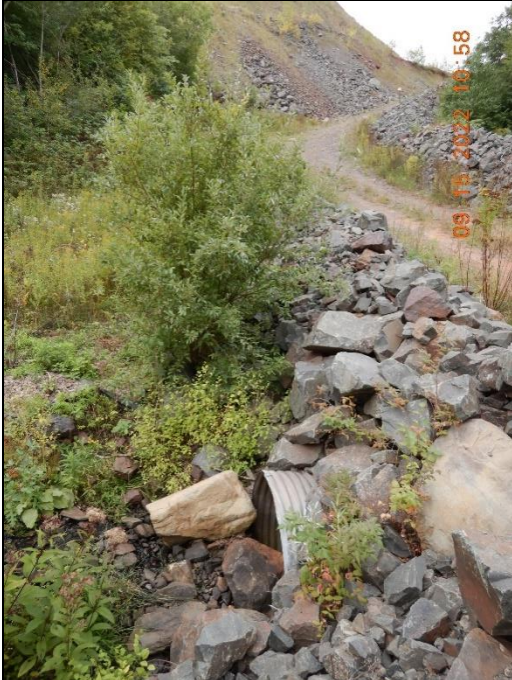
60: DSCN1024.JPG

Location: Tilden and Empire Mine  
Photographer: Jonathan Moody  
Date/Time: 9/15/2022 10:55 AM  
Description: At the location of the stormwater monitoring location 'M' or CC-93.

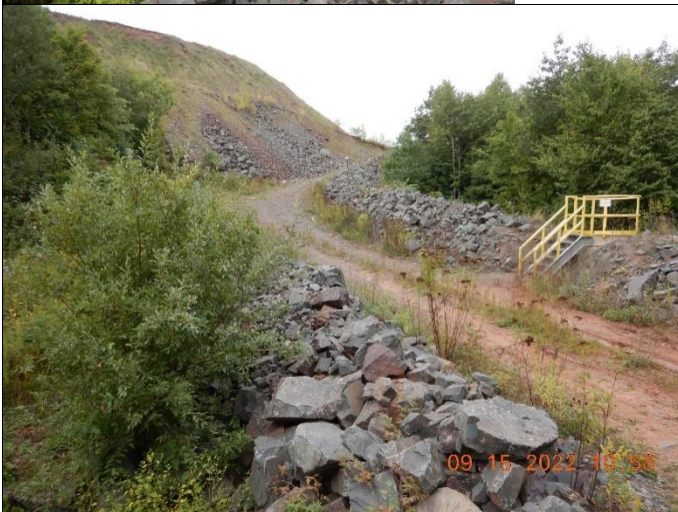
61: DSCN1025.JPG

Location: Tilden and Empire Mine  
Photographer: Jonathan Moody  
Date/Time: 9/15/2022 10:58 AM  
Description: Upstream of the stormwater monitoring location 'M' or CC-93.

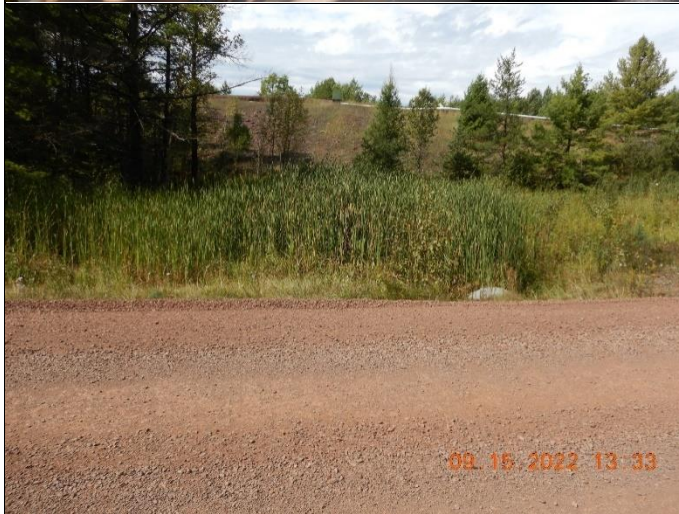
63: DSCN1027.JPG

Location: Tilden and Empire Mine  
Photographer: Jonathan Moody  
Date/Time: 9/15/2022 1:30 PM  
Description: At the location of the stormwater monitoring location '13' or CC-179. This was the upstream end of a culvert under the County Road 476. At the time of the inspection, the water in this culvert had an unnatural red color. EPA monitoring location 18.
