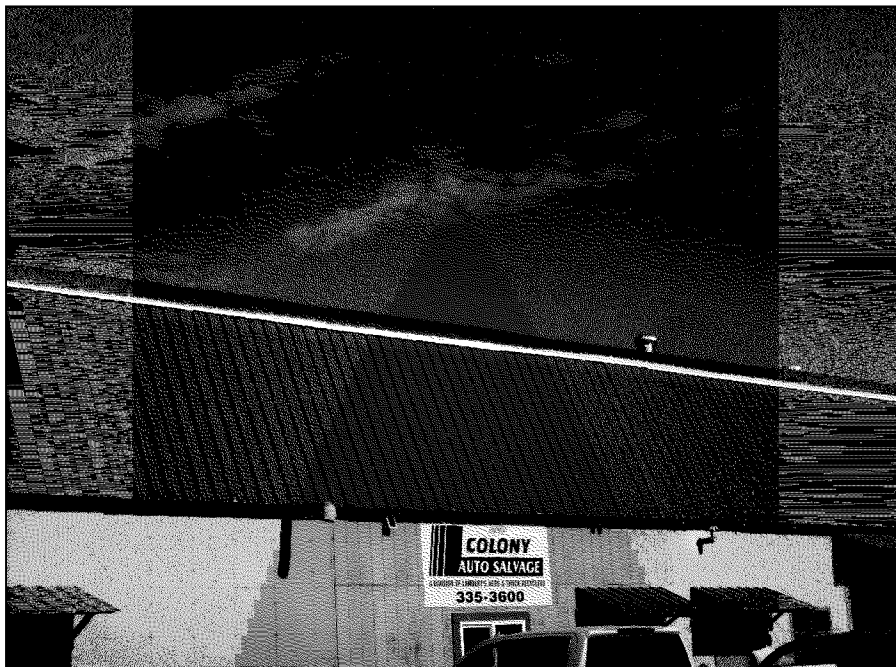
**Photograph 20.** Colony Auto Parts LLC 10/24/2024 11:24 DSCN9065.JPG

Description: View of the Facility's signage and main building.
