# NPDES Compliance Inspection Report

## Preserve at Illahee Springs

NPDES Permit Tracking Number  
# WAR306947

Inspection Dates: 01/28/2021 & 02/11/2021

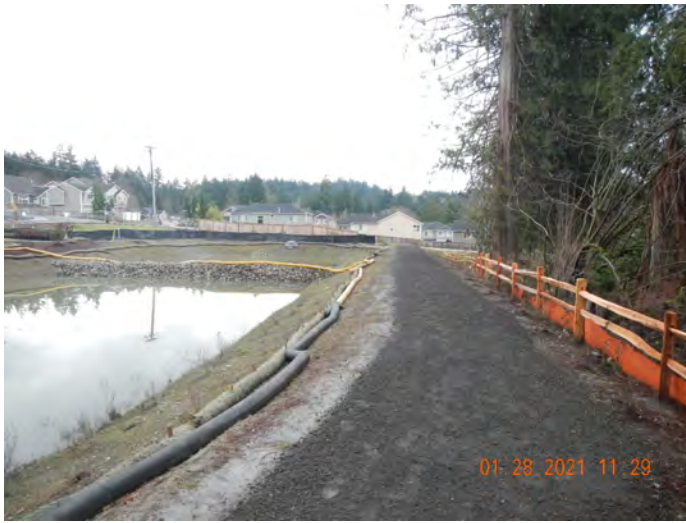
Photo #:01 (DSCN2018)

Description: Facing south from along the southwest perimeter of the site, photo of the stormwater detention pond serving the Phase 1 area and silt fencing installed along the site perimeter. Stormwater is pumped from the pond to the on-site treatment system and then discharged.

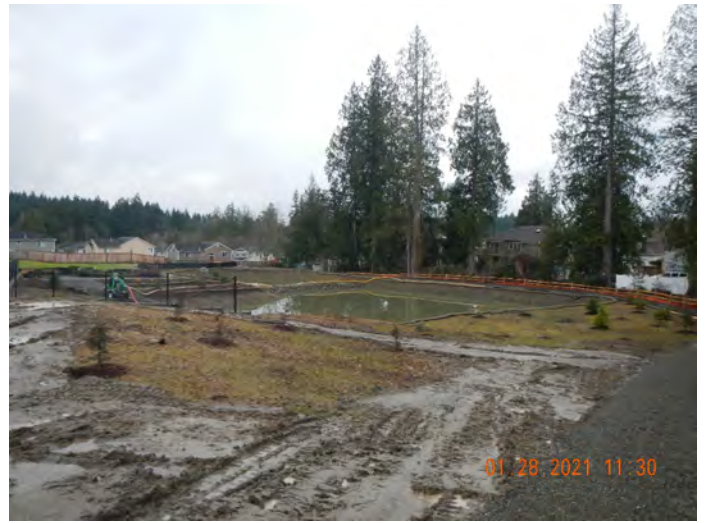
Photo #:02 (DSCN2019)

Description: Facing south along the southwest perimeter, photo of the stormwater detention pond serving the Phase 1 area. Stormwater is pumped from the pond to the Phase 3 on-site treatment system and then discharged.

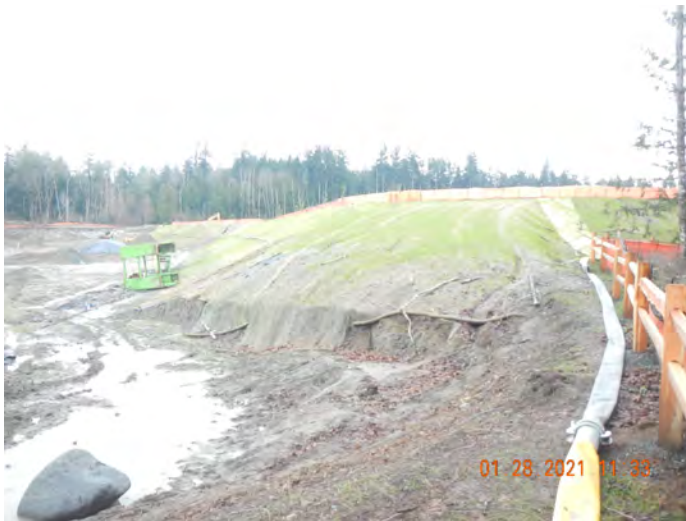
Photo #:03 (DSCN2020)

Description: Facing southeast from the northwest corner of the site, photo of the Phase 3 area and hose that conveys stormwater from the southwest detention pond.

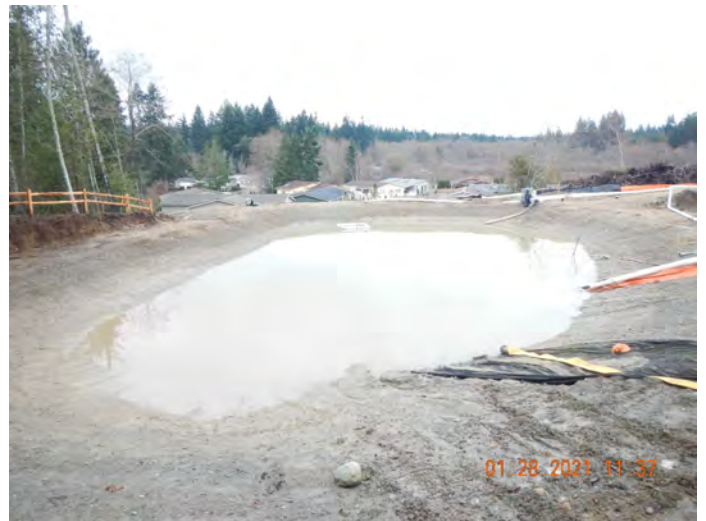
Photo #:04 (DSCN2021)

Description: Facing north from the northwest corner of the site, photo of the temporary detention pond that receives pumped stormwater from the Phase 1 area and then feeds the stormwater treatment system prior to discharge.

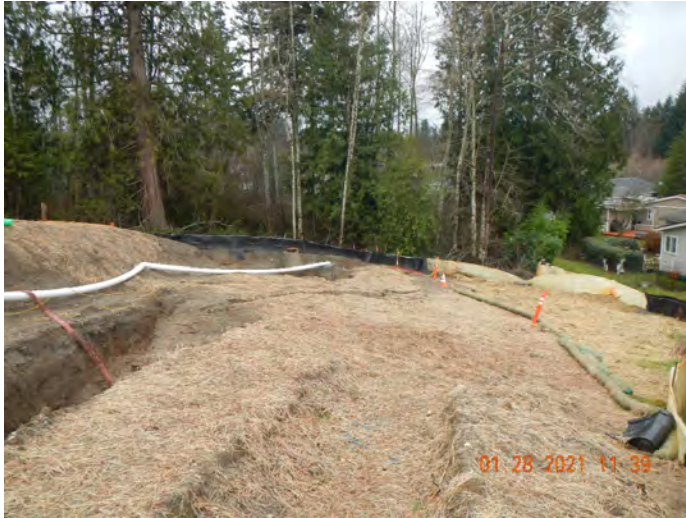
Photo #:05 (DSCN2022)

Description: Facing west from the northwest corner of the site, photo of the temporary stabilized area within Phase 3 and stormwater discharge pipe from the on-site treatment system.

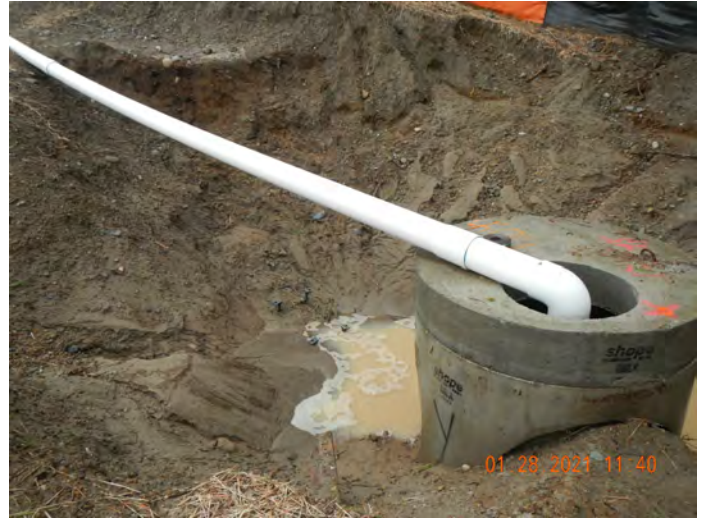
Photo #:06 (DSC2023)

Description: Facing south, photo of the site's discharge pipe entering the on-site Kitsap Country stormwater system manhole.

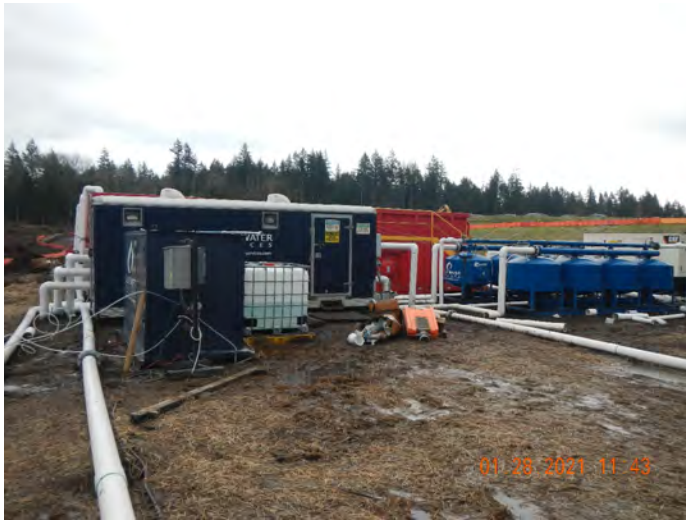
Photo #:07 (DSCN2024)

Description: Facing east from the northwest corner of the site, photo of the Clear Water Services on-site treatment system.

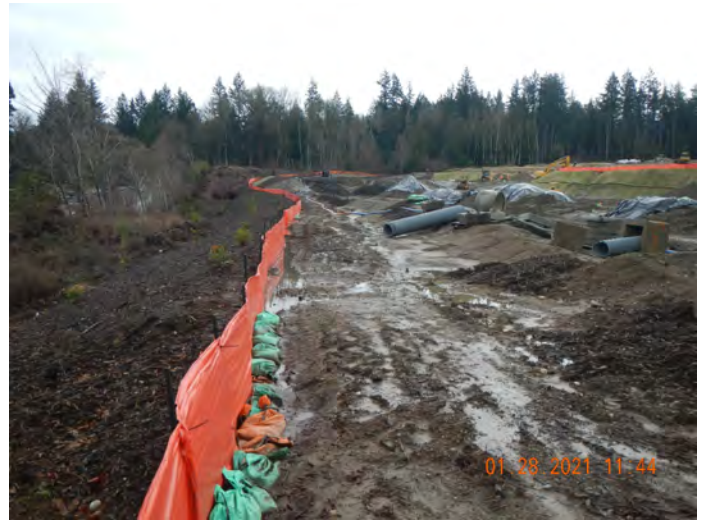
Photo #:08 (DSCN2025)

Description: Facing east, photo showing silt fencing along the northern perimeter within the Phase 3 area.

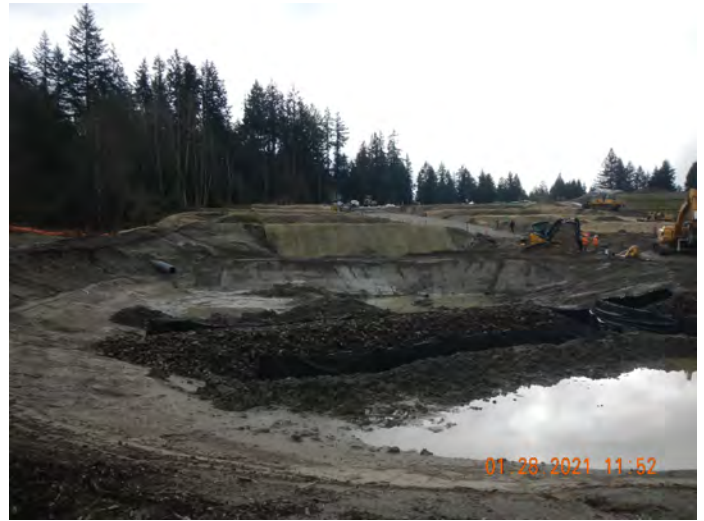
Photo #:10 (DSC2027)

Description: Facing south from the northeast corner of the site, photo of a temporary holding pond for stormwater collecting along the eastern perimeter.

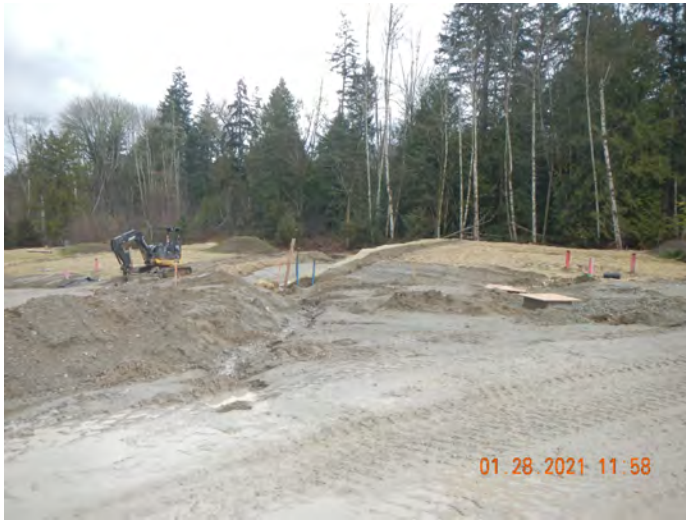
Photo #:13 (DSCN2030)

Description: Facing east from within the Phase 2 area, photo of the beginning of the stormwater conveyance channel that intercepts and runs along the eastern perimeter.

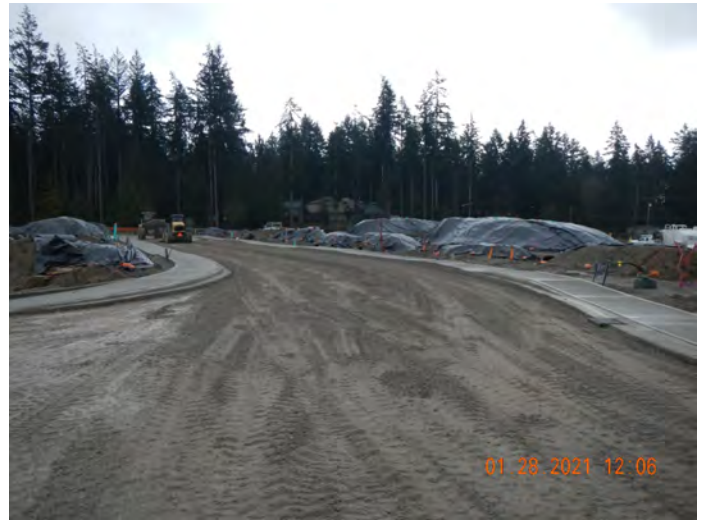
Photo #:14 (DSC2031)

During our site tour on January 28, 2021, I observed dry and wet utilities installed along the southern areas of Phase 2, sidewalks and curbing had recently been installed (**Photo 14**). Phase 3 had yet to be graded and material was actively being moved. Phase 3 areas were generally used for stockpiling material and were being prepped for wet utility installation (**Photo 8 and Photo 9**). Slopes for one of the Phase 2/3 stormwater detention ponds appeared to be recently graded (**Photo 10**). During our site tour on February 11, 2021, additional sidewalks and curbing had been installed within the Phase 2 area. Curbing had also extended into portions of the Phase 3 area, it also appeared that wet utilities were being installed in some Phase 3 areas.

Description: Facing south from within the central area of the site, photo of curbing and walkways recently completed. Stockpiles in this area were generally covered.

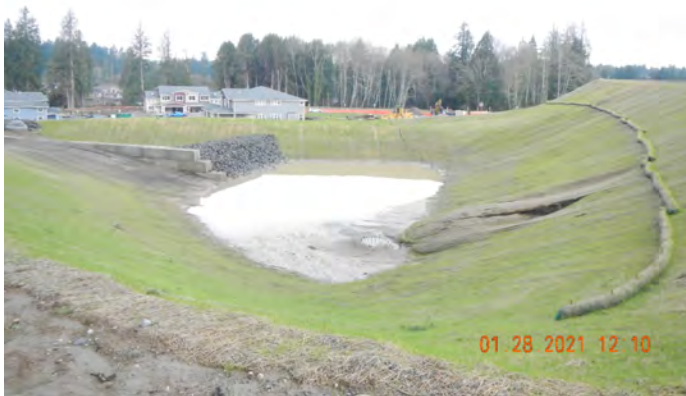
Photo #:15 (DSCN2032)

Stormwater from Phase 2 areas is routed or conveyed to two detention ponds, one is a smaller pond located along the souther perimeter (**Photo 15**) and the other is a larger pond located in the northeast corner of the development (**Photo 10**). Stormwater from the Phase 3 area was being collected in a temporary pond that will later be reconstructed as part of the final design (**Photo 3**).

Description: Facing north, photo of a stormwater detention pond located along the southern perimeter of the site. The Pond receives stormwater from the southern portion of the Phase 2 area.

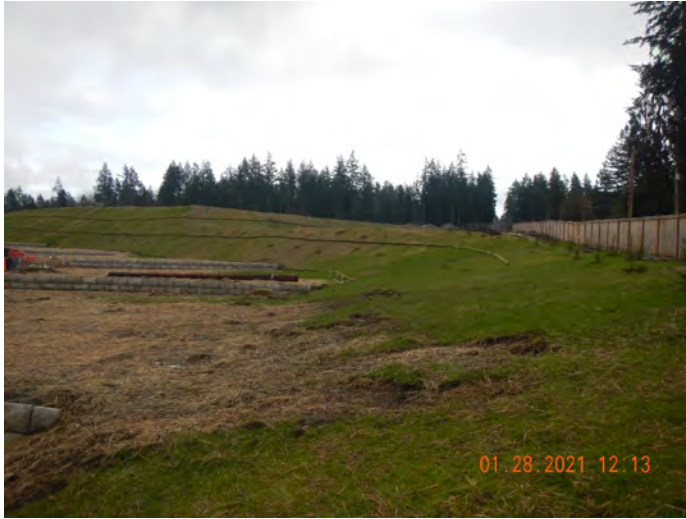
Photo #:17 (DSCN2034)  
Description: Facing east, photo of the stabilized areas near the southwest corner of the development.

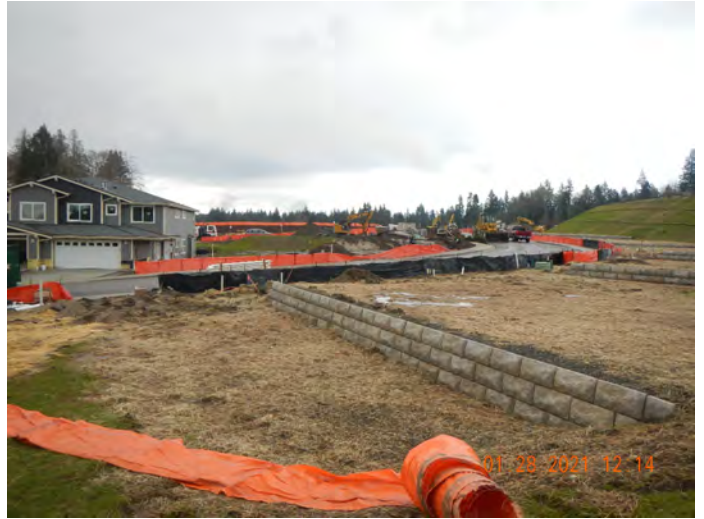
At the time of inspection, all three phases of the housing development had been cleared of vegetation and were generally engaged in active construction. Some of the Phase 1 homes appeared to be nearing the end of construction and some Phase 1 lots appeared empty but prepared and stabilized (**Photo 18**). Phase 1 is generally located within the southwest corner of the development, access to this area and the project's office trailer is from a paved entrance off of NE McWilliams Road near the southwest corner of the development.

Photo #:18 (DSCN2035)  
Description: Facing north, photo of the Phase 1 area just east of the main entrance.

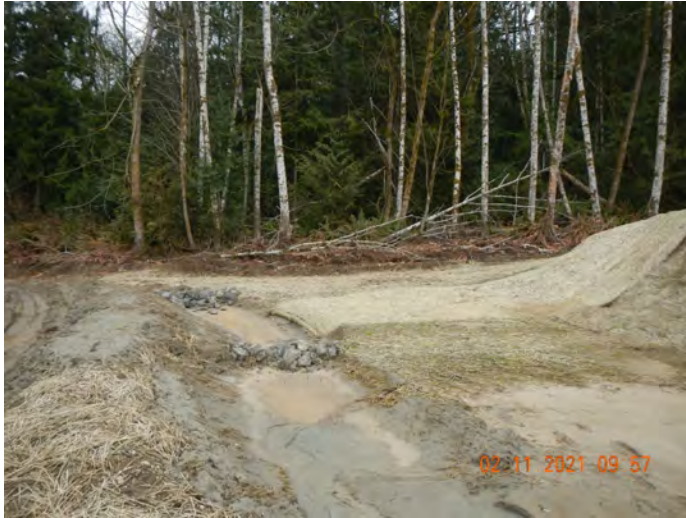
Photo #:21 (DSCN2047)

Description: Facing east from within the Phase 2 area, photo of the beginning of the stormwater conveyance channel that runs along the eastern perimeter. Photo taken on 02/11/21.

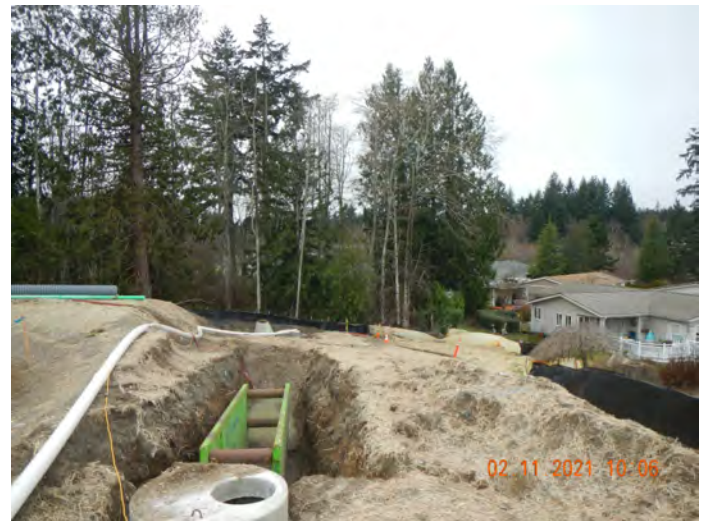
Photo #:24 (DSCN2050)

Description: Facing west from the northwest corner of the site, photo of the temporary stabilized area within Phase 3 and stormwater discharge pipe from the on-site treatment system. Photo taken 02/11/21.

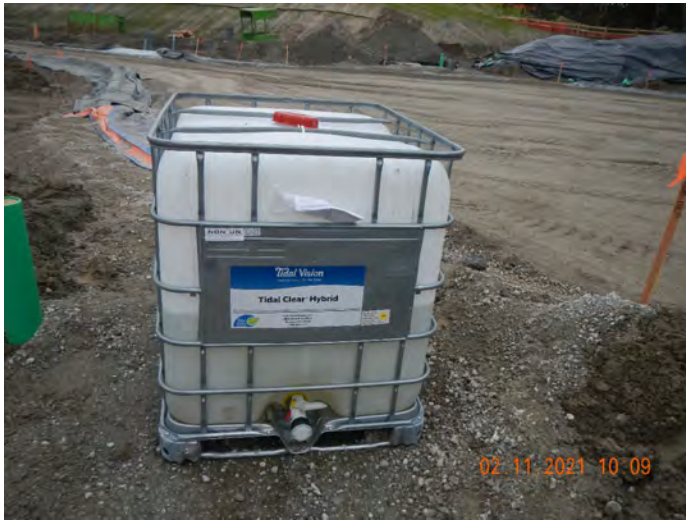
Photo #:25 (DSCN2051)

Description: Facing southeast, photo of tote staged near the on-site treatment system. Photo taken 02/11/21.

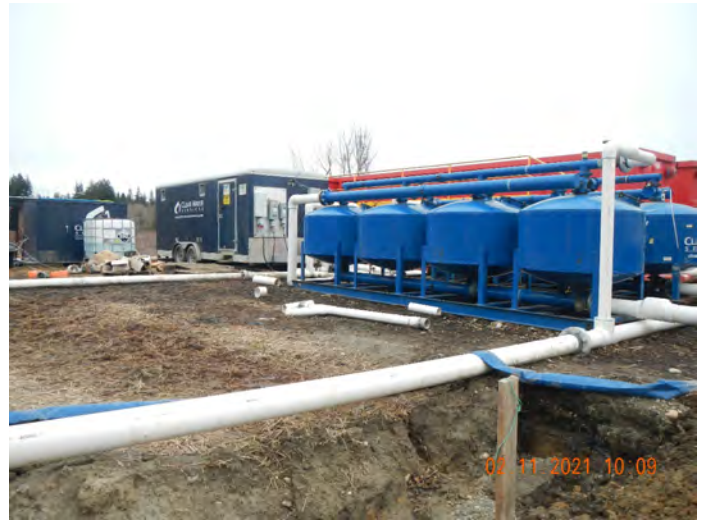
Photo #:26 (DSC2052)

Description: Facing north, photo of the on-site treatment system. Photo taken on 02/11/21.

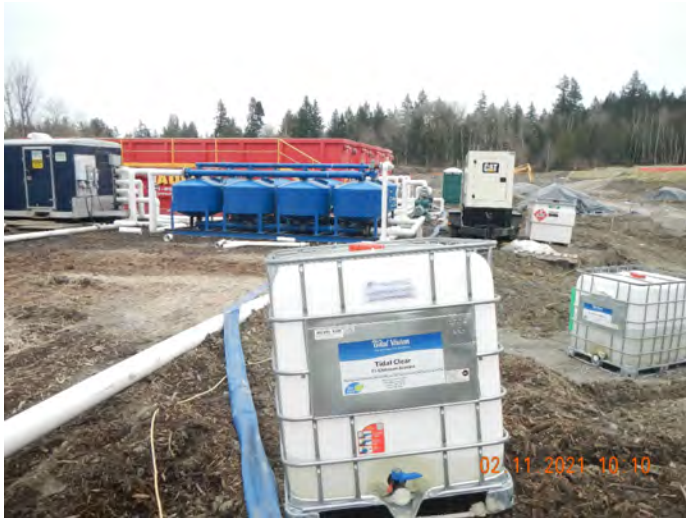
Photo #:27 (DSCN2053)

Description: Facing east, photo of the on-site treatment area along the northern edge of Phase 3 area. Photo taken on 02/11/2021.

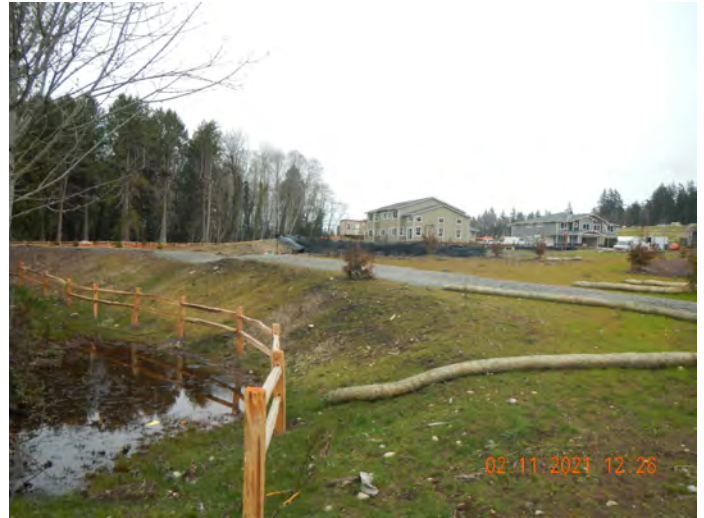
Photo #:28 (DSCN2075)

Description: Facing northeast, photo taken from McWilliams Road of the stabilized area southwest of the detention pond serving the Phase 1 area. Photo taken on 02/11/2021.
