## Region 6 - Enforcement & Compliance Assurance Division

### INSPECTION REPORT

| Company Name: | <b>LBOC, LLC</b> | |
| Facility Name: | <b>Baker Sand Unit Tank Battery</b> | |

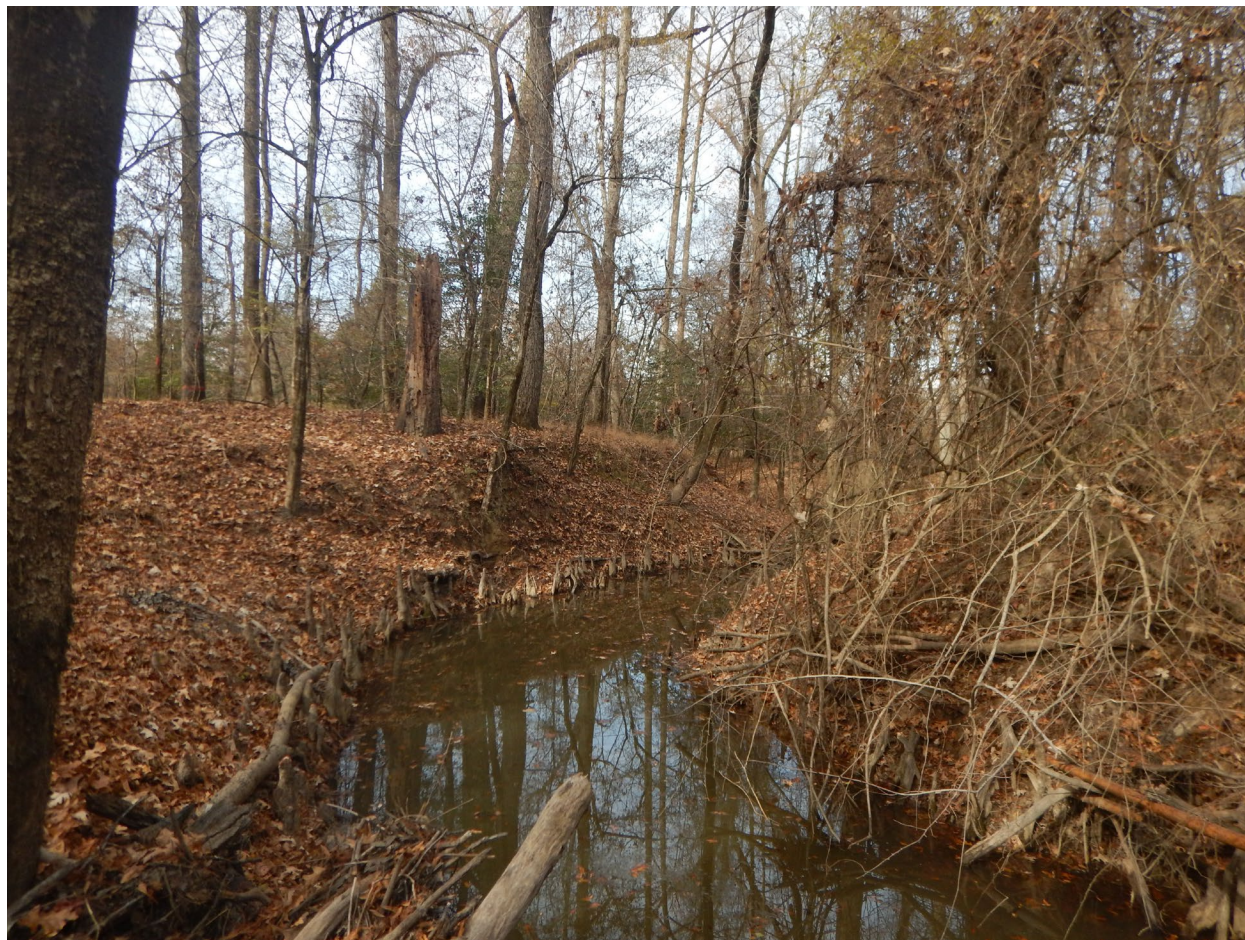
**Photo File Name:** 6216

**Description:** This photo was taken looking N, from river left facing downstream of the unnamed tributary 2. The TDS field reading observed in photo No. 12 was taken at this location.

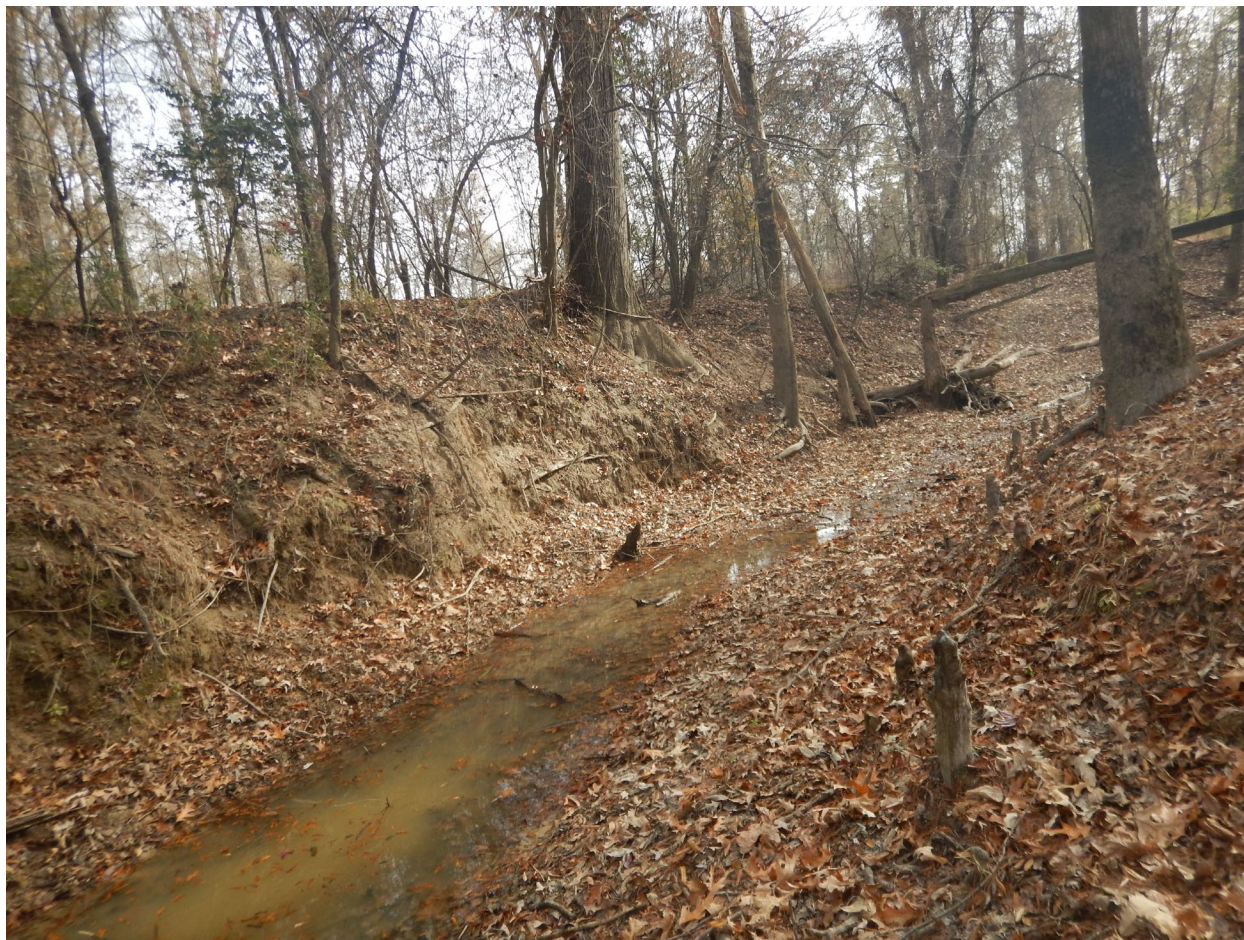
**Photo File Name:** 6217

**Description:** This photo was taken looking S, from river left facing upstream of the unnamed tributary 2. The TDS field reading observed in photo No. 12 was taken at this location.

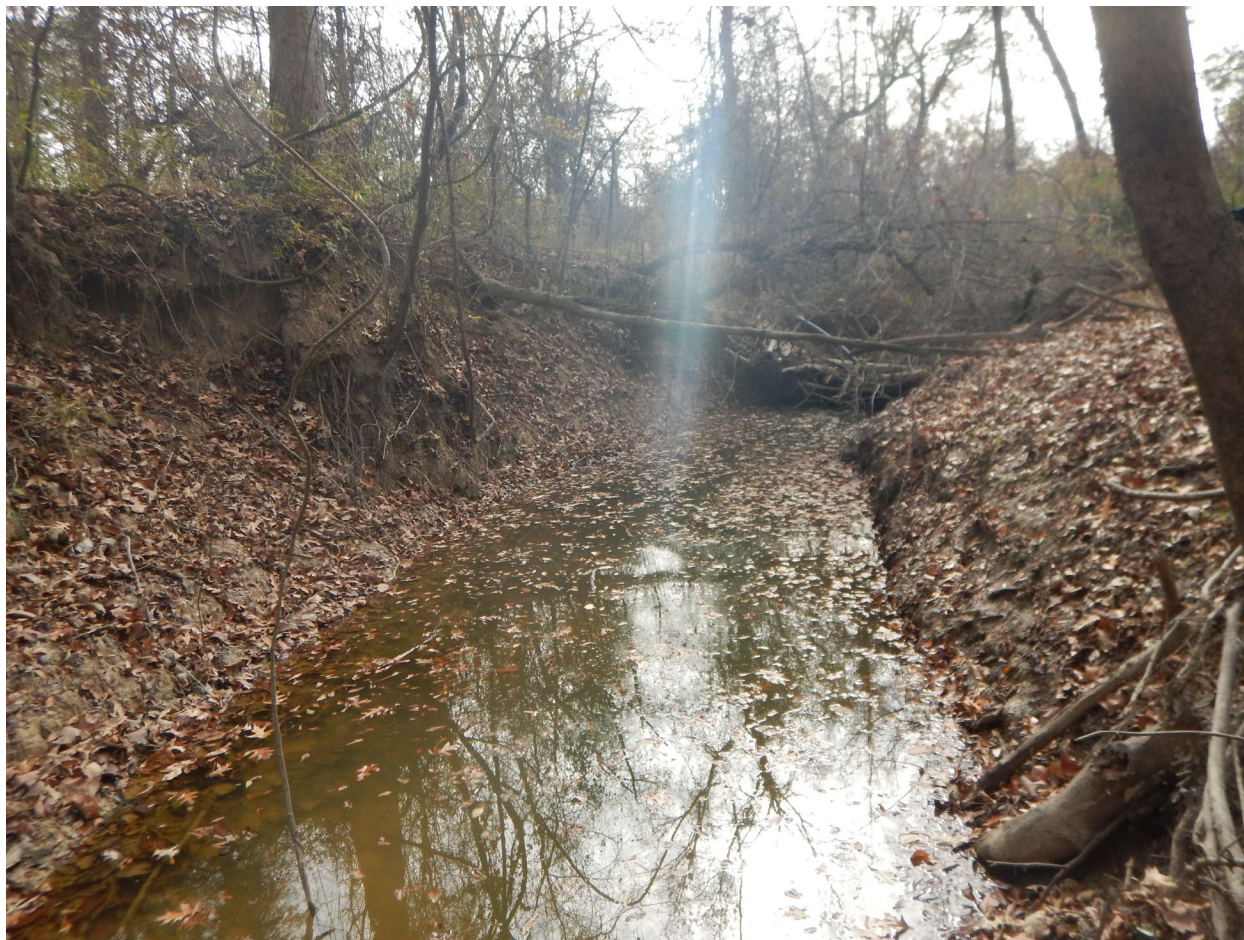
**Photo File Name:** 6218

**Description:** This photo was taken looking S, from the stream bed facing upstream of the unnamed tributary 2. The TDS field reading observed in photo No. 16 was taken at this location.

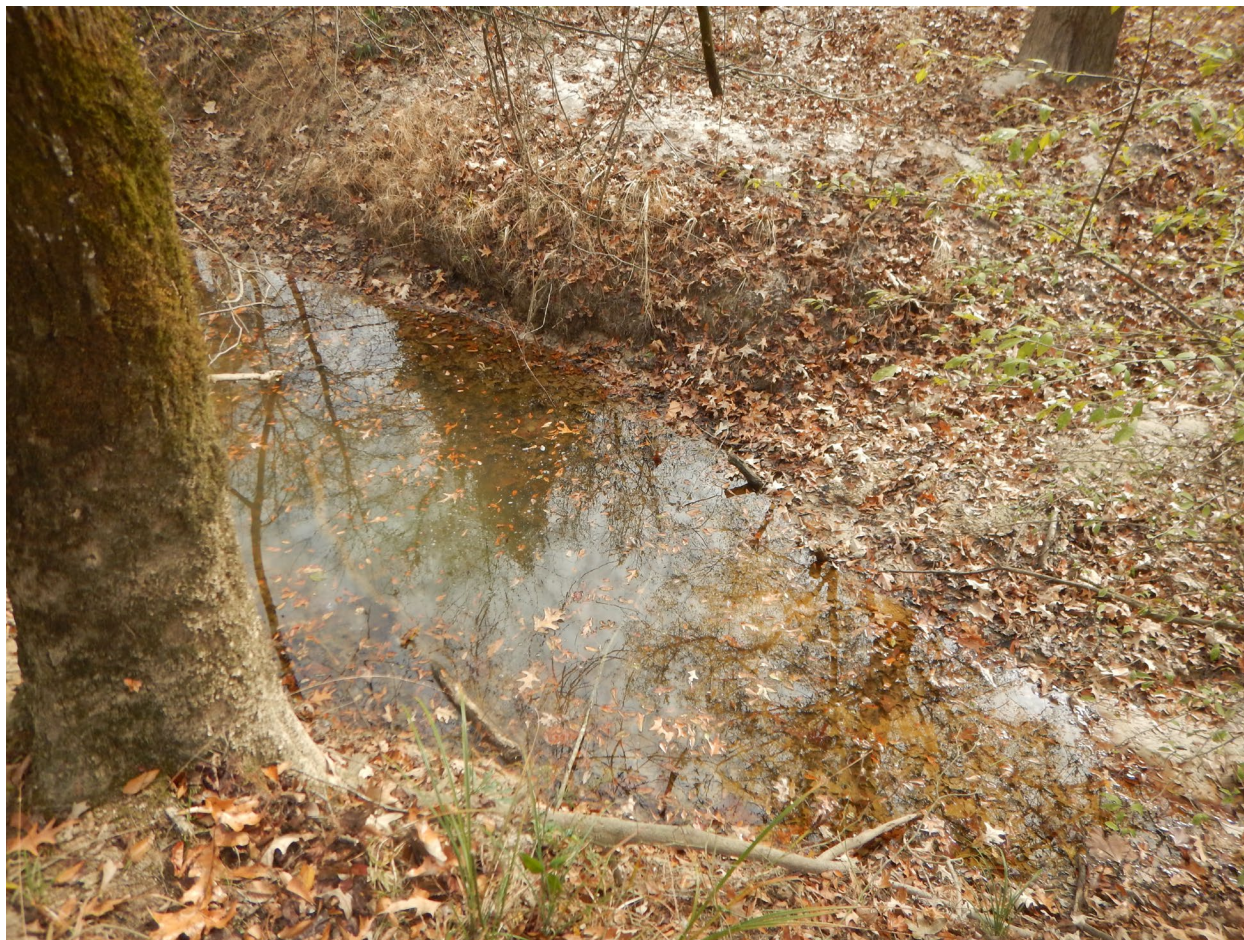
**Photo File Name:** 6221

**Description:** This photo was looking E, from river left across to river right of the unnamed tributary 2. The TDS field reading observed in photo No. 17 was taken at this location.

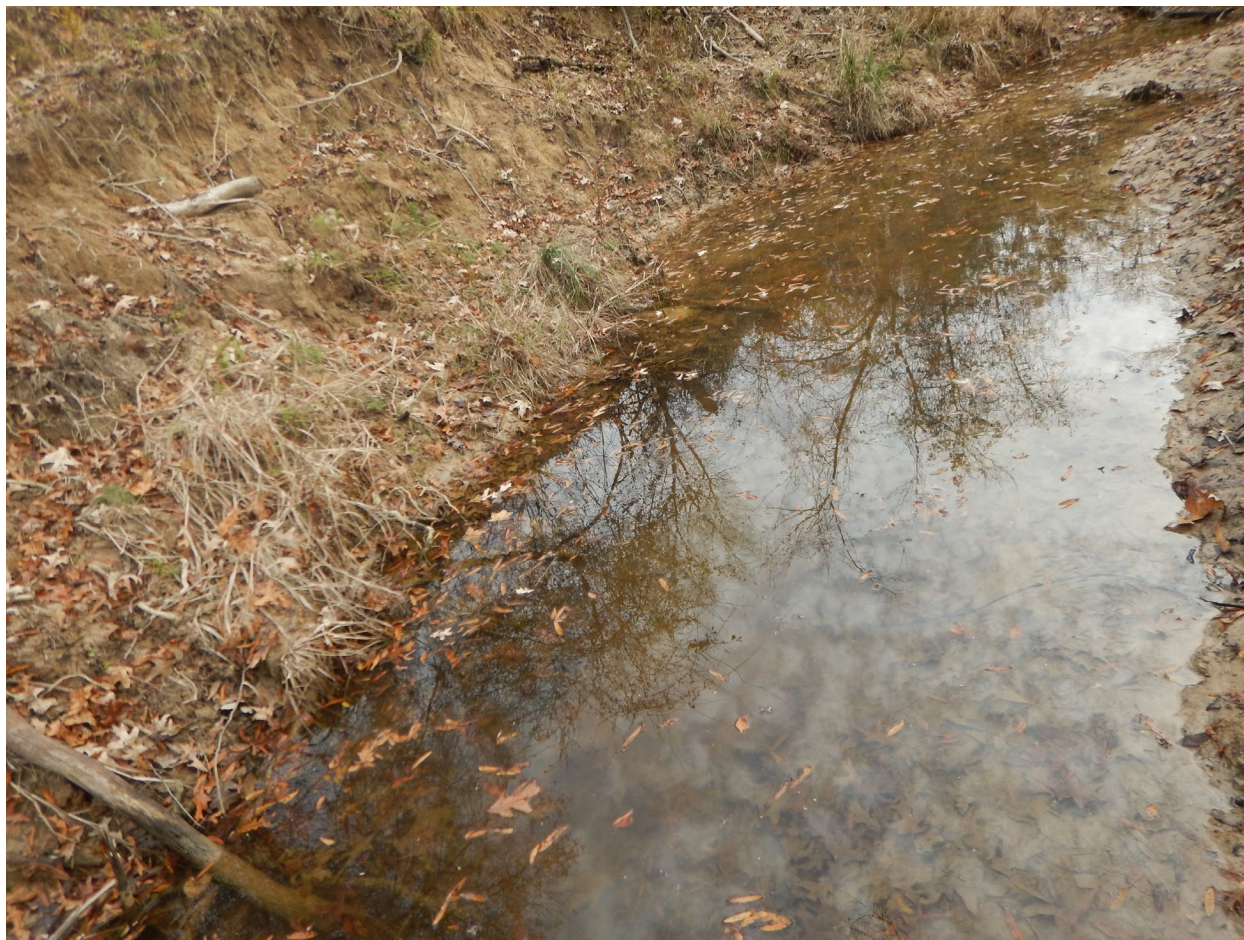
**Photo File Name:** 6223

Note: reddish, hazy water. The TDS field reading observed in photo No. 19 was taken at this location.

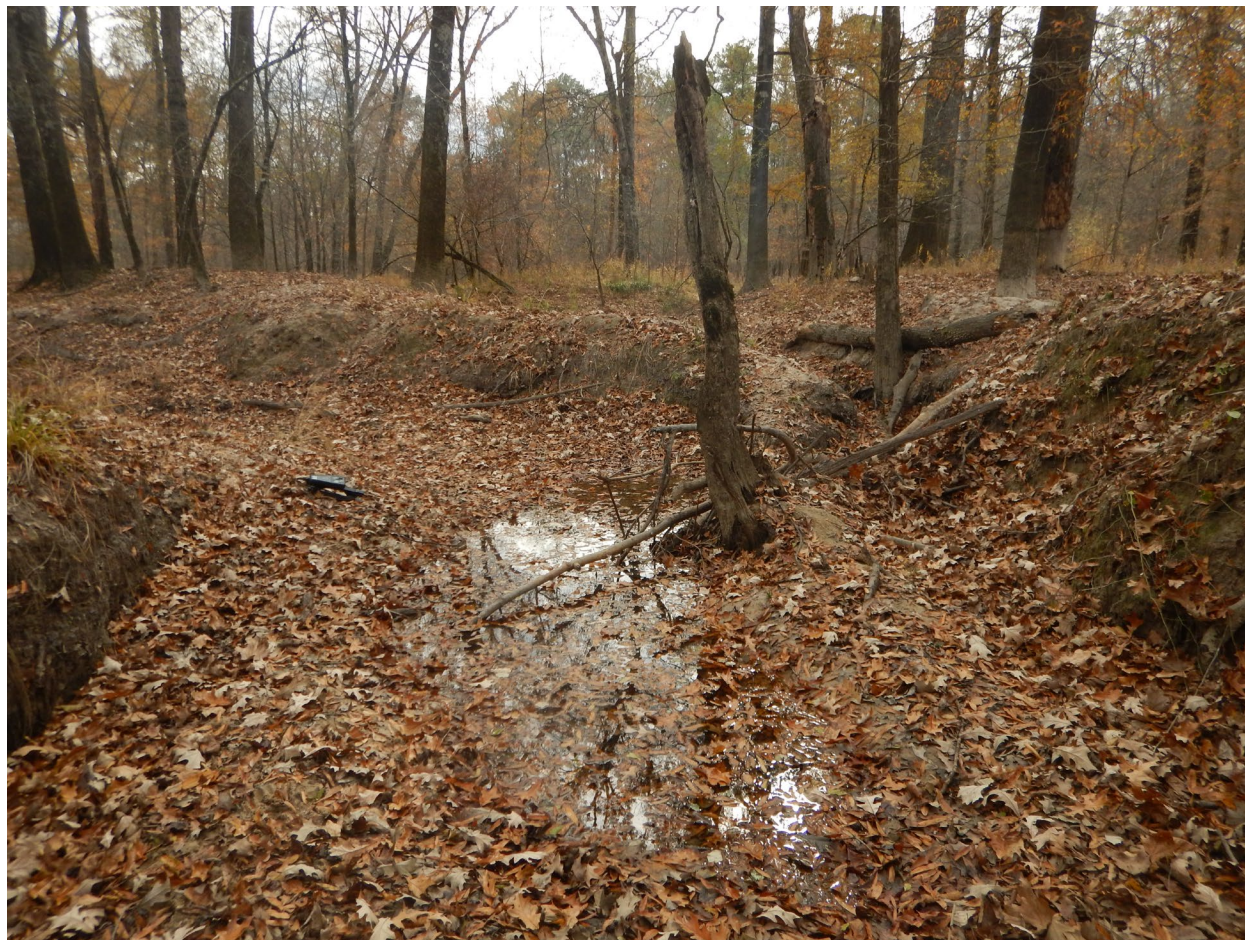
**Photo File Name:** 6229

**Description:** This photo was looking S, upstream from stream bed of the unnamed tributary 2 showing confluence of the Point of Entry of unnamed tributary 1 and unnamed tributary 2. Note: Point of Entry to your southwest and the unnamed tributary 2 continues to the southeast. The TDS field reading observed in photo No. 23 was taken at this location.

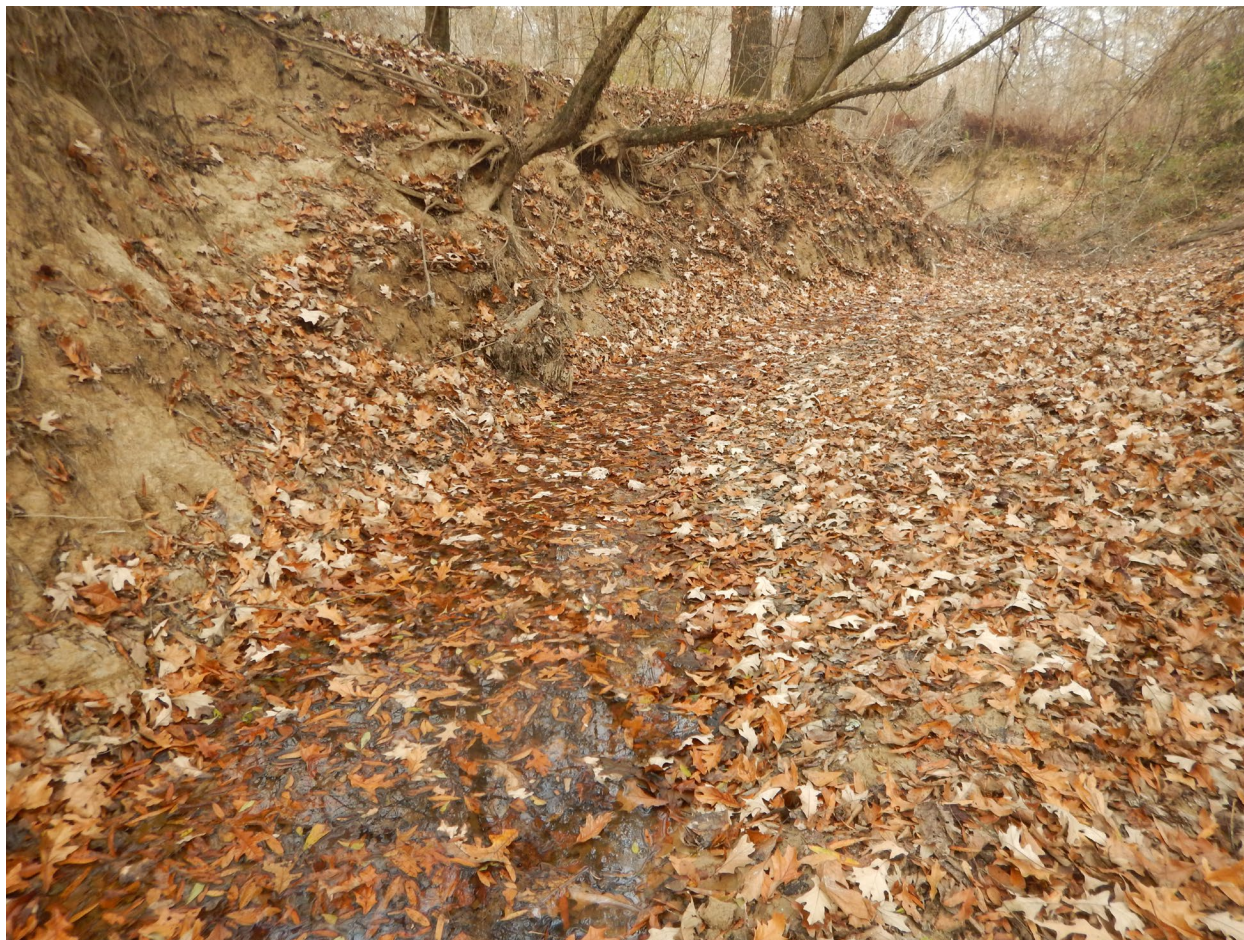
**Photo File Name:** 6230

**Description:** This photo was looking N, from the stream bed facing downstream of the unnamed tributary 2. The TDS field reading observed in photo No. 23 was taken at this location.

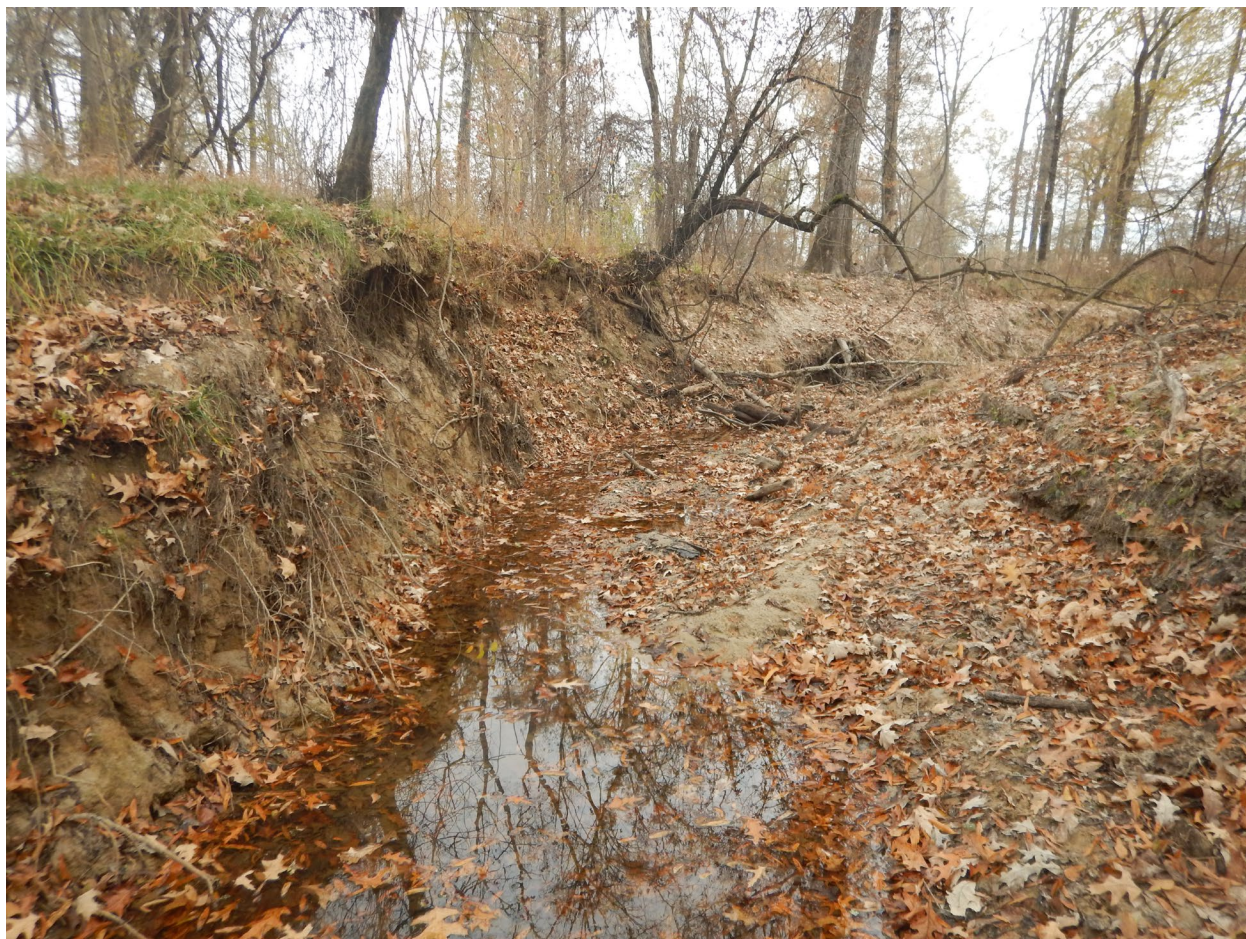
**Photo File Name:** 6233

**Description:** This photo was looking S, from the stream bed facing upstream above the confluence of the Point of Entry of unnamed tributary 1 and unnamed tributary 2. The TDS field reading observed in photo No. 24 was taken at this location.

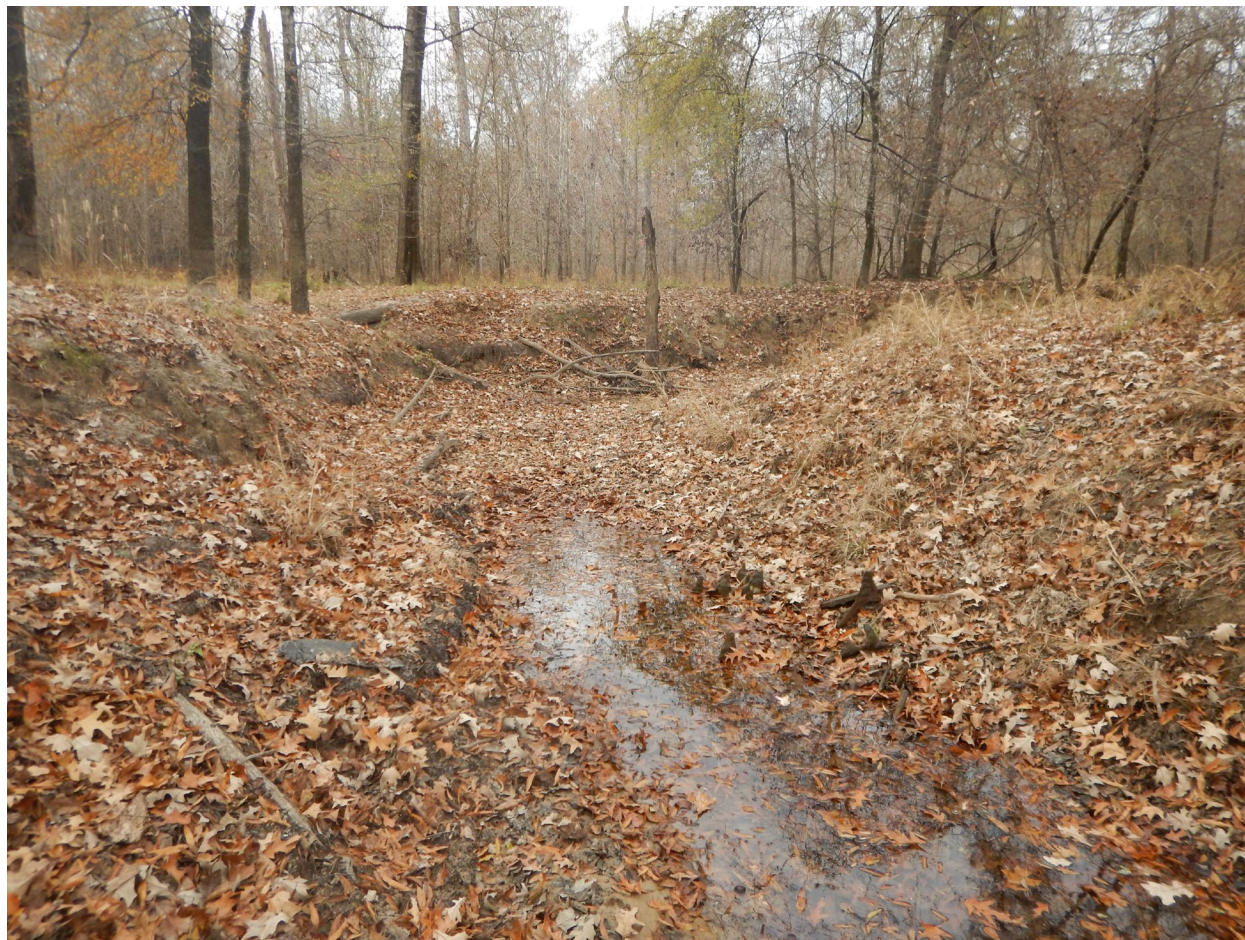
**Photo File Name:** 6234

**Description:** This photo was looking N, from the stream bed facing downstream above the confluence of the Point of Entry of unnamed tributary 1 and unnamed tributary 2. The TDS field reading observed in photo No. 24 was taken at this location.

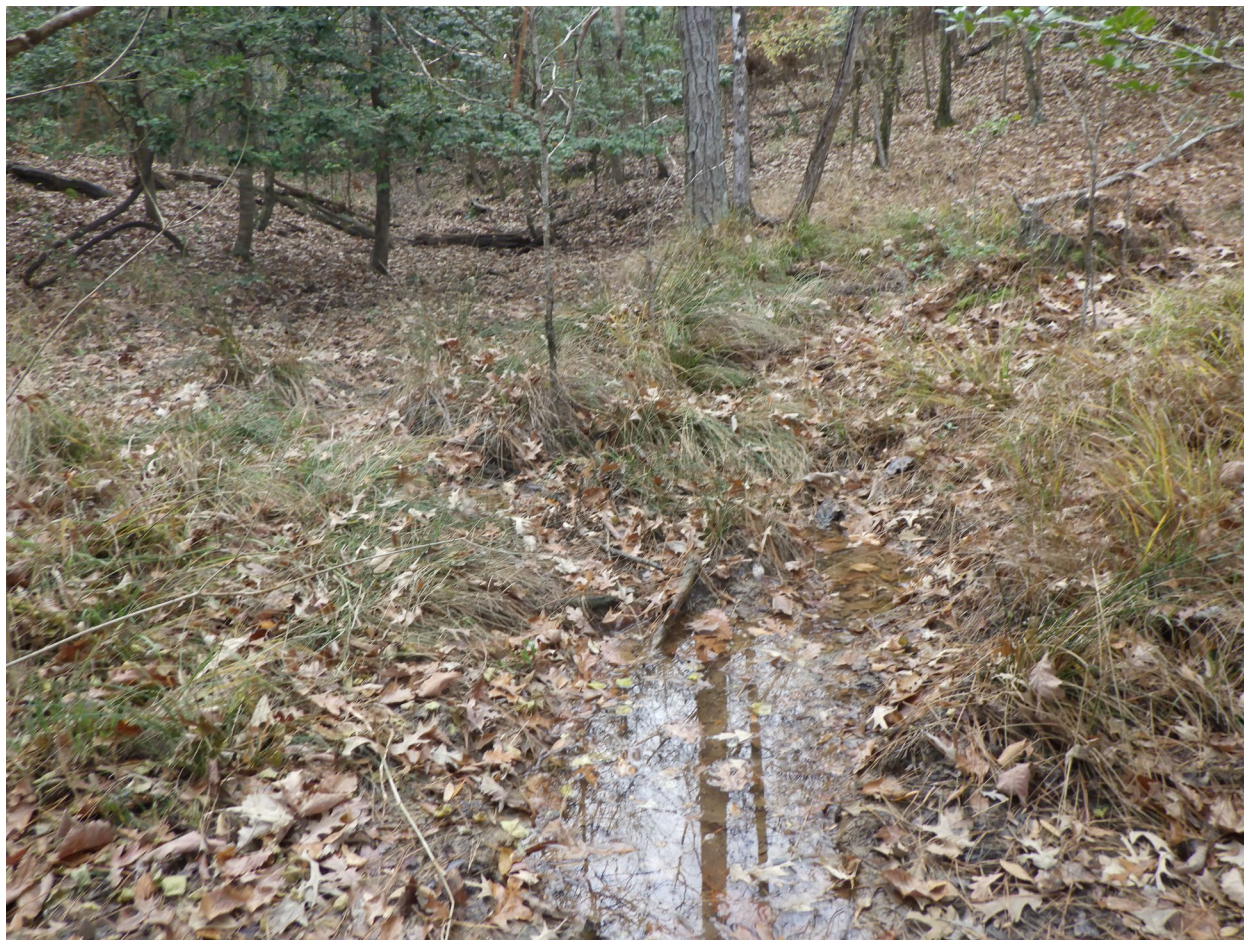
**Photo File Name:** R0010331

**Description:** This photo was looking S, upstream of unnamed tributary 1. The TDS field reading observed in photo No. 34 was taken at this location. Note: File name changes and time of photos from photo number 35-46 because camera died and had to use the other camera.

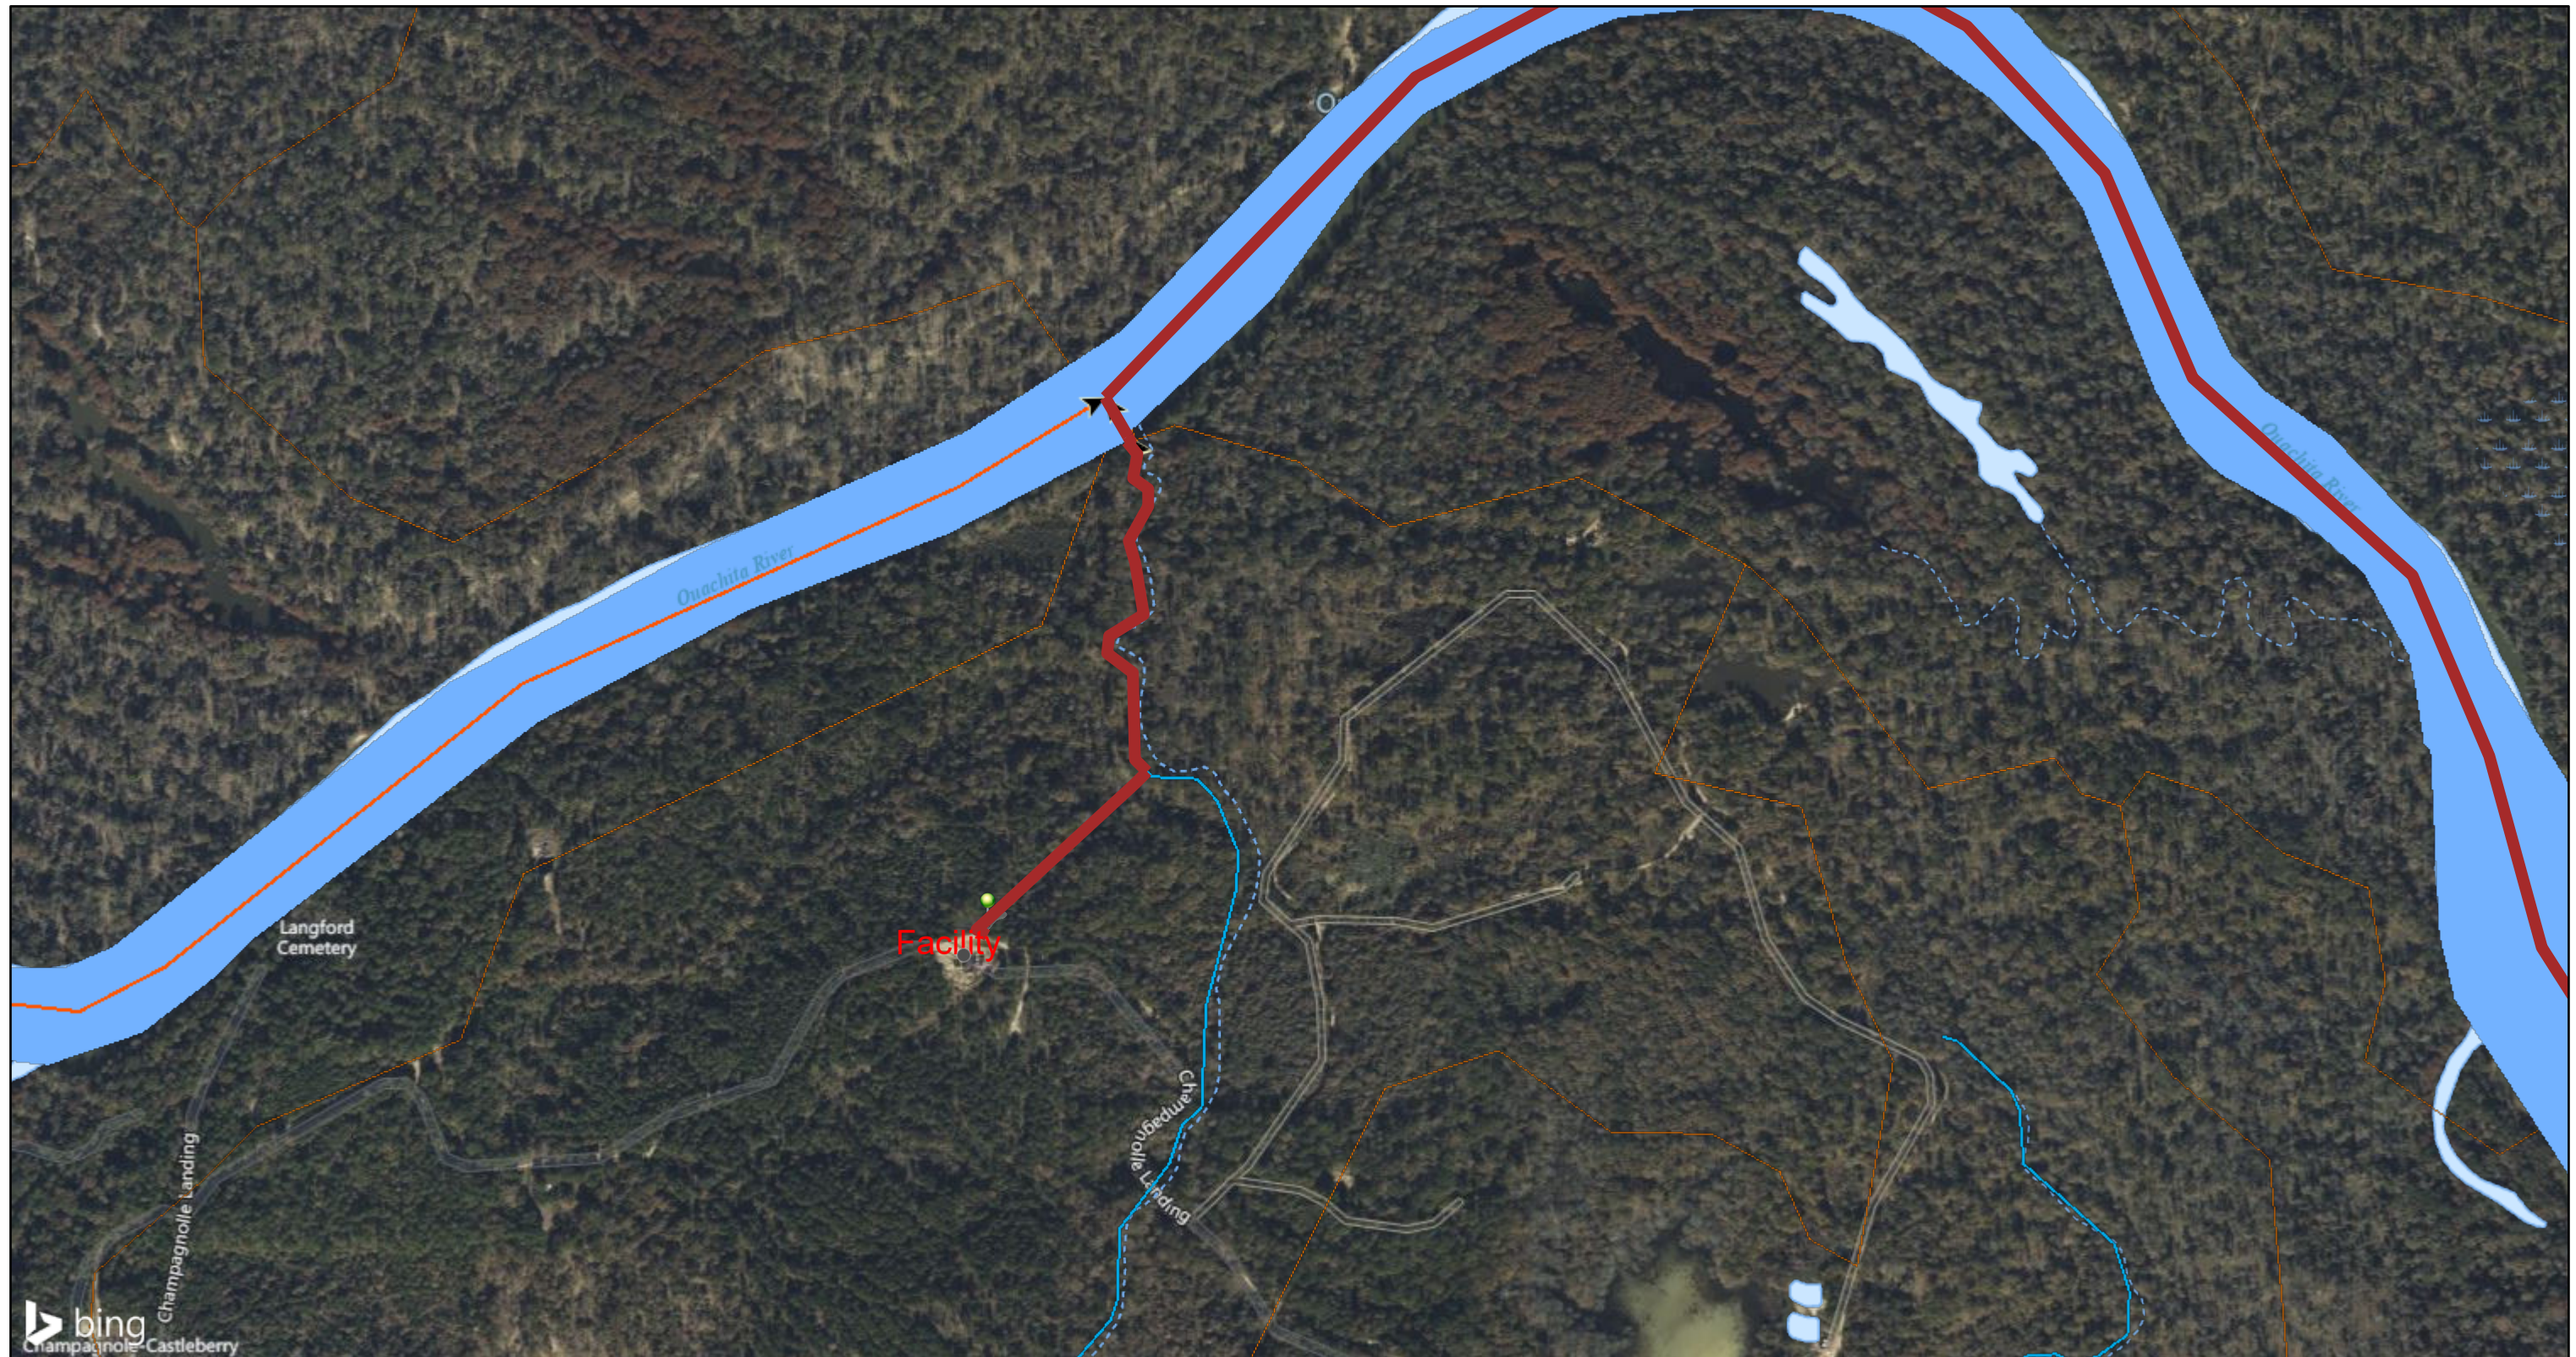
# LBOC, LLC Baker Sand Unit Tank Battery Downstream Flow Path Analysis

reddish, orange staining on soil, gravel, and vegetation. Note: stressed and dead vegetation around and downstream from pipe; 8) elevated TDS readings downstream from facility; and 9) potential of contaminants to enter the Ouachita River, a Traditional Navigable Water, which is approximately only 0.45 miles downstream (see downstream analysis flow path map).
