# Riverside/Gees Mill Subdivision

## Photolog

Stormwater CEI August 24, 2023

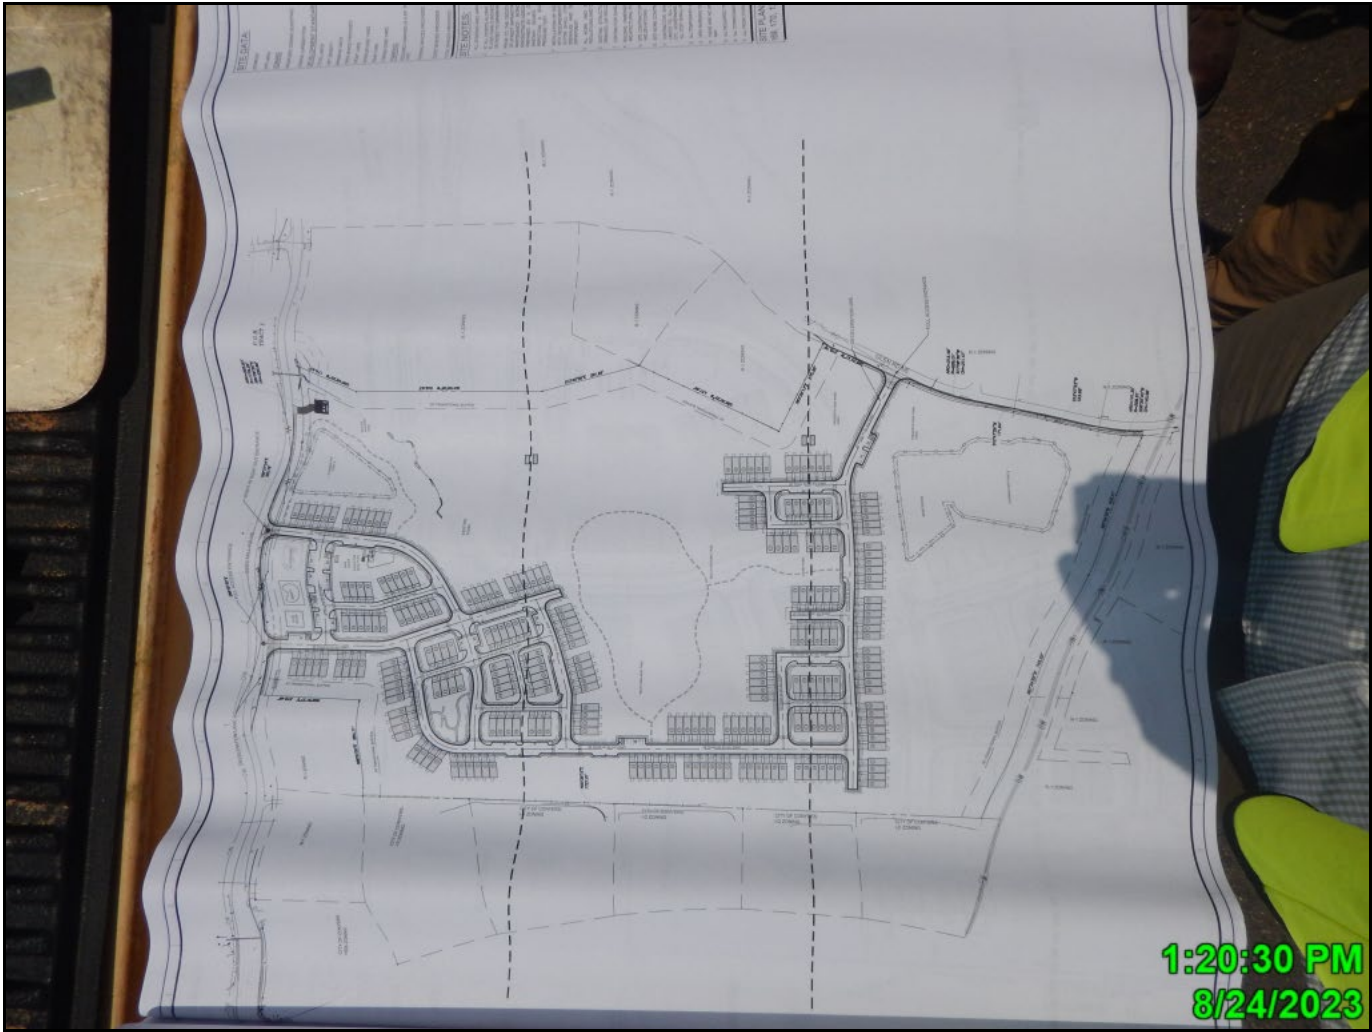
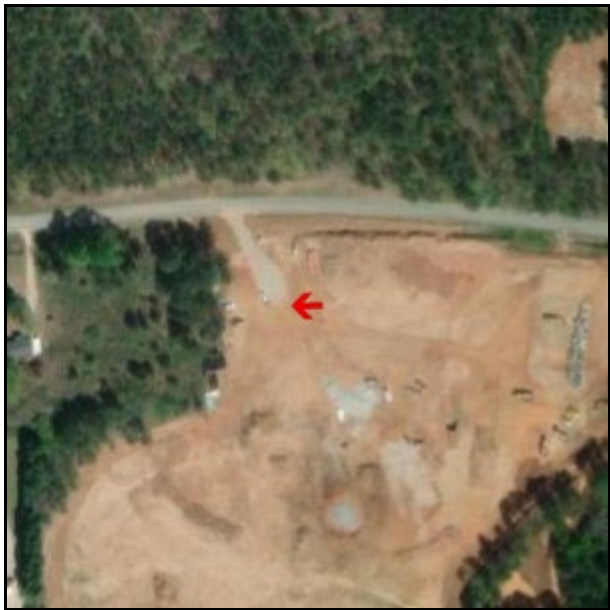
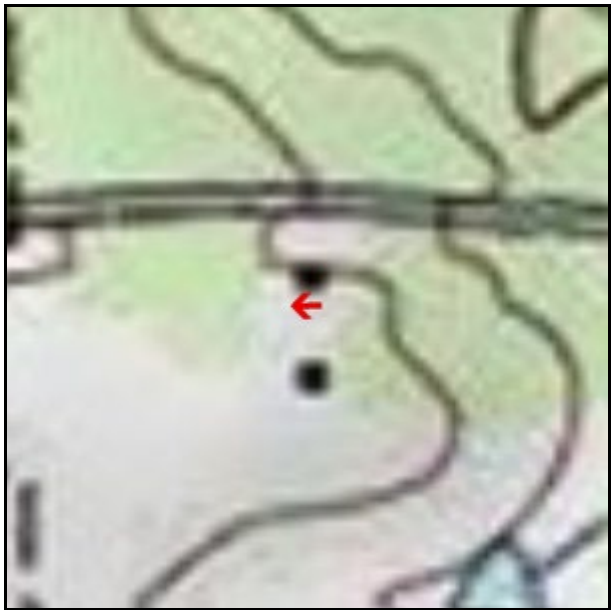
| Attributes | |
|---|---|
| Description | Locational map showing phases 1 and 2 of the Riverside subdivision. Phase one is roughly the northern half, on the left of the photo. |

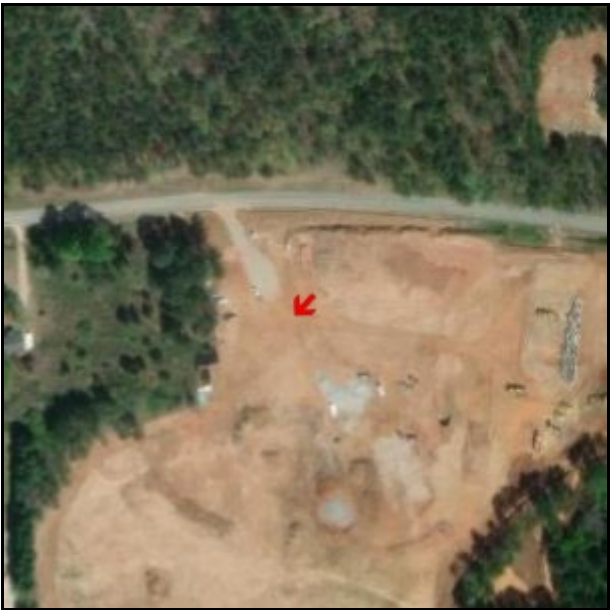
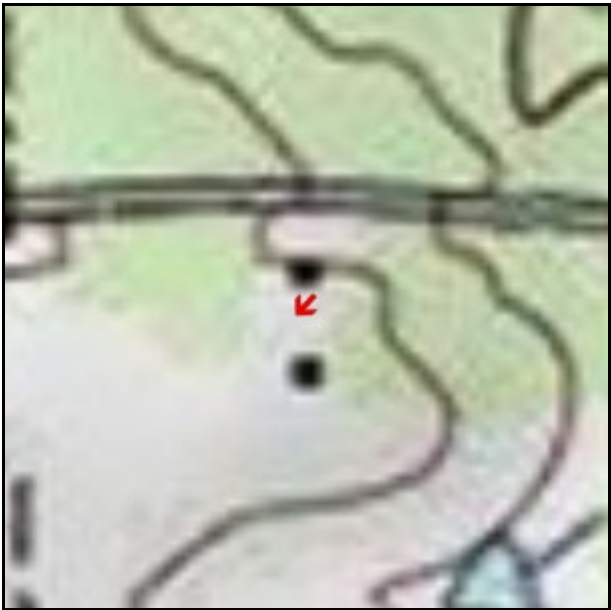
| Attributes | |
|---|---|
| Description | Stormwater runoff sampling from January 2023 shows turbidity of 533 and 246 turbidity units at the two sampling locations. |

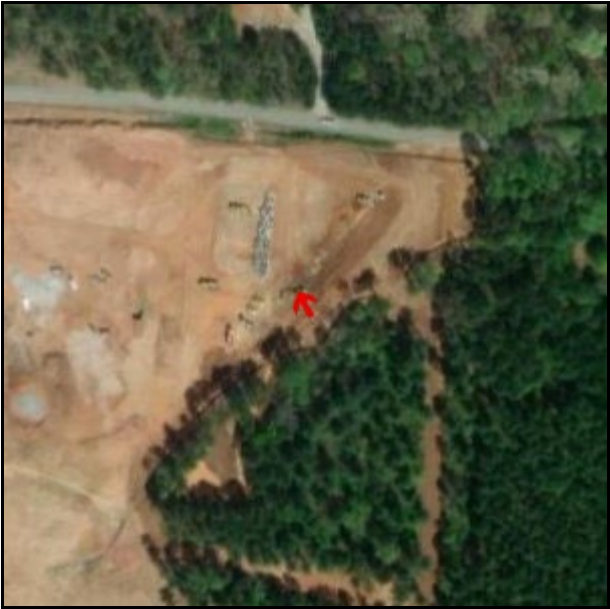
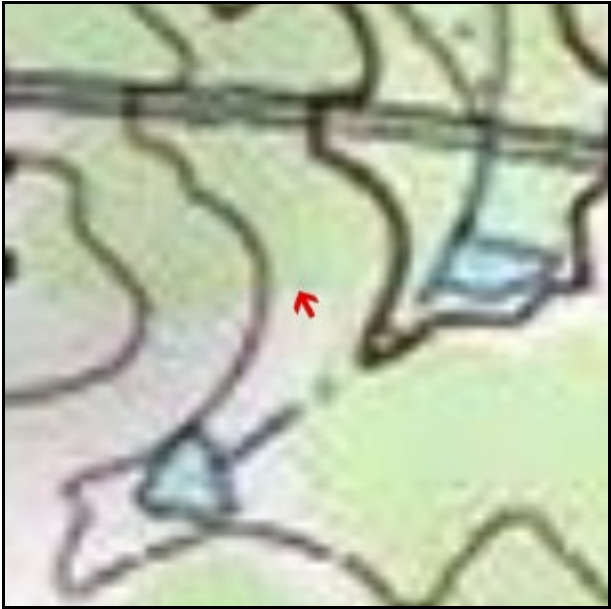
| Attributes | |
|---|---|
| Description | The northeasterly pond. One inlet in the foreground and one inlet in the left center of the pond. The outlet is at the back right of the photo, in the northeast corner. |

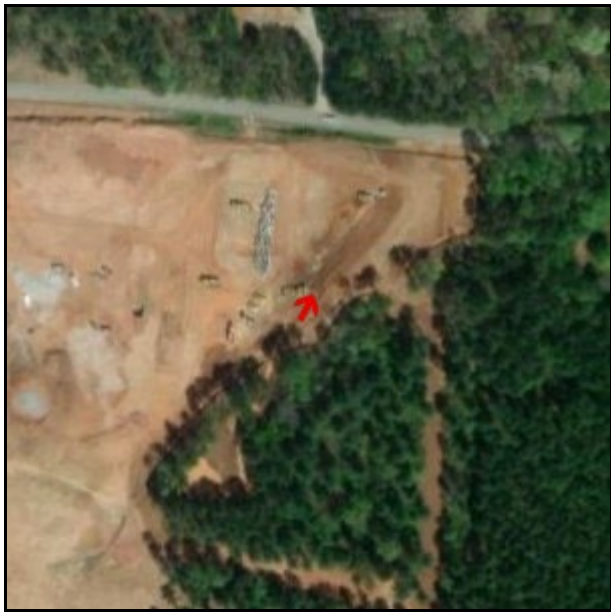
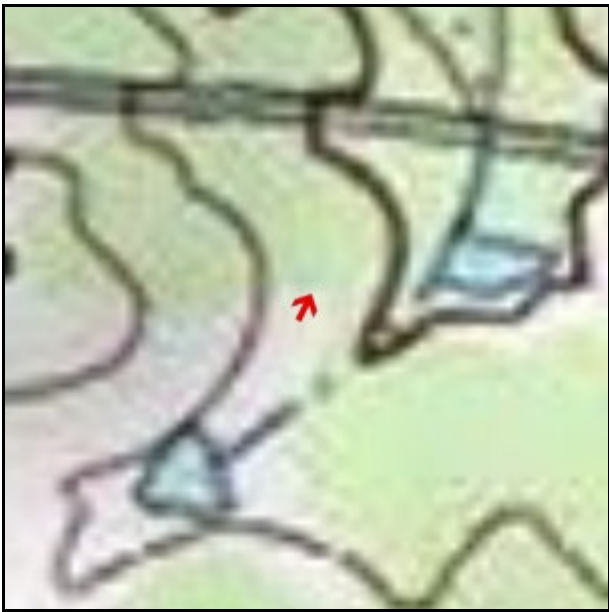
| Attributes | |
|---|---|
| Description | Zoomed-in detail of the outlet structure for the northeast pond. |

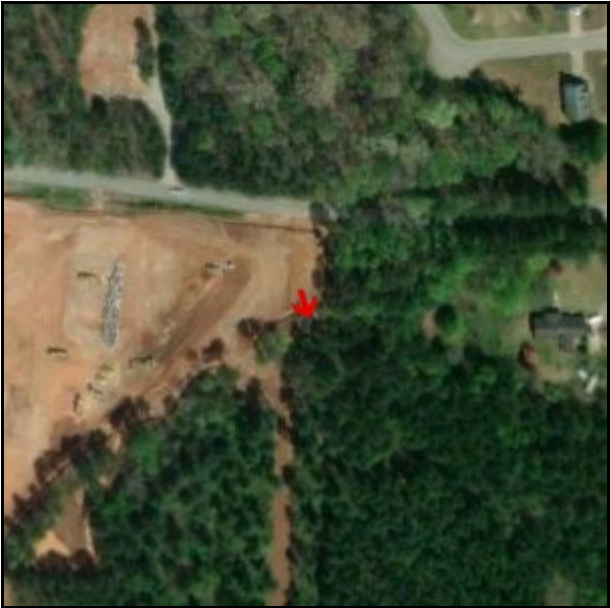
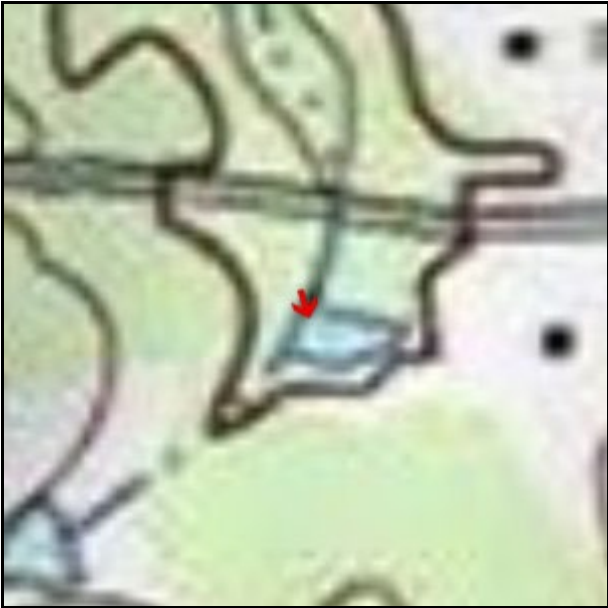
| Attributes | |
|---|---|
| Description | At the northeast pond outlet, there had been some sediment transfer from the pond to the outlet area. The sediment did not continue to a receiving water. |

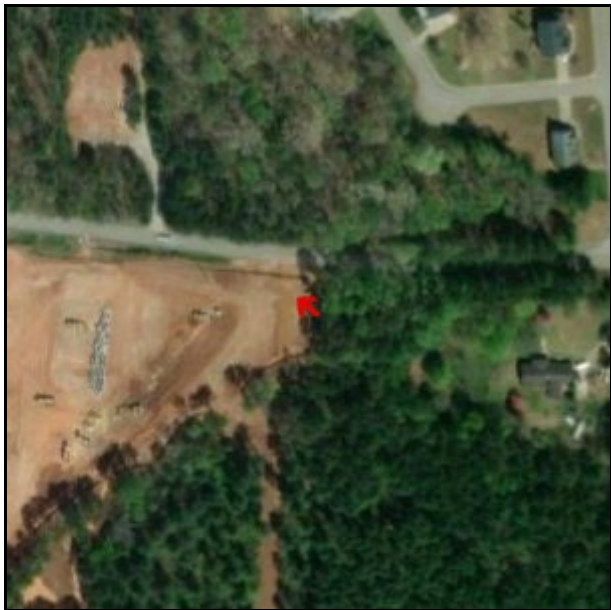
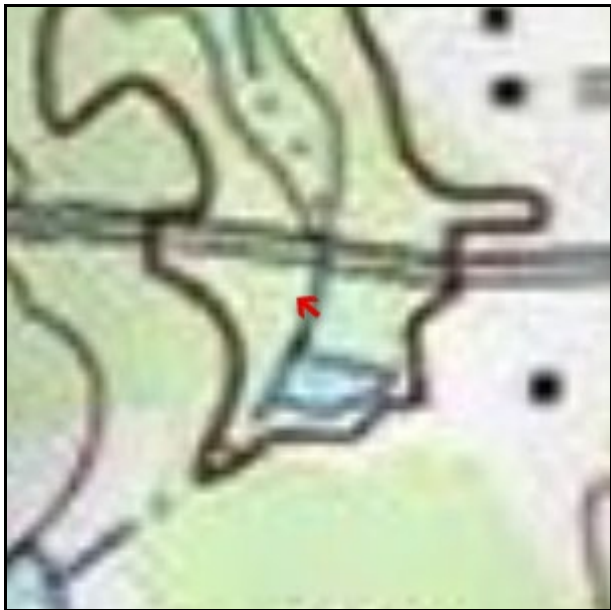
| Attributes | |
|---|---|
| Description | At the outlet structure for the northeasterly pond, there was a double row of silt fence installed. Some of the fence was damaged, and the riprap was irregularly covering the surface. The Manual for Erosion and Sediment Control in Georgia, 2016 edition, has proper design information for outfall structures. The smaller outlet on the right discharges from the roadside ditch. |

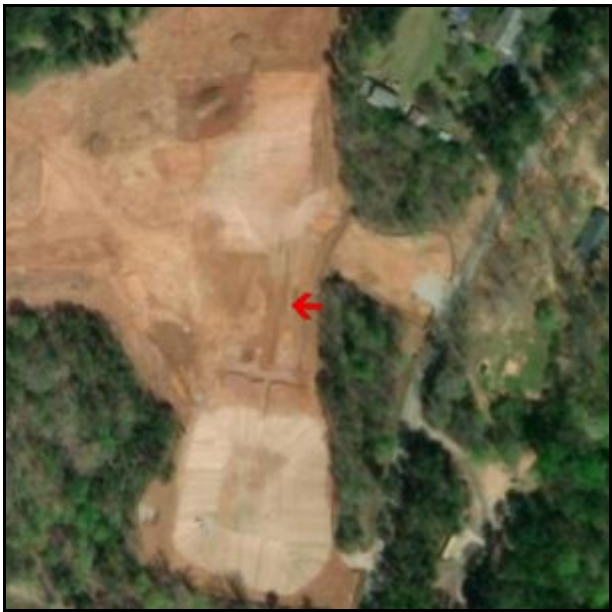
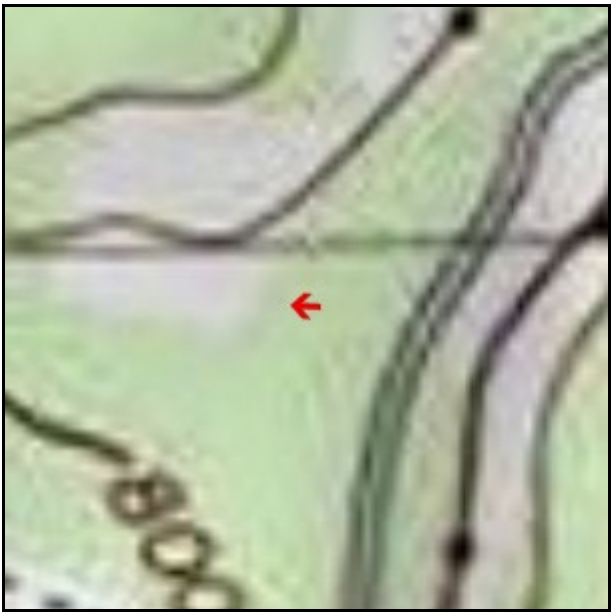
| Attributes | |
|---|---|
| Description | The main pond serving the phase 2 area had two basins. This is a view of the incompletely stabilized northerly wall of the basin and the three inlet structures from the phase 2 area. Improper rock installation was causing partial plugging of the pipe closest to the photographer. |

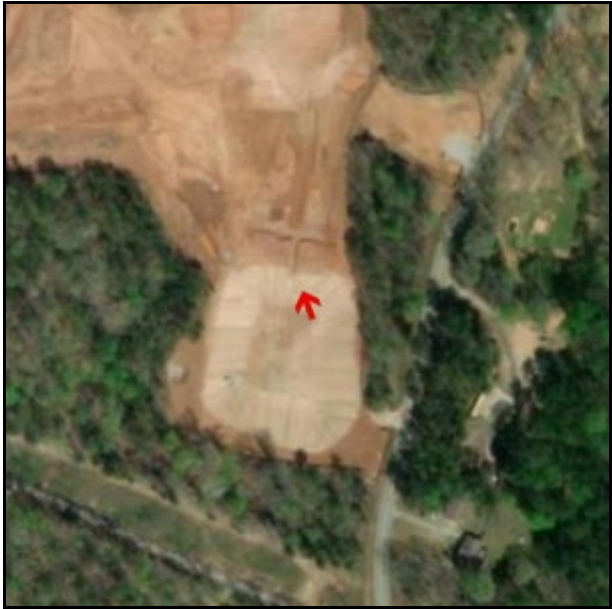
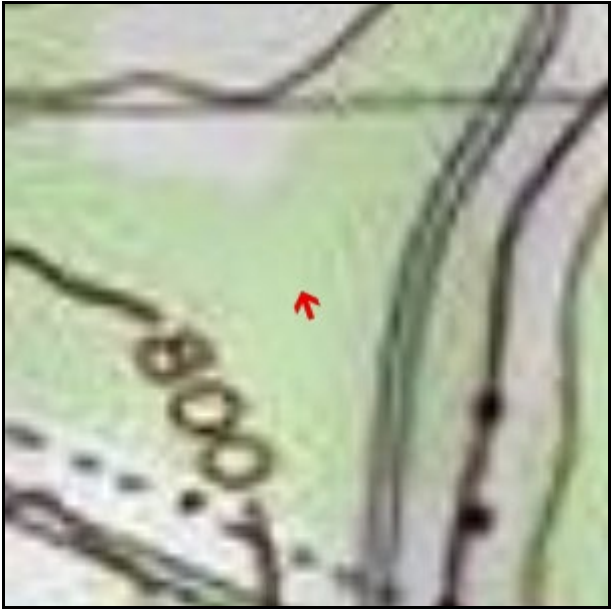
| Attributes | |
|---|---|
| Description | A look at the higher basin of the southerly pond, looking at the northerly wall. To the photographers left is a cut channel from the higher basin to the lower basin. |

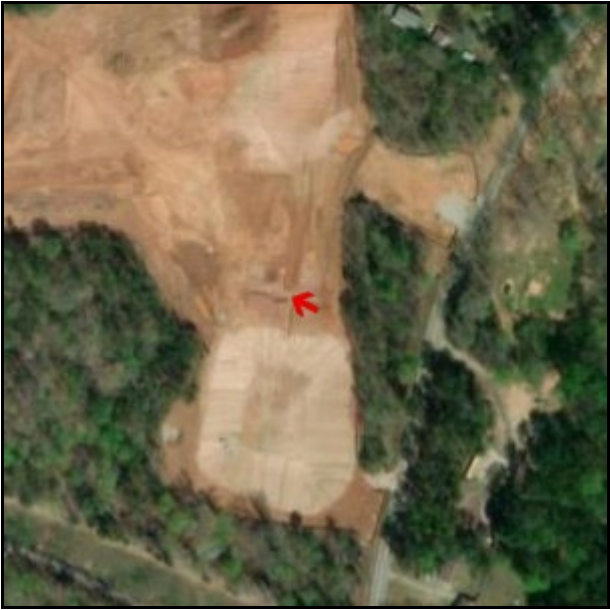
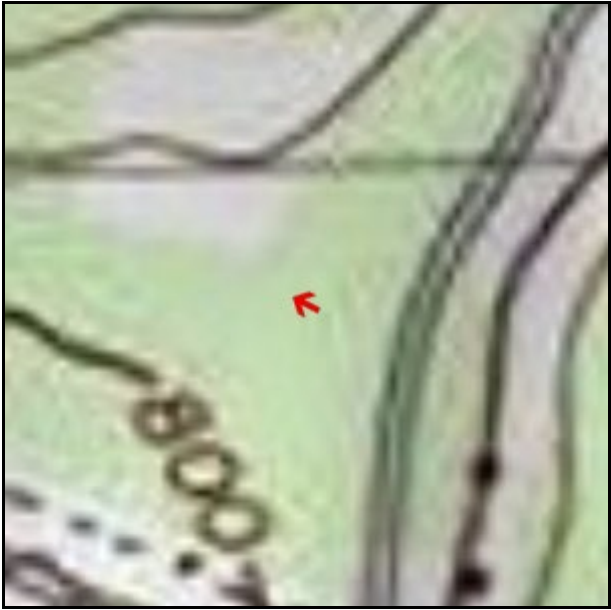
| Attributes | |
|---|---|
| Description | A view of the higher basin of the southerly pond, looking northwesterly. There is some ongoing erosion at the northwest corner. Pond banks are not properly stabilized. |

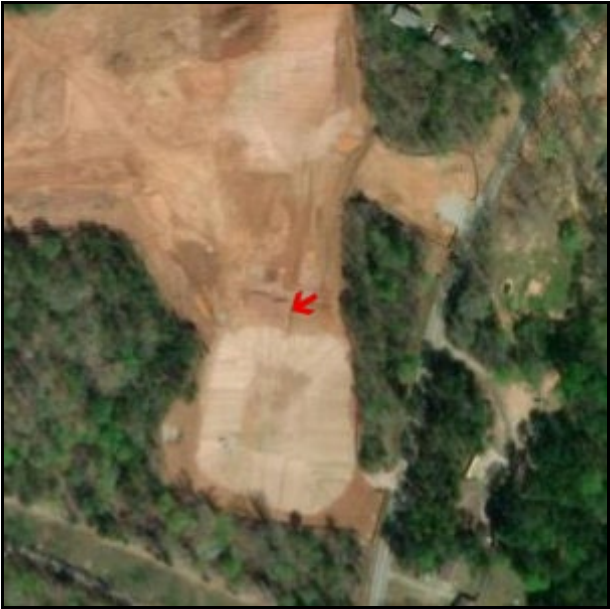
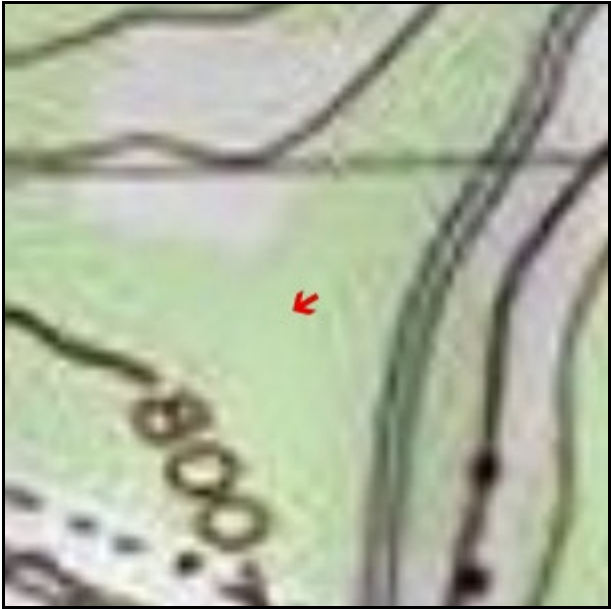
| Attributes | |
|---|---|
| Description | The trench in the foreground links the upper and lower stormwater basins in the southerly pond. The banks and bottom of the pond are not properly vegetated. This trench is not properly stabilized and could lead to upper basin collapse. |

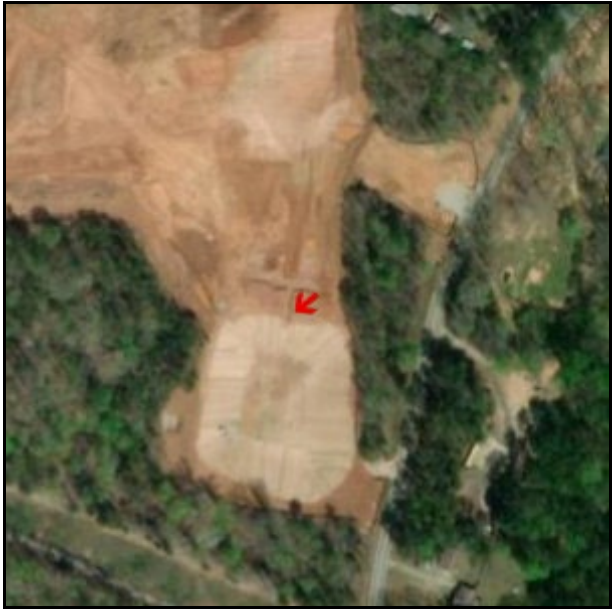
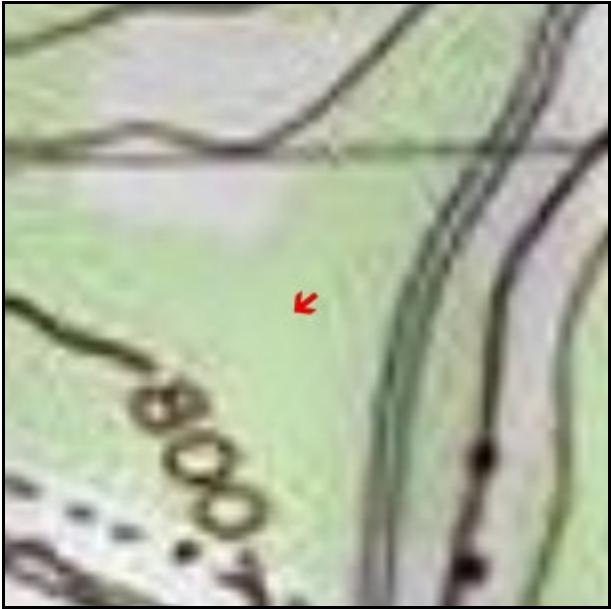
| Attributes | |
|---|---|
| Description | The western half of the lower basin is not properly vegetated or stabilized. |

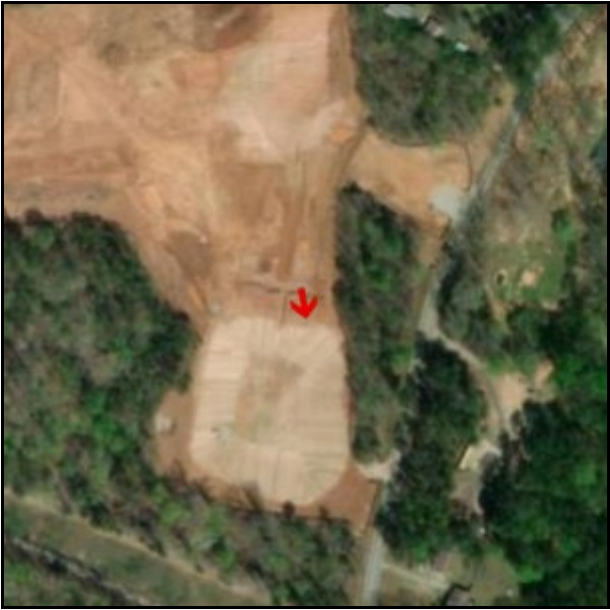
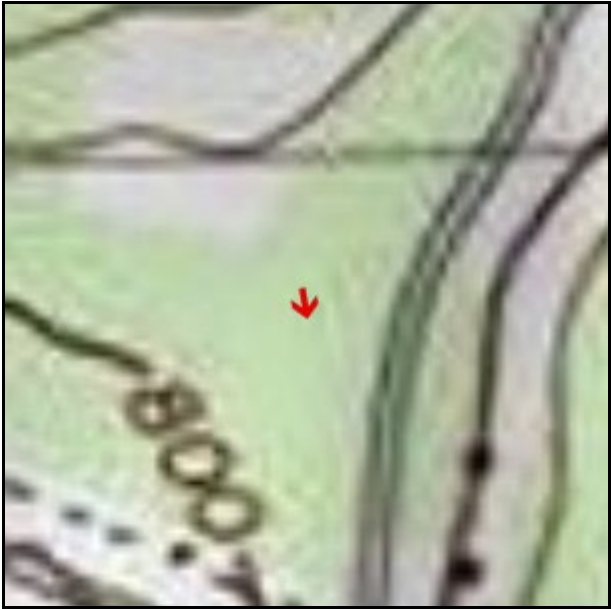
| Attributes | |
|---|---|
| Description | The eastern half of the lower basin is not properly vegetated or stabilized. |

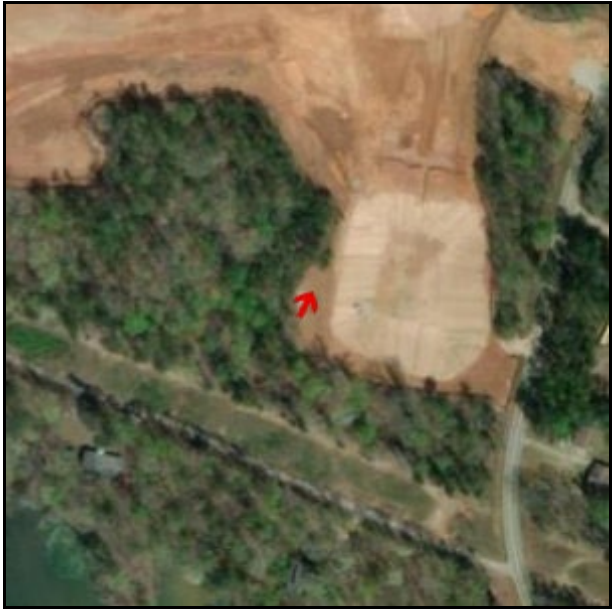
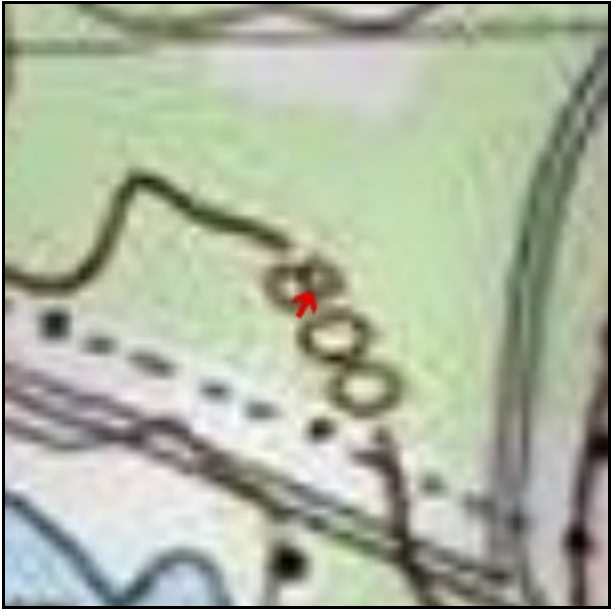
| Attributes | |
|---|---|
| Description | Outfall structure from the lower basin of the south pond. Camera was not horizontal. |

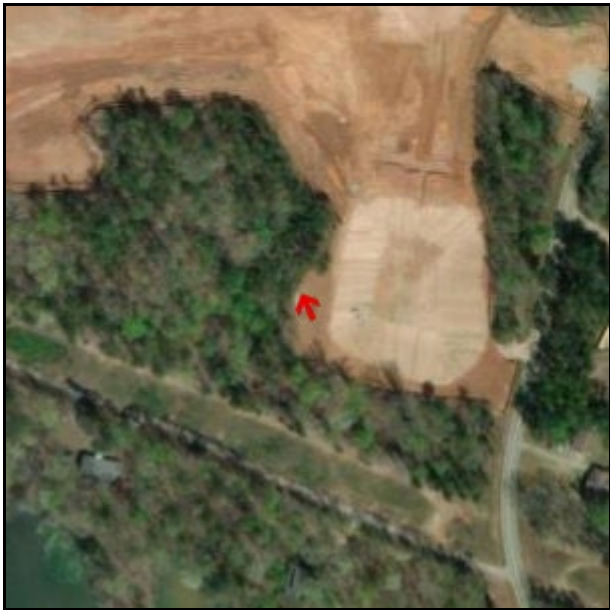
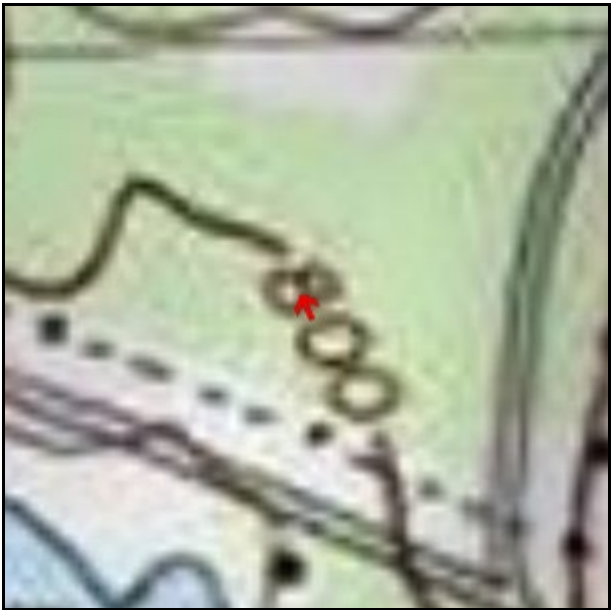
| Attributes | |
|---|---|
| Description | Outlet structure from the southerly pond: riprap may be improperly installed. |

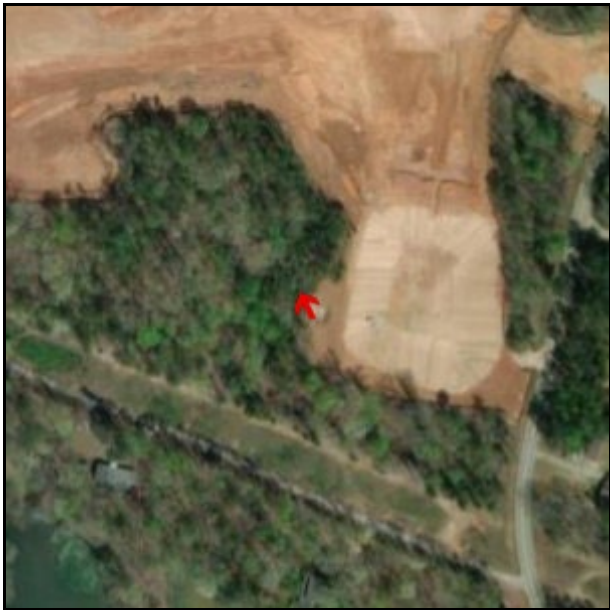
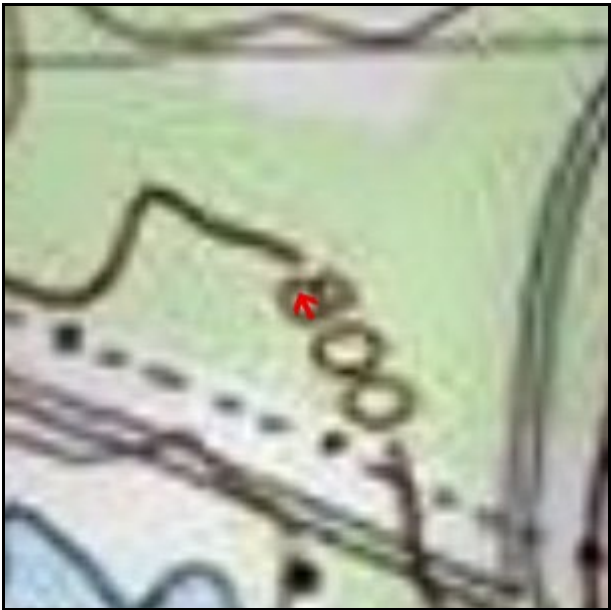
| Attributes | |
|---|---|
| Description | Near the outlet structure for the south pond, there was some sediment loss past the silt fences, but the silt deposition only went a few feet into the adjacent woods. |
