| Inspection Date(s): | 05/20/25 | |
| Company Name: | <b>Tri-County Special Utility District – Public Water System</b> | |
| Facility Name: | <b>Tri-County Special Utility District</b> | |
| PWS ID: | TX0730004 | |

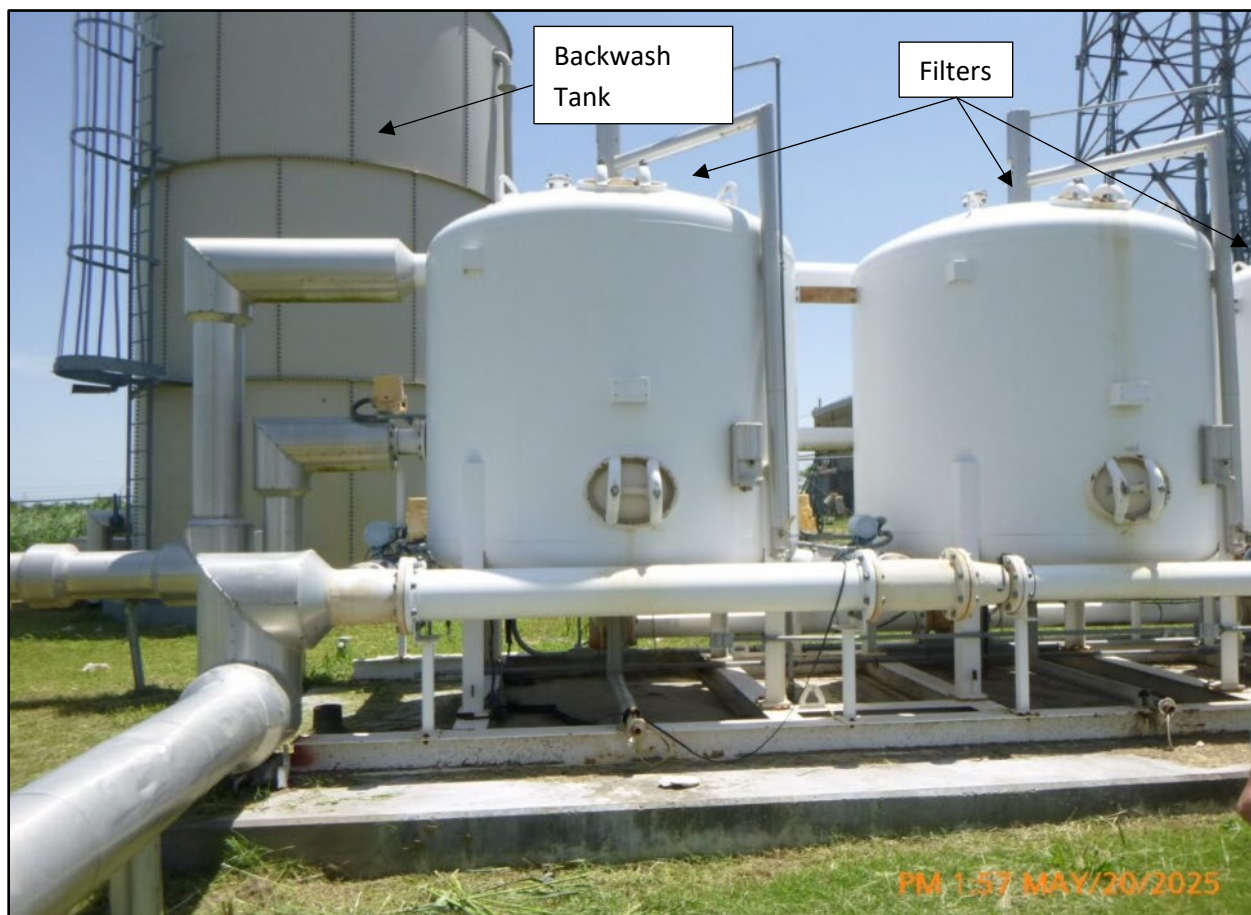
**Photograph 1. 05/20/2025 01:57 P1010523.JPG**

The System pilot tested iron and arsenic treatment for Wells 4 and 6. The pilot studies proved successful, and in 2014, the System received approval to implement a full-scale arsenic treatment system for Well 4 (Plant 6) (Refer to Appendix 3, Photograph 1). Polyphosphate is injected into the raw water to sequester high iron in the water and then flows through a cooling tower where gaseous chlorine is injected for disinfection. The cooling tower provides a 20°F to 30°F temperature reduction.

Description: Filters containing media for arsenic removal and backwash tank.
