**U.S. Environmental Protection Agency  
Region 5**

**Purpose:** Clean Water Act National Pollutant Discharge Elimination System Compliance Evaluation Inspection

**Facility:** Watco Transloading, LLC  
5297 River Road,  
Cincinnati, Ohio, 45233

**Inspection Date:** February 23-24, 2023

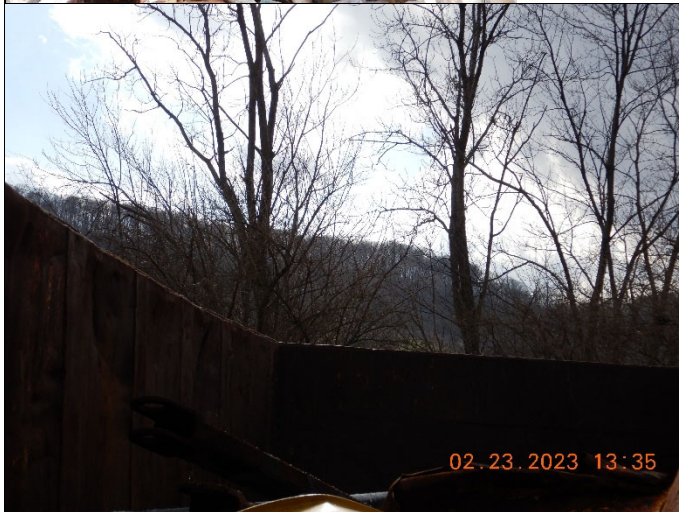
- EPA observed a roll off container stored outside of containment and in an area where runoff is tributary to the Ohio River. The roll off container was located southeast of the truck wash. Photos 8 through 12 show the contents of that dumpster which included crushed drums used to store oil. Before the end of the inspection, the facility relocated the roll off container to inside the truck wash containment, which is tributary to a blind tank with no outlet. The relocated container location is shown in photo 35.

Description: Looking inside a dumpster stored outside of the containment structures. At the time of the inspection there were two crushed oil drums.

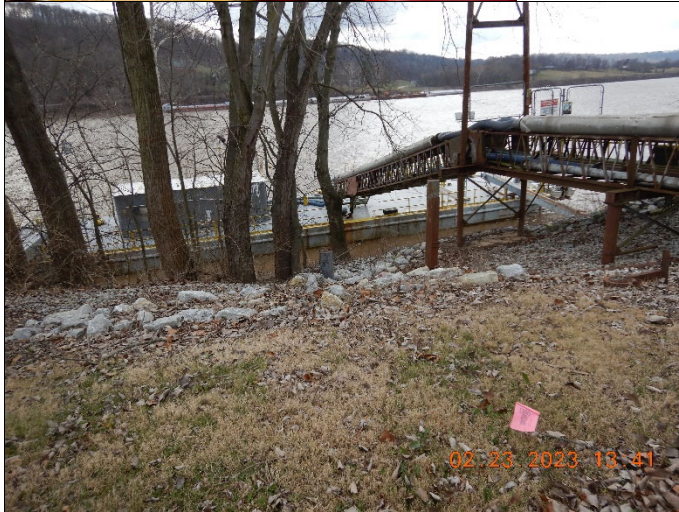
12: DSCN1289.JPG

Location: Watco Transloading  
Photographer: Jonathan Moody  
Date/Time: 2/23/2023 1:37 PM  
Description: Close-up of a label on an other oil drum inside the dumpster stored outside the containment. Photo taken through a hole in the sidewall of the dumpster.

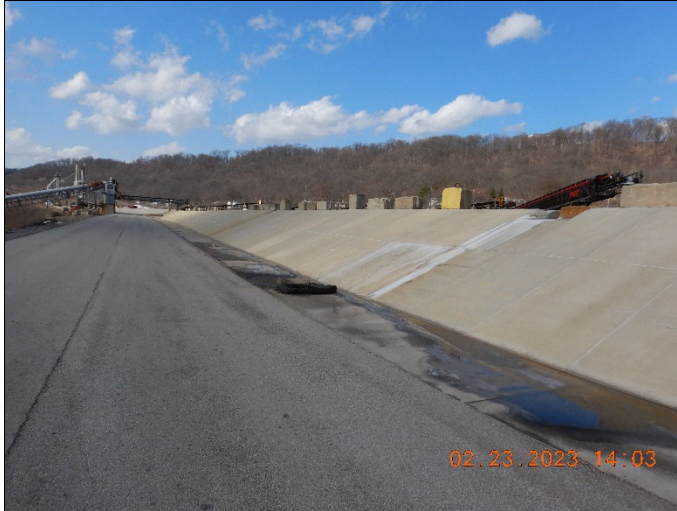
Description: Camera looking west along the north side of the southernmost containment wall for the liquid area containment. Per Carlton Lawrence, this inlet is tributary to the same manhole in photo 7 where monitoring for outfall 002 is conducted, however, this is likely connected to the white plastic pipe which is not monitored for NPDES compliance.

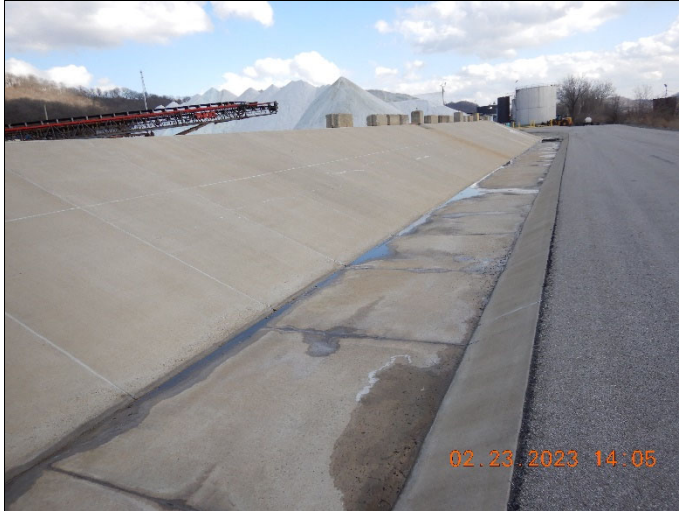
19: DSCN1296.JPG

Location: Watco Transloading  
 Photographer: Jonathan Moody  
 Date/Time: 2/23/2023 2:05 PM  
 Description: Camera is facing north, at a location along the riverside edge of the salt pile pad. A cut in the concrete berm surrounding the pad allows stormwater to flow from the pad into the collection ditch surrounding the pad. At the time of the inspection, straw bales were placed on the upstream side of the cut.

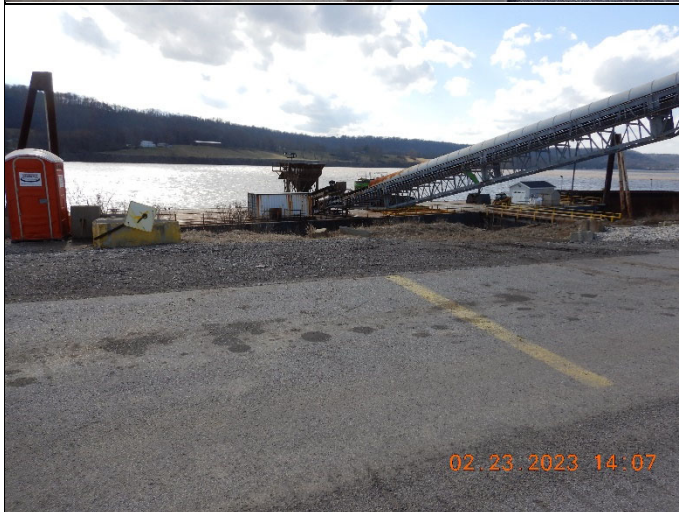
20: DSCN1297.JPG

Location: Watco Transloading  
 Photographer: Jonathan Moody  
 Date/Time: 2/23/2023 2:05 PM  
 Description: Camera facing east, looking along the riverside edge of the salt pile pad.

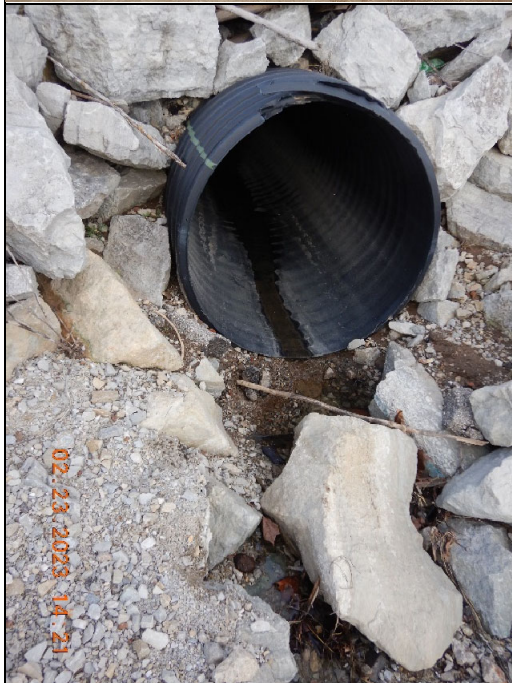
26: DSCN1303.JPG

- The inlet shown in photo 18 goes to an onsite sewer system tributary to outfall 011. At the time of the inspection there was filtersock surrounding the inlet, and a filter hat inside the inlet. There was a small rip forming along the upper edge of the hat.
- There were straw bales at locations of concentrated storm water flow. At one location shown in photo 22 the bale was loose, and another location shown in photo 24 the bale had begun disintegrating with loose straw visible on the surrounding pavement as shown in photo 25.
- A small pile of sand was present adjacent to the slope leading down to the river, and shown in photo 26. At the time of the inspection there was a filter sock surrounding the pile, but sand could be seen on the pavement downstream of the filter sock. Per Mike

Beatty this pile is wash sand and is used under a tank floor when the floor is repaired or replaced.

Location: Watco Transloading  
 Photographer: Jonathan Moody  
 Date/Time: 2/23/2023 2:17 PM  
 Description: At a location west of the salt pile pad and near the river. This sand was wash sand used under a tank floor when the floor is repaired or replaced. This sand was in an area that was tributary to the river. At the time of the inspection a filter sock was present, but solids were visible downstream of the filter sock.

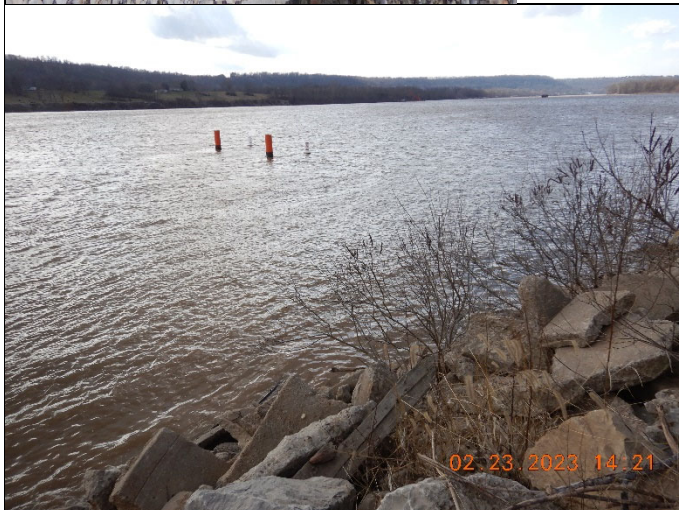
27: DSCN1304.JPG

Location: Watco Transloading  
 Photographer: Jonathan Moody  
 Date/Time: 2/23/2023 2:21 PM  
 Description: At the monitoring location for Outfall 011. This is the location where compliance monitoring samples are collected.
