**U.S. ENVIRONMENTAL PROTECTION AGENCY  
REGION III WATER BRANCH, ENFORCEMENT  
AND COMPLIANCE ASSURANCE DIVISION  
CLEAN WATER ACT  
COMPLIANCE INSPECTION REPORT**

**Name of Facility:** AdvanSix Resins & Chemicals, LLC – Hopewell Plant

| <b>Type of Inspection:</b> | Industrial Stormwater |
| <b>NPDES Permit No:</b> | VAR052505 (General Permit) and VA0005291 (Individual Permit) |

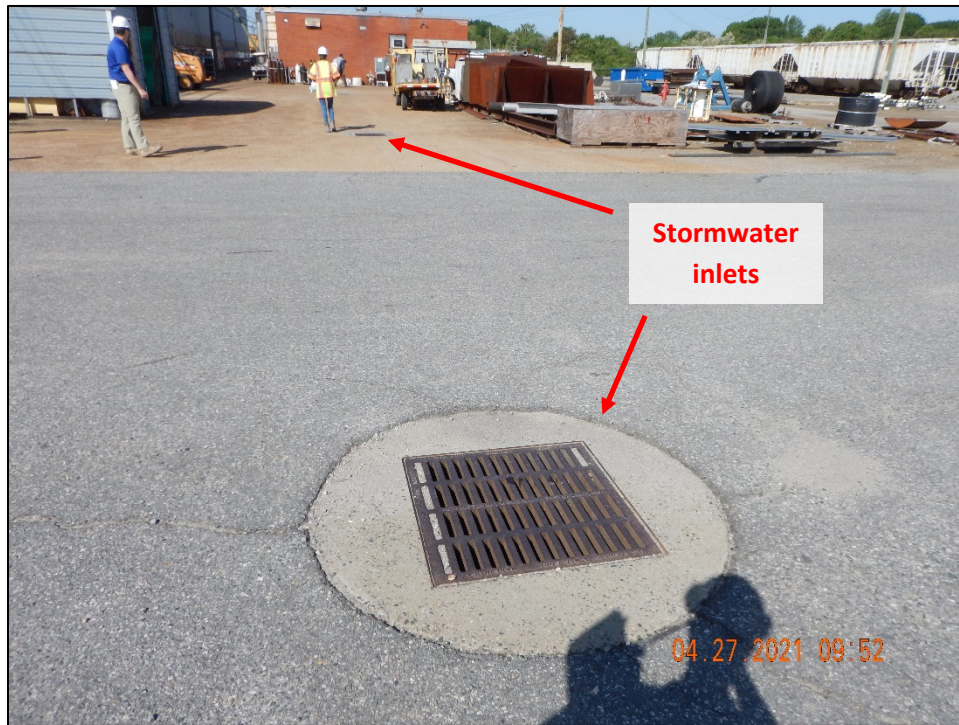
**DSCN2305.** View, facing west, of a stormwater inlet near the North Maintenance Shop, in the Outfall 912 drainage area.

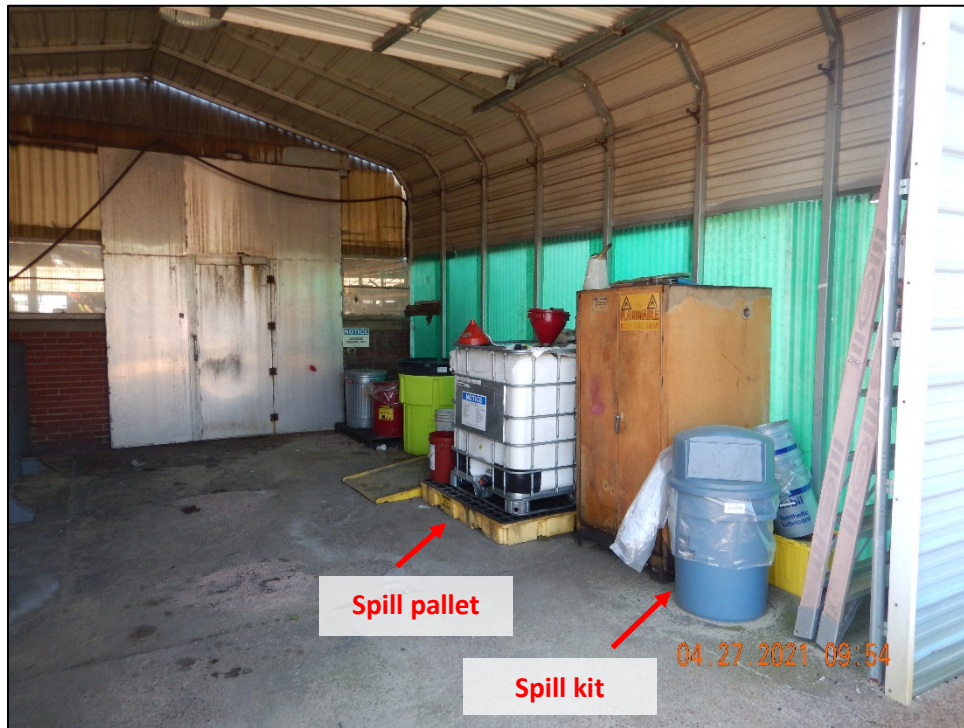
**DSCN2306.** View inside the covered drum shed in the North Maintenance Shop. Note the used oil tote on a spill pallet and the presence of a spill kit.

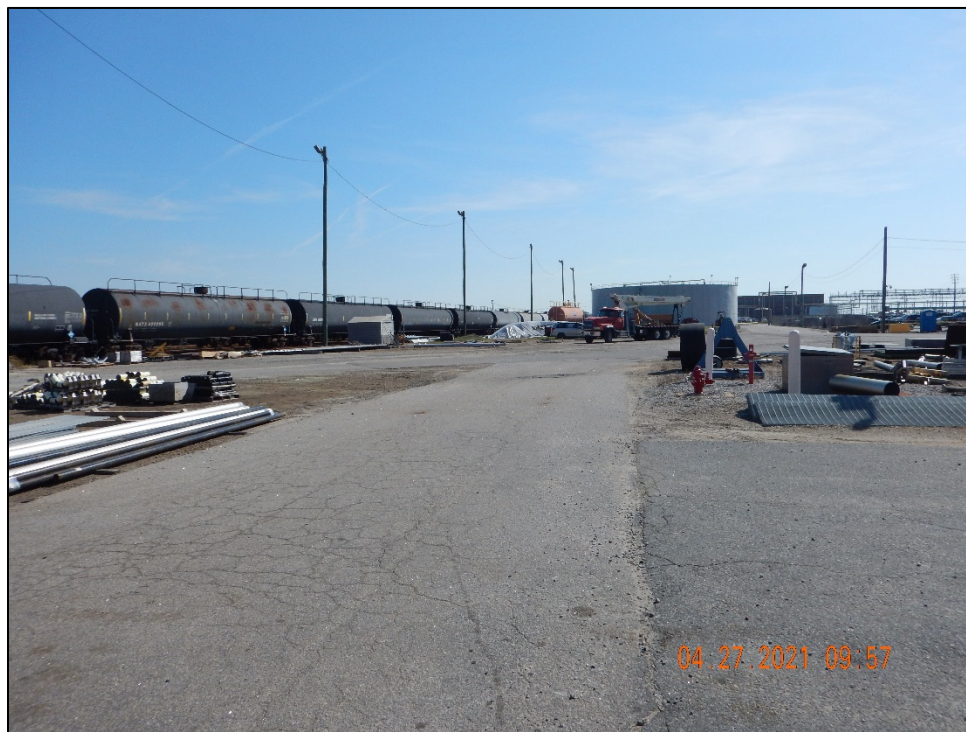
**DSCN2307.** View, facing east, of the equipment laydown yard in the Outfall 912 drainage area.

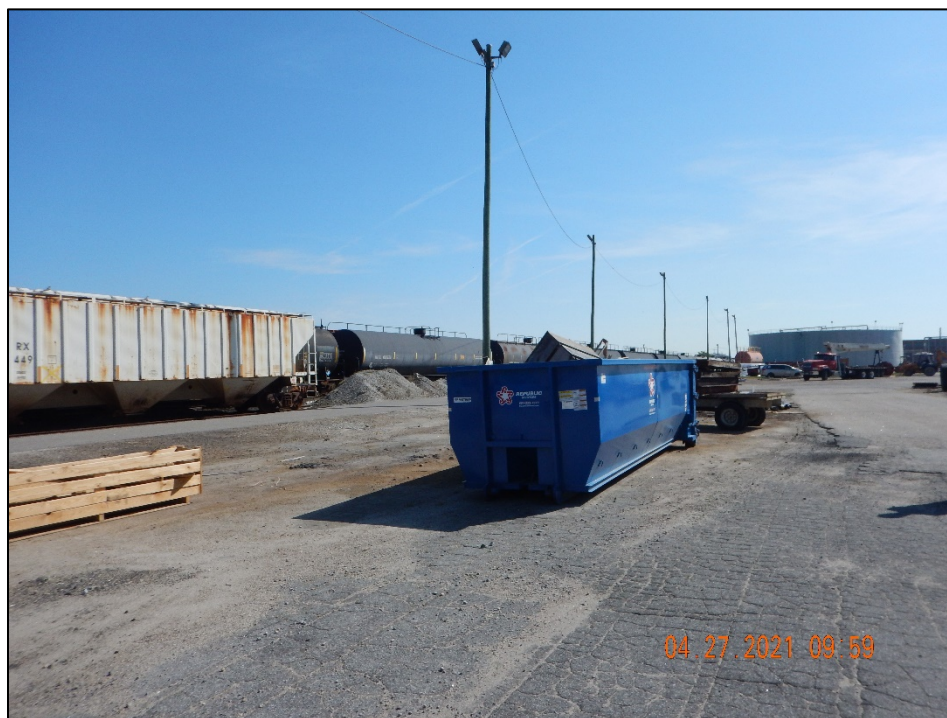
**DSCN2308.** View, facing east, of an uncovered scrap metal dumpster in the Outfall 912 drainage area.

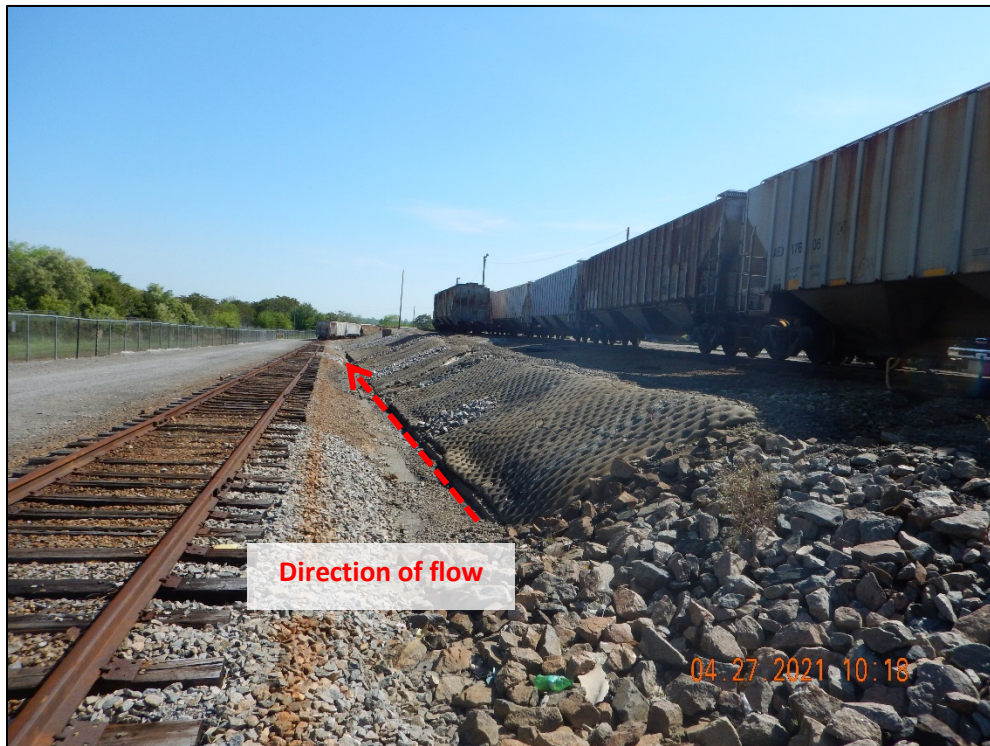
**DSCN2317.** View, facing east, of the slope between the rail tracks and the north perimeter fence. Note the concrete stabilization on the slope.

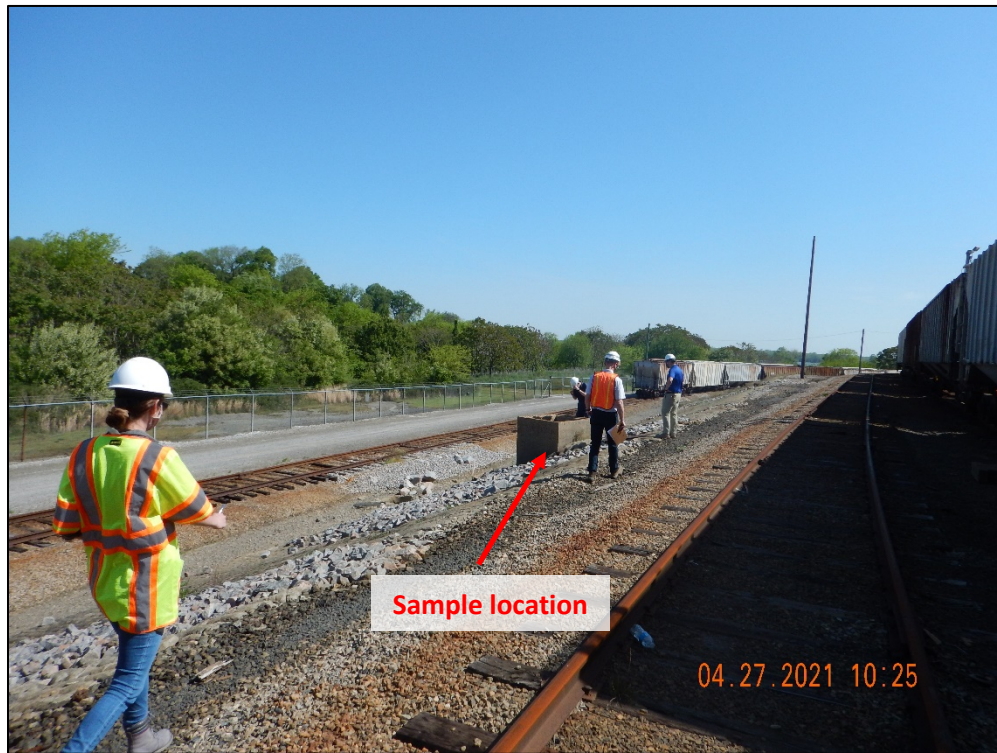
**DSCN2320.** View, facing northeast, of the sampling location for the Outfall 907 drainage area. The actual outfall is in the woods to the north of the Facility perimeter fence.

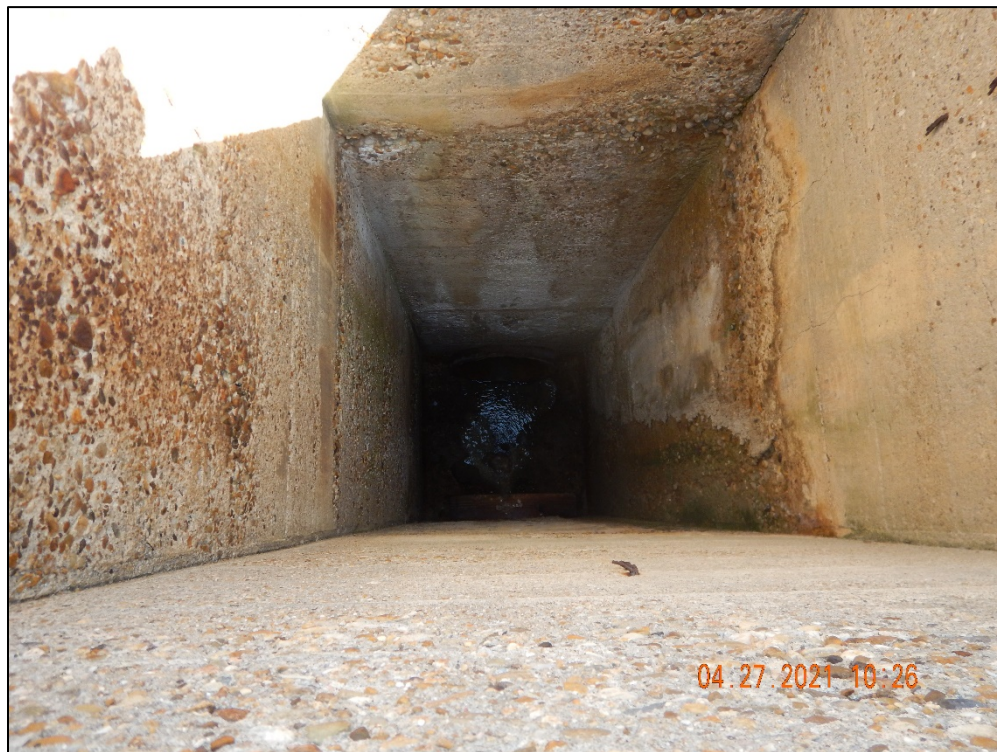
**DSCN2321.** View inside the sampling location for the Outfall 907 drainage area.

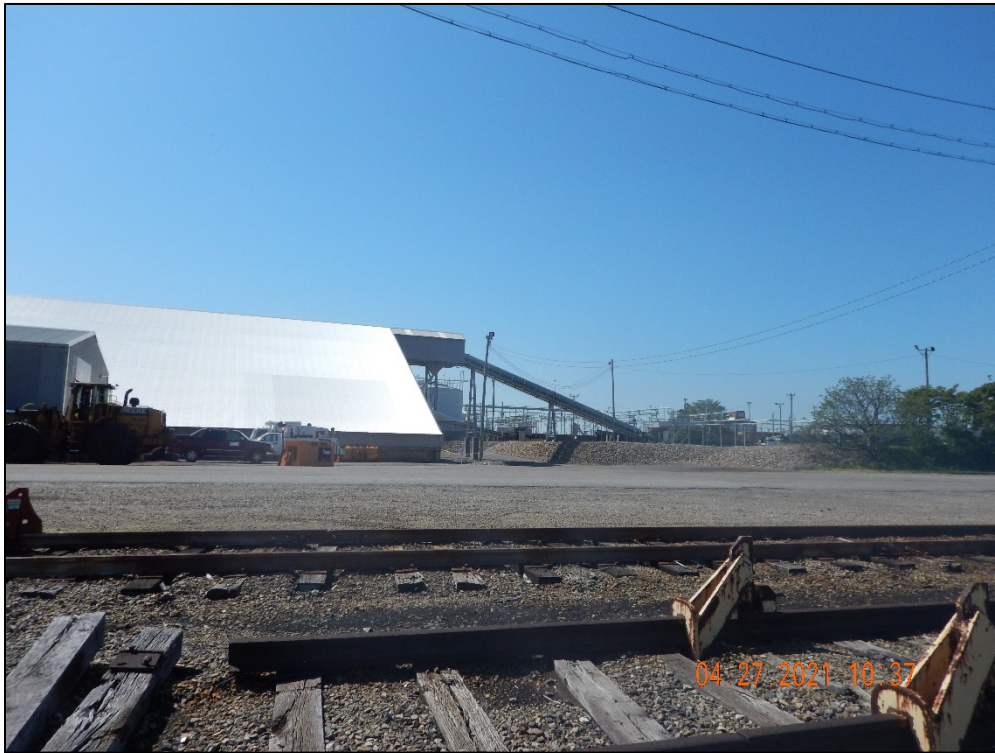
**DSCN2324.** View, facing south, of one of the two main ammonium sulfate storage warehouses in the northeast corner of the Facility. The second warehouse is behind the large white building.

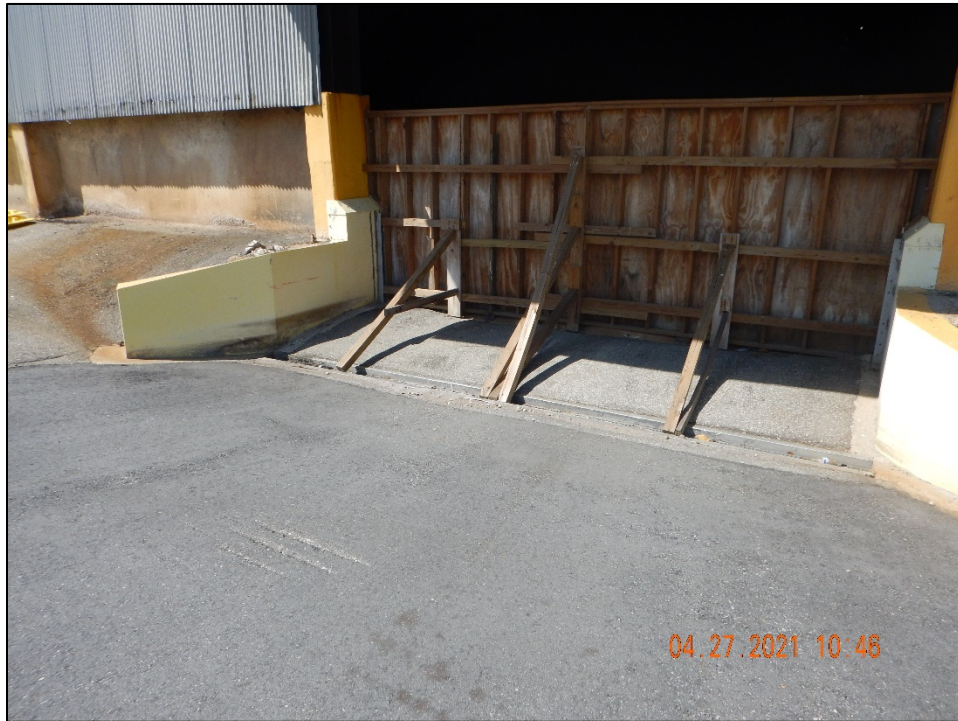
**DSCN2328.** View, facing west, of the entryway to the northernmost fertilizer warehouse. Facility representatives stated that this warehouse was no longer used.

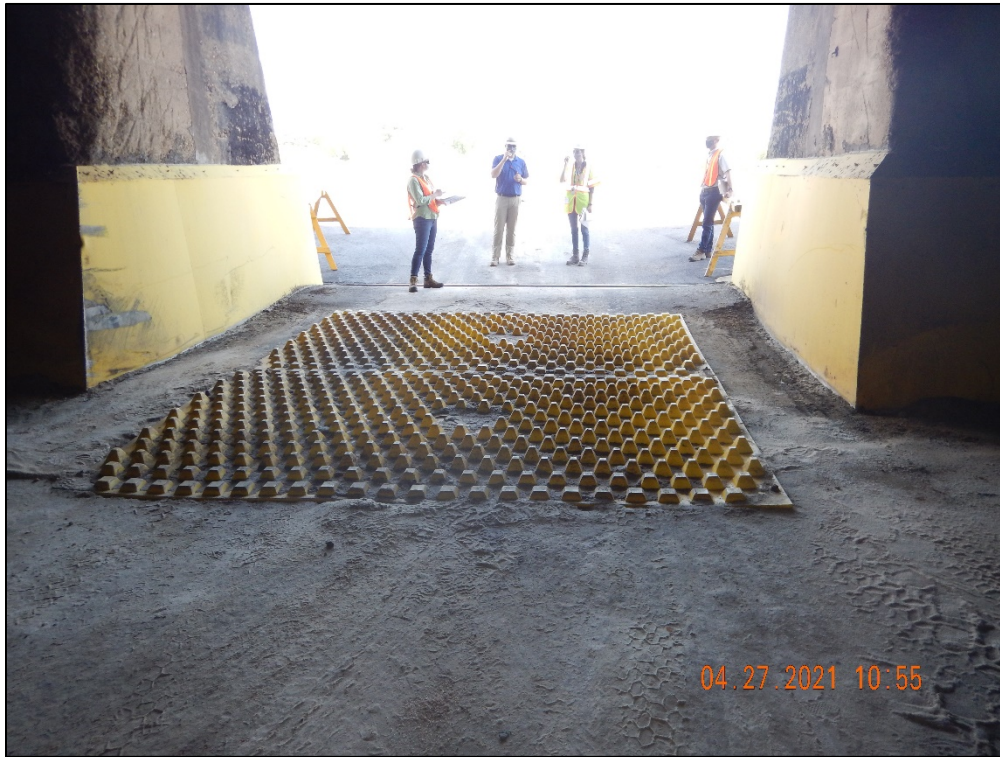
**DSCN2331.** View, facing north, of the yellow foreign object debris system in the entryway to the fertilizer warehouse. It is used to reduce the fertilizer track-out on dump truck tires.

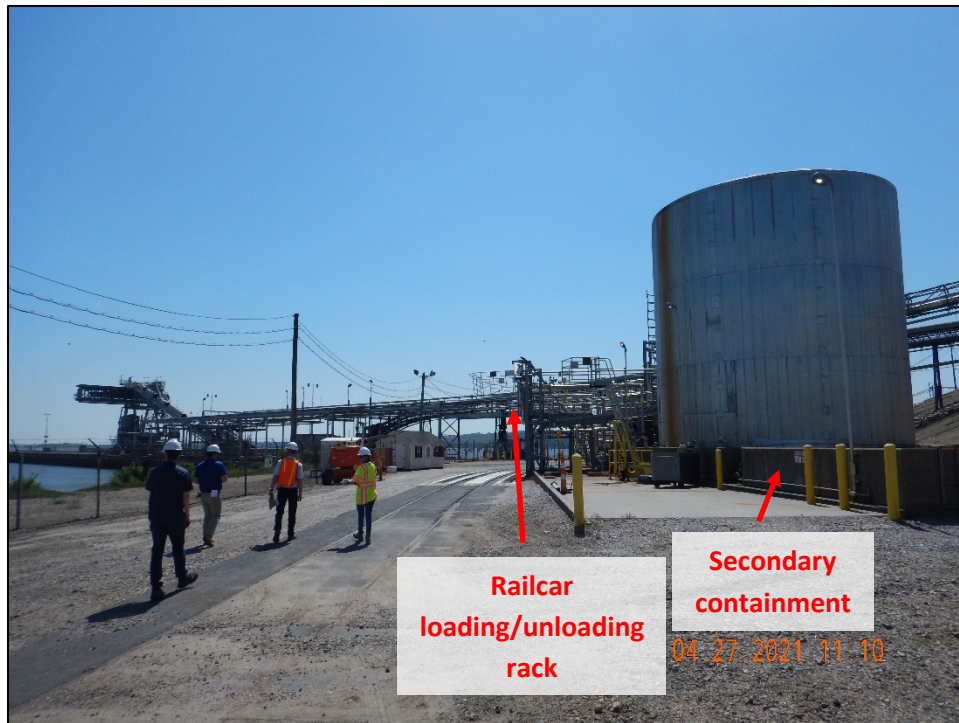
**DSCN2338.** View, facing south, of two oleum tanks in secondary containment and a railcar loading/unloading rack.

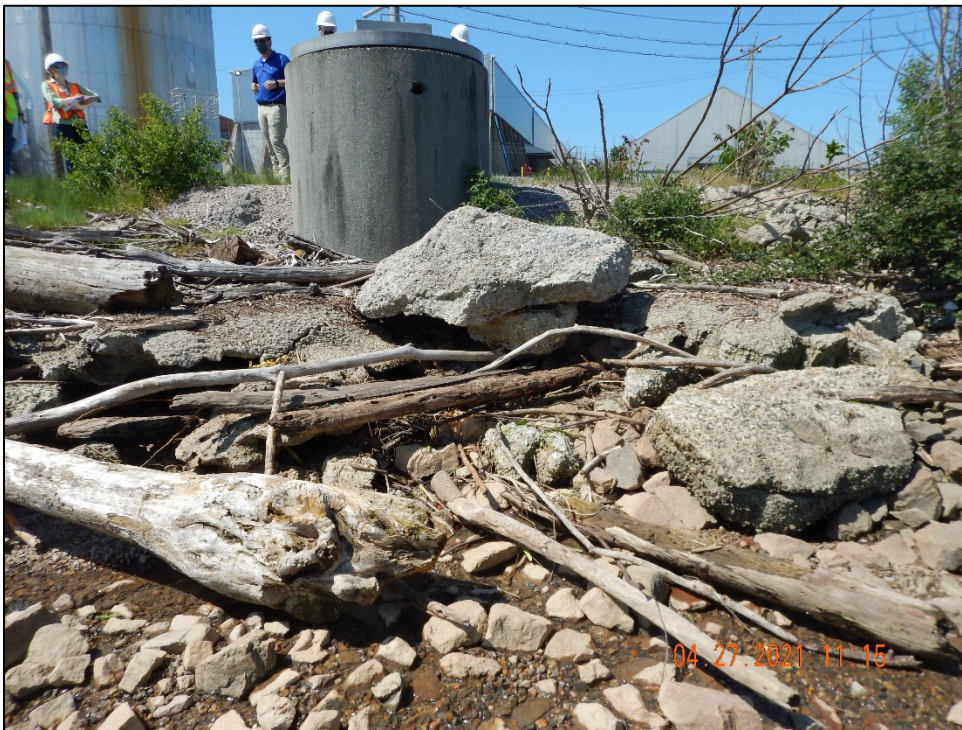
**DSCN2339.** View, facing west, of the final manhole upgradient of Outfall 906. The EPA Inspection Team observed a small amount of water draining from the manhole.

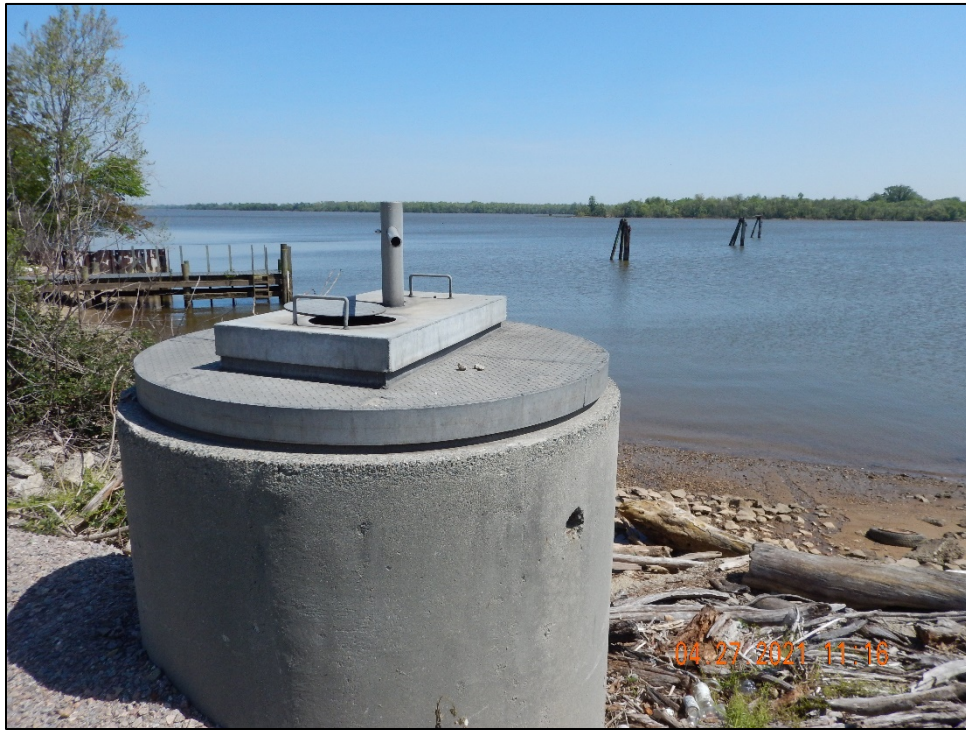
**DSCN2340.** View, facing east, of the final manhole upgradient of Outfall 906. Facility representatives stated that the actual outfall was currently submerged in the James River.

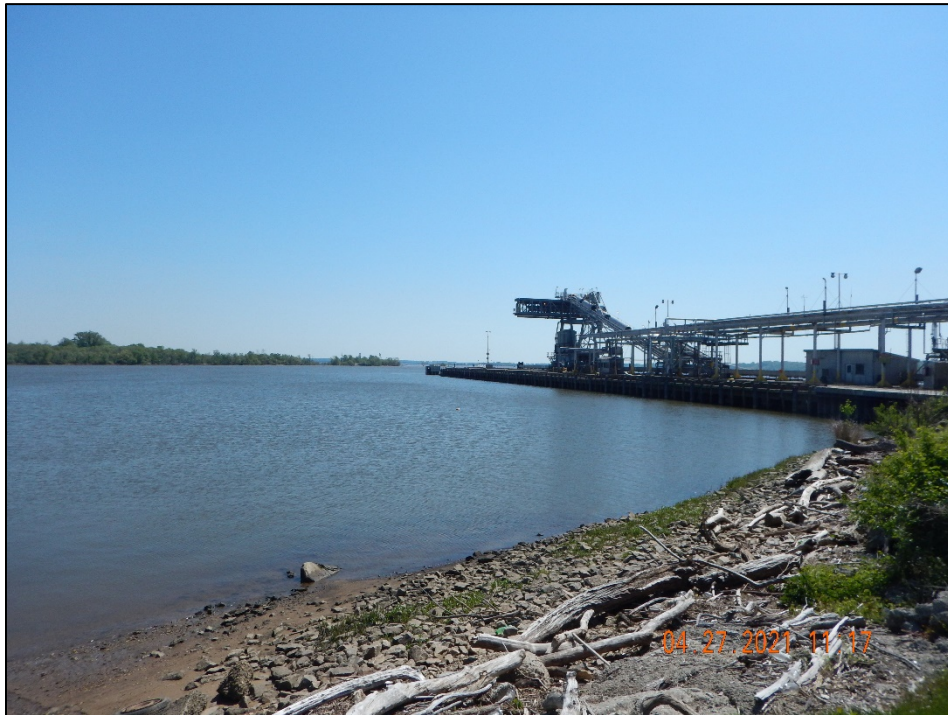
**DSCN2341.** View, facing southeast, of the Facility's large marine dock on the James River.

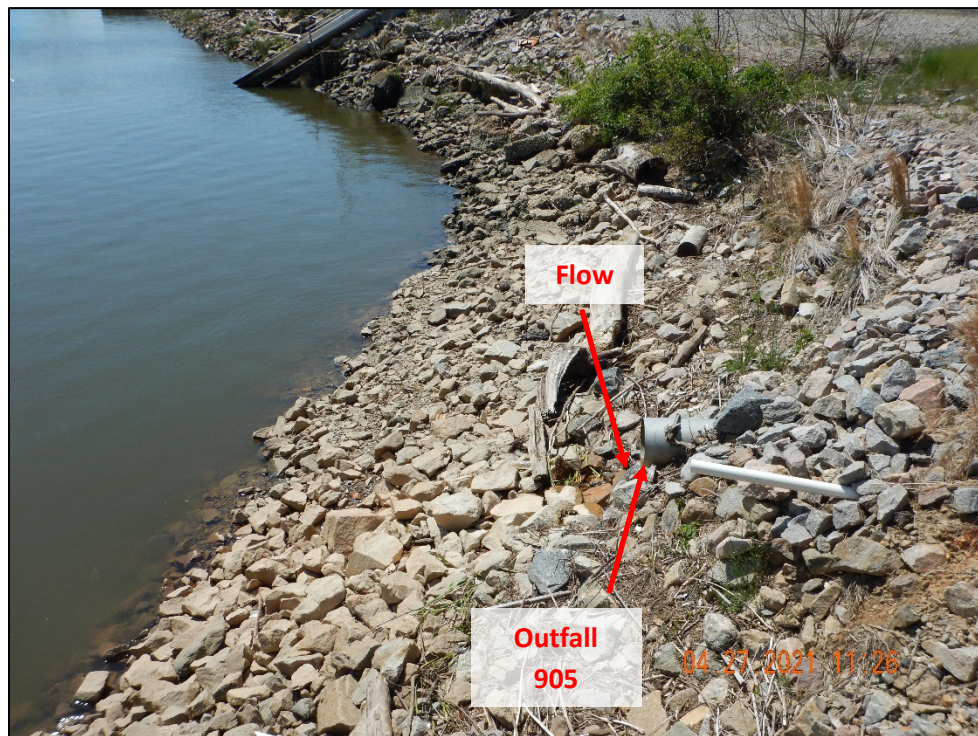
**DSCN2343.** View, facing south, of Outfall 905 discharging into the James River. Facility representatives stated the flow was from air-conditioning condensate.

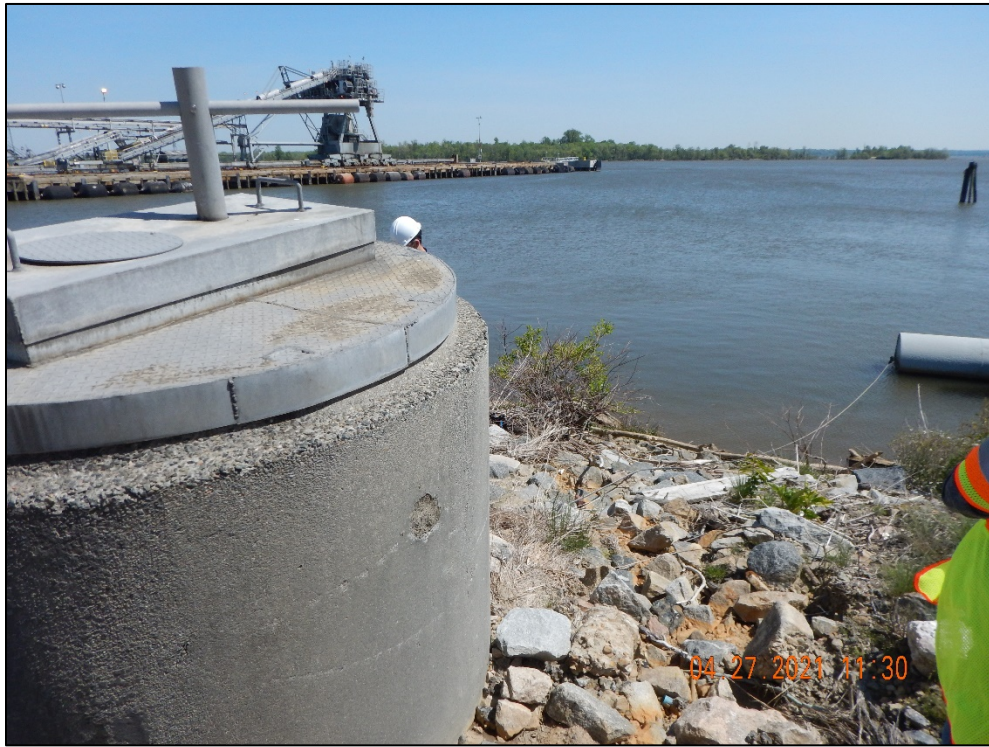
The EPA Inspection Team moved south from Outfall 905 and observed the final manhole upgradient of Outfall 904 (refer to [Appendix A, DSCN 2345](#)). Facility representatives stated that the actual outfall was submerged in the James River. Stormwater in the Outfall 904 drainage area generally flows to the east. Thirteen (13) stormwater inlets are located in the drainage area upgradient of the outfall. The drainage area also includes a third, actively used, ammonium sulfate fertilizer warehouse.

**DSCN2345.** View, facing northeast, of the final manhole upgradient of Outfall 904. Facility representatives stated the actual outfall was submerged in the James River.

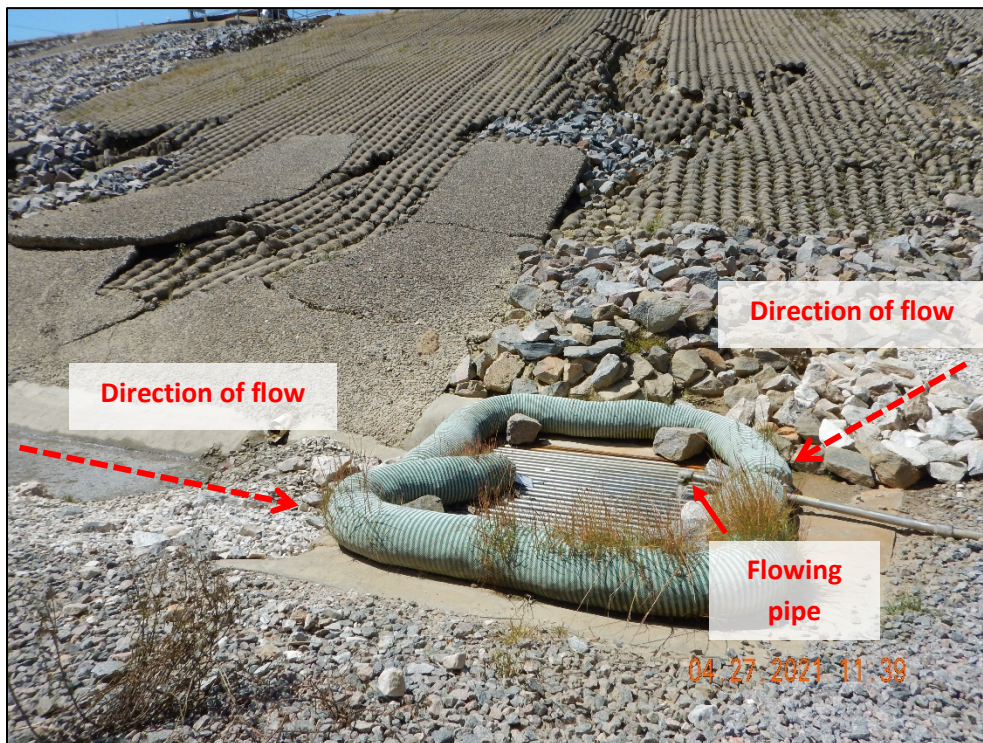
The EPA Inspection Team moved northwest of Outfall 904 and observed the final storm drain located upgradient of Outfall 905 (refer to [Appendix A, DSCN 2346 and DSCN 2348](#)). The stormwater inlet receives flow from ditches to the northwest and south. The EPA Inspection Team observed gravel and rolled inlet protection surrounding the inlet. The EPA Inspection Team also observed a small pipe labelled “WTO-HVAC H2O-DISCHARGE” above the inlet with water flowing directly into the inlet (refer to [Appendix A, DSCN 2349](#)). The EPA Inspection Team moved south of the aforementioned inlet and observed a concrete ditch running down the steep slope to the west of the inlet (refer to [Appendix A, DSCN 2351](#)). Facility representatives stated that the six other inlets in this drainage area flow to this ditch before running down the slope. The EPA Inspection Team again observed the presence of an unknown white substance in the ditch at the bottom of the steep slope. The unknown white substance also appeared to be draining from a small pipe built into the side of the steep slope (refer to [Appendix A, DSCN 2350](#)). The EPA Inspection Team continued south along the ditch and observed that it peaked and then began running downgradient towards a different stormwater inlet draining to Outfall 904 (refer to [Appendix A, DSCN 2352](#)). This stormwater inlet received drainage from a ditch to the north and another ditch to the southwest. This stormwater inlet receives drainage from 10 of the 13 stormwater inlets in the Outfall 904 drainage area. Facility representatives stated that they sample from the ditches on either side of this inlet, along with another inlet approximately 25 feet to the west (refer to [Appendix A, DSCN 2355 and DSCN 2356](#)) in order to get a representative sample of flow to Outfall 904. The EPA Inspection Team observed dry-weather flow to the third sampling point upgradient of Outfall 904, which Facility representatives attributed to a possible leak in a subsurface river water intake pipe.

**DSCN2346.** View, facing west, of the final storm drain located upgradient of Outfall 905. The Facility stated they sample from this location for Outfall 905.

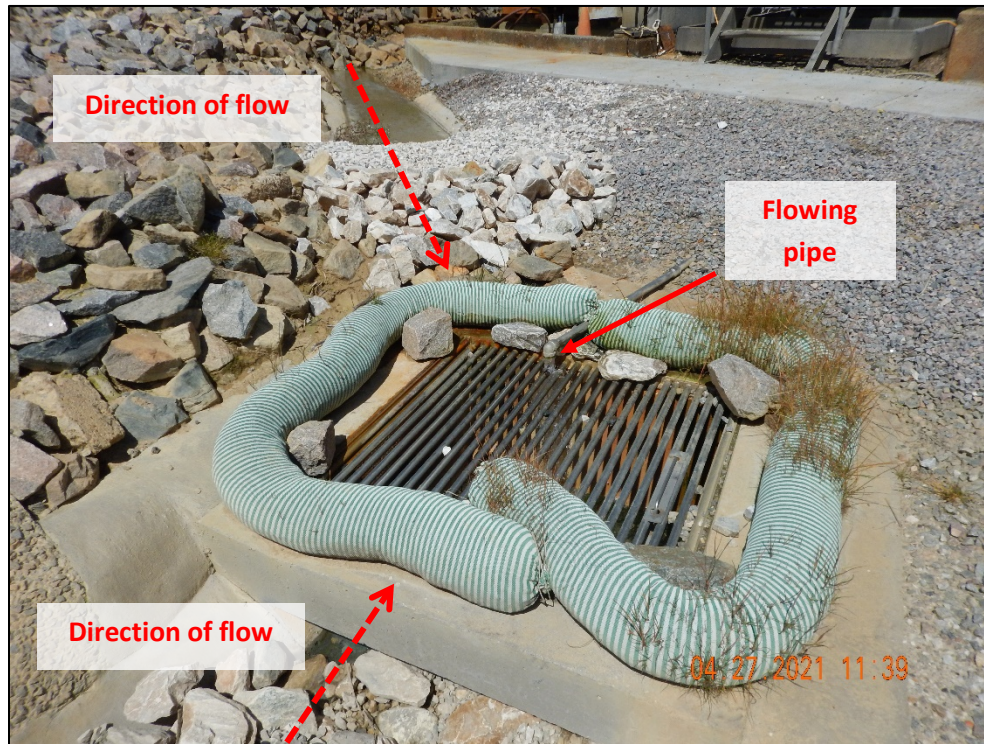
**DSCN2348.** Alternate view, facing northwest of the stormwater inlet from DSCN 2348. Note the ditches on either side and the flowing water from a small pipe above the inlet.

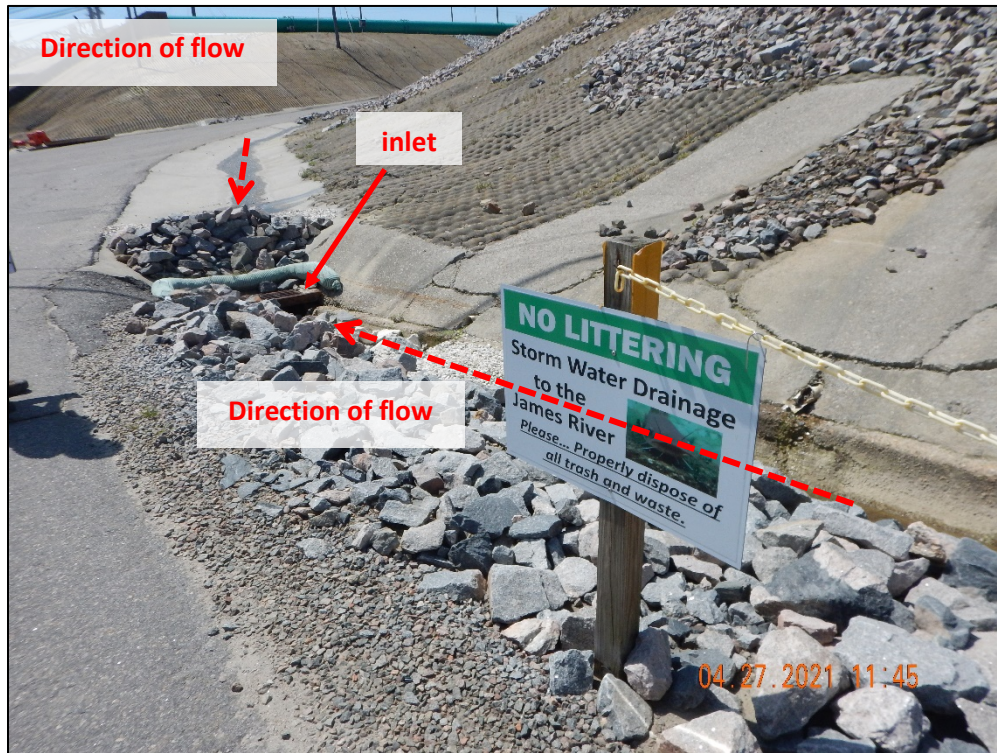
**DSCN2352.** View, facing south, of a storm inlet upgradient of Outfall 904. Note the rip rap and rolled inlet protection.

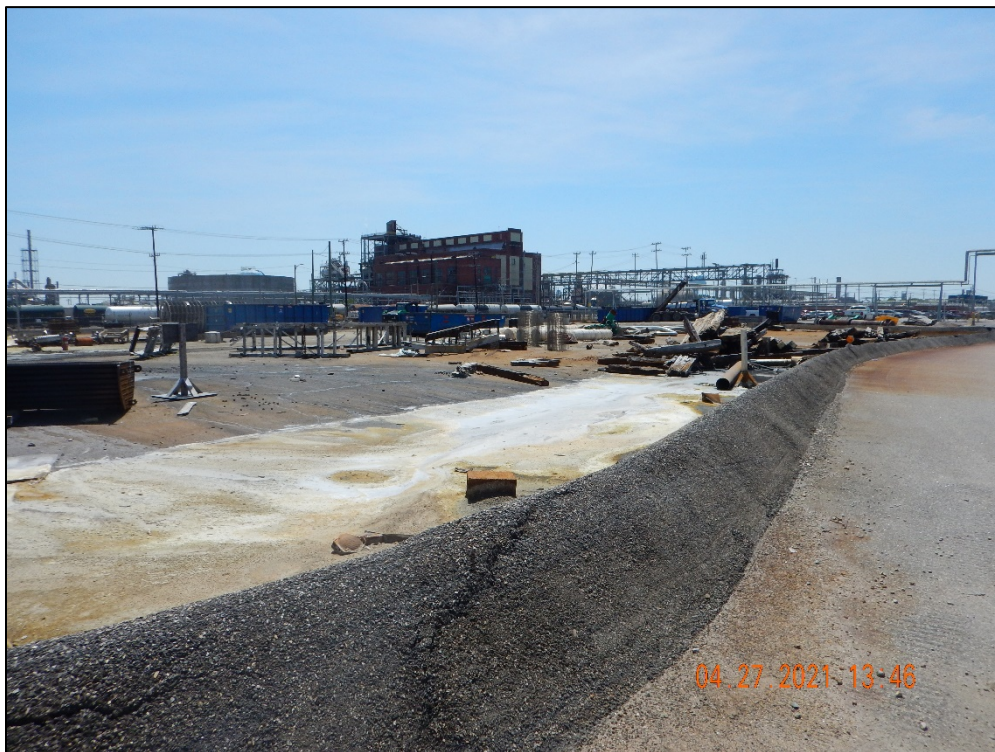
The EPA Inspection Team left the Facility for lunch and returned to visit the equipment lay-down area in the north-central portion of the Facility (refer to [Appendix A, DSCN 2369](#)). The EPA Inspection Team observed the entire area to be inside of a berm, and Facility representatives stated that the entire bermed area drains to the process waste sewer system. The EPA Inspection Team moved east into the Outfall 907 drainage area in the north-central portion of the Facility. According to the detailed site map (refer to [Appendix B, Exhibit 9](#)), drainage in this area flows to four stormwater inlets and then is piped north to Outfall 907, north of the Facility's perimeter fence. The main activity in this area involves dump truck unloading of ammonium sulfate fertilizer into a subsurface pit, which then carries fertilizer via a lift and conveyor system into the nearby warehouse (refer to [Appendix A, DSCN 2375](#)). The EPA Inspection Team observed an unprotected stormwater inlet approximately 20 feet northeast of the fertilizer pit, which was not identified on the Facility's site map. The fertilizer pit had a small bermed area and a cover that slid over the pit during rain events; however, the EPA Inspection Team observed pipes through the berm in two locations (refer to [Appendix A, DSCN 2376 and DSCN 2374](#)). The EPA Inspection Team observed a second stormwater inlet, which was present on the site map, located approximately 10 feet west of the fertilizer pit (refer to [Appendix A, DSCN 2373 and DSCN 2374](#)). The EPA Inspection Team observed improperly placed rolled inlet protection on the stormwater inlet and the presence of fertilizer on the pavement surrounding the inlet.

**DSCN2369.** View, facing southwest, of the bermed equipment lay-down area. Facility representatives stated this area drains to the process waste sewer system.

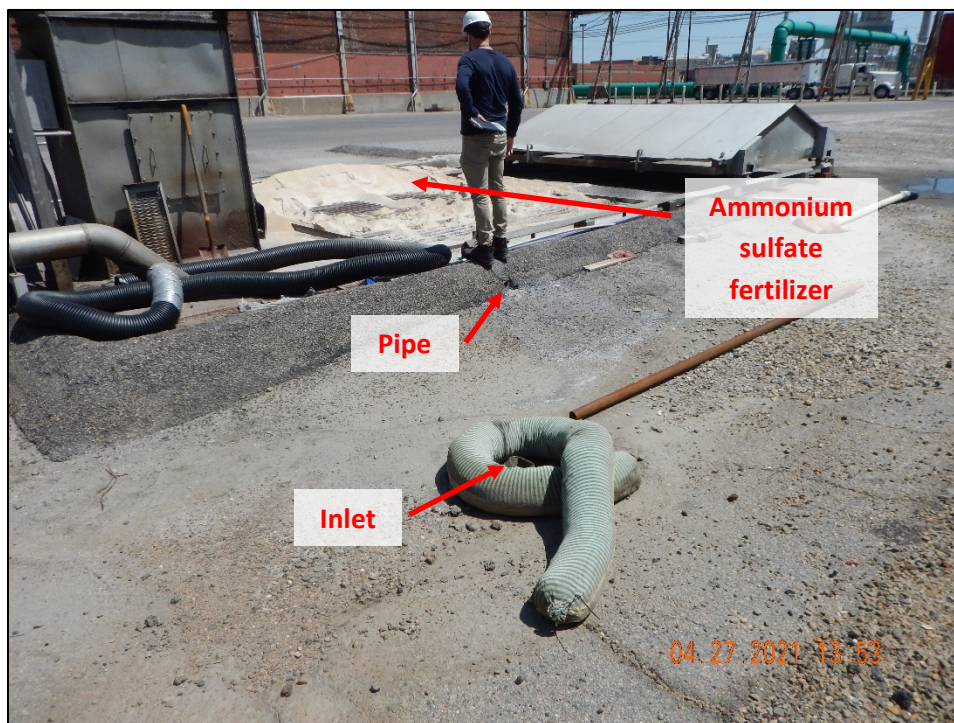
**DSCN2373.** View, facing southeast, of another stormwater inlet located approximately 10 feet from the ammonium sulfate fertilizer pit.

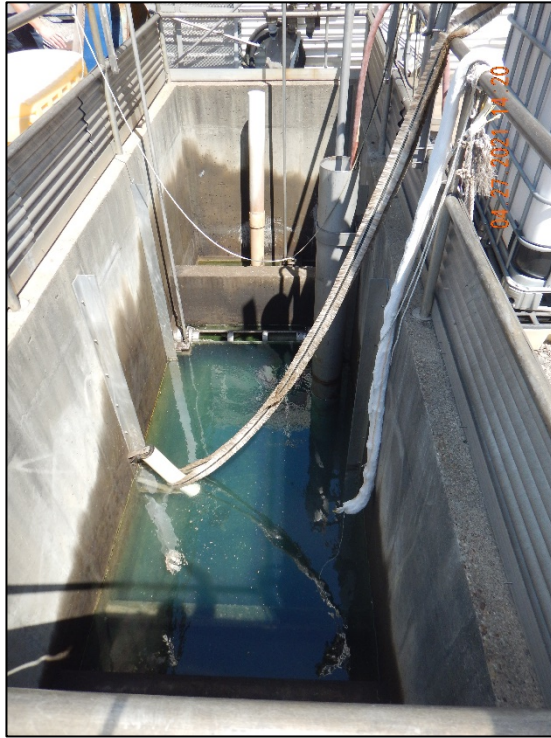
**DSCN2379.** View, facing east, of an oil/water separator in the Outfall 003 clear water sewer system area.

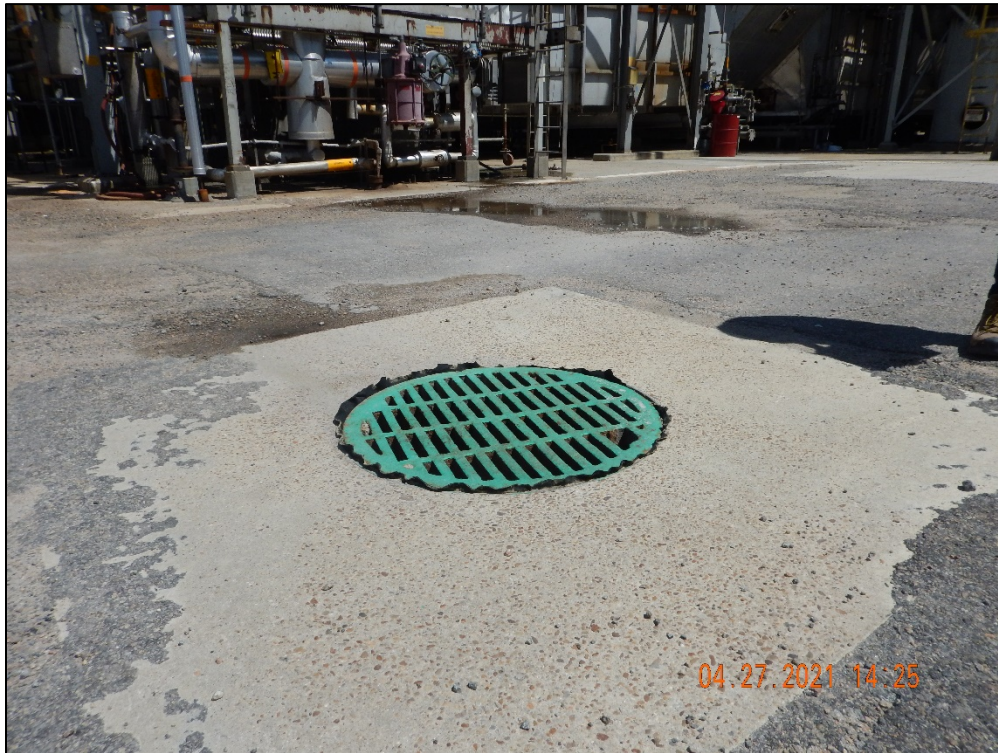
**DSCN2380.** View, facing southeast, of a stormwater inlet in the Outfall 003 clear water sewer system area.

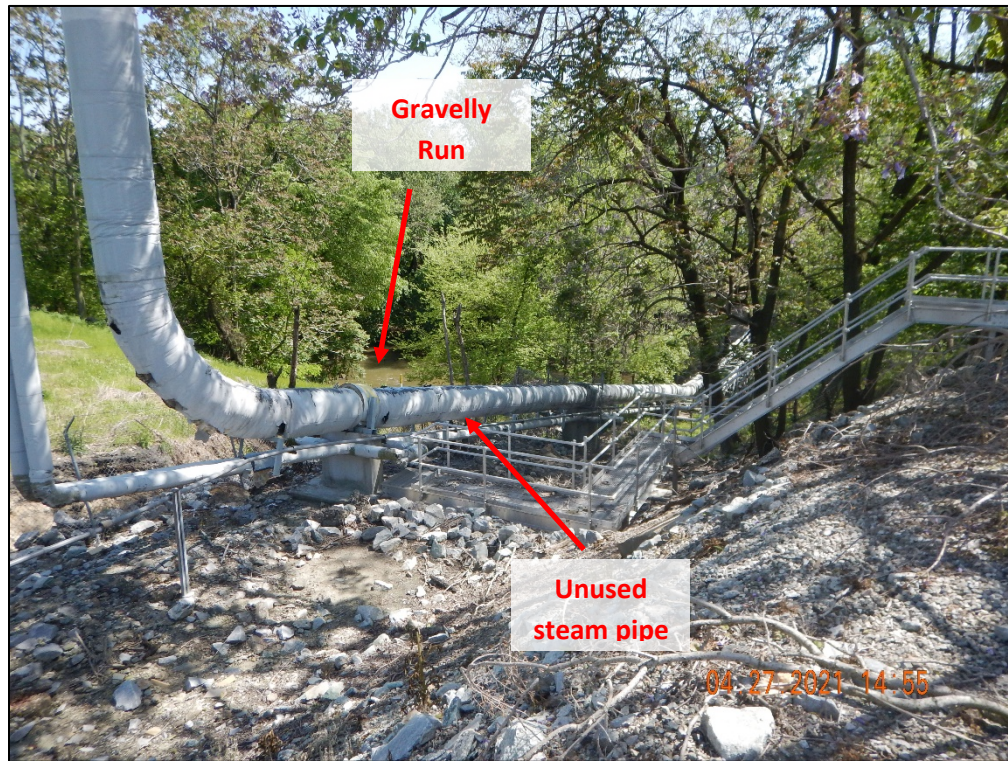
**DSCN2388.** View, facing south, of the Outfall 910 drainage ditch to Gravelly Run. Note the large pipe is an old, unused steam pipe.

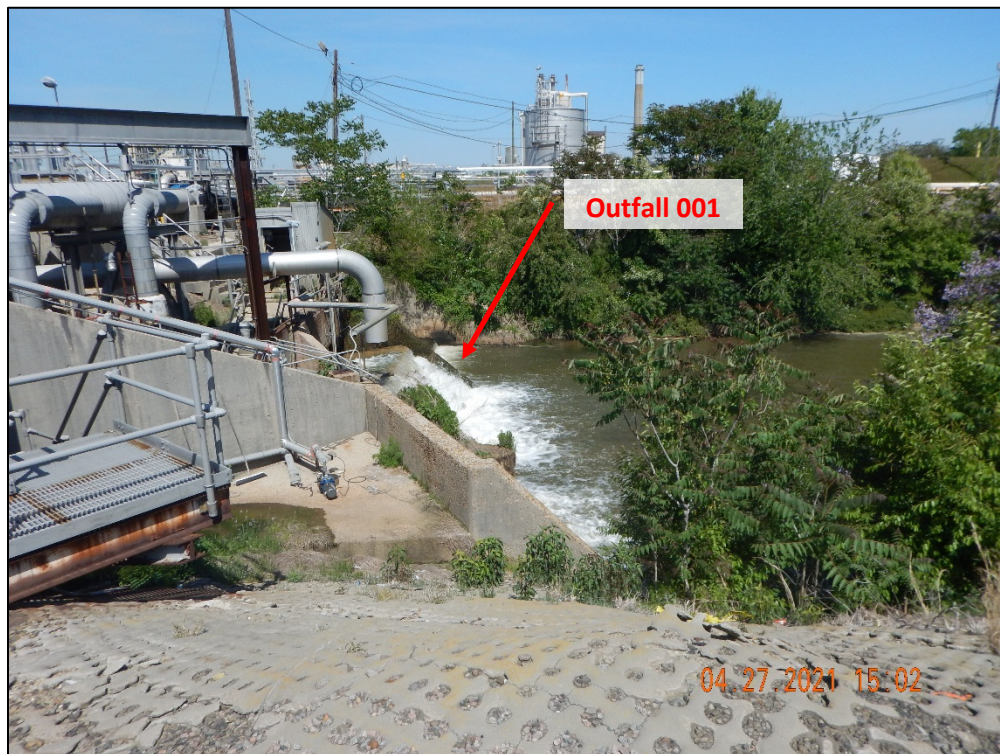
**DSCN2391.** View, facing east, of the large clear water sewer system Outfall 001. Outfall 001 drains stormwater, contact cooling water, and non-contact cooling water to Gravelly Run.

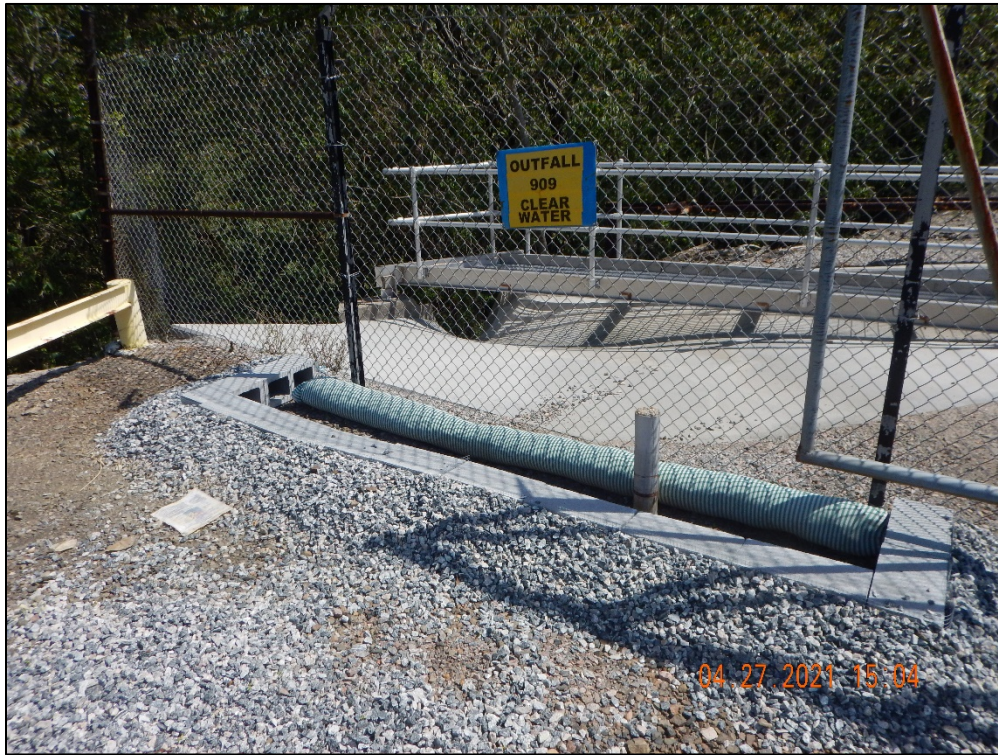
**DSCN2393.** View, facing south, of Outfall 909 to Gravelly Run. Outfall 909 receives stormwater from a single stormwater inlet in a small parking lot.

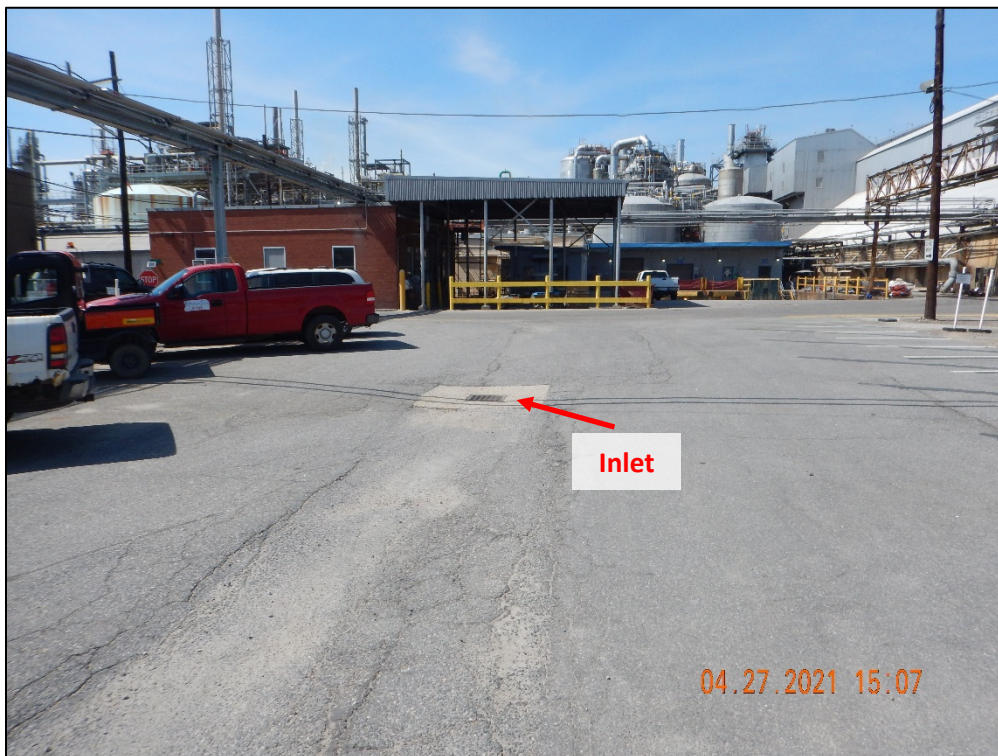
**DSCN2394.** View, facing north, of the single inlet draining to Outfall 909.
