**Report Title:** Clean Water Act, Section 404 Inspection Report for Paul Goodwin Site  
**Inspection Date(s):** 07/17/2024  
**Start Time:** 09:10 **End Time:** 11:05  
**Regulatory Program(s):** Inspections authorized pursuant to Clean Water Act, Sections 308 and 404 (33 U.S.C. §§ 1318 and 1344)  
**Site Name:** Paul Goodwin  
**Site Location:** Near Dixie Winds Lane  
Bremo Bluff, VA 23022  
**Latitude:** 37.739458 **Longitude:** -78.2234262  
**County/Parish:** Fluvanna County  
**Site Owner(s):** Christopher Lacy  
**Mailing Address:** 115 Carriage Hill Road  
Palmyra, Virginia 22974

**DSB-ID #:** ECAD-5512

On July 17, 2024, the U.S. Environmental Protection Agency (“EPA”) conducted an inspection for compliance with Section 404 of the Clean Water Act pertaining to an Administrative Order on Consent (“Order”, EPA Docket # CWA-03-2022-0039DW). The inspection was conducted as part of injunctive relief monitoring of the aquatic resource restoration activities required by paragraph 17 of the Order. On January 11, 2023, EPA issued a letter approving the Restoration and Mitigation Plan (“RMP”), prepared for Mr. Paul Goodwin by Wetland Studies and Solutions, Inc (“WSSI”).

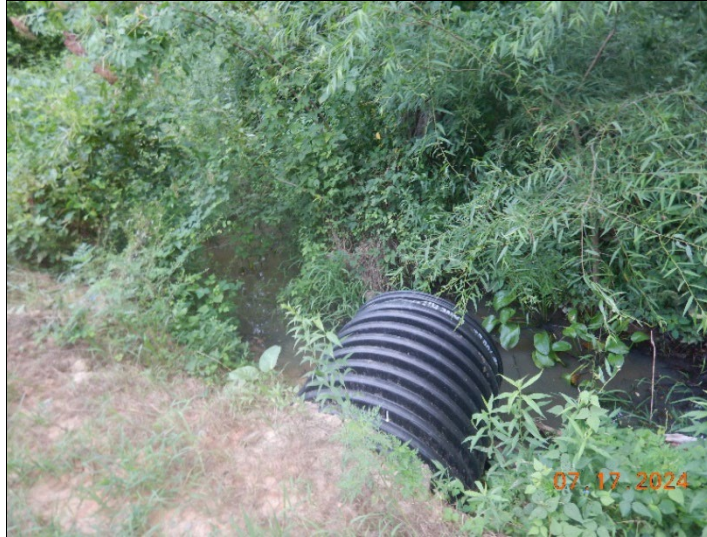
Paul Goodwin  
Date: 17 July 2024  
Photo ID: DSCN5486.JPG  
Photo taken by: Laura Mathew

Notes: UNT1 and inlet of existing culvert 1B.

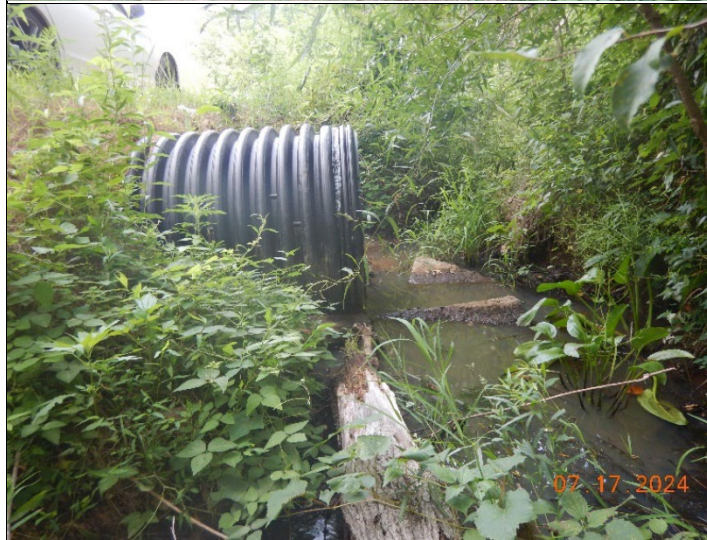
Paul Goodwin  
Date: 17 July 2024  
Photo ID: DSCN5487.JPG  
Photo taken by: Laura Mathew

Notes: West facing view of UNT1 and inlet of culvert 1B.

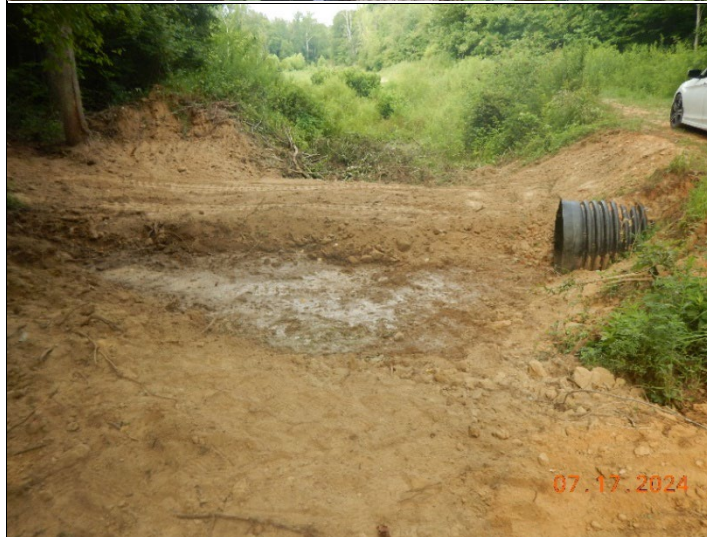
Paul Goodwin  
Date: 17 July 2024  
Photo ID: DSCN5488.JPG  
Photo taken by: Laura Mathew

Notes: Outlet of culvert 1B.

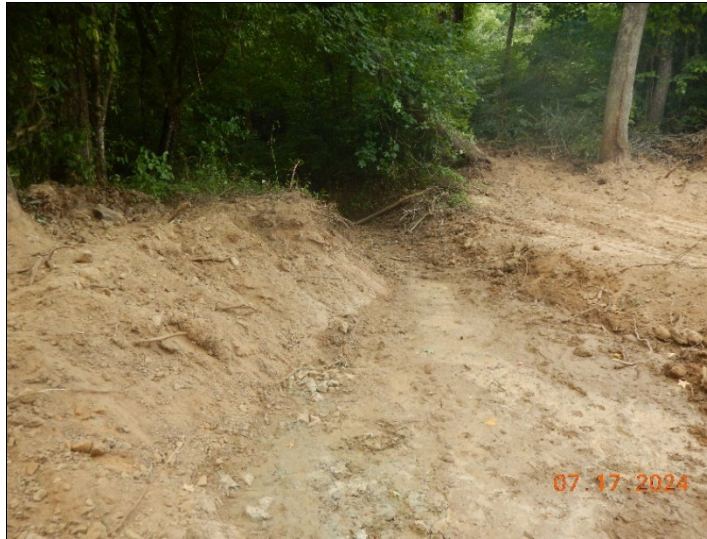
Paul Goodwin  
Date: 17 July 2024  
Photo ID: DSCN5489.JPG  
Photo taken by: Laura Mathew

Notes: Southward view of UNT1 from Dixie Winds Lane.

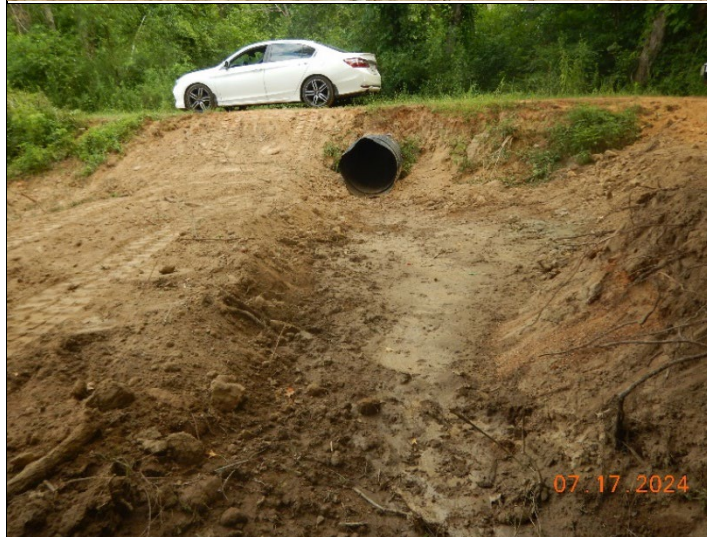
Paul Goodwin  
Date: 17 July 2024  
Photo ID: DSCN5490.JPG  
Photo taken by: Laura Mathew

Notes: Upstream view of UNT1 and culvert 1B. Dixie Winds Lane is in the background.

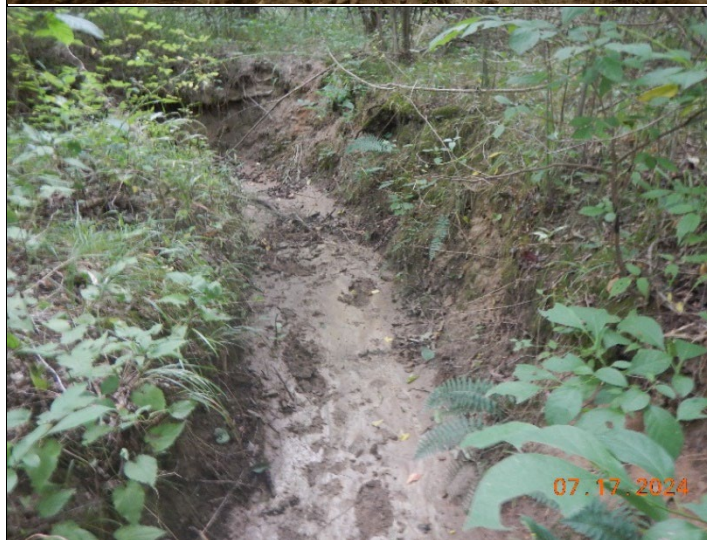
Paul Goodwin  
Date: 17 July 2024  
Photo ID: DSCN5492.JPG  
Photo taken by: Laura Mathew

Notes: Southward view of UNT1.

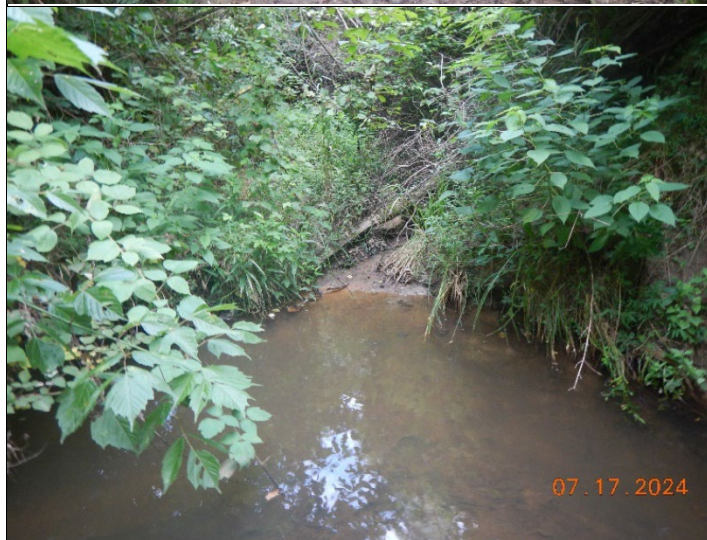
Paul Goodwin  
Date: 17 July 2024  
Photo ID: DSCN5495.JPG  
Photo taken by: Laura Mathew

Notes: Northward view of the confluence  
of UNT1 with South Creek.

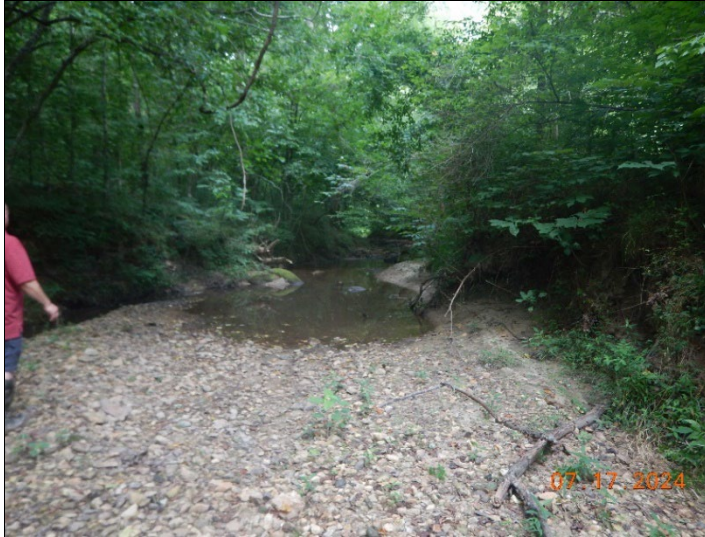
Paul Goodwin  
Date: 17 July 2024  
Photo ID: DSCN5496.JPG  
Photo taken by: Laura Mathew

Notes: Westward view of South Creek.

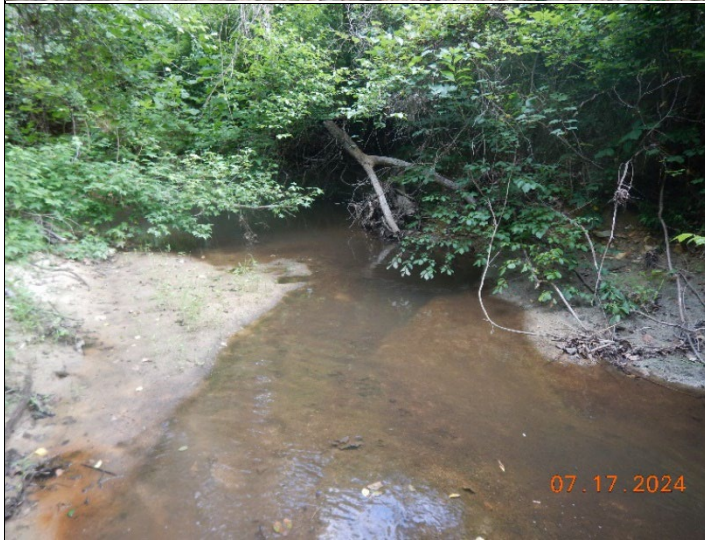
Paul Goodwin  
Date: 17 July 2024  
Photo ID: DSCN5497.JPG  
Photo taken by: Laura Mathew

Notes: Westward view of South Creek.

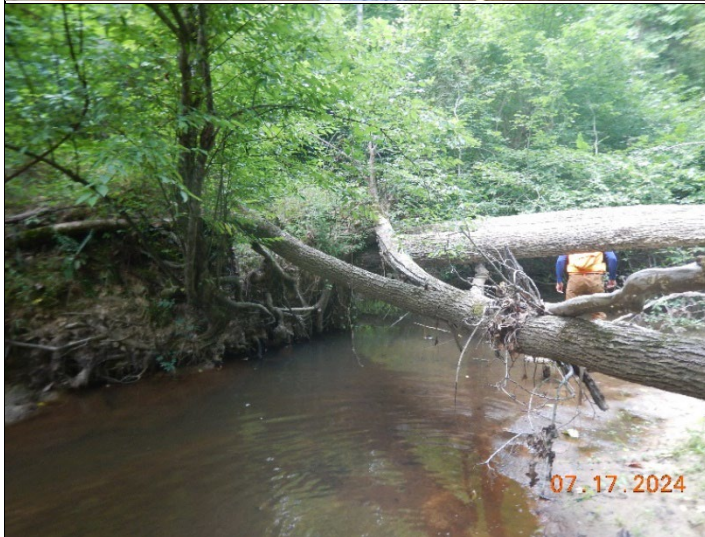
Paul Goodwin  
Date: 17 July 2024  
Photo ID: DSCN5498.JPG  
Photo taken by: Laura Mathew

Notes: Westward view of South Creek.

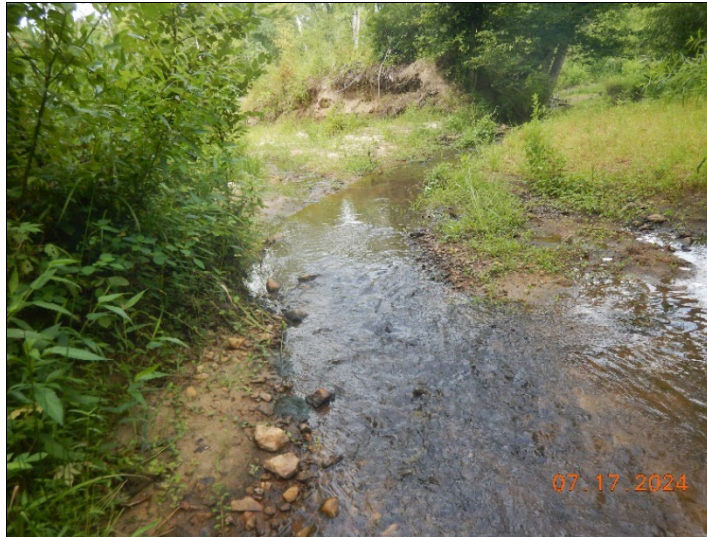
Paul Goodwin  
Date: 17 July 2024  
Photo ID: DSCN5500.JPG  
Photo taken by: Laura Mathew

Notes: Westward view of South Creek with the ditch in the background.

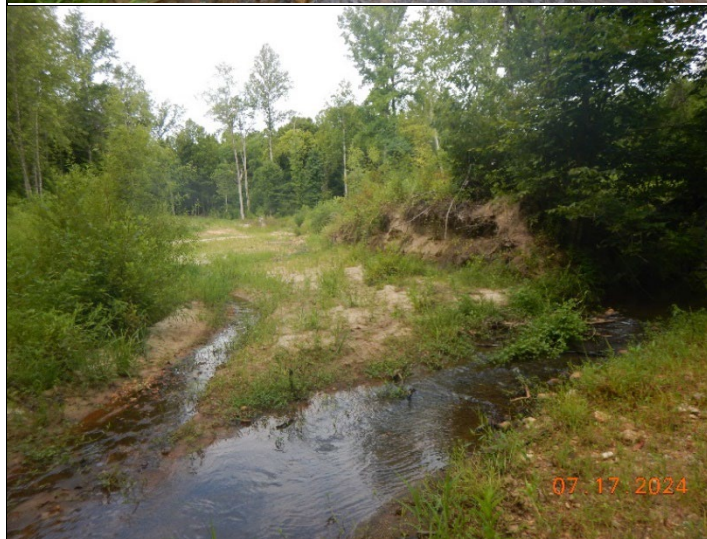
Paul Goodwin  
Date: 17 July 2024  
Photo ID: DSCN5501.JPG  
Photo taken by: Laura Mathew

Notes: Westward view of the ditch. South Creek is visible in the foreground.

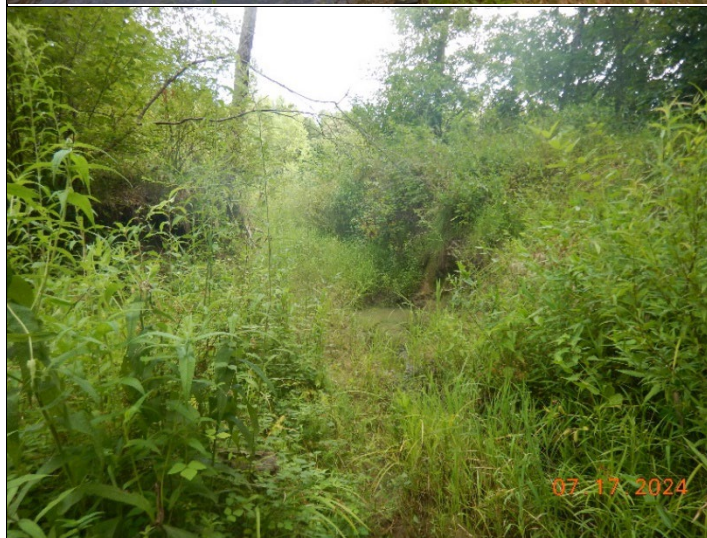
Paul Goodwin  
Date: 17 July 2024  
Photo ID: DSCN5502.JPG  
Photo taken by: Laura Mathew

Notes: Eastward view of vegetation along bank of South Creek.

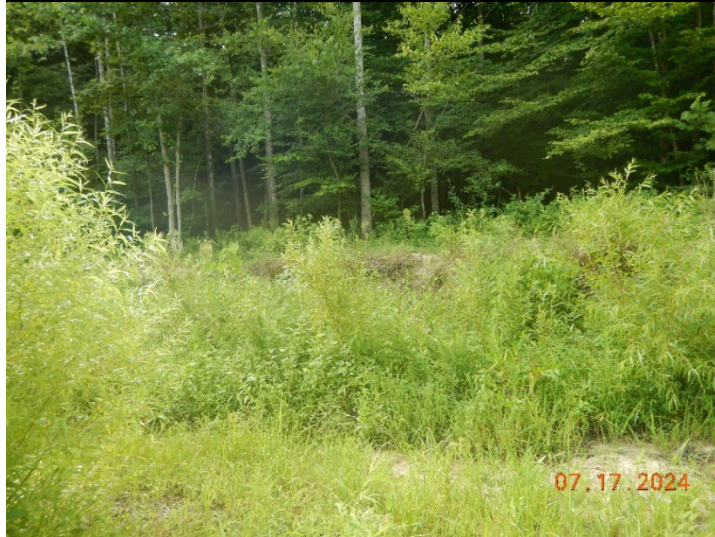
Paul Goodwin  
Date: 17 July 2024  
Photo ID: DSCN5503.JPG  
Photo taken by: Laura Mathew

Notes: Southward view near the confluence of South Creek and the ditch.

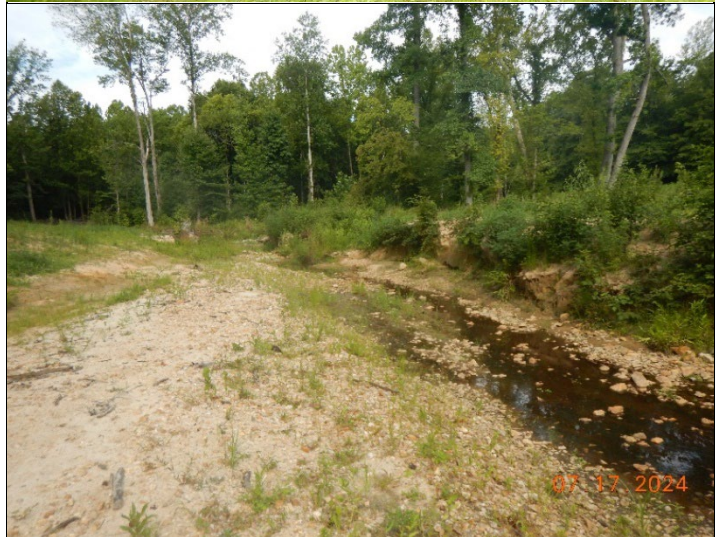
Paul Goodwin  
Date: 17 July 2024  
Photo ID: DSCN5504.JPG  
Photo taken by: Laura Mathew

Notes: Westward view of the ditch.

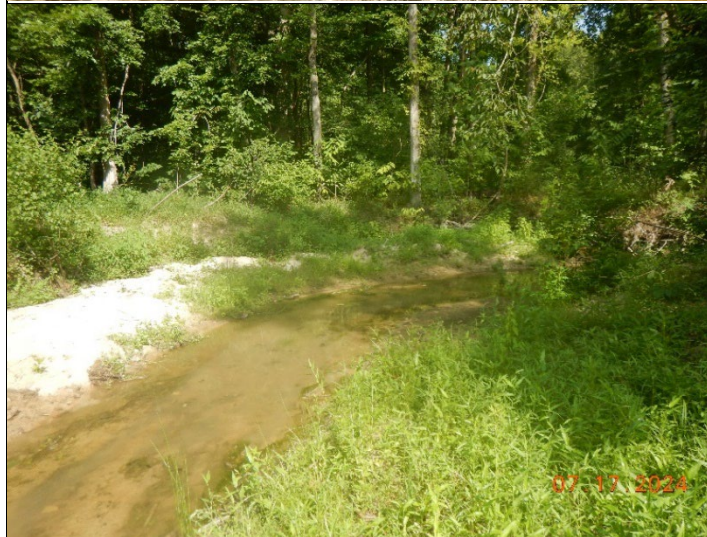
Paul Goodwin  
Date: 17 July 2024  
Photo ID: DSCN5510.JPG  
Photo taken by: Laura Mathew

Notes: Westward view of bank opposite the berm.

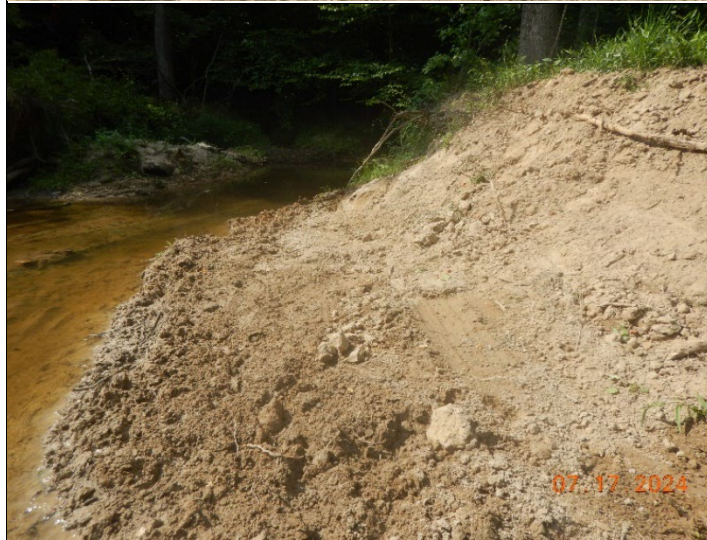
Paul Goodwin  
Date: 17 July 2024  
Photo ID: DSCN5513.JPG  
Photo taken by: Laura Mathew

Notes: Southward view of the far bank located to the west of the berm.

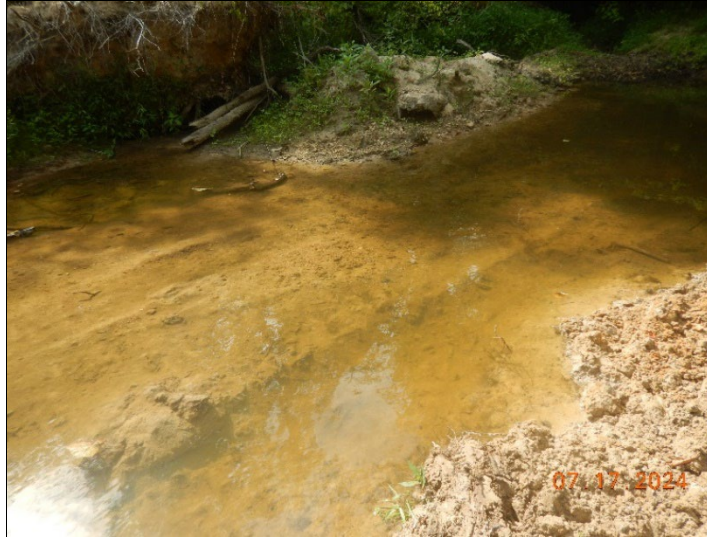
Paul Goodwin  
Date: 17 July 2024  
Photo ID: DSCN5515.JPG  
Photo taken by: Laura Mathew

Notes: View of South Creek channel proximate to the berm.

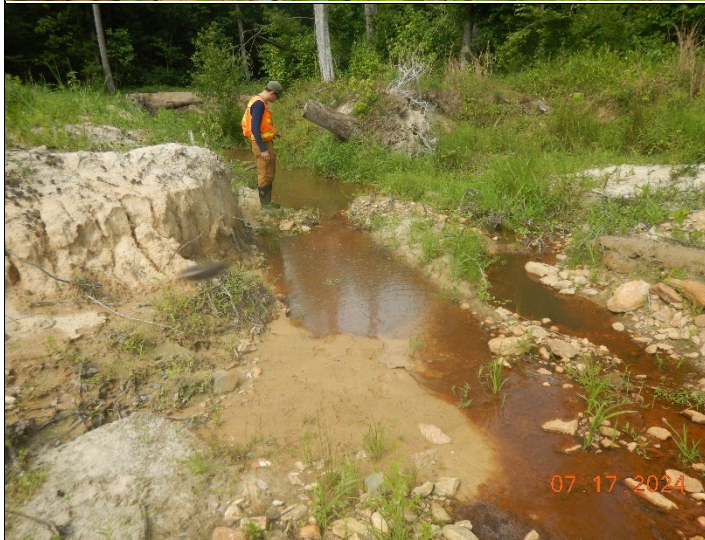
Paul Goodwin  
Date: 17 July 2024  
Photo ID: DSCN5523.JPG  
Photo taken by: Laura Mathew

Notes: View of surface water within the ditch.

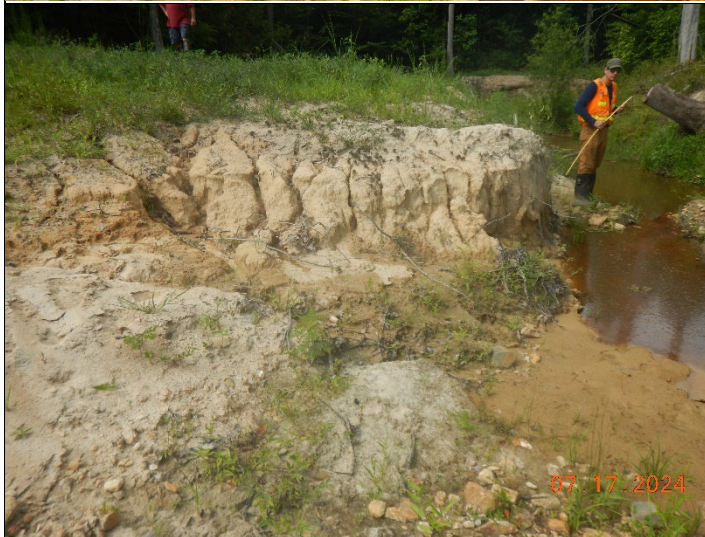
Paul Goodwin  
Date: 17 July 2024  
Photo ID: DSCN5524.JPG  
Photo taken by: Laura Mathew

Notes: Another view of the ditch, with denuded areas in the foreground.

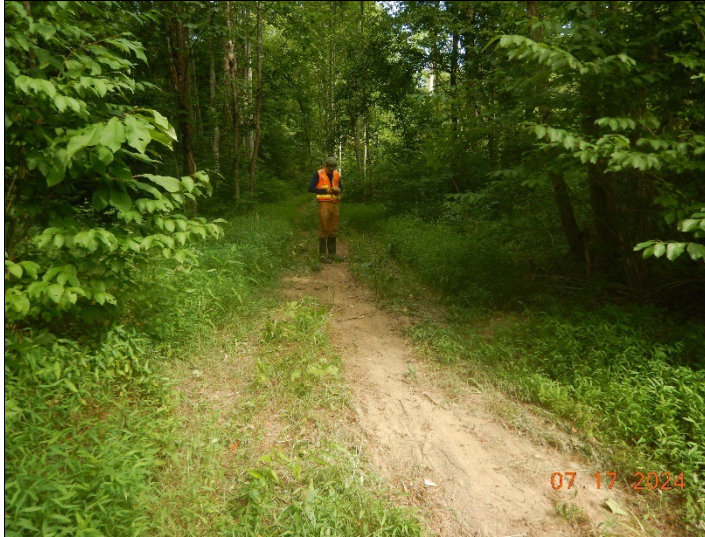
Paul Goodwin  
Date: 17 July 2024  
Photo ID: DSCN5528.JPG  
Photo taken by: Laura Mathew

Notes: Upgradient view of access path.

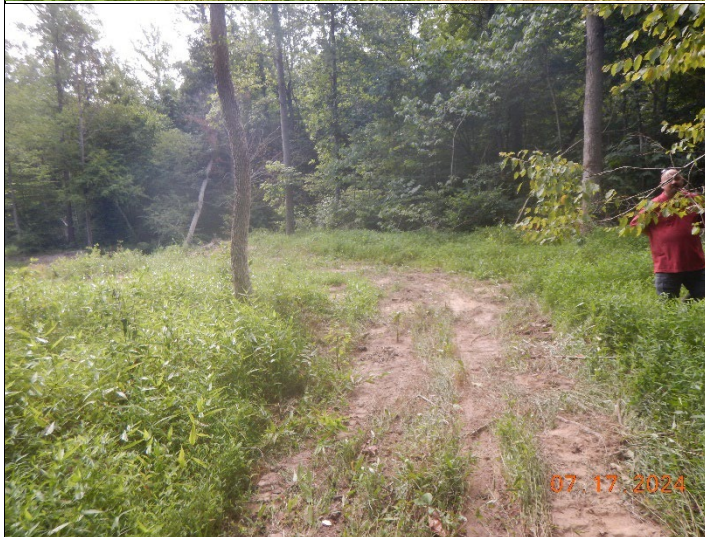
Paul Goodwin  
Date: 17 July 2024  
Photo ID: DSCN5529.JPG  
Photo taken by: Laura Mathew

Notes: Downgradient view of access path.

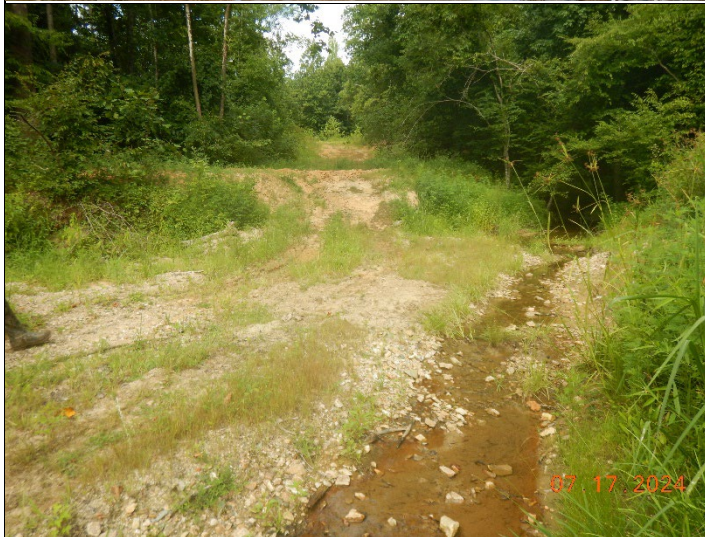
Paul Goodwin  
Date: 17 July 2024  
Photo ID: DSCN5533.JPG  
Photo taken by: Laura Mathew

Notes: Upstream facing view where culvert 3 was once located.

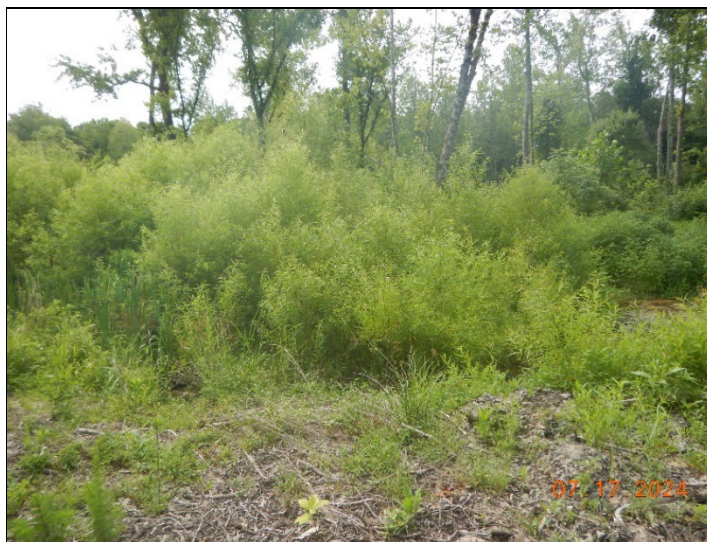
Paul Goodwin  
Date: 17 July 2024  
Photo ID: DSCN5536.JPG  
Photo taken by: Laura Mathew

Notes: Westward view of vegetation, including black willow saplings along UNT3.

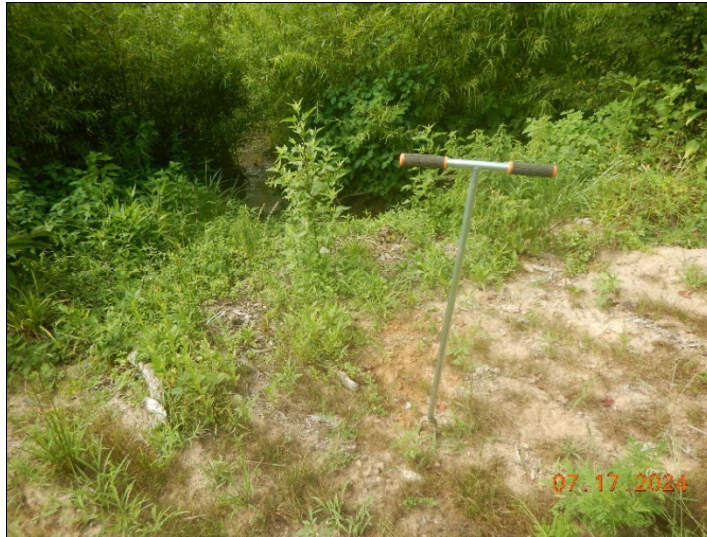
Paul Goodwin  
Date: 17 July 2024  
Photo ID: DSCN5537.JPG  
Photo taken by: Laura Mathew

The inspectors then moved to the east to document the floodplain wetlands that occurred immediately to the north of South Creek. A soil boring was conducted at 38.738848, -78.23546 within an area where wetland areas were proposed to be seeded with a wetland mix, per the Planting Plan (**Attachment 3**). The soil boring was characterized as: [0-15 inches] 10YR 4/4 sandy fill; [15-21 inches] 10YR 4/3 sandy fill with 40% 10YR 6/4 redoximorphic features; [21-27 inches] 5YR 5/1 sandy loam matrix with 15% 5YR 4/6 redoximorphic features. No hydrology was observed, and the area was sparsely vegetated with approximately 40% Oriental lady's thumb (*Polygonum cespitosum*), 10% crabgrass (*Digitaria sp.*), 5% soft rush (*Juncus effusus*), 5% yellow nutsedge (*Cyperus esculentus*), and trace amount of Chinese bushclover (*Lespedeza cuneata*). Overall, approximately 21 inches of non-native fill was observed over the native hydric soil layer; evidence of wetland hydrology were not present; and the area did not possess a hydrophytic community. The soils, vegetation and hydrology were altered by the discharge of fill. At the time of the inspection, this area was disturbed, did not meet the definition of a wetland, and evidence of seeding with wetland plants was not observed. As noted, wetland hydrology was not observed in this area, likely due to two observations: (i) the presence of a 21" fill layer and (ii) the absence of root wads, which would restore the flow to South Creek. As outlined in a paragraph above, the ditch possessed water and was diverting flow from South Creek. The RMP proposes to restore the hydrology to South Creek, which would also restore the hydrology to the adjacent wetlands. Under the observed condition, the hydrology of the Site was impaired and was not in compliance with the RMP.

Notes: View of soil boring located at 38.738848, -78.23546.

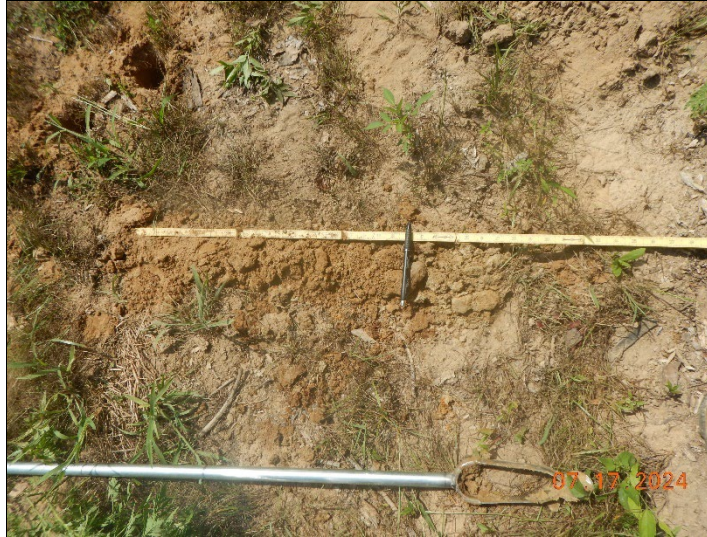
Paul Goodwin  
Date: 17 July 2024  
Photo ID: DSCN5540.JPG  
Photo taken by: Laura Mathew

Notes: View of the soil boring.
