INSPECTION REPORT

| <b>Inspection Date:</b> | 02/23/2021 | |
| <b>Regulatory Program:</b> | CWA NPDES/Construction Stormwater | |
| <b>Site Name:</b> | Rising Sun Subdivision | |

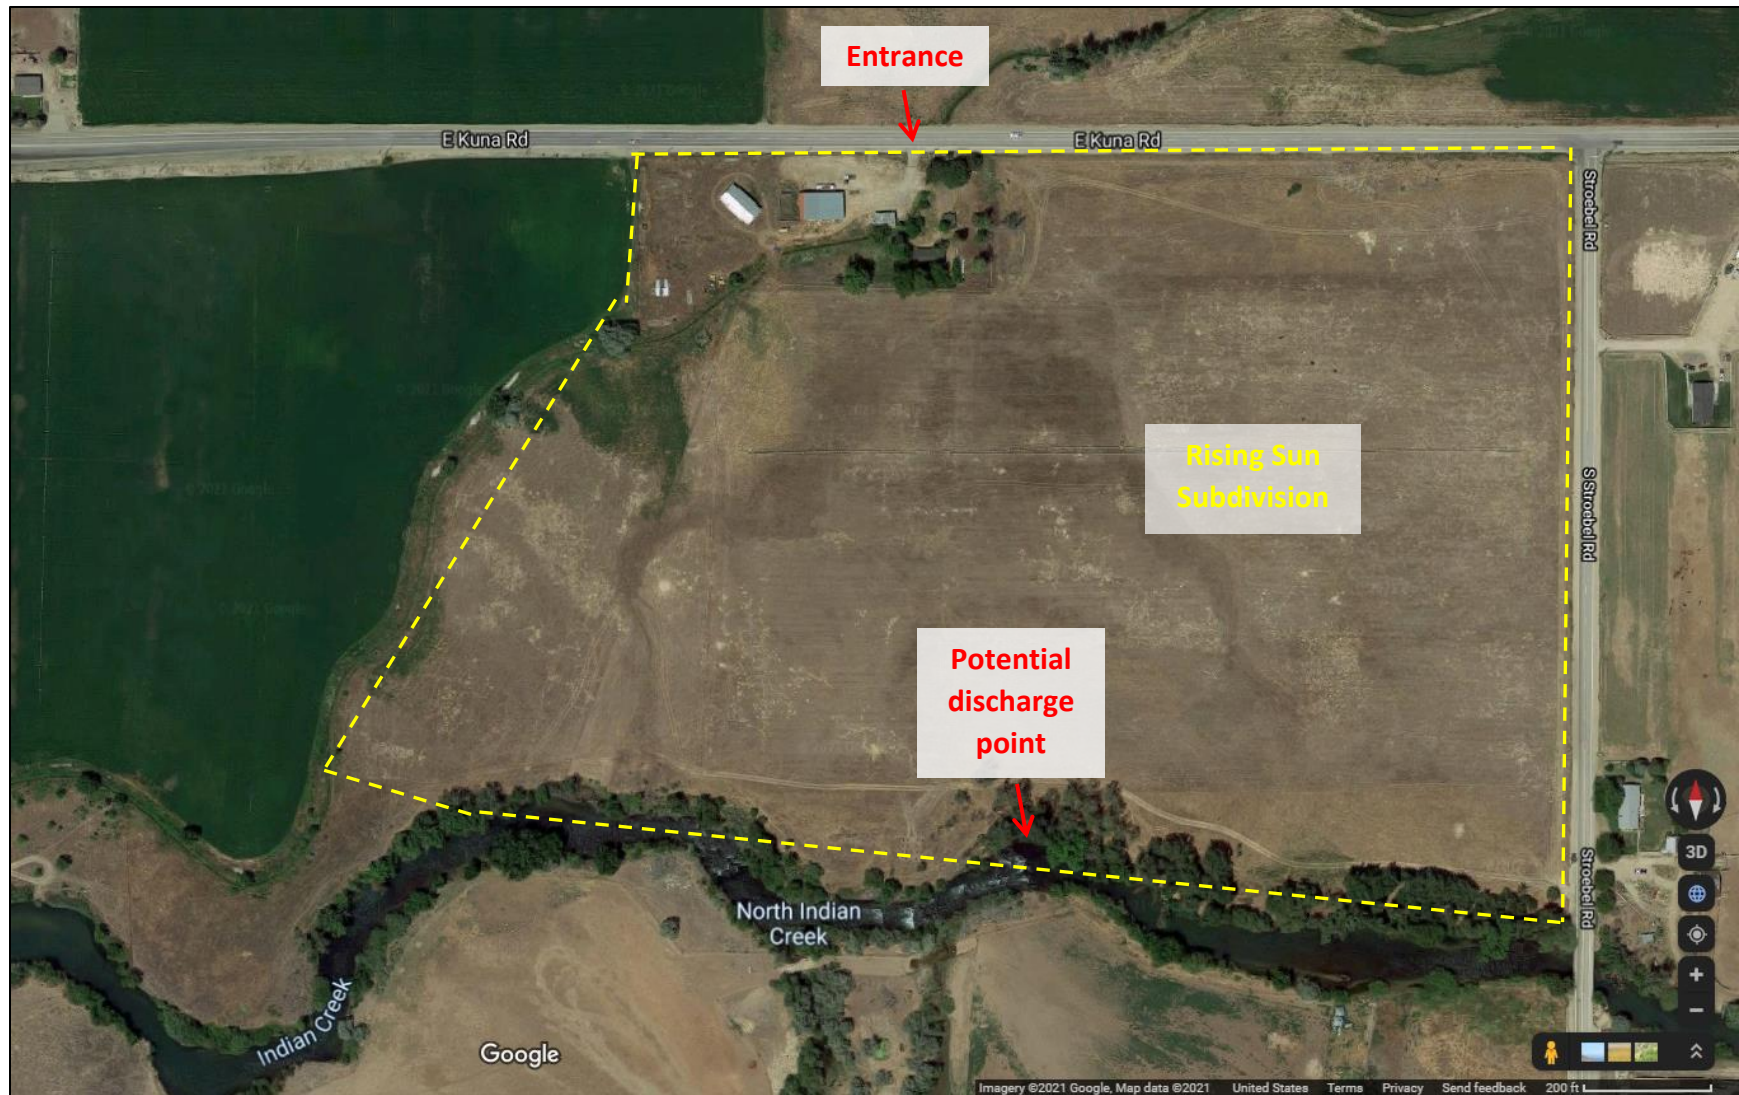
**Exhibit 1.** Google map (copyright date: 2021). Location of Rising Sun Subdivision in Kuna, Idaho. Note the approximate Site perimeter outlined with the dotted yellow line, the Site entrance, and the potential discharge point.
