**UNITED STATES ENVIRONMENTAL PROTECTION AGENCY**  
**OFFICE OF ENFORCEMENT AND COMPLIANCE ASSURANCE**

**SUBJECT:** CLEAN AIR ACT INSPECTION REPORT  
Waste Management Atascocita Landfill, Humble, TX

**Facility Name:** Waste Management Atascocita Landfill

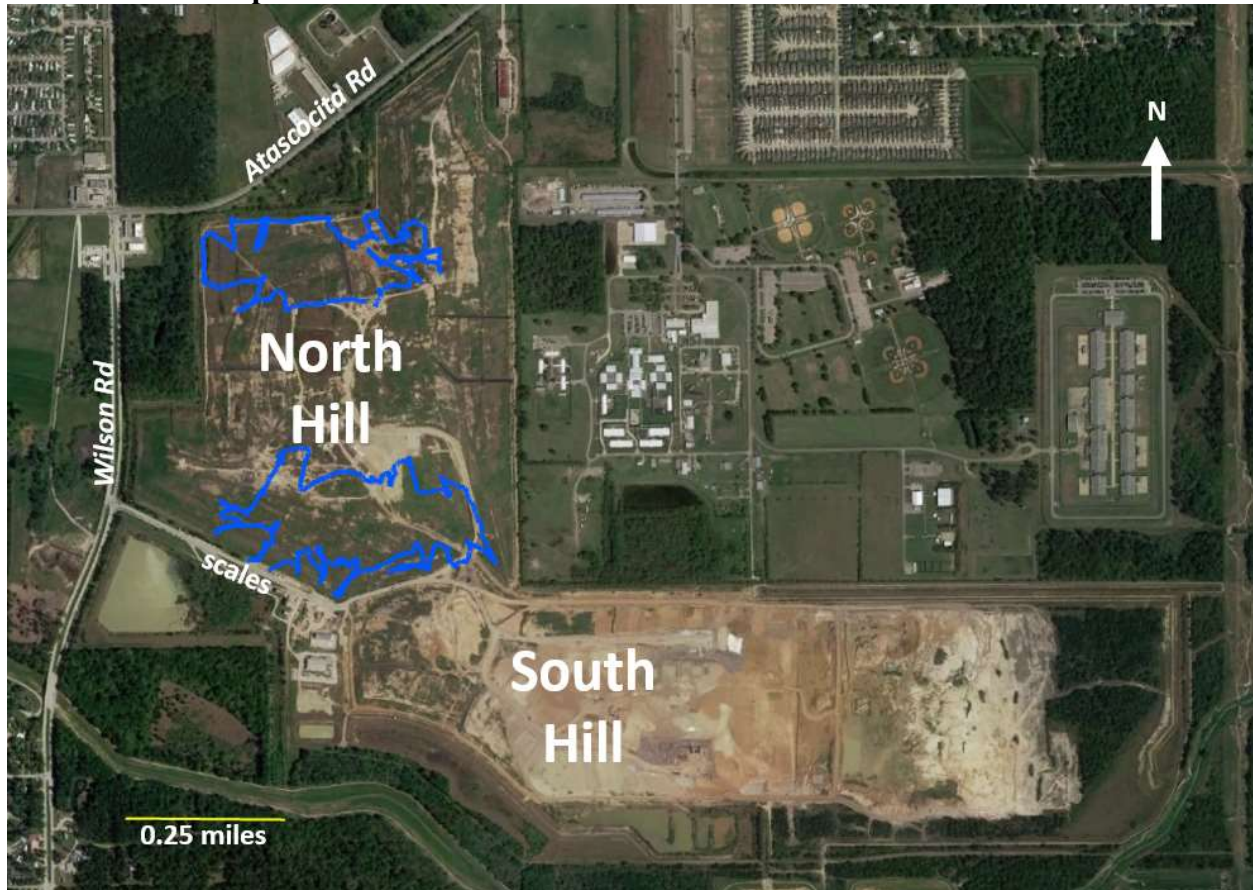
### Site Overview Map

Blue line roughly shows EPA survey coverage, tracing the confirmation reading instrument. Active area at far eastern end of South Hill. Satellite imagery dated to April 2022 as shown on Google Earth.
