**Region 6 Compliance Assurance and Enforcement Division  
INSPECTION REPORT**

| Inspection Date(s): | 06/20/2018 | | |
| Facility Name: | Petal Dairy | | |
| Identification/Permit Number: | WQ0004905000 (TX0132357) | | |

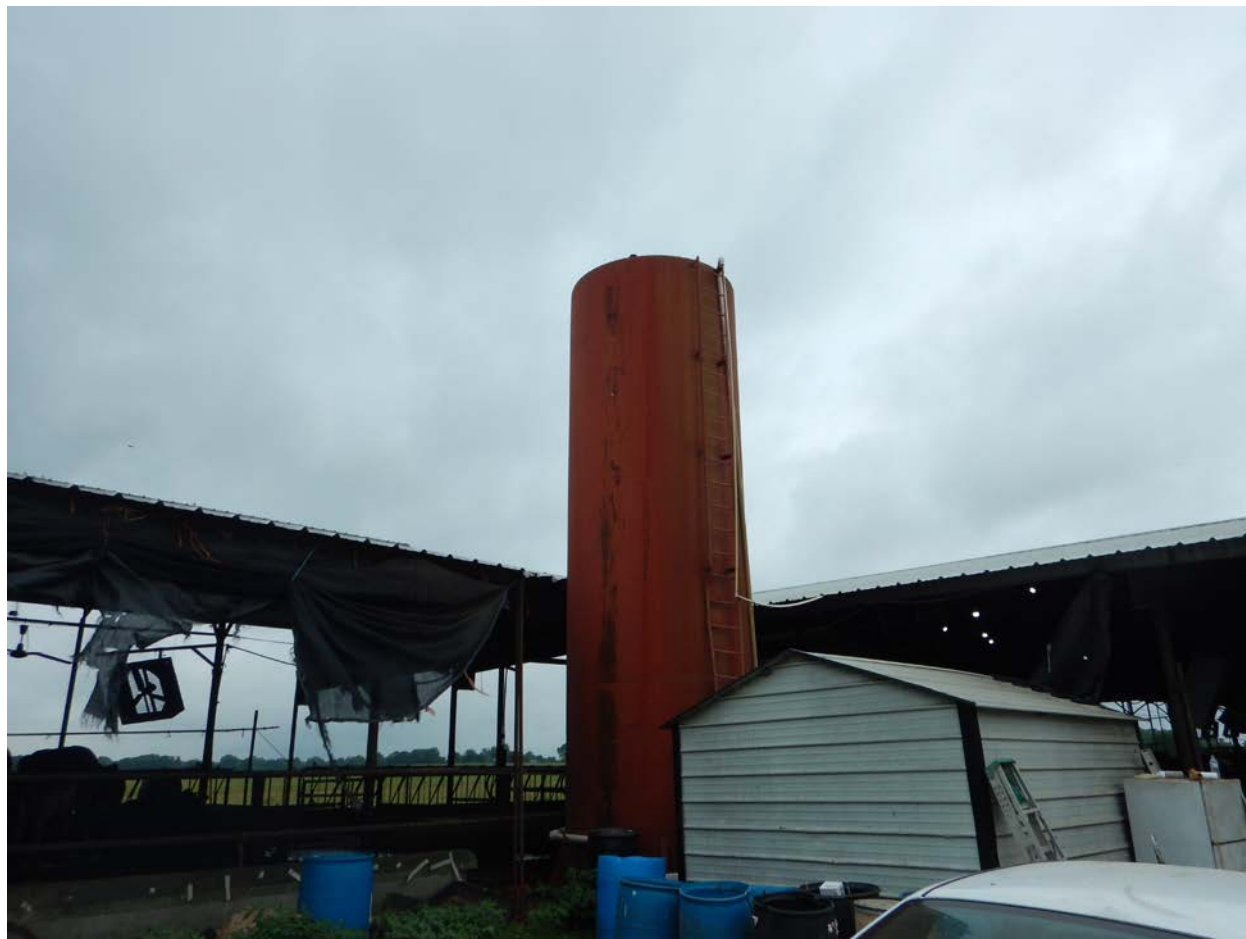
Photo No. 2

Description: This photo was taken facing southwest towards one of the facility's recycled wastewater flush tanks.

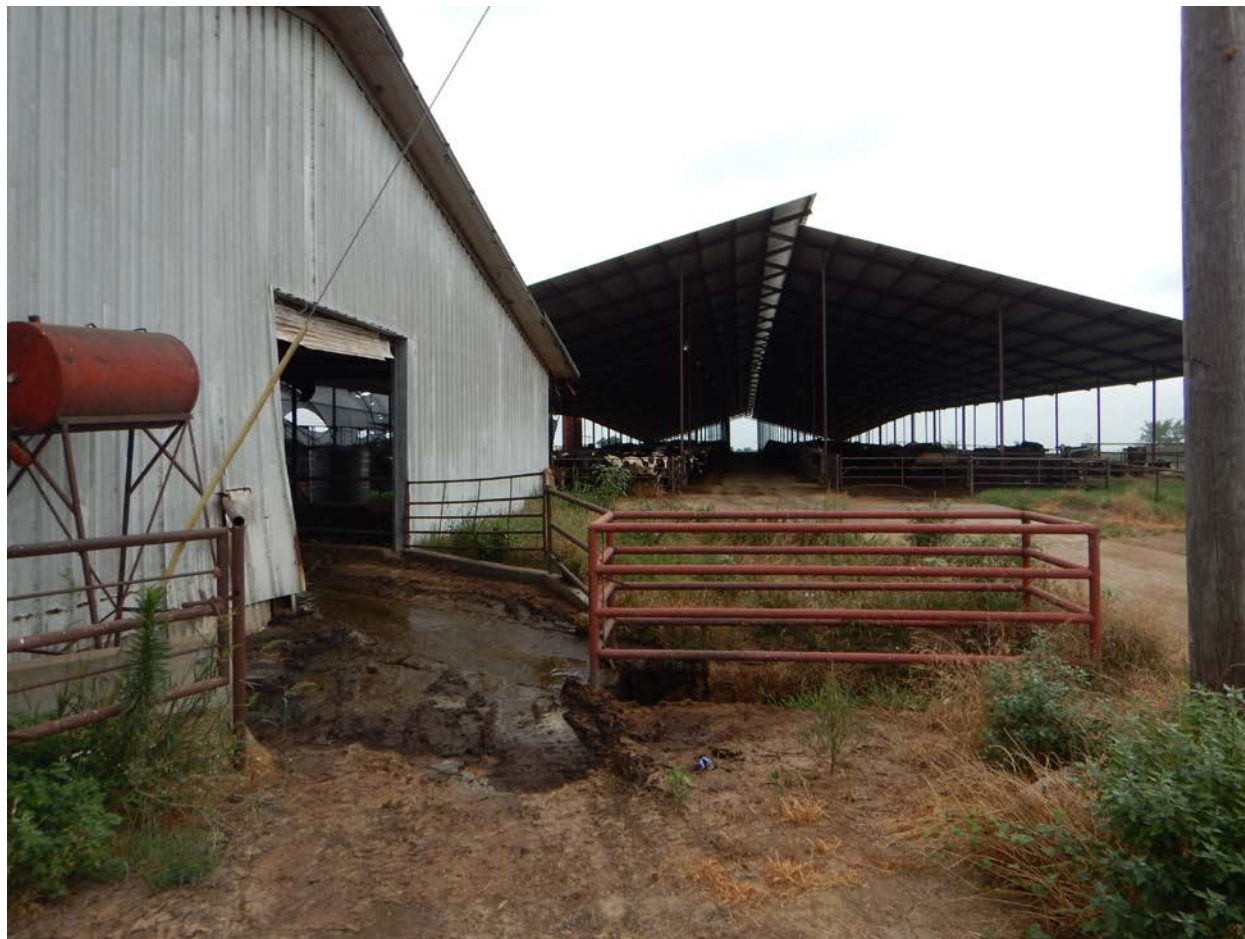
Photo No. 3

Description: This photo was taken facing west towards the point at which wastewater exits the milking parlor holding pen. Note the in-ground catchment basin which collects this wastewater and routes it to the nearby solid settling structures.
