**INSPECTION REPORT**

| <b>Inspection Date:</b> | 05/24/2021 | |
| <b>Regulatory Program:</b> | CWA NPDES/Industrial Stormwater | |
| <b>Facility Name:</b> | Darigold Caldwell Facility | |

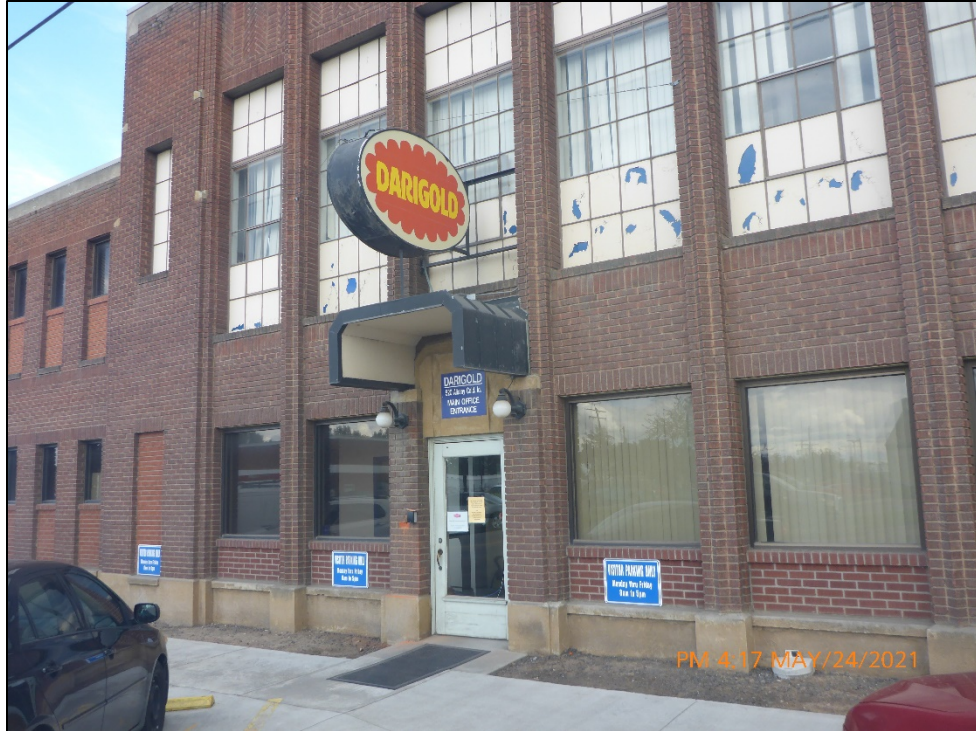
**Photograph 1.** View of main Facility entrance off N. 5<sup>th</sup> Ave.

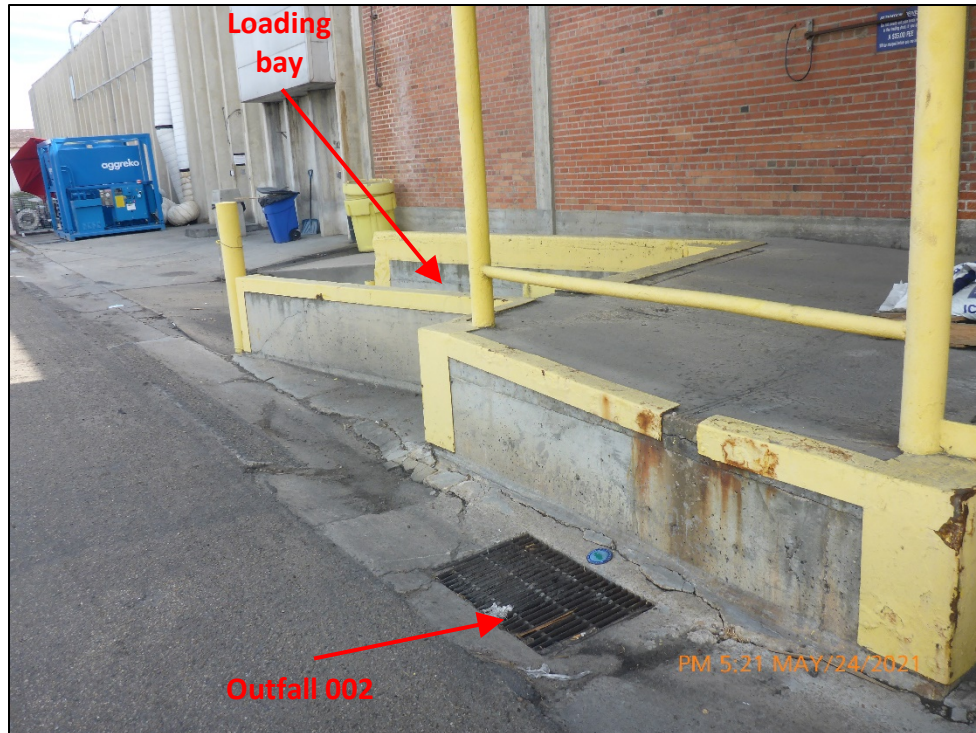
**Photograph 5.** View of Outfall 002. A storm drain located in the loading bay in the background is the Facility's sample point for Outfall 002, shown in Photographs 7 through 9.

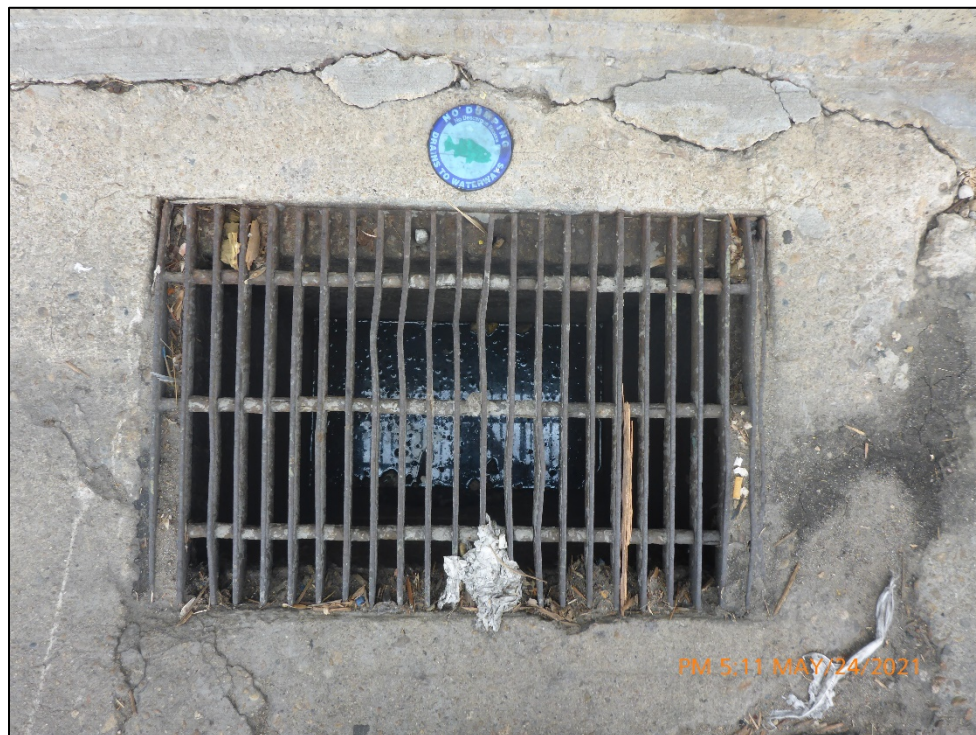
**Photograph 6.** Close-up view of Outfall 002.

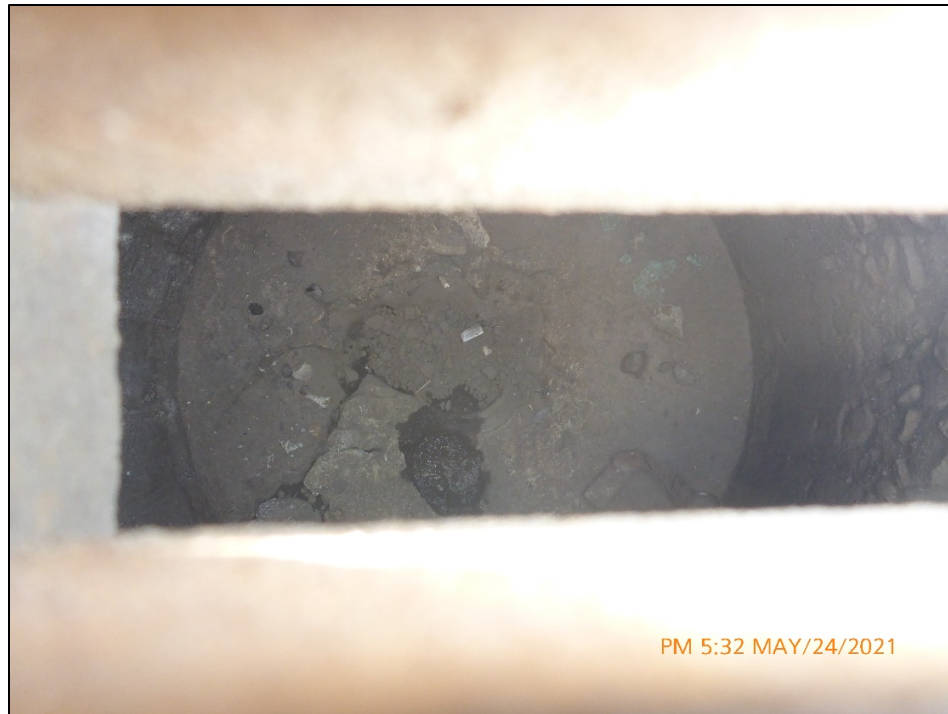
**Photograph 11.** View of inside the catch basin of the Outfall 005 storm drain.

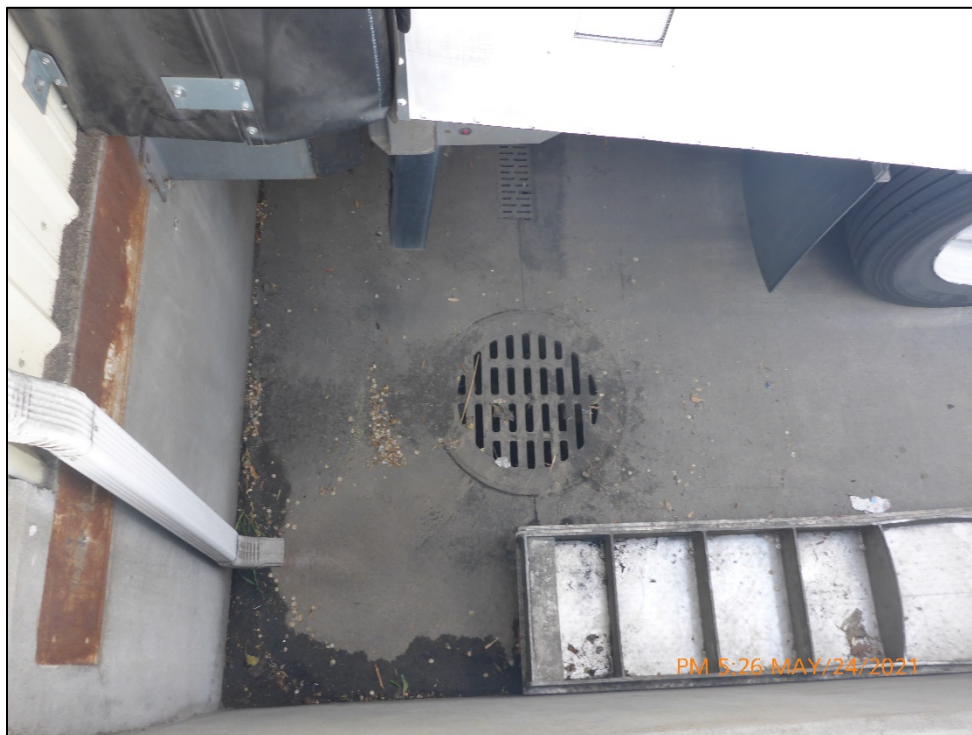
**Photograph 16.** View of the storm drain in the loading bay which flows to the Facility's gravel infiltration bed, as shown in Photograph 15.
