## Clean Water Act Section 404: Site Visit/Case Development

| Site Name | Henry Brick Company, Inc. (Claude Jack Mine) | | | | |

**Henry Brick Company, Inc. - Claude Jack Mine**  
**Selma, Dallas County, Alabama**  
**January 22, 2024**

### Henry Brick Company, Inc. Claude Jack Mine Site Inspection Photographic Log

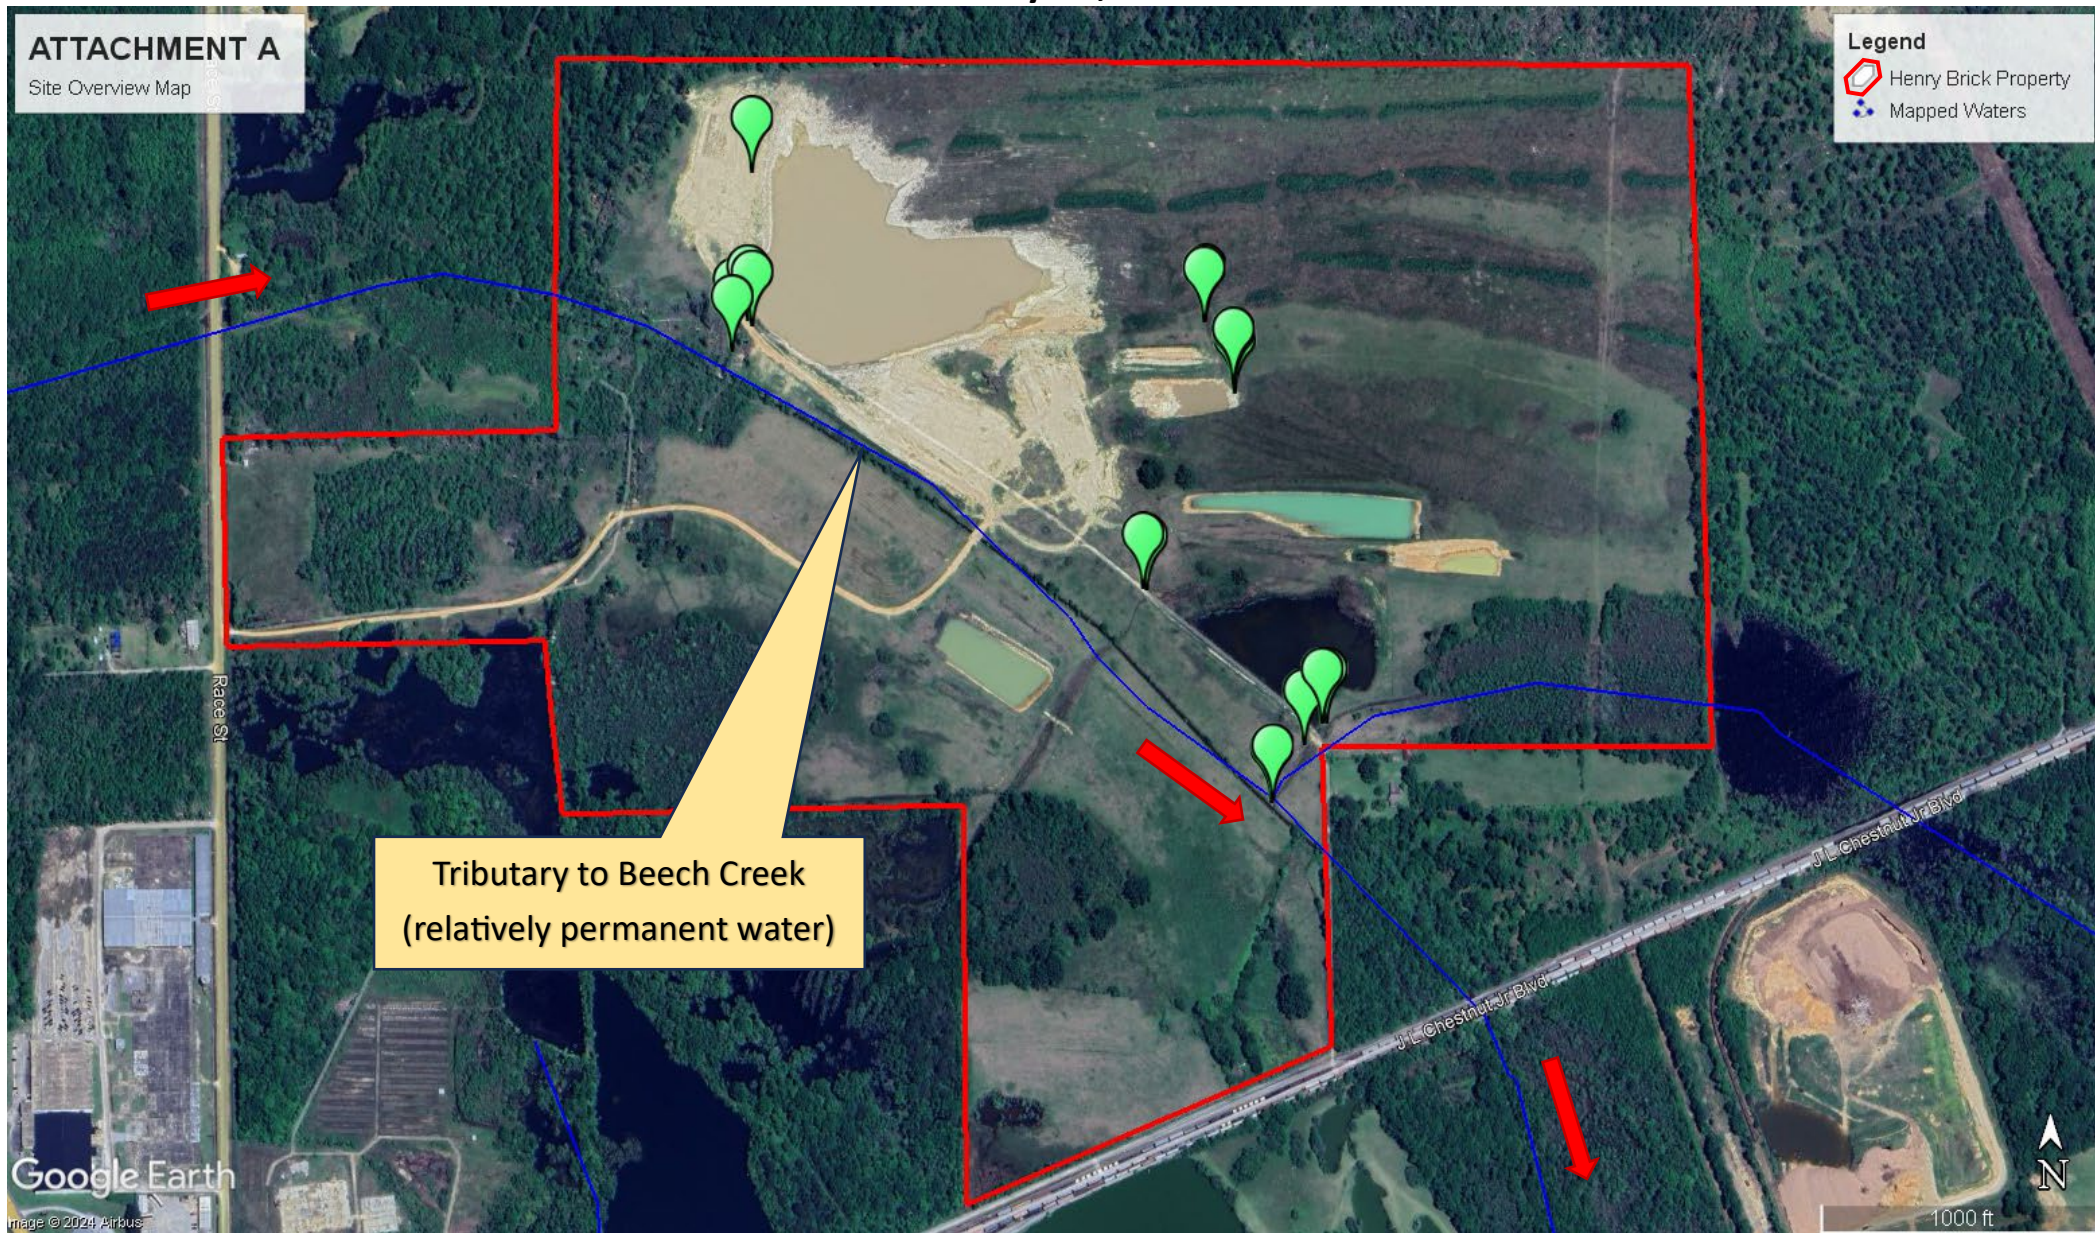
Mapped Waters

Tributary to Beech Creek  
(relatively permanent water)

*Red arrows indicate the direction of flow. Seventeen (17) photos were taken onsite.*
