**CWA COMPLIANCE EVALUATION INSPECTION REPORT  
U.S. ENVIRONMENTAL PROTECTION AGENCY, REGION 5**

**Purpose:** Compliance Evaluation Inspection

**Facility:** Benton Dairy, LLC  
8444 South 900 West  
Ambia, Indiana 47917-003

**Date of Inspection:** April 28 and 29, 2021

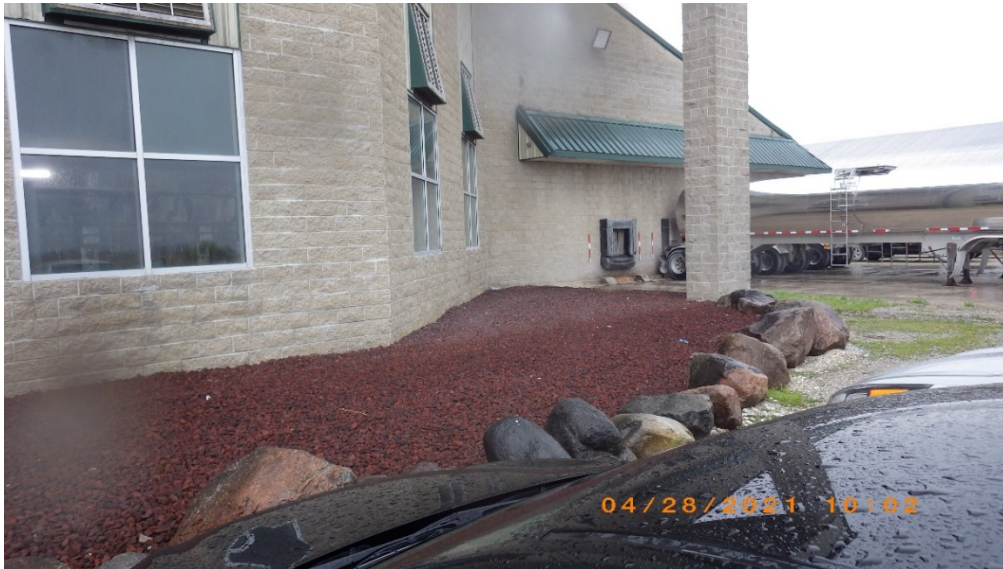
Photo Number: RIMG0067

Description: The Chemical Storage Area has drains that convey flow to the Recirculation Pit between Barns 2 and 3.

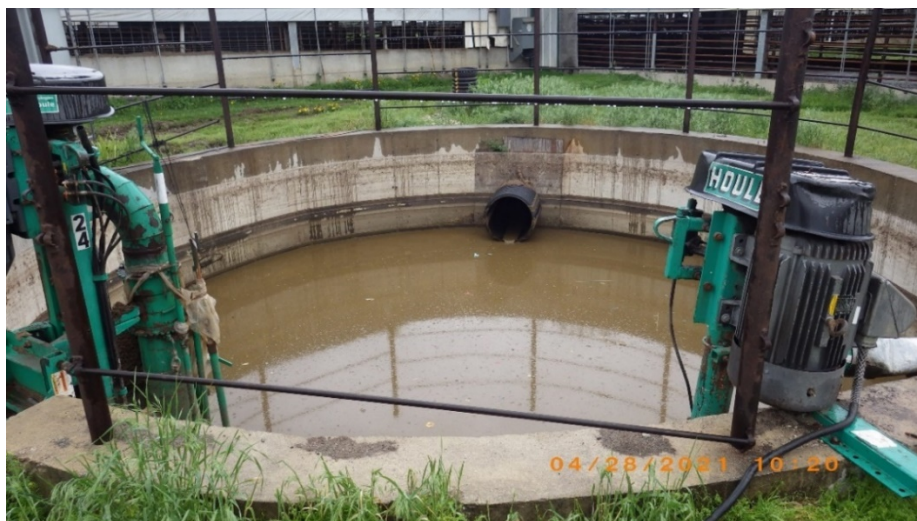
Photo Number: RIMG0071

We continued to the north side of the Milking Parlor where we observed the Chemical Storage Area. The Chemical Storage Area held teat dip, formaldehyde, and other chemicals. EPA observed drains in the Chemical Storage Area, which Mr. Benton explained would drain into the Sand Separation Lane (Photos RIMG0067 and RIMG0070) if there was a leak or spill from the chemicals. We continued to walk between Barn 2 and Barn 3 to the Recirculation Pit. The Milking Parlor has a drain that collects manure and process wastewater. The drain flows by gravity into the Recirculation Pit (Photo RIMG0071).

Description: Recirculation Pit. Process wastewater from the clean out of the Milking Parlor gravity flows into the Recirculation Pit. The water within the Recirculation Pit is used to clean out the holding area for the cows.

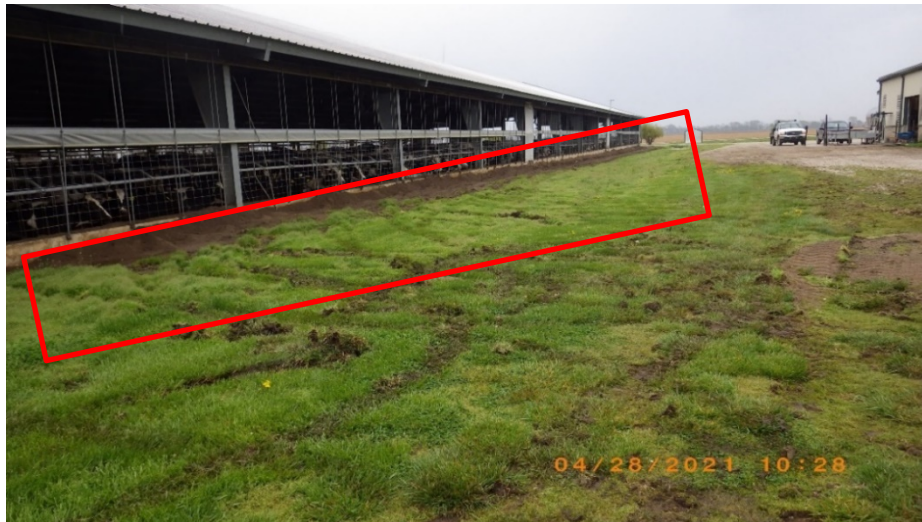
Photo Number: RIMG0072

Description: Flow from between Barn 3 and Barn 2 flows to the east. Bedding from Barn 2 is pushed out of Barn 2 on the south side of the Barn 2. The red outlined box shows the bedding pushed out of Barn 2.

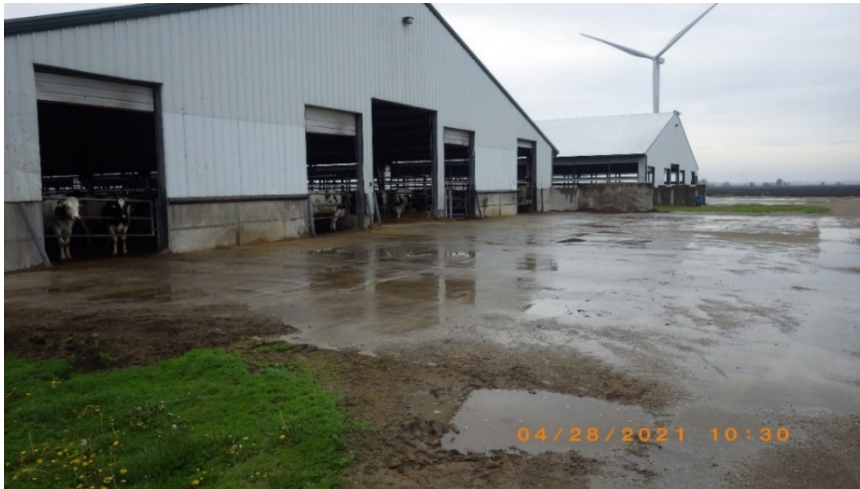
Photo Number: RIMG0073

Description: Barn 2 had some used bedding that was outside the doors on the east side of the barn and mixed with stormwater. The stormwater flows into drainage tile inlets between the Barns and outlets into the East Drainage Channel.

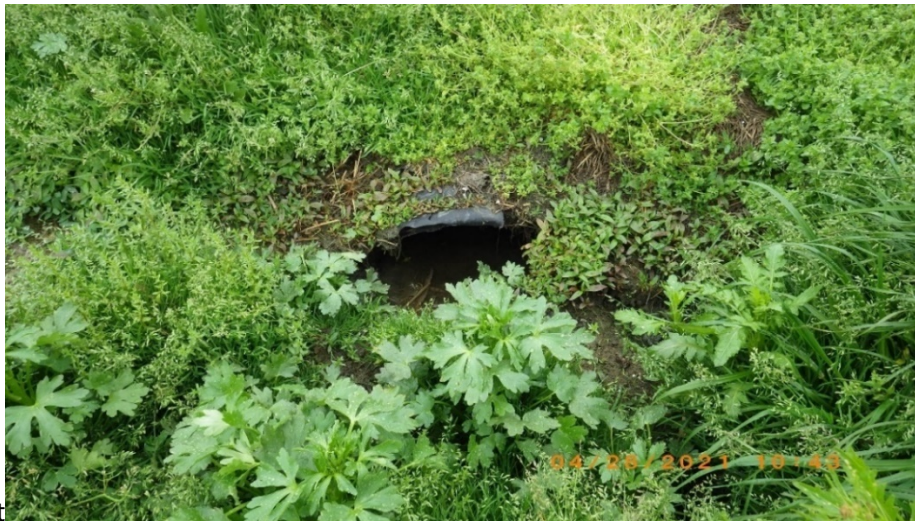
Photo Number: RIMG0079

Description: The drainage tile inlet that collects the flow from between Barn 2 and Barn 1. The drainage tile conveys flow under the East Access Road into the East Drainage Channel.

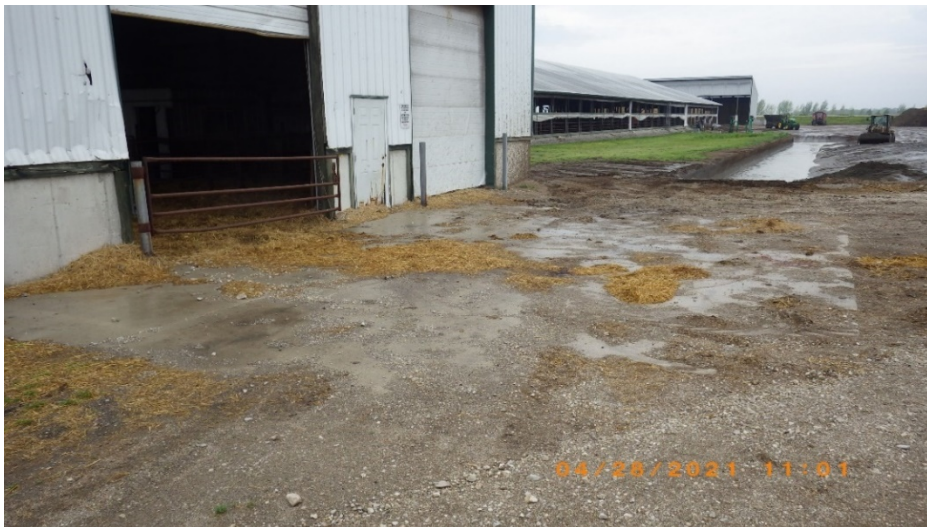
Photo Number: RIMG0085

EPA observed on the north side of Barn 5 that used bedding and feed had been pushed out the door (Photos RIMG0085 and RIMG0086). Mr. Boerman explained that when stormwater comes into contact with any track out on the north side, it surface flows by gravity into the Sand Separation Lane. We also observed the outlet into the Sand Separation Lane. The outlet is from the trenches that collect used bedding, manure, and process wastewater in the barns and flow by gravity into the Sand Separation Lane (Photo RIMG0087).

Description: Used bedding pushed out of the door of Barn 1.

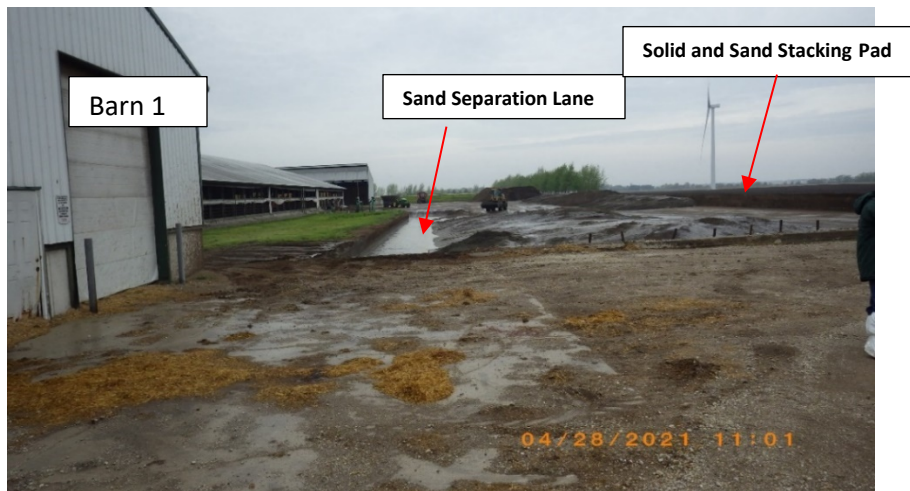
Photo Number: RIMG0086

Description: Used bedding and feed pushed out of Barn 1, the Sand Separation Lane and Solid and Sand Stacking Pad which are labeled in the photo above.

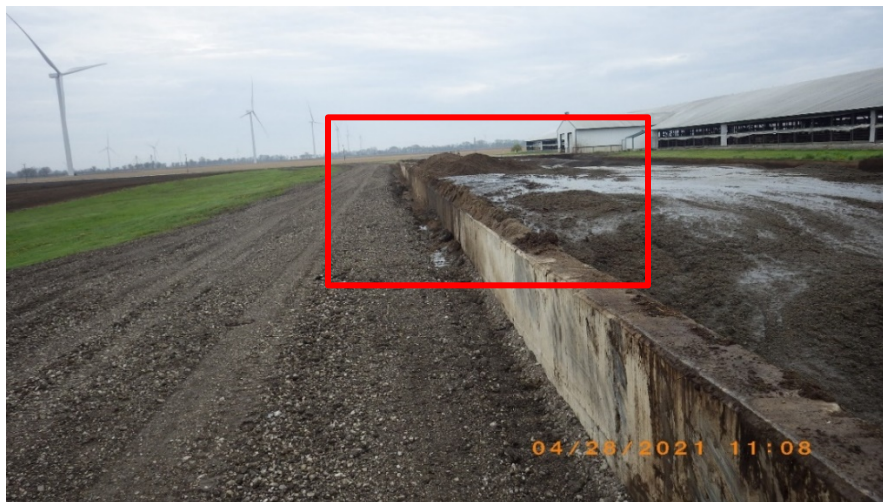
Photo Number: RIMG0091

EPA continued walking west on the north side of the facility and observed solids pushed over the concrete wall of the Solid and Sand Stacking Pad. Mr. Boerman explained that any stormwater that comes into contact with the solids been pushed over the wall would flow to the Stormwater Pond (Photo RIMG0091). We walked on the Solid and Sand Stacking Pad to observe how the process wastewater is pumped into the 1<sup>st</sup> Stage Lagoon (Photos RIMG0095 and RIMG0096).

Description: In the red outline box in the photo above, some solids from the Solid and Sand Stacking Pad spilled over the concrete wall onto the North Access Road.

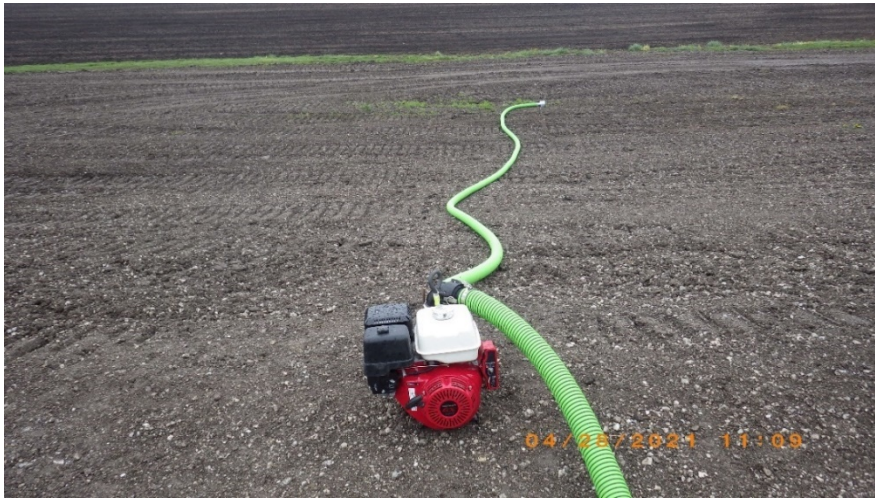
Photo Number: RIMG0092

Description: The pump used to pump liquid from the Solid and Sand Stacking Pad into the 1<sup>st</sup> Stage Lagoon.

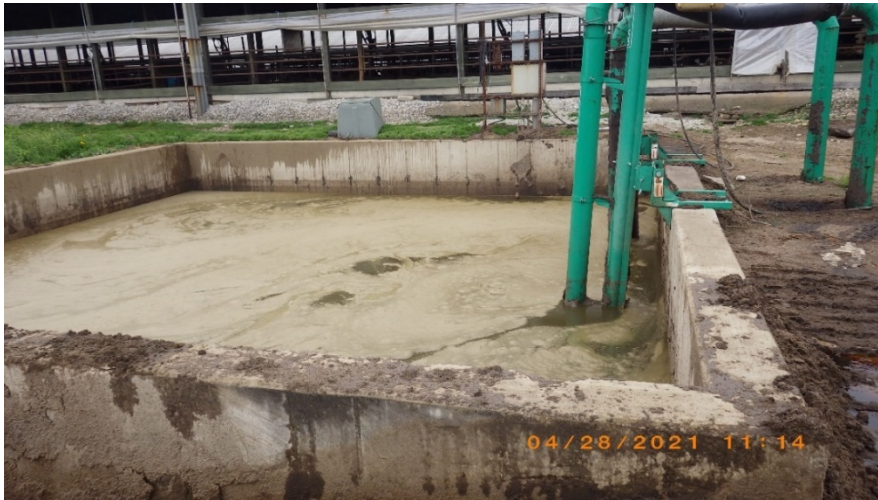
Photo Number: RIMG0096

Description: This is where the process wastewater from the Sand Separation Lane is pumped to the 1<sup>st</sup> Stage Lagoon.

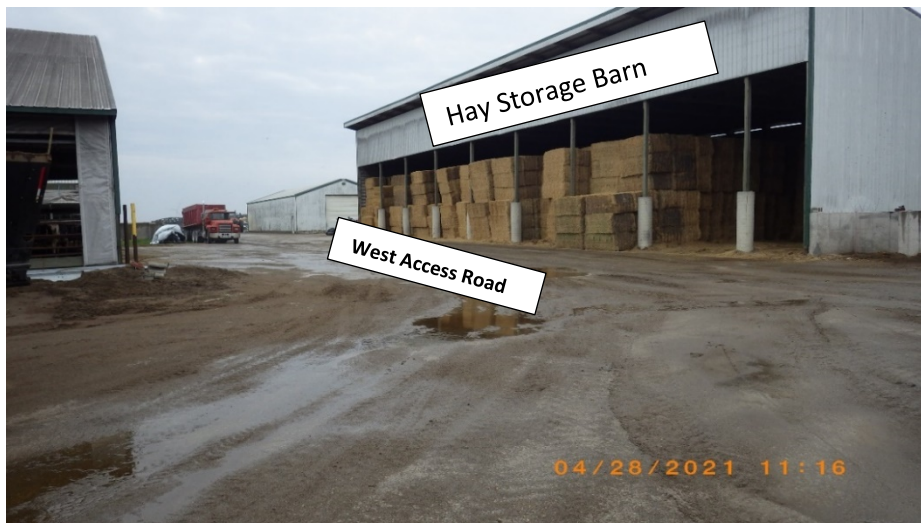
Photo Number: RIMG0097

Description: Any process wastewater on the West Access Road flows into the Stormwater Pond. The Hay Storage Barn is labeled in the photo along with the West Access Road.

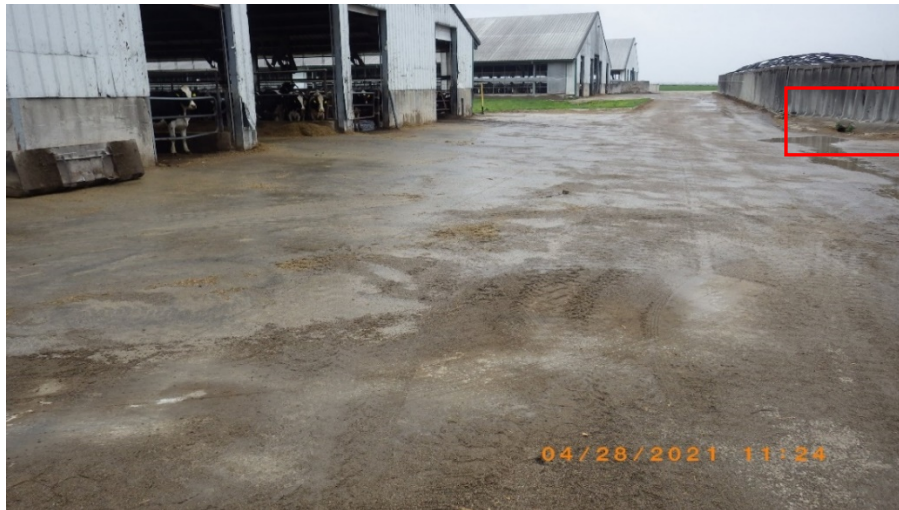
Photo Number: RIMG0105

Description: The feed and used bedding pushed out of the Barn 2 and Barn 1 and drains to the southwest and drains to Stormwater Pond through tile inlets. One of the tile inlets is in the red box.

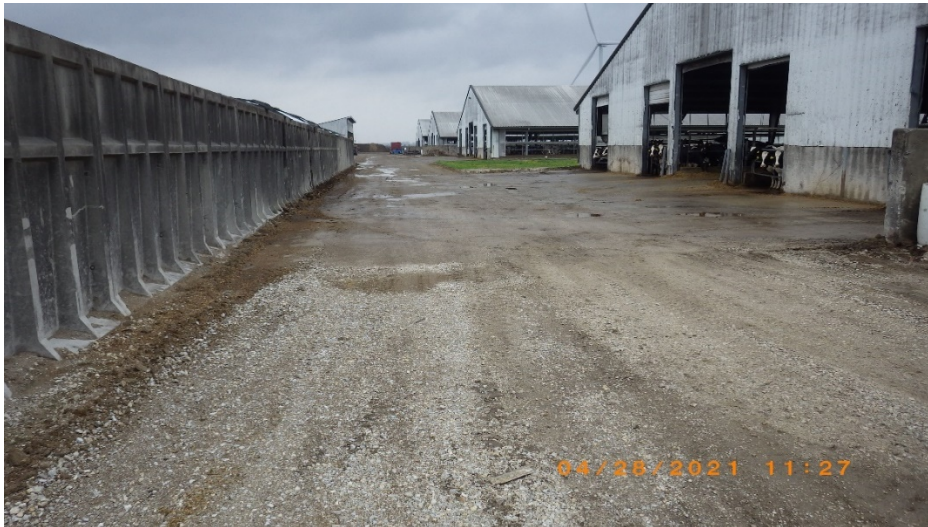
Photo Number: RIMG0109

Description: The drainage tile inlet near the northwest corner of Barn 3 and used bedding being pushed out of Barn 3 shown inside the red outlined boxes in the photo above.

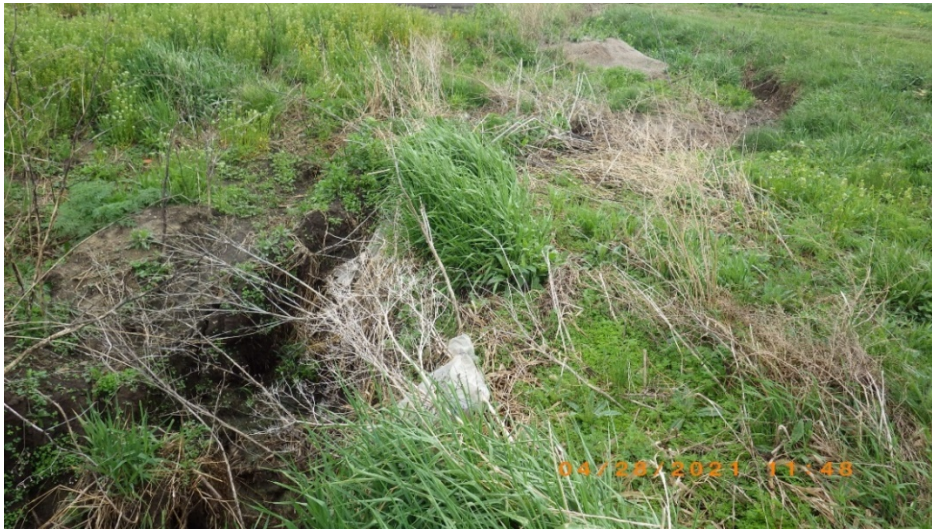
Photo Number: RIMG0126

Description: The eroded drainage channel that flows into the Stormwater Pond.

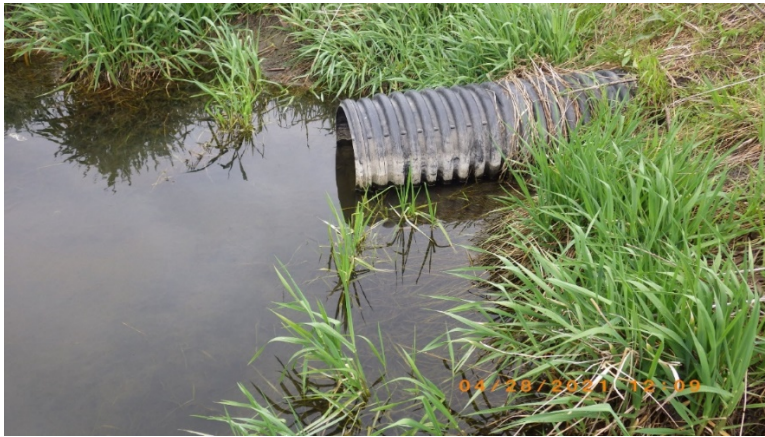
Photo Number: RIMG0136

agricultural field to the south was tiled to flow into Prudential Ditch (Photos RIMG0135 and RIMG0136), but this tile has been plugged and is now tiled to flow into the Stormwater Pond (Photo RIMG0133). We observed an access ramp into the Stormwater Pond, which Mr. Boerman explained farmers use to access the Stormwater Pond for irrigating their crops (Photo RIMG0134).

Description: The close-up of the tile outlet into Prudential Ditch that has been plugged and rerouted to drain into the Stormwater Pond.

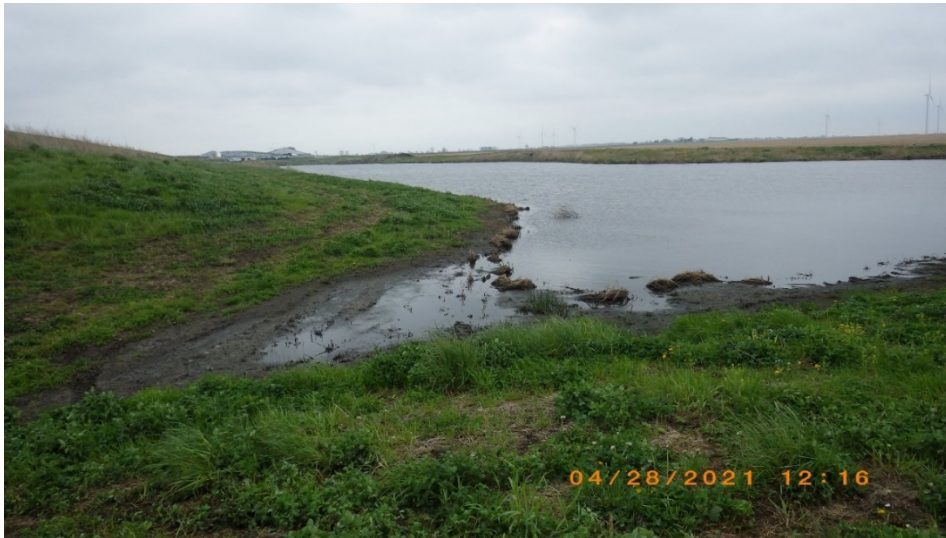
Photo Number: RIMG0138

Description: The flow drains from the north to the south into the Stormwater Pond.

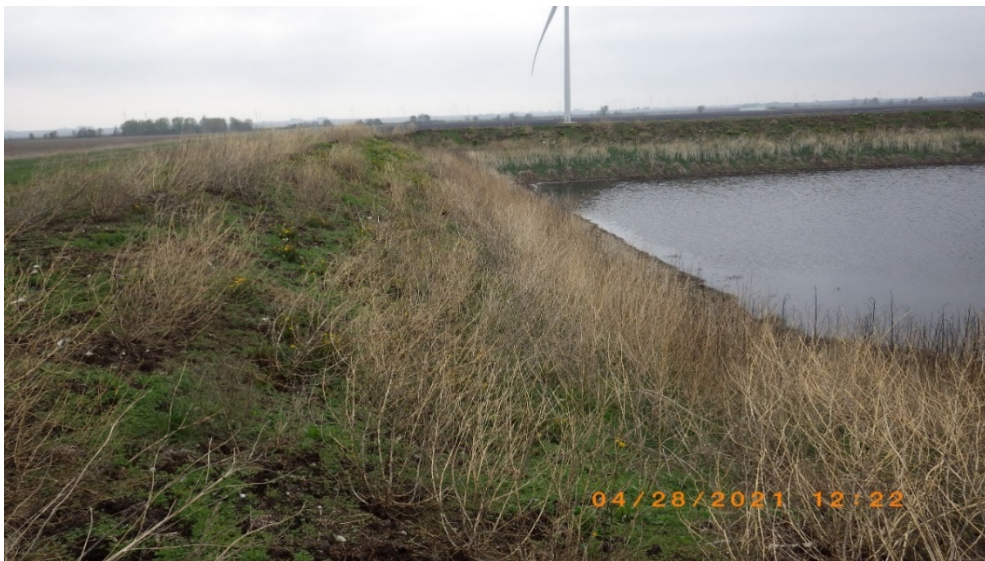
Photo Number: RIMG0139

Description: The west berm of the 5<sup>th</sup> Stage Lagoon.

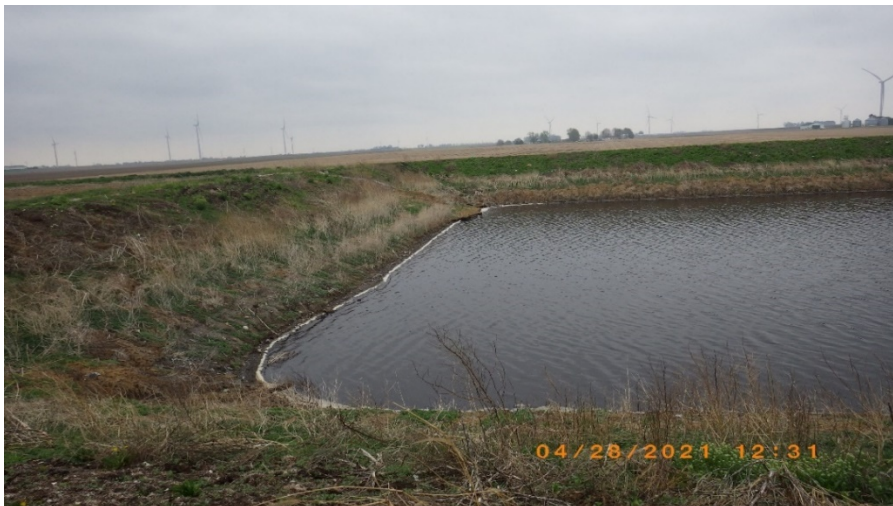
Photo Number: RIMG0141

Description: The east berm of the Stormwater Pond.

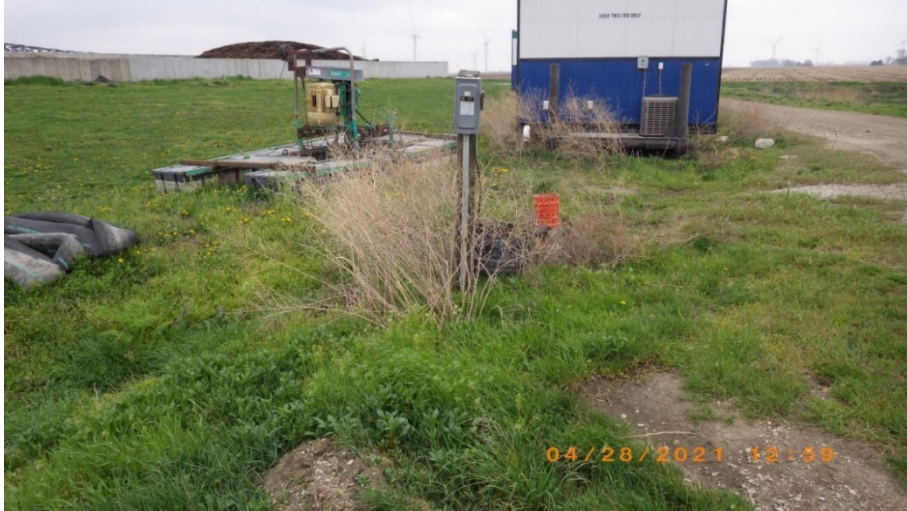
Photo Number: RIMG0168

Description: The perimeter tile pump into the Stormwater Pond.

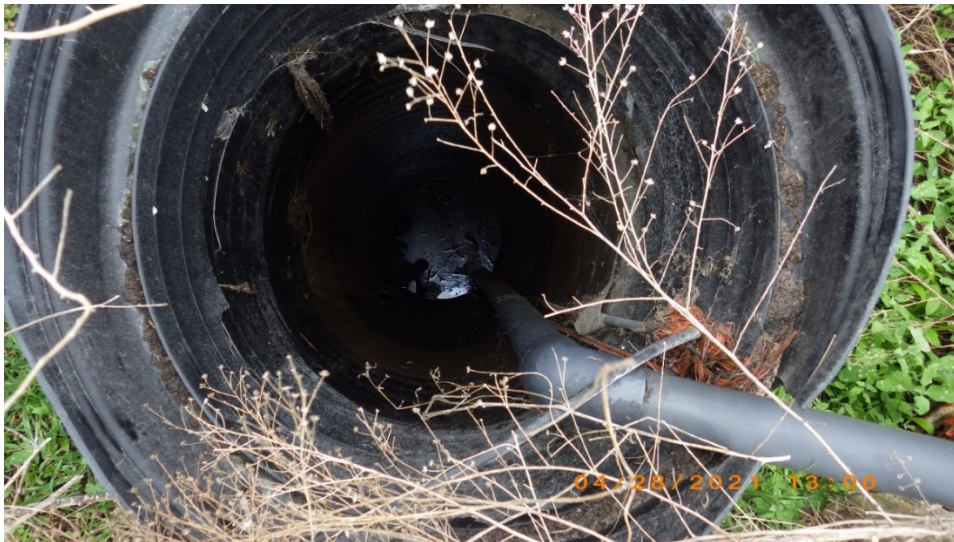
Photo Number: RIMG0169

Description: The perimeter tile pump into the Stormwater Pond.

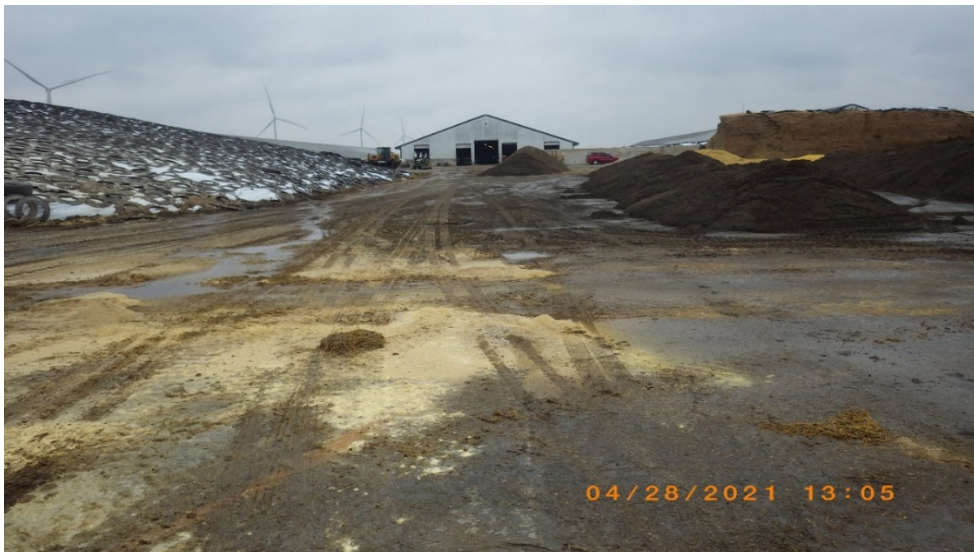
Photo Number: RIMG0173

Description: Concrete Feed Storage Area.

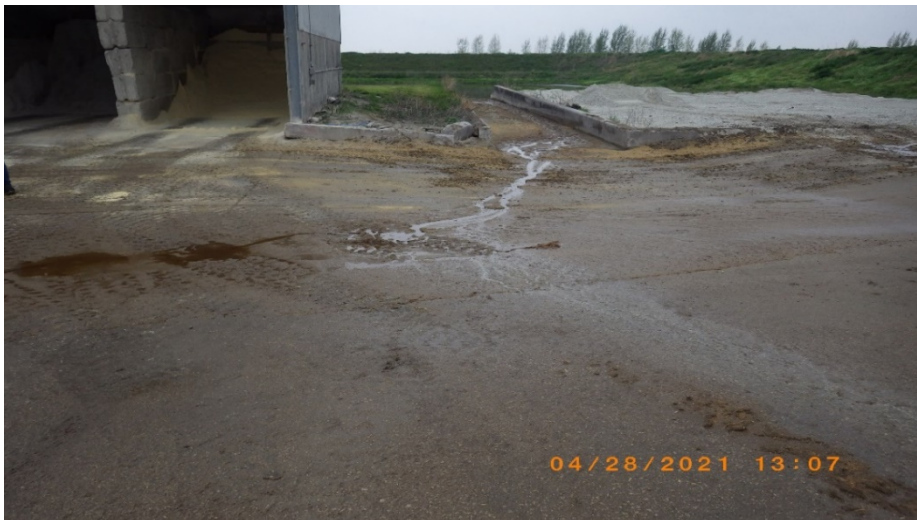
Photo Number: RIMG0175

We observed a few of the manholes within the concrete Feed Storage Area and observed flow into the manholes. These manholes are connected to the Sileage Leachate Collection Pond.

Description: The manhole on the concrete Feed Storage Area that conveys flow to the Silage Leachate Collection Pond.

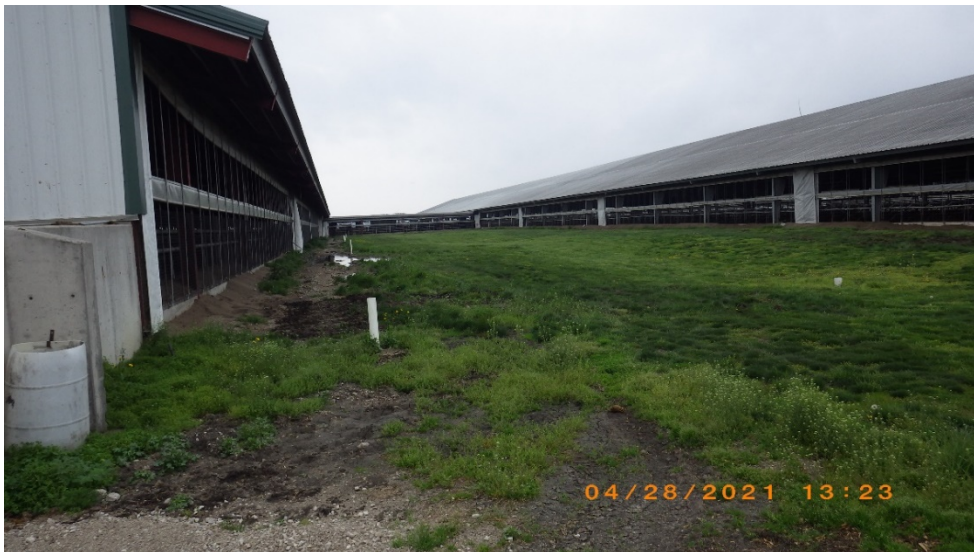
Photo Number: RIMG0179

Description: The drain pipe between Barn 4 and Barn 5.

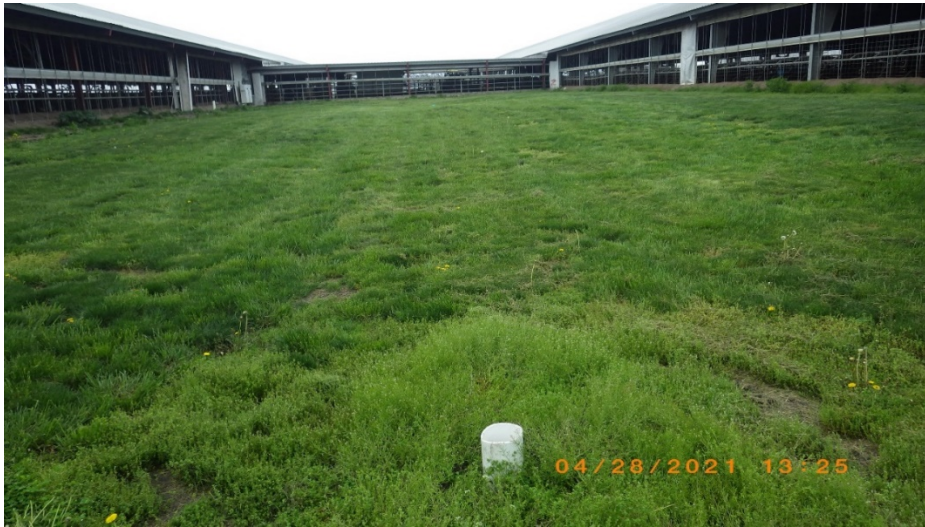
Photo Number: RIMG0180

After completing the walk-through on the west side, we went back to the east side of the facility to walk between Barn 5 and Barn 4. Again, we observed inlet pipes and outlets into the East Drainage Channel.

Description: The drainage tile inlet between Barn 4 and Barn 5 on the east side of the barns.

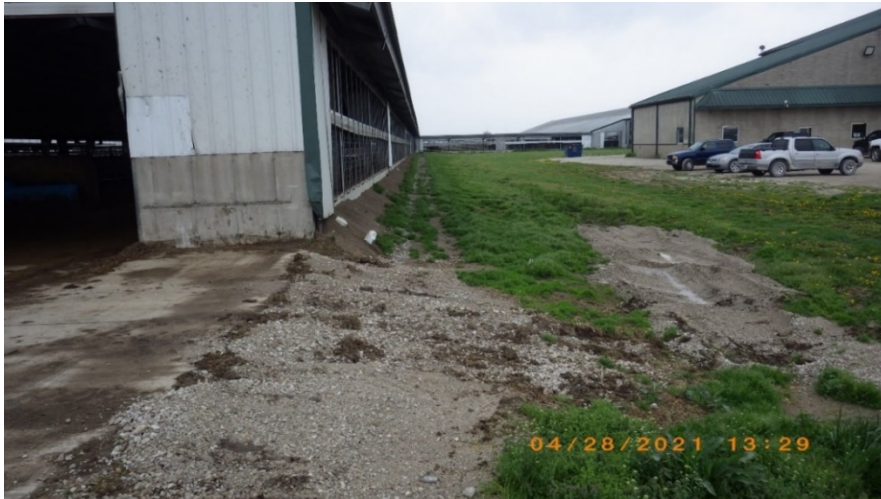
Photo Number: RIMG0181

Description: Stormwater that comes into contact with used bedding and feed pushed out of Barn 4 flows to the north and to the east through the drainage tile inlet that runs under the East Access Road and outlets into the East Drainage Channel that flows into the Stormwater Pond.

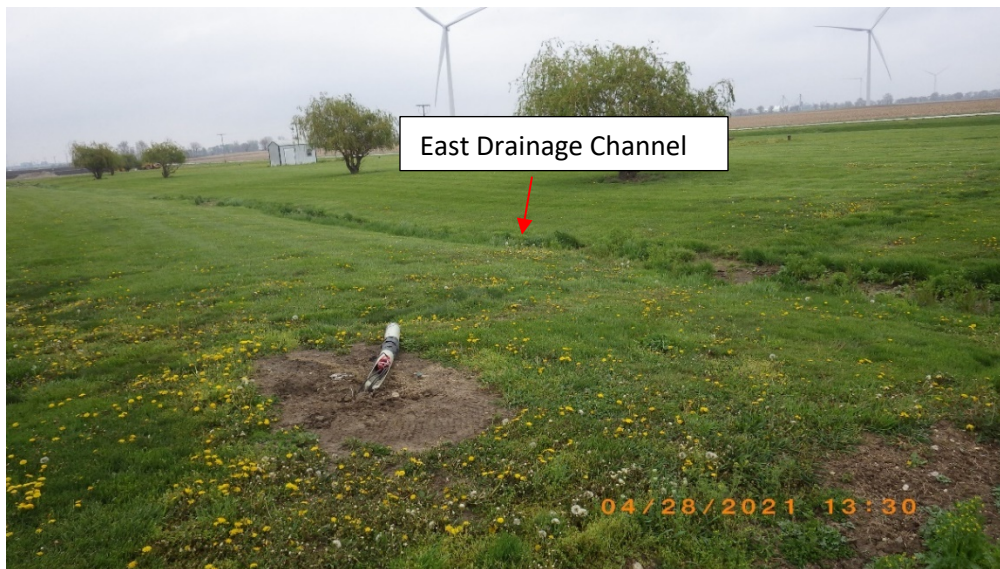
Photo Number: RIMG0184

Description: The East Drainage Channel on the east side of the facility east of the east access road.
