# **NPDES Compliance Inspection Report**

## **Tree Farm North Bend, Washington**

### **Washington State Department of Ecology Construction Stormwater General Permit Permit # WAR309272**

**Inspection Date: December 16, 2022**

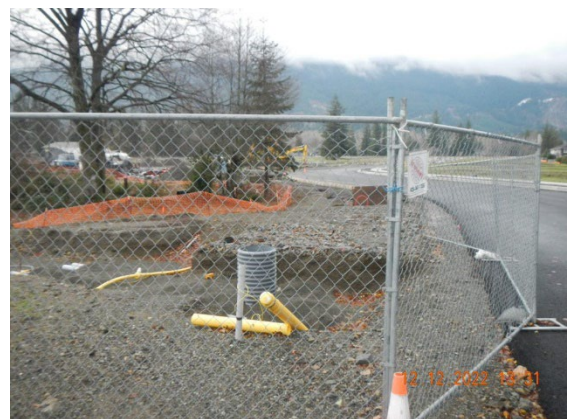
| Photo Number | Digital Image Number | Description of Digital Image | Date and Time | |
|---|---|---|---|---|
| Photo 4 | DSCN2957.JPG | Facing west, photo of area south of the paved construction access from Malone Grove SE | 12/12/2022 | 12:31 PM |

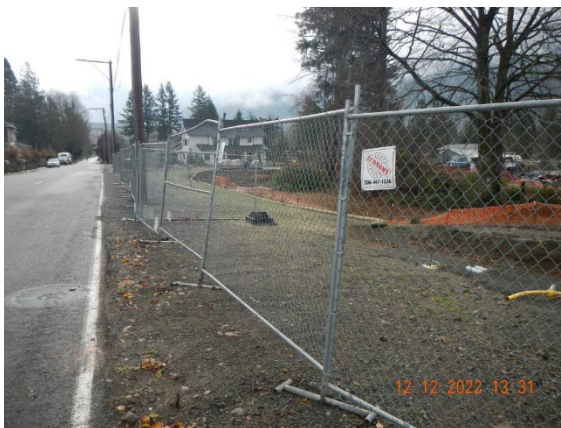
| Photo Number | Digital Image Number | Description of Digital Image | Date and Time | |
|---|---|---|---|---|
| Photo 5 | DSCN2958.JPG | Facing south, photo of eastern perimeter along Malone Grove SE | 12/12/2022 | 12:31 PM |

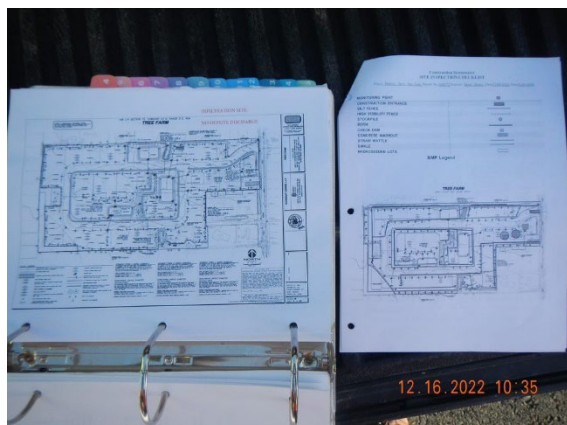
| Photo Number | Digital Image Number | Description of Digital Image | Date and Time | |
|---|---|---|---|---|
| Photo 7 | DSCN3066.JPG | Photo of SWPPP Site Map & BMP Legend | 12/16/2022 | 10:35 AM |

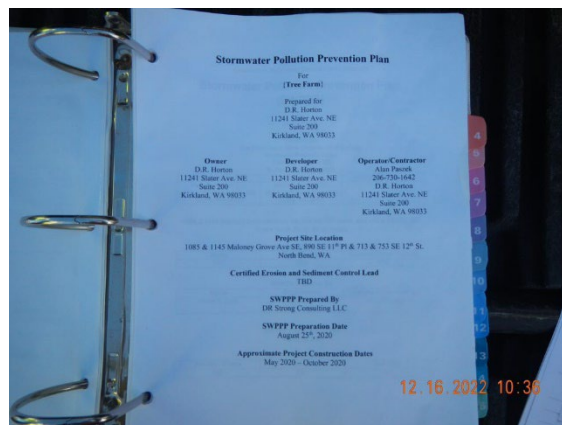
| Photo Number | Digital Image Number | Description of Digital Image | Date and Time | |
|---|---|---|---|---|
| Photo 8 | DSCN3067.JPG | Photo of SWPPP Cover Page | 12/16/2022 | 10:36 AM |

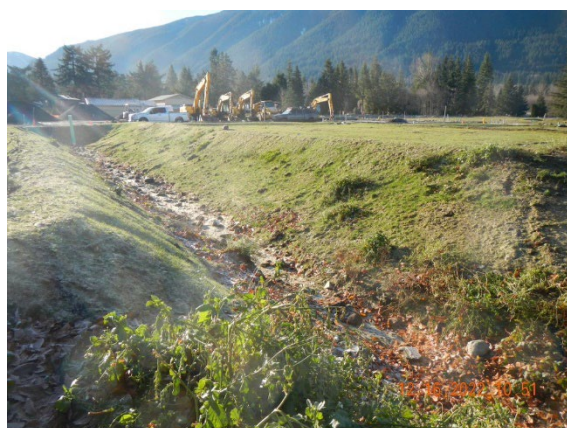
| Photo Number | Digital Image Number | Description of Digital Image | Date and Time | |
|---|---|---|---|---|
| Photo 11 | DSCN3070.JPG | Facing south, photo of north/northeast bioswale from northern perimeter | 12/16/2022 | 10:51 AM |

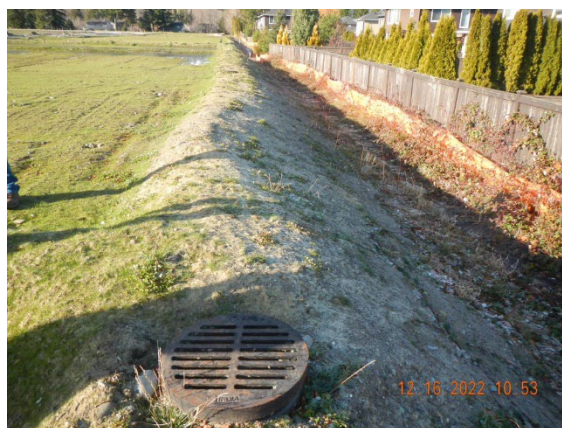
| Photo Number | Digital Image Number | Description of Digital Image | Date and Time | |
|---|---|---|---|---|
| Photo 12 | DSCN3071.JPG | Facing west, photo of northern perimeter and overflow catch basin to primary swale/outfall location. | 12/16/2022 | 10:53 AM |

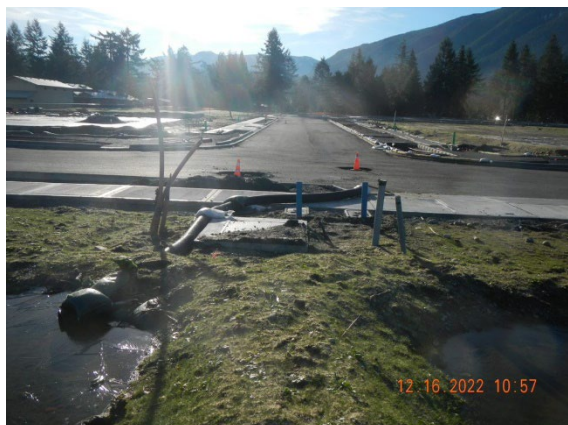
| Photo Number | Digital Image Number | Description of Digital Image | Date and Time | |
|---|---|---|---|---|
| Photo 13 | DSCN3072.JPG | Facing south, photo of temporary lot drainage to central paved area. | 12/16/2022 | 10:57 AM |

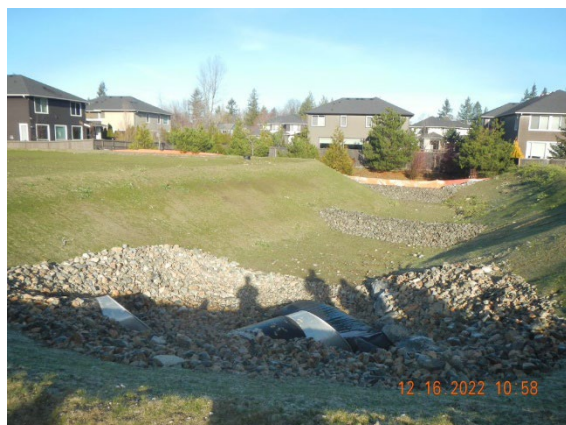
| Photo Number | Digital Image Number | Description of Digital Image | Date and Time | |
|---|---|---|---|---|
| Photo 14 | DSCN3073.JPG | Facing north, photo of northern bioswale and potential outfall area | 12/16/2022 | 10:58 AM |

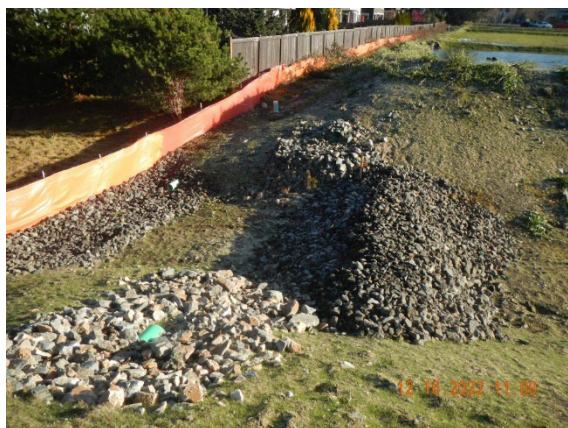
| Photo Number | Digital Image Number | Description of Digital Image | Date and Time | |
|---|---|---|---|---|
| Photo 15 | DSCN3074.JPG | Facing east, photo of check dam and drainage area within northern bioswale | 12/16/2022 | 11:00 AM |

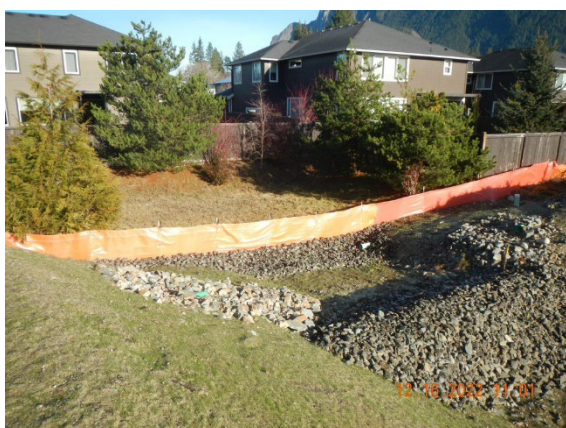
| Photo Number | Digital Image Number | Description of Digital Image | Date and Time | |
|---|---|---|---|---|
| Photo 16 | DSCN3075.JPG | Facing northeast, photo of check dam and drainage area within northern bioswale | 12/16/2022 | 11:01 AM |

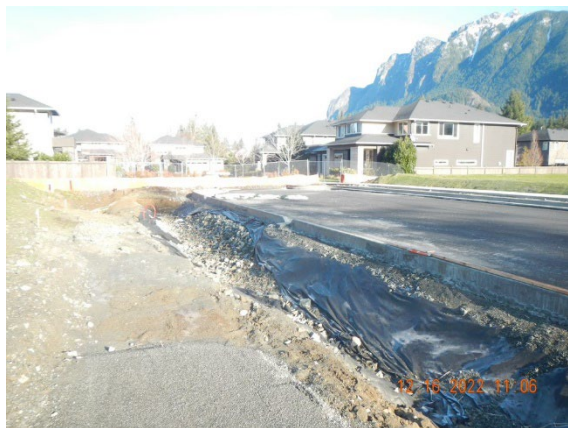
| Photo Number | Digital Image Number | Description of Digital Image | Date and Time | |
|---|---|---|---|---|
| Photo 17 | DSCN3076.JPG | Facing north, photo of sandbag diversion and silt fence bmp between adjacent neighborhood access road | 12/16/2022 | 11:06 AM |

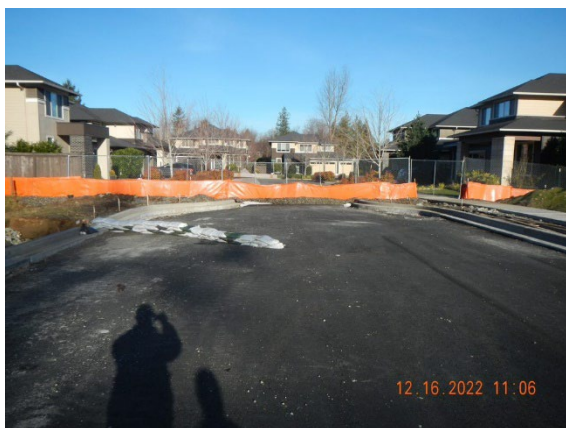
| Photo Number | Digital Image Number | Description of Digital Image | Date and Time | |
|---|---|---|---|---|
| Photo 18 | DSCN3077.JPG | Facing north, photo of sandbag diversion and silt fence bmp between adjacent neighborhood access road | 12/16/2022 | 11:06 AM |

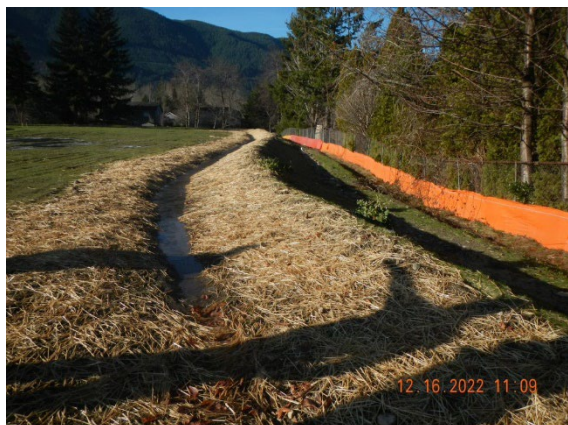
| Photo Number | Digital Image Number | Description of Digital Image | Date and Time | |
|---|---|---|---|---|
| Photo 19 | DSCN3078.JPG | Facing west, photo of northwest perimeter and associated drainage channel. | 12/16/2022 | 11:09 AM |

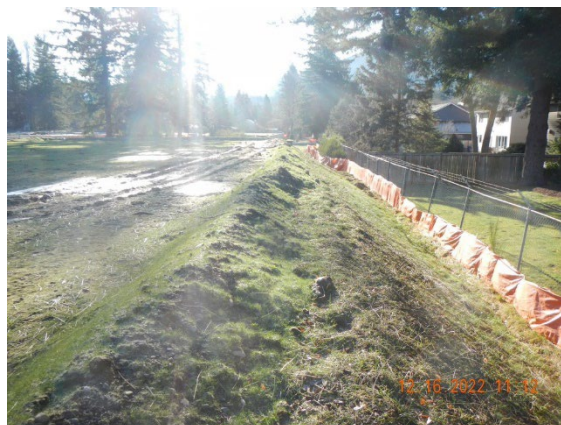
| Photo Number | Digital Image Number | Description of Digital Image | Date and Time | |
|---|---|---|---|---|
| Photo 20 | DSCN3079.JPG | Facing south, photo of western perimeter and silt fencing/berming BMPs | 12/16/2022 | 11:12 AM |

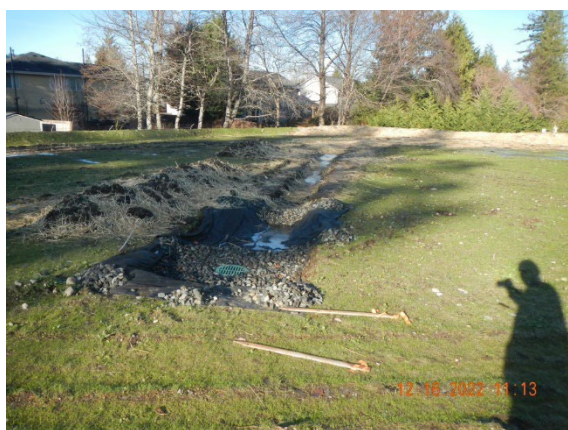
| Photo Number | Digital Image Number | Description of Digital Image | Date and Time | |
|---|---|---|---|---|
| Photo 21 | DSCN3080.JPG | Facing northwest, photo of northwest lot drainage/overflow | 12/16/2022 | 11:13 AM |

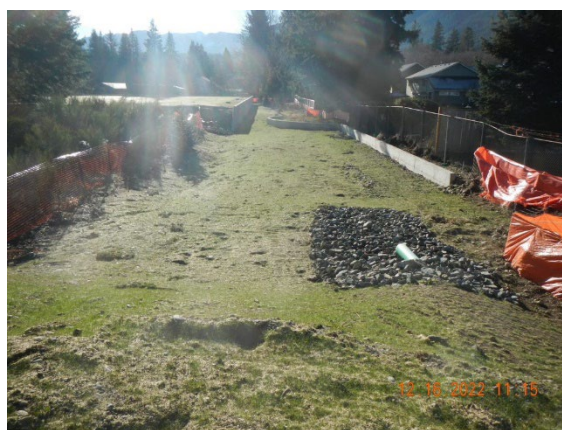
| Photo Number | Digital Image Number | Description of Digital Image | Date and Time | |
|---|---|---|---|---|
| Photo 22 | DSCN3081.JPG | Facing south, photo of FEMA floodplain area along western | 12/16/2022 | 11:15 AM |

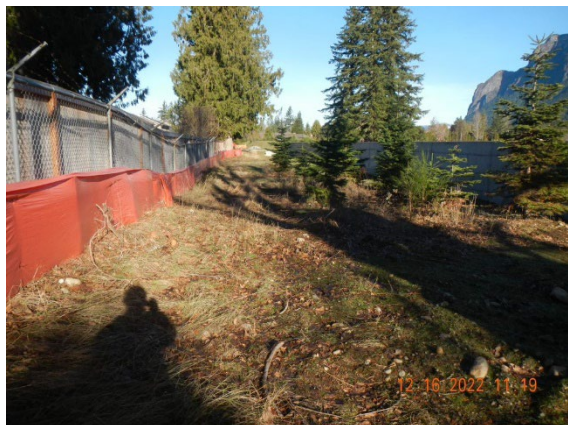
| Photo 23 | DSCN3082.JPG | Facing north, photo of FEMA floodplain area along western perimeter | 12/16/2022 | 11:19 AM |

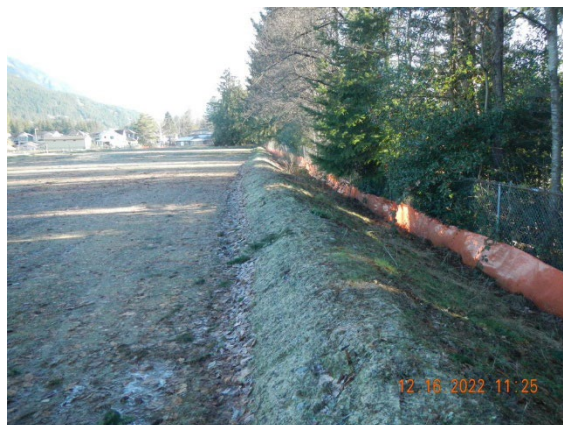
| Photo 26 | DSCN3085.JPG | Facing east, photo of southwest perimeter | 12/16/2022 | 11:25 AM |
