**Region 2 Caribbean Environmental Protection Division
Multimedia Permits and Compliance Branch
Air Protection Team**

CAA Inspection Report

Inspection Date: May 2, 2024

Facility Name: Municipality of Toa Baja Landfill

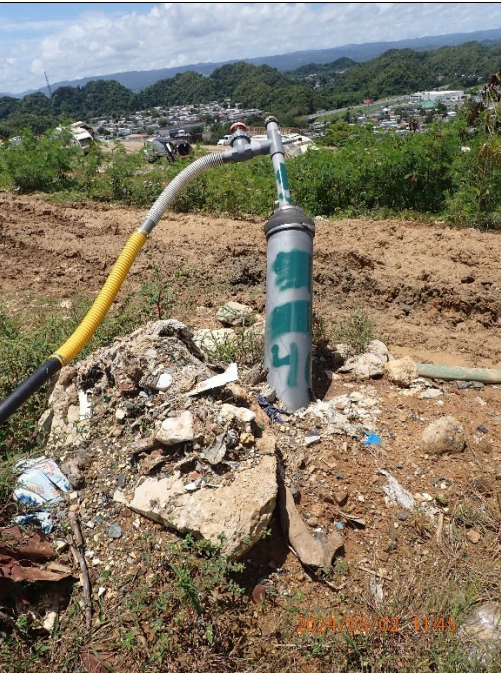
21	P5020021.JPG

<p data-bbox="1192 1312 1409 1344">2024/05/02 11:42</p> <p data-bbox="575 1398 737 1425">Exposed waste</p>	5/2/2024	1142
