## Region 6 - Enforcement & Compliance Assurance Division

### INSPECTION REPORT

| Facility Name: | <b>Southeast White County Public Water System</b> | |

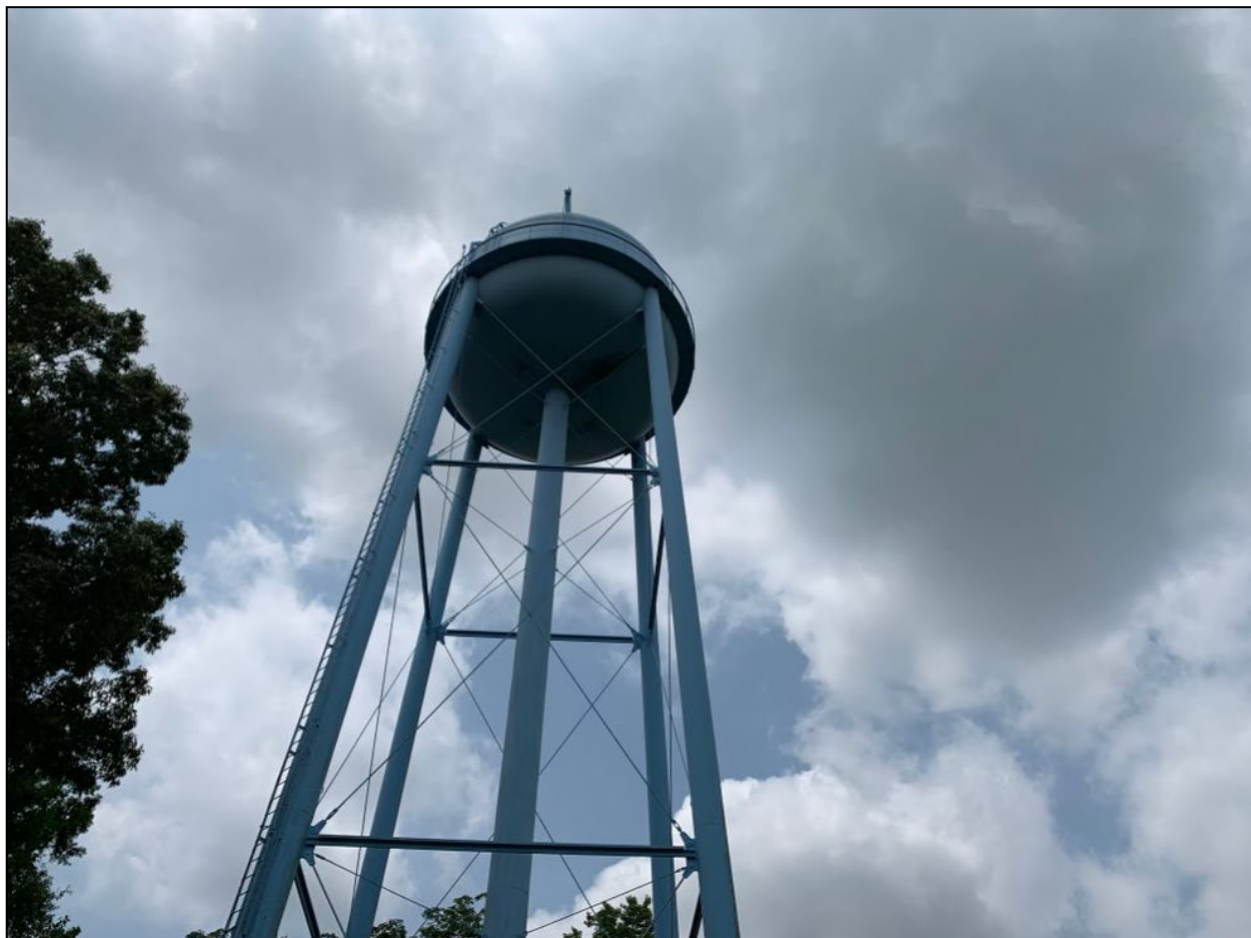
Photo No. 16

The West Point Tank was inspected first (refer to [Appendix 2, Photograph 16](#)). The tank is a 100,000-gallon elevated storage tank. The tank was surrounded by a locked perimeter fence with barbed wire (refer to [Appendix 2, Photograph 17](#)). A sign with information about SEWCO and what number to call in case of an emergency was sitting on the ground next to the fence (refer to [Appendix 2, Photograph 18](#)). An overflow pipe extended to the ground and terminated over a concrete splash pad (refer to [Appendix 2, Photograph 19](#)). The end of the pipe was covered by a 24-inch mesh screen, but debris was covering the majority of the screen (refer to [Appendix 2, Photograph 20](#)). The bottom rungs were removed from the tank's ladder, and a locked security shield covered the lower rungs (refer to [Appendix 2, Photograph 21](#)). [REDACTED]

**Photograph 16. West Point Water Tank** View of the West Point Water Tank. The tank is an elevated, 100,000-gallon storage tank.

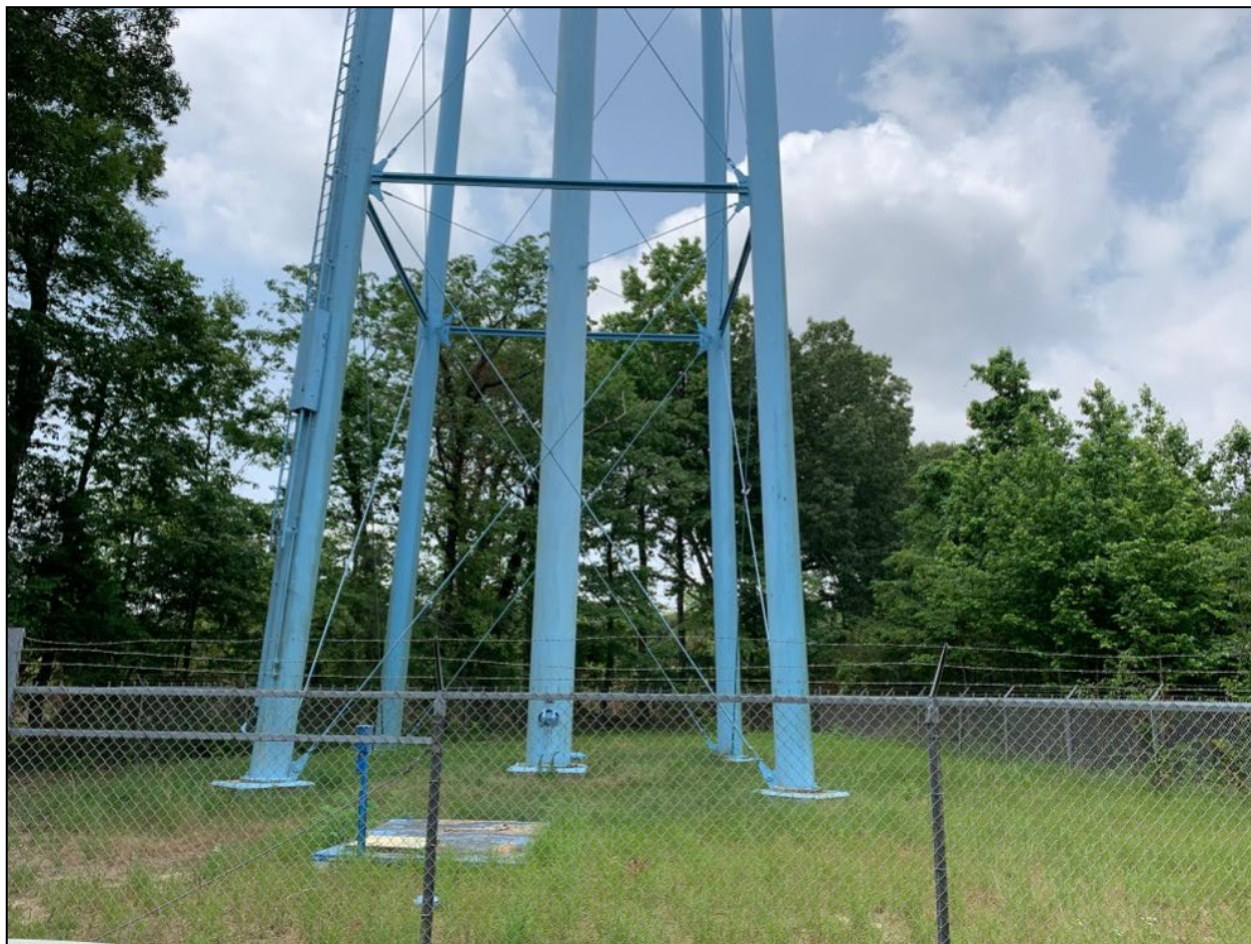
Photo No. 17

**Photograph 17. Perimeter Fence, West Point Water Tank** View of the locked security fence that surrounded the West Point Water Tank. The fence was equipped with barbed wire.

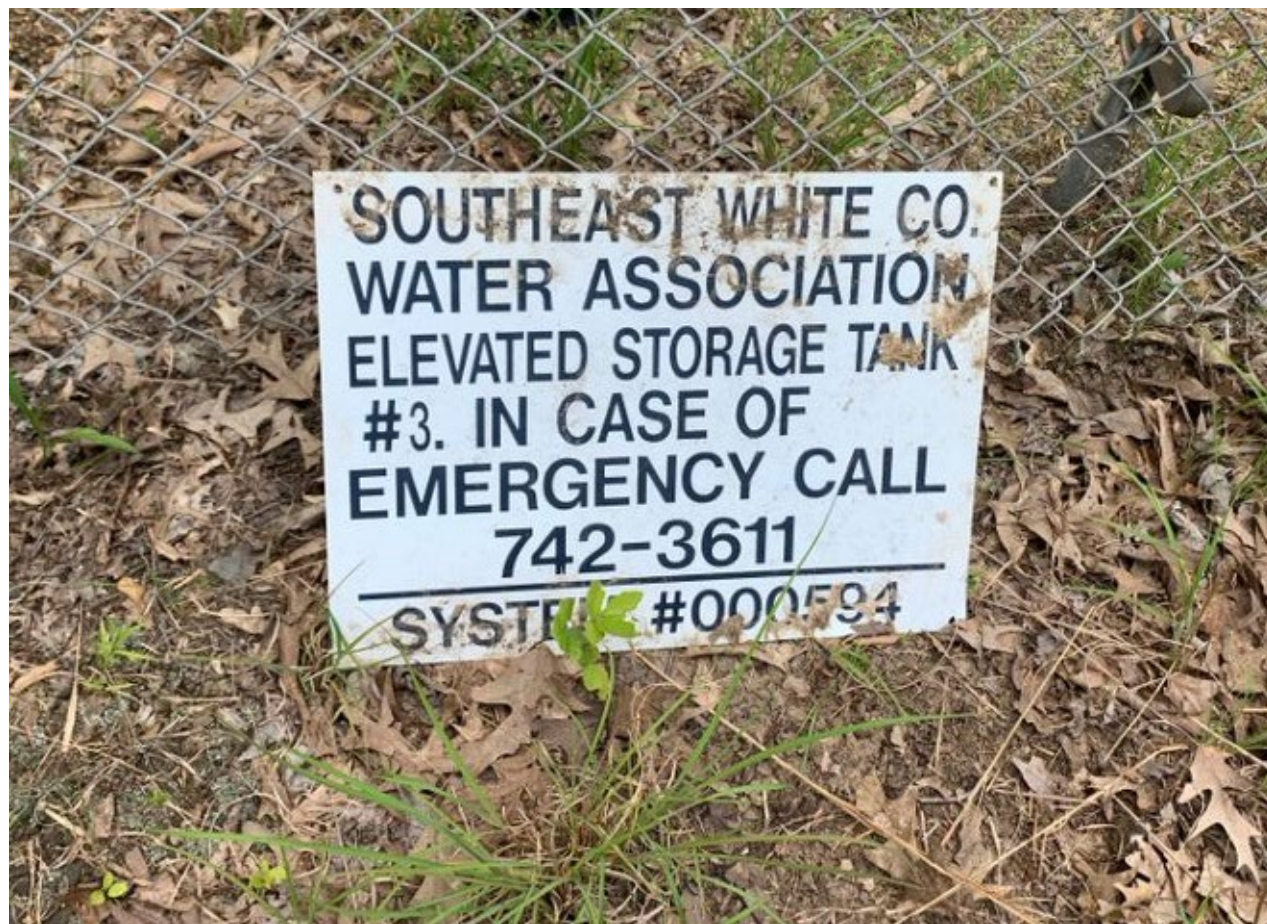
Photo No. 18

**Photograph 18. Security Sign, West Point Water Tank** View of the security sign that was on the ground near the West Point Water Tank security fence. The sign contained the System's information including a phone number to call in case of an emergency.

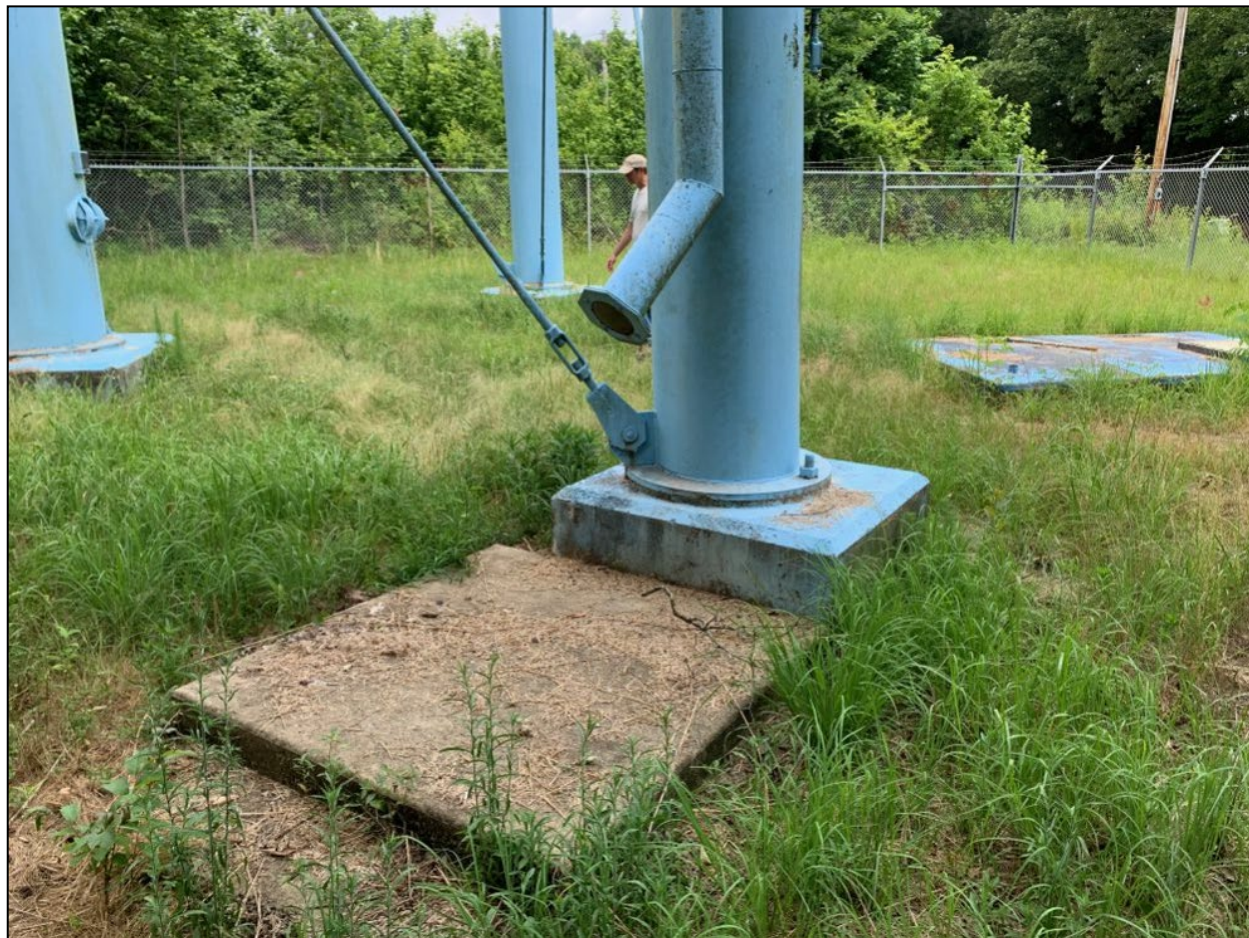
Photo No. 19

**Photograph 19. Concrete Splash Pad, West Point Water Tank** View of the end of the overflow pipe at the West Point Water Tank. The pipe ended over a concrete splash pad and contained a 24-inch mesh screen covering the opening.

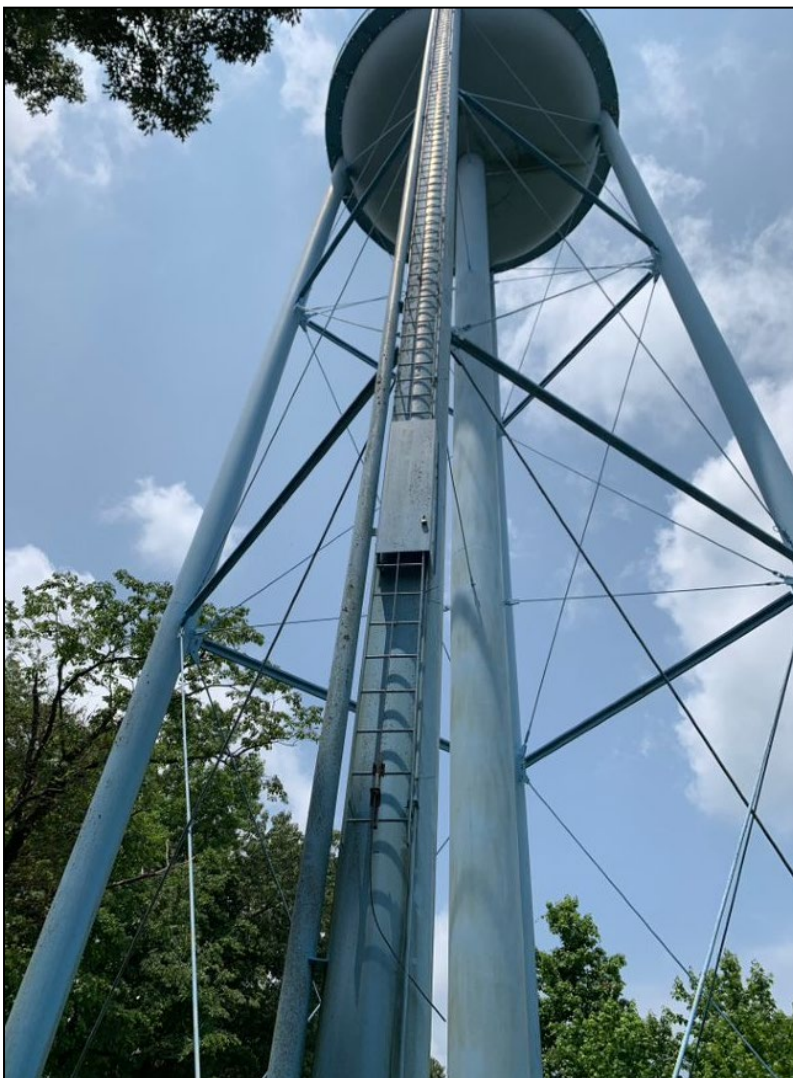
Photo No. 21

**Photograph 21. Security Ladder, West Point Water Tank** View of the security ladder and ladder shield at the West Point Water Tank. The ladder shield was locked, and the bottom rungs of the ladder were removed.

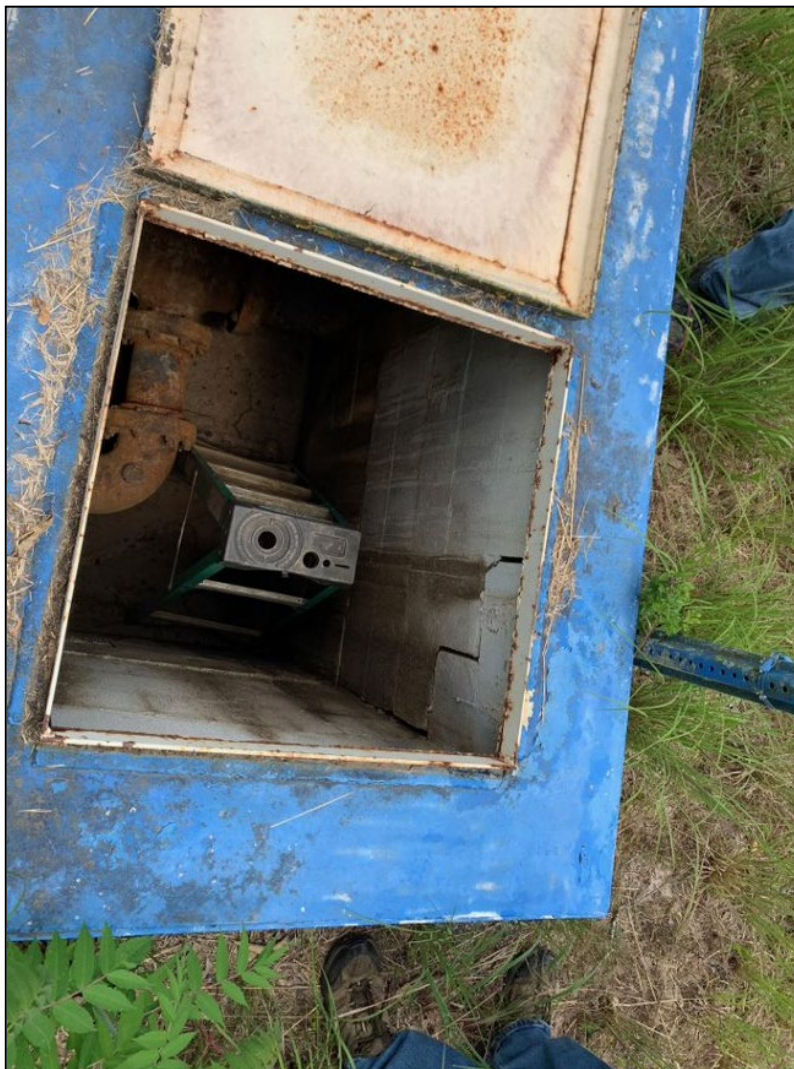
Photo No. 22

[REDACTED] A valve vault was positioned next to the tank (refer to [Appendix 2, Photograph 22](#)). The vault contained an altitude valve used to regulate the water level inside of the tank. [REDACTED]

**Photograph 22. Valve Vault, West Point Water Tank** View of the inside of the valve vault located next to the West Point Water Tank. The vault contained an altitude valve used to regulate the water level inside of the tank. [REDACTED]

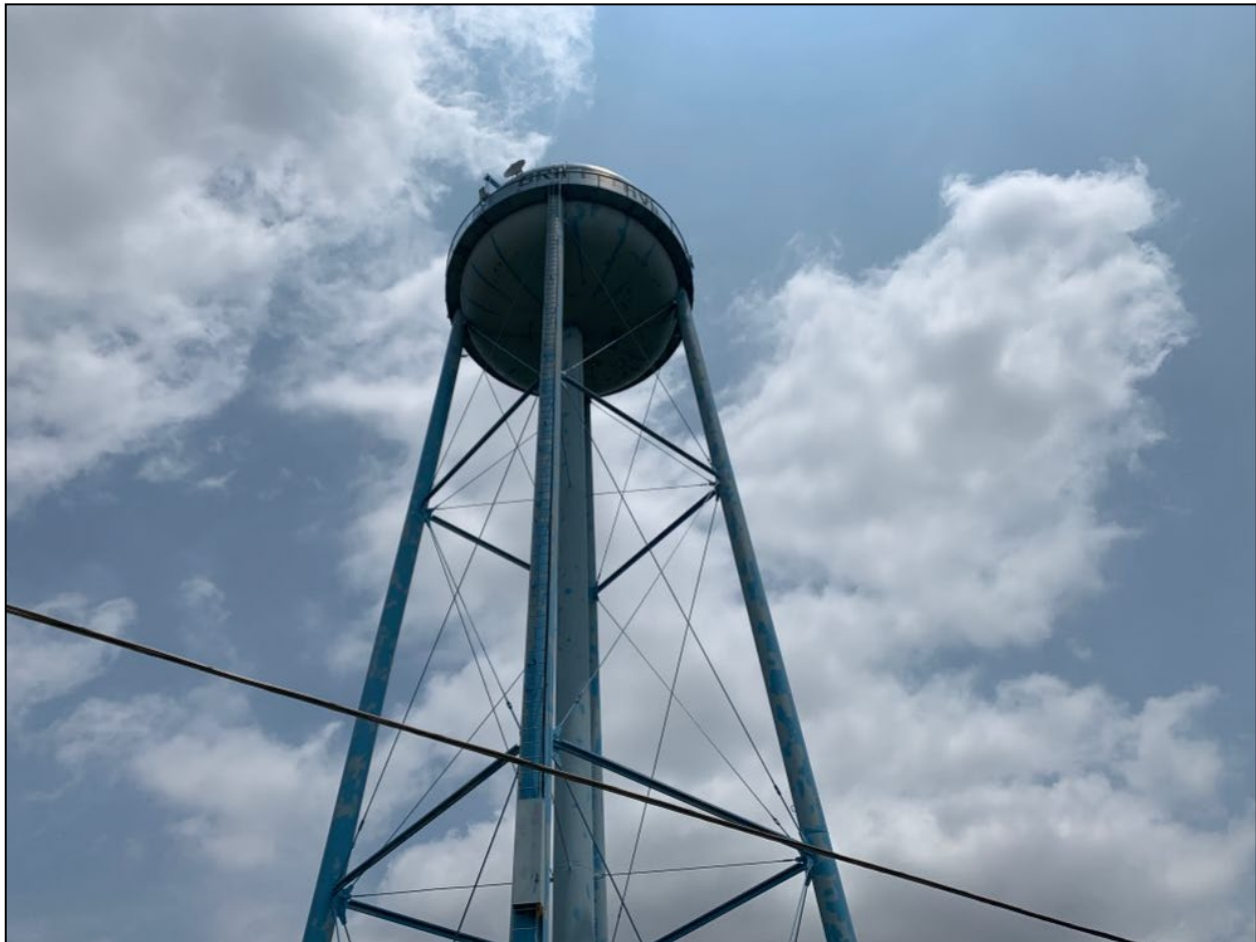
Photo No. 23

The Griffithville Tank was observed next (refer to [Appendix 2, Photograph 23](#)). The tank is an elevated, 100,000-gallon storage tank. The tank was surrounded by a locked perimeter fence with barbed wire (refer to [Appendix 2, Photograph 24](#)). [REDACTED] An overflow pipe extended to the ground and terminated over a concrete splash pad (refer to [Appendix 2, Photograph 25](#)). The end of the pipe was covered by a 24-inch mesh screen, but debris was covering the majority of the screen (refer to [Appendix 2, Photograph 26](#)). The bottom rungs were removed from the

**Photograph 23. Griffithville Water Tank** View of the Griffithville Water Tank. The tank is an elevated, 100,000-gallon storage tank.

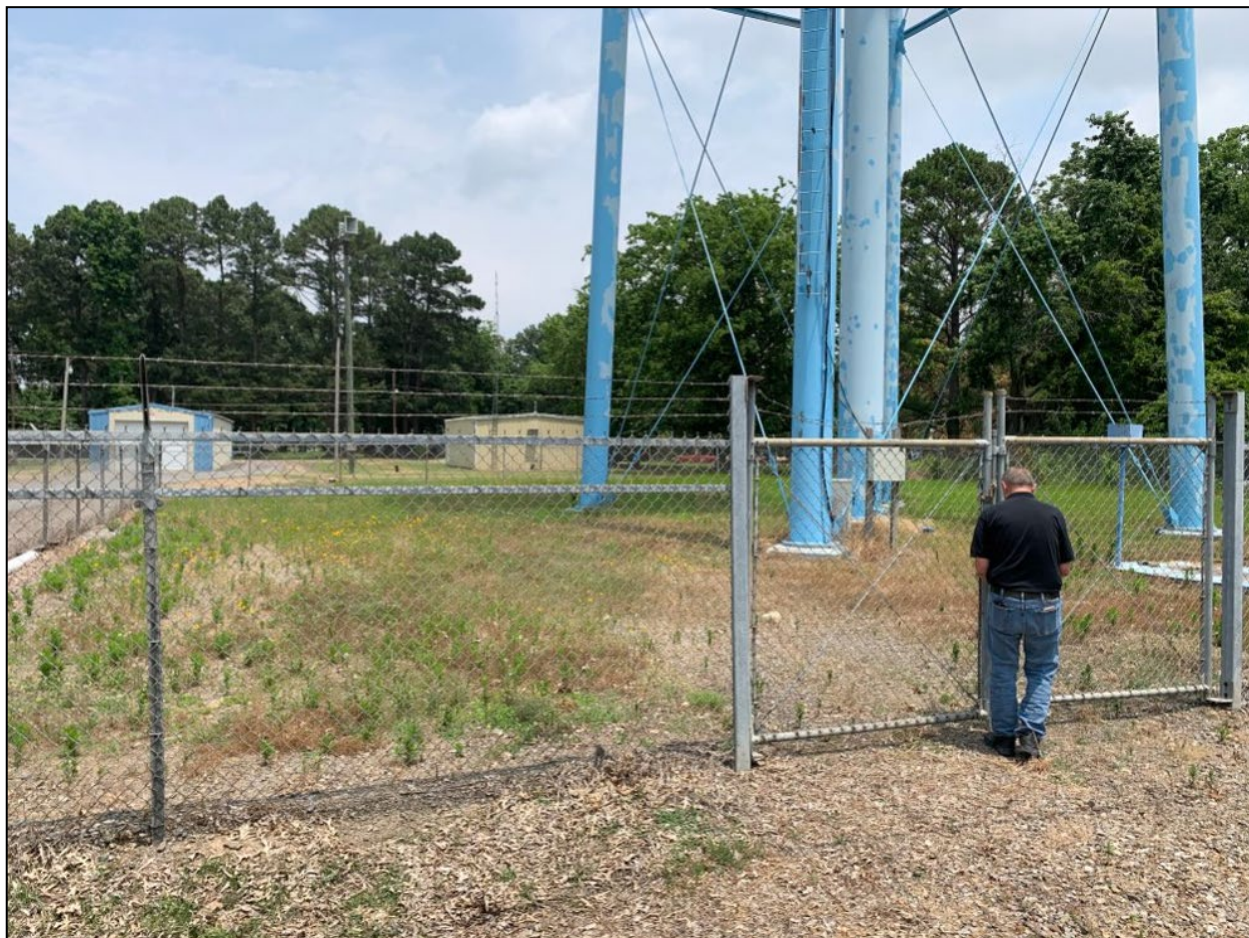
Photo No. 24

**Photograph 24. Perimeter Fence, Griffithville Water Tank** View of the perimeter fence surrounding the Griffithville Water Tank. The fence [REDACTED] was locked and equipped with barbed wire.

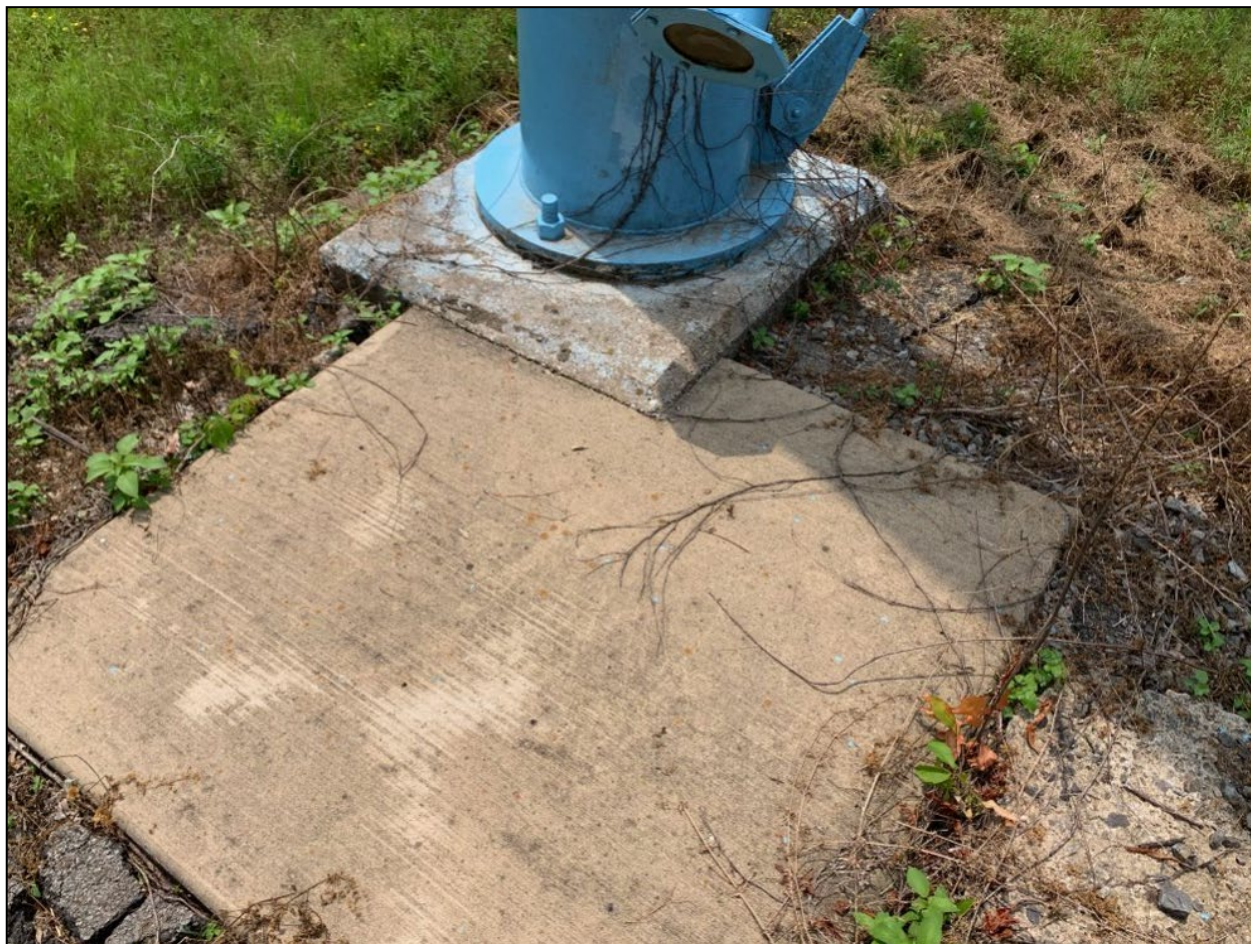
Photo No. 25

**Photograph 25. Concrete Splash Pad, Griffithville Water Tank** View of the concrete splash pad beneath the end of the Griffithville Water Tank overflow pipe.

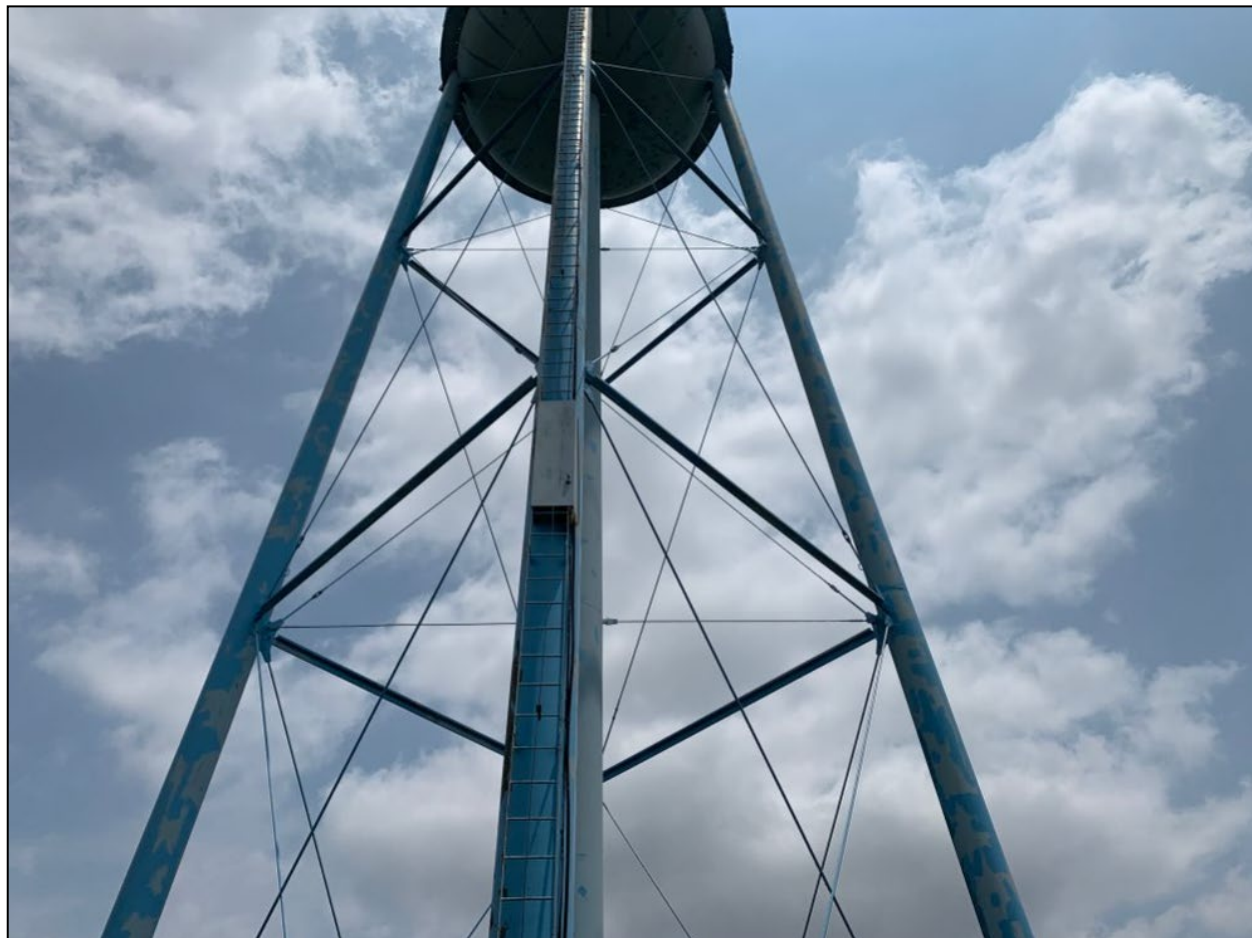
Photo No. 27

tank's ladder, and a locked security shield covered the lower rungs (refer to Appendix 2, Photograph 27).

**Photograph 27. Security Ladder, Griffithville Water Tank** View of the security ladder and ladder shield at the Griffithville Water Tank. The ladder shield was locked, and the bottom rungs of the ladder were removed.
