**Region 6 - Enforcement & Compliance Assurance Division**  
**INSPECTION REPORT**

| Media Program: | Water | |
| Company Name: | LaRay Oil, LLC | |
| Facility Name: | Morgan #1 | |

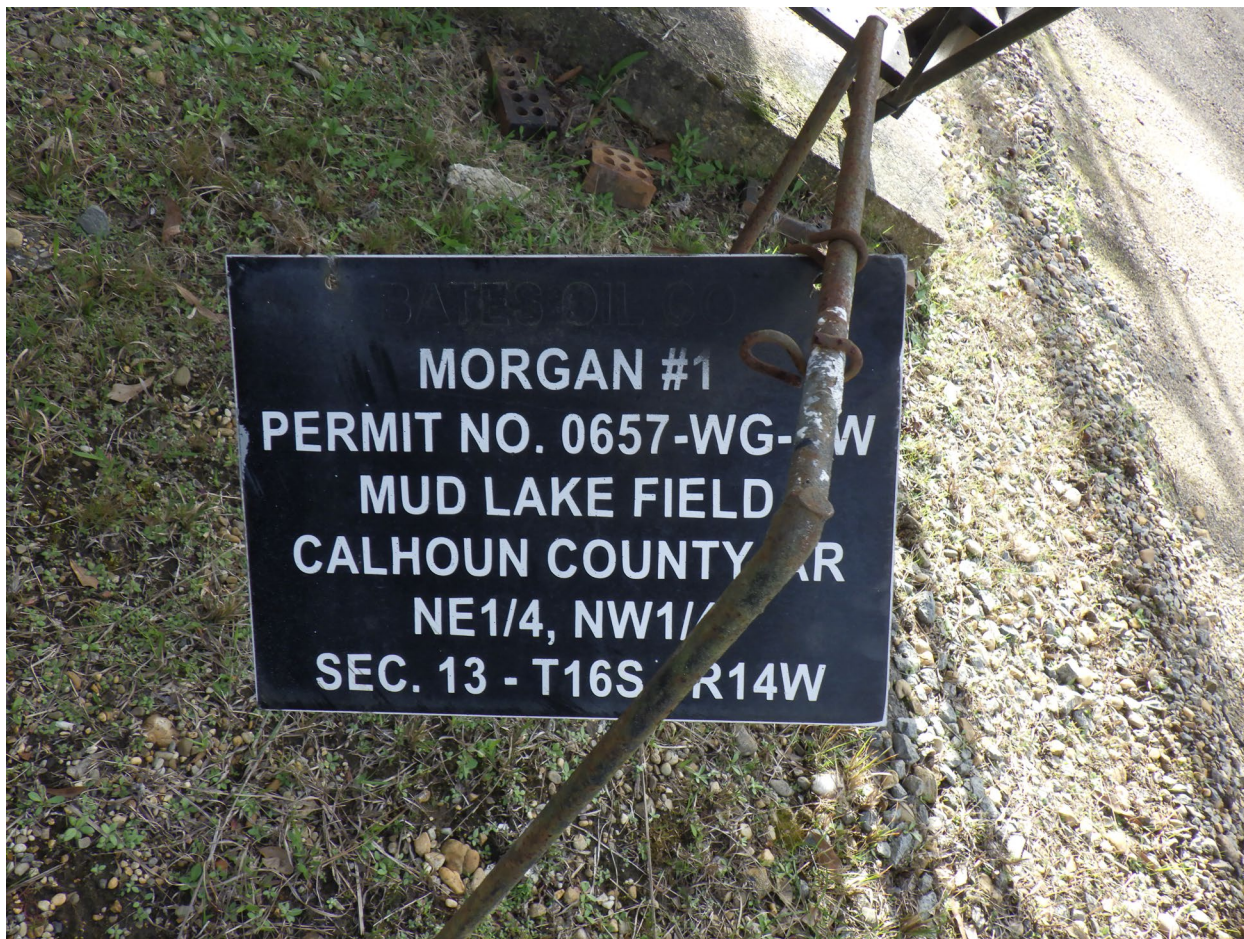
I observed the facility sign, secondary containment, pipes, valves, and tanks located at the facility; see Appendix 1 (photo log), photo No. 1 and No. 2. For additional GPS location and photo metadata, see Appendix 1.

**Photo File Name:** R0010151**Orientation:** E**Date of Photo:** 03/11/2024**Time of Photo:** 4:51 PM**Latitude:** 33.33494**Longitude:** -92.50951**Photographer:** Kerri McCabe**Description:** This photo was taken looking east and shows the facility sign.

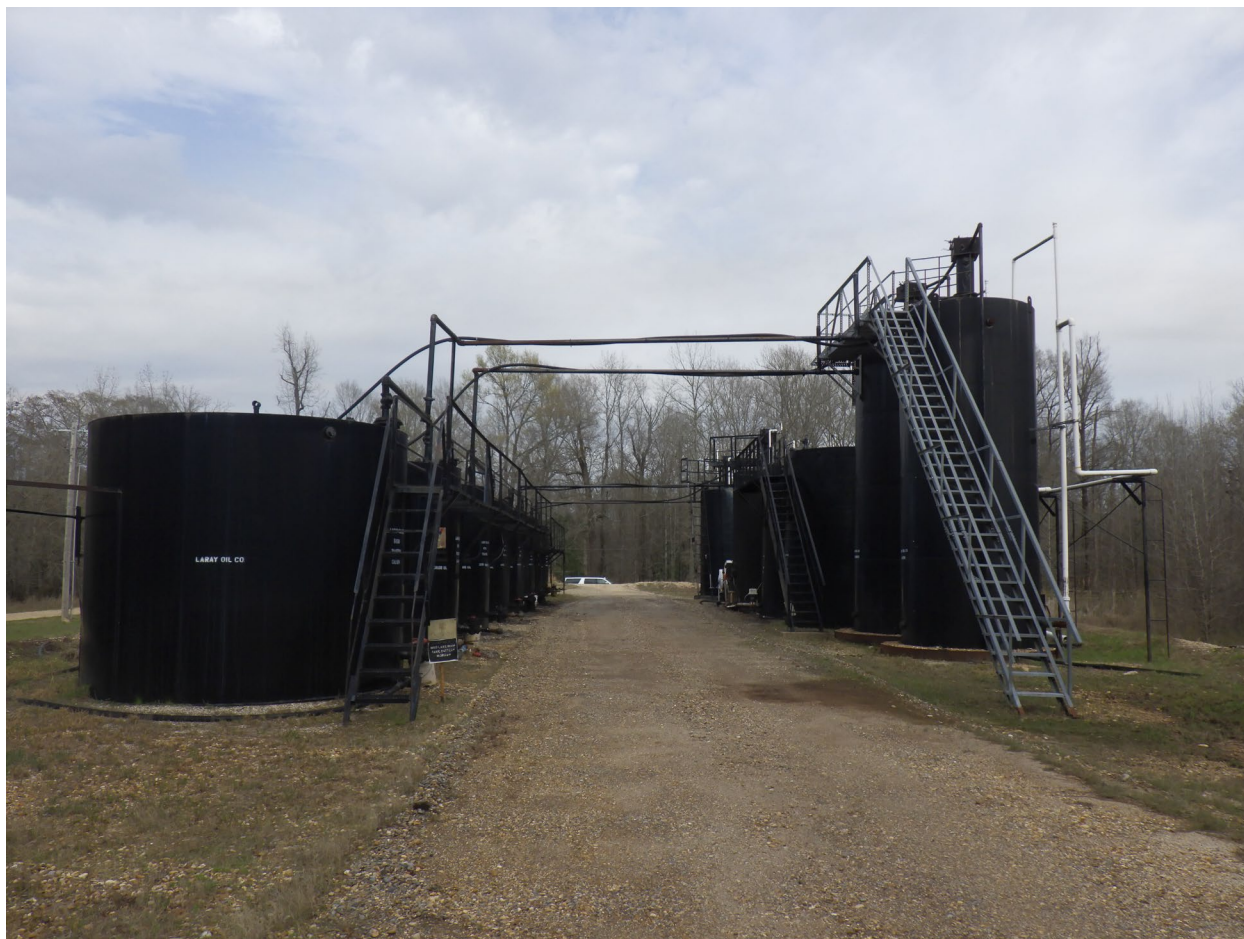
Photo No. 2

**Photo File Name:** R0010145**Orientation:** E**Date of Photo:** 03/11/2024**Time of Photo:** 4:38 PM**Latitude:** 33.33494**Longitude:** -92.50976**Photographer:** Kerri McCabe**Description:** This photo was taken looking east and shows an overview of the facility.
