## EPA REGION 10 Enforcement Division

### INSPECTION REPORT

| <b>Type of Inspection</b> | Compliance Evaluation Inspection (CEI) | | |
| <b>Facility or Site Name</b> | Coeur Alaska, Inc. - Kensington Gold Mine | | |

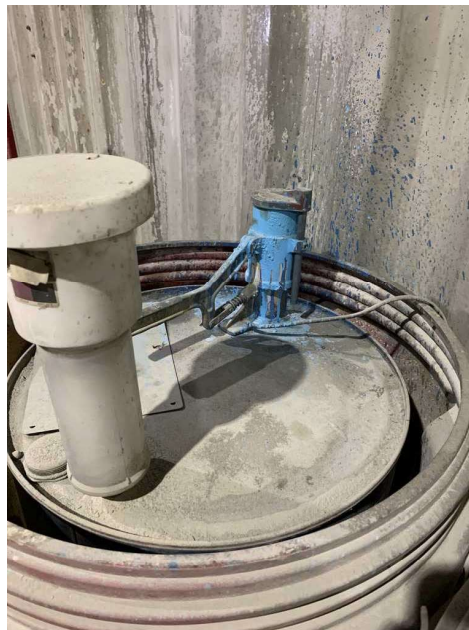
| Underground Maintenance 940 Paste Plant | | | [Geographic Coordinates] |

While inspecting the 940 Paste Plant, we saw a 55-gallon SAA container with an attached aerosol can popper. At the time of the inspection, the SAA container contained hazardous waste, but the cover on the attached aerosol can popper was not closed; therefore, the container was not closed.

| View of the SAA container, showing that the attached aerosol can popper cover is open, and the container is not closed. | | | |
