## REGION 10 Enforcement Division

### INSPECTION REPORT

| <b>Company Name:</b> | United States Postal Service (USPS) | | |
| <b>Facility or Site Name:</b> | USPS Seattle Network Distribution Center (NDC) | | |

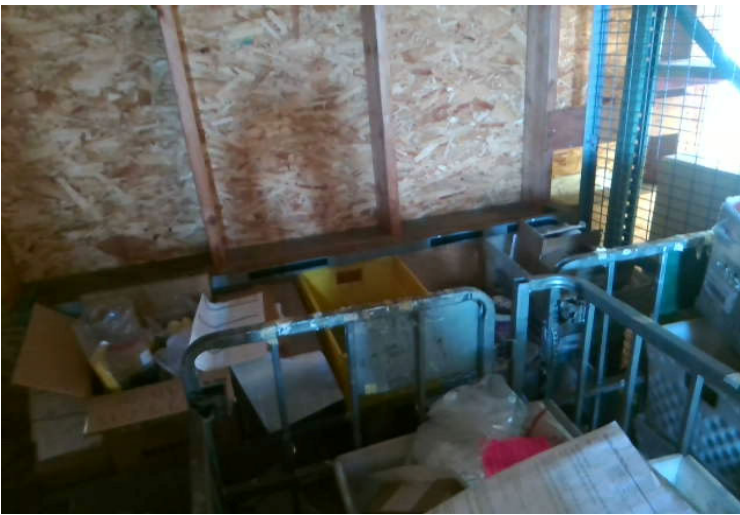
| IMG-202203091121482148222050.jpg | |

| Another view of an abundance of waste, including waste marked as either hazardous or non-hazardous waste. Some was internally designated, and some is waiting on Clean Harbors/Safety Kleen for designation. |

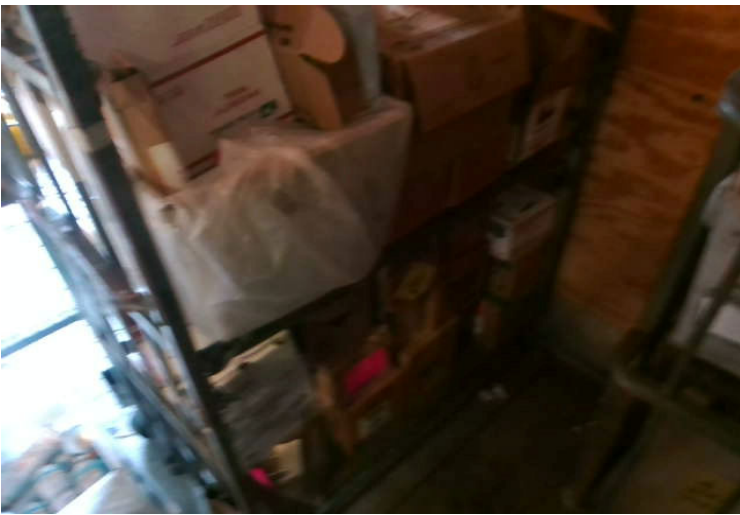
| Another view of an abundance of waste, including waste marked as either hazardous or non-hazardous waste. Some was internally designated, and some is waiting on Clean Harbors/Safety Kleen for designation. | |

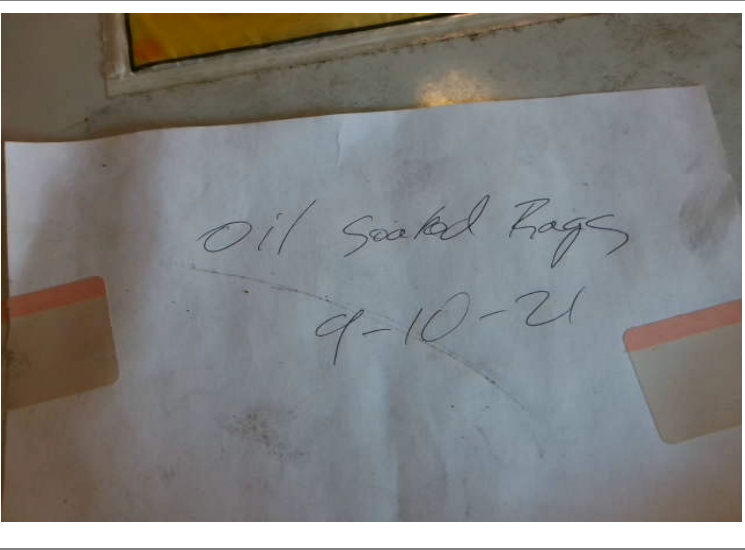
| <p>[Title]</p> <p>IMG-202203091125442544123159.jpg</p> <p>03/09/2022 11:25 AM (AKT)</p> <p>Jon Jones</p> <p>Lubrication Shed</p> <p>No CBI</p> <p>No PII</p> <p>Close-up view of the labeling on one of the 55-gallon containers holding oil soaked rags seen in IMG-202203091125382538195762.jpg.</p> | |

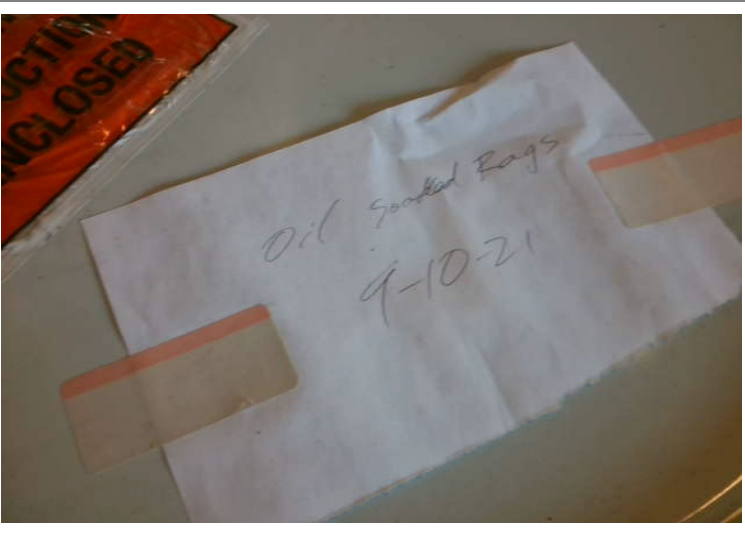
| <p>[Title]</p> <p>IMG-202203091125532553123024.jpg</p> <p>03/09/2022 11:25 AM (AKT)</p> <p>Jon Jones</p> <p>Lubrication Shed</p> <p>No CBI</p> <p>No PII</p> <p>Close-up view of the labeling on one of the 55-gallon containers holding oil soaked rags seen in IMG-202203091125382538195762.jpg.</p> | |

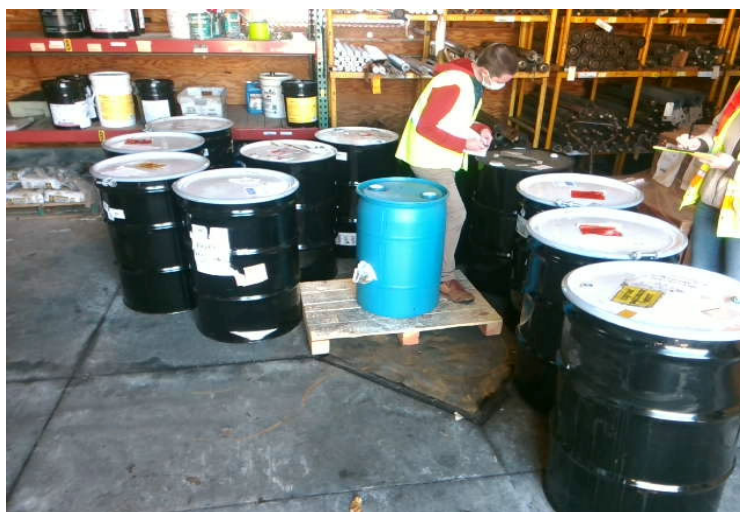
IMG-202203091128532853270838.jpg

View of 12, 55-gallon containers and one, 25-gallon poly container, all of which contained wastes and most of which still required a waste designation.

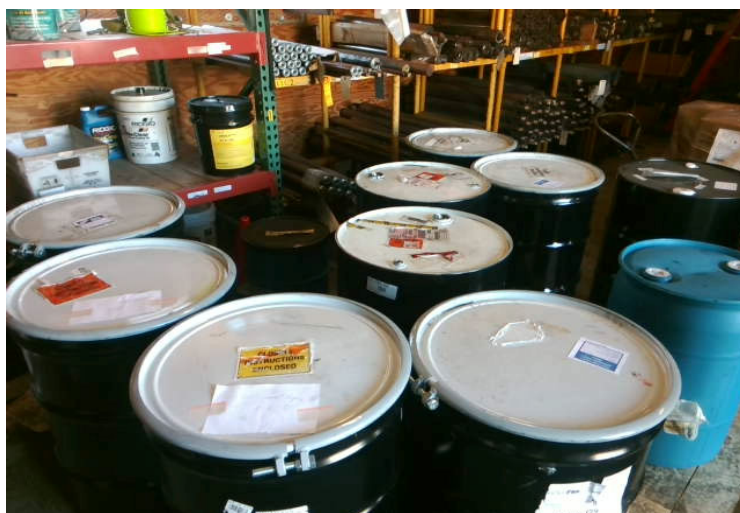
IMG-20220309112904294246570.jpg

Another view of 12, 55-gallon containers and one, 25-gallon poly container, most of which still required a waste designation.

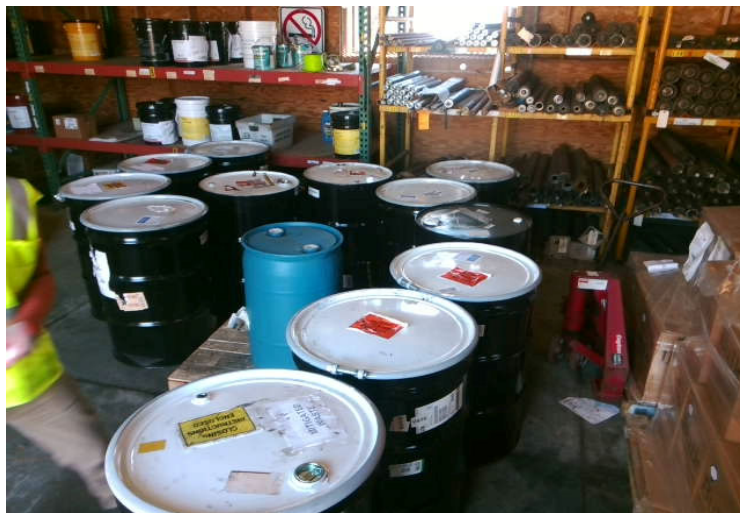
IMG-202203091129182918260276.jpg

Another view of 12, 55-gallon containers and one, 25-gallon poly container, most of which still required a waste designation.

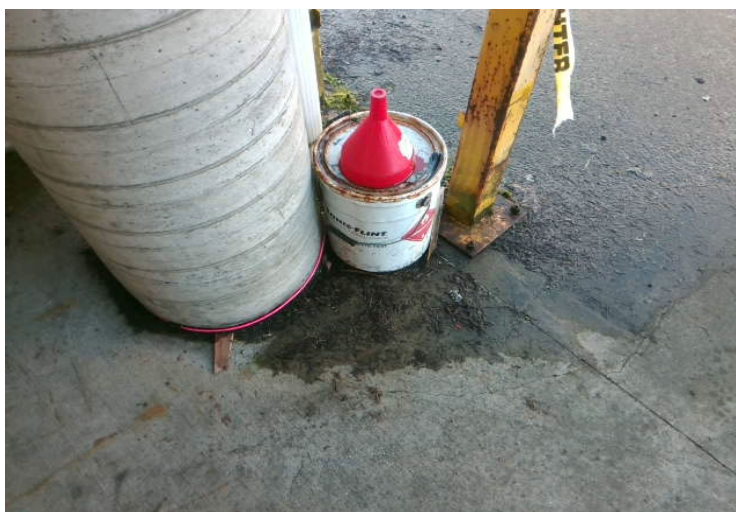
View of a 5-gallon container of solvent-based white traffic paint that has been sitting outside and allowed to freeze and thaw over the winter. Leaving paint out is not managing it as a valuable product, but as a waste. Therefore, this waste requires a waste designation.

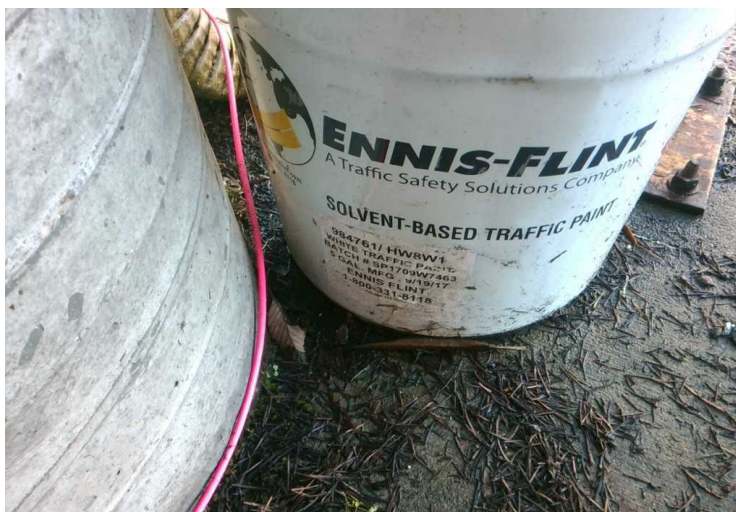
IMG-2022030909574157411194180.jpg

Close-up view of a 5-gallon container of solvent-based white traffic paint that has been sitting outside and allowed to freeze and thaw over the winter. Leaving paint out is not managing it as a valuable product, but as a waste. Therefore, this waste requires a waste designation.

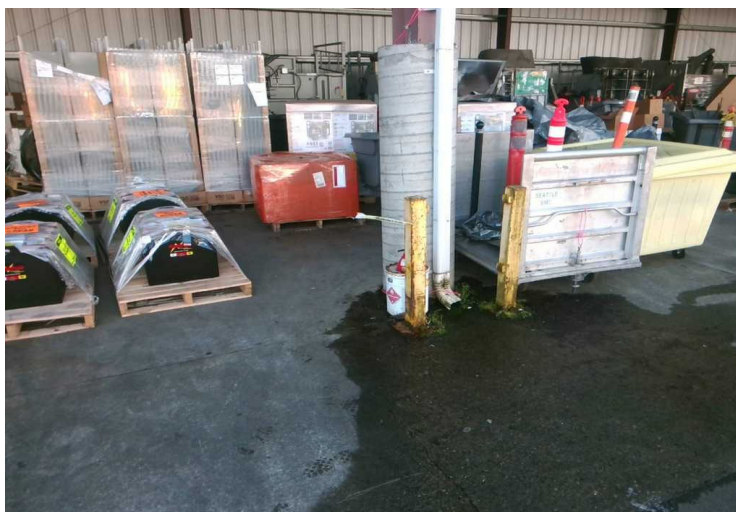
IMG-202203090958045841071168.jpg

Another view of a 5-gallon container of solvent-based white traffic paint that has been sitting outside and allowed to freeze and thaw over the winter. Leaving paint out is not managing it as a valuable product, but as a waste. Therefore, this waste requires a waste designation.

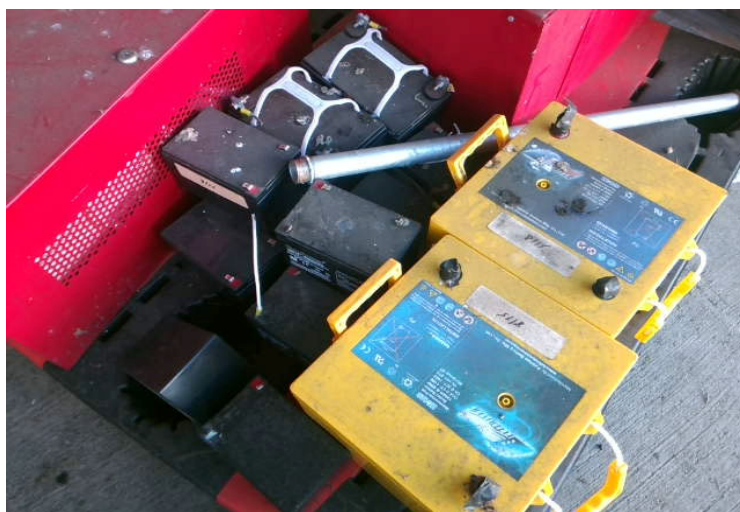
| There were two small flat tubs that contained a mix of waste batteries and six loose lead-acid batteries that were not labeled as "Universal Waste – Batteries," "Waste Batteries," or "Used Batteries." | <b>Regulation:</b><br><br>WAC 173-303-573(10) | <b>Sections:</b> |

Close-up view of waste lead-acid batteries. Mr. Gibson told us these batteries would be managed by the site as Universal Waste. The batteries are not labeled as "Universal Waste – Batteries," "Waste Batteries," or "Used Batteries."

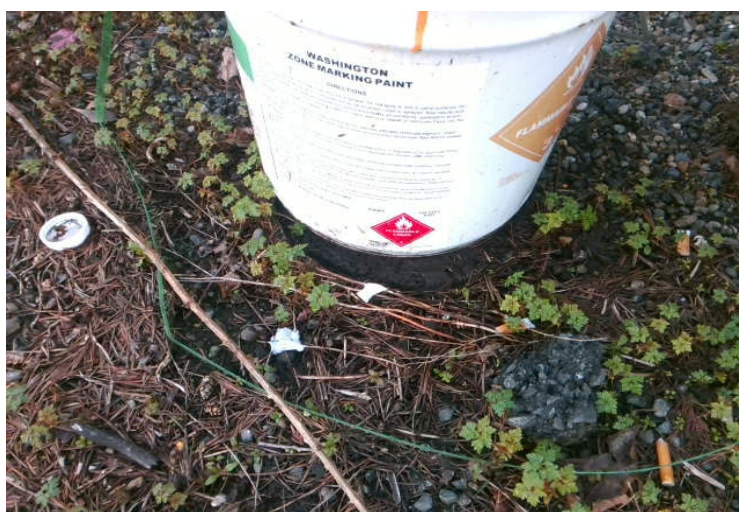
| Another view of 5-gallon containers of solvent-based traffic paint that has been left inside of an unheated storage container and allowed to freeze and thaw over the winter. Some of the containers had not been closed and may have been allowed to dry out. |

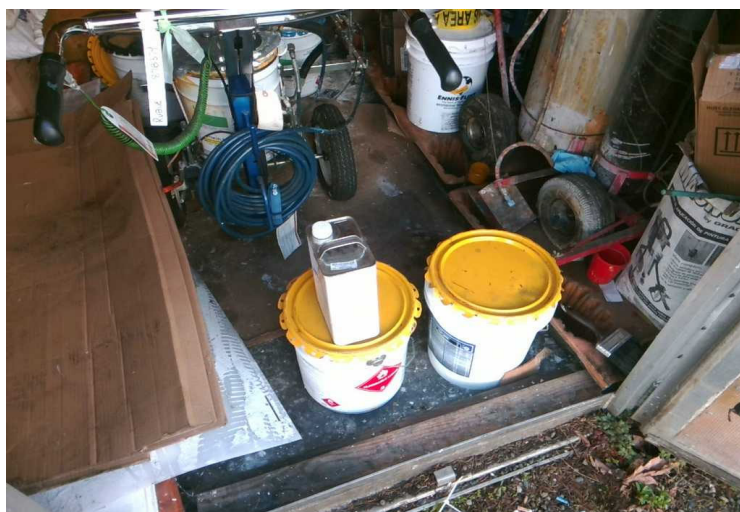
IMG-2022030910251225121195899.jpg

Another view of 5-gallon containers of solvent-based traffic paint that has been left inside of an unheated storage container and allowed to freeze and thaw over the winter. Some of the containers had not been closed and may have been allowed to dry out.

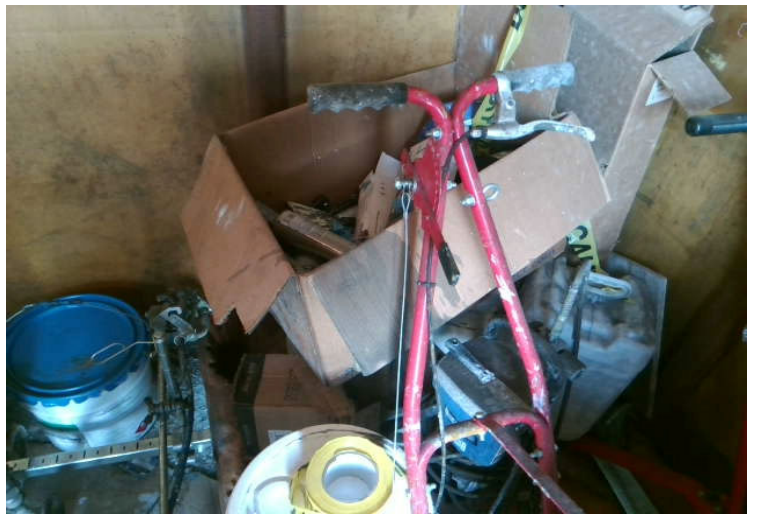
View of the cardboard box containing the aerosols seen in IMG-202203091036163616226746.jpg.

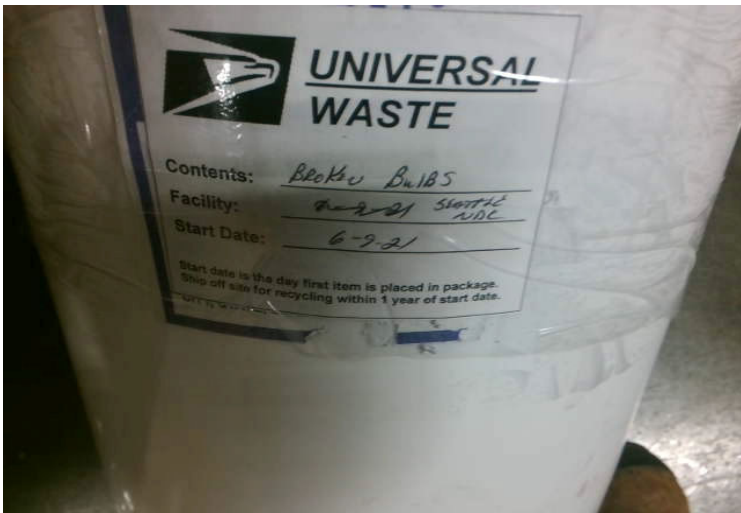
| <p>[Title]</p> <p>IMG-20220309092307237128382.jpg</p> <p>03/09/2022 09:23 AM (AKT)</p> <p>Jon Jones</p> <p>Seattle NDC Room 133A</p> <p>No CBI</p> <p>No PII</p> <p>Close-up view of the label on the 5-gallon poly container being used to accumulate broken waste bulbs, showing that it was being managed as universal waste.</p> | |

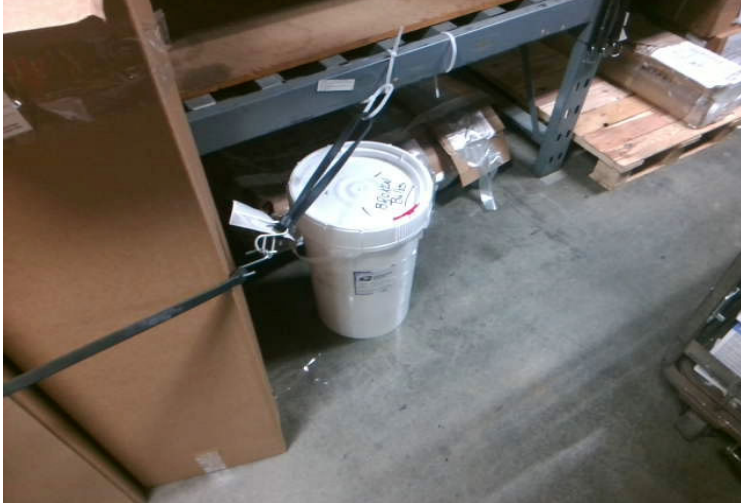
| <p>[Title]</p> <p>IMG-202203090923192319179872.jpg</p> <p>03/09/2022 09:23 AM (AKT)</p> <p>Jon Jones</p> <p>Seattle NDC Room 133A</p> <p>No CBI</p> <p>No PII</p> <p>Another view of the 5-gallon poly container being used to accumulate broken waste bulbs the site was managing as universal waste.</p> | |

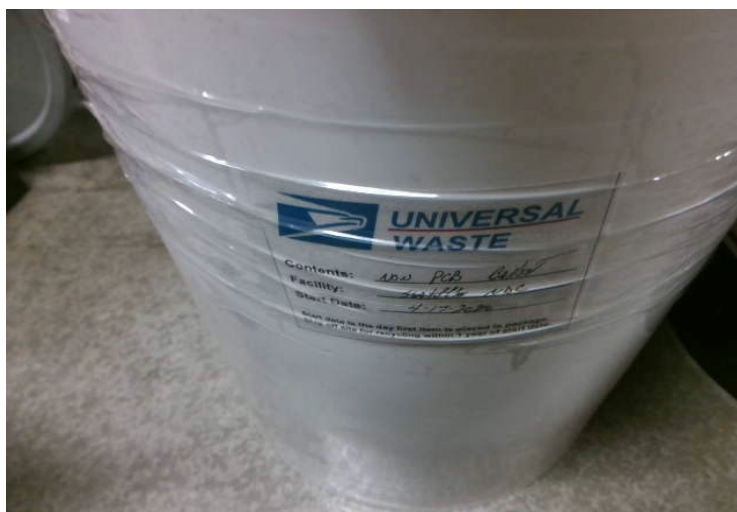
IMG-202203090944444444136942.jpg

Close-up view of the container label on the container of waste non-PCB ballasts. The container was labeled as universal waste and dated 4/17/2020.

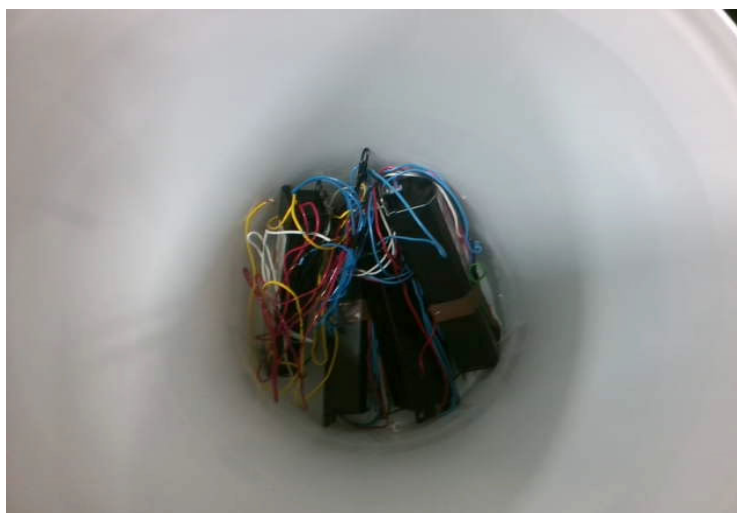
IMG-202203090944514451100827.jpg

View of the Non-PCB ballasts inside the container. The container was labeled as universal waste and dated 4/17/2020.

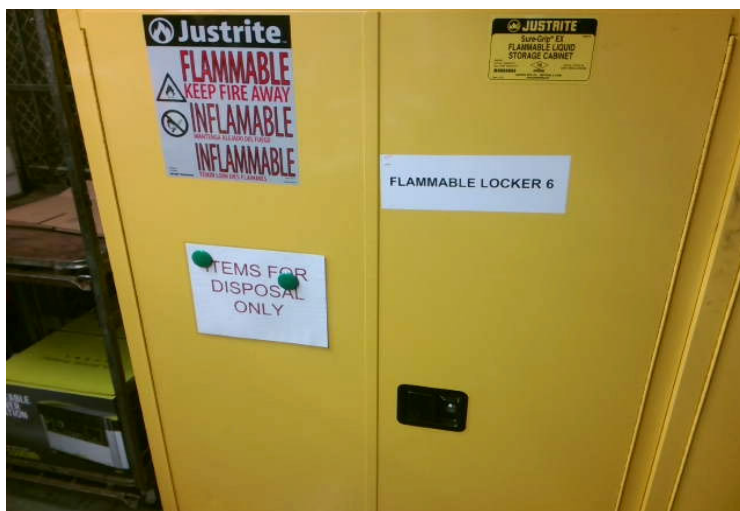
IMG-20220309120238238149192.jpg

| <p>A significant number of Damaged items referred to as "Loose-in-the-mail" located in flammable storage lockers, two vent hood type storage areas, and on carts were either undesignated or if designated as either "Hazardous/Dangerous Waste" were not marked with hazard indicators.</p> | <p><b>Regulation:</b></p> | <p><b>Sections:</b></p> |

View of the flammable storage cabinet marked as "Items for Disposal Only."

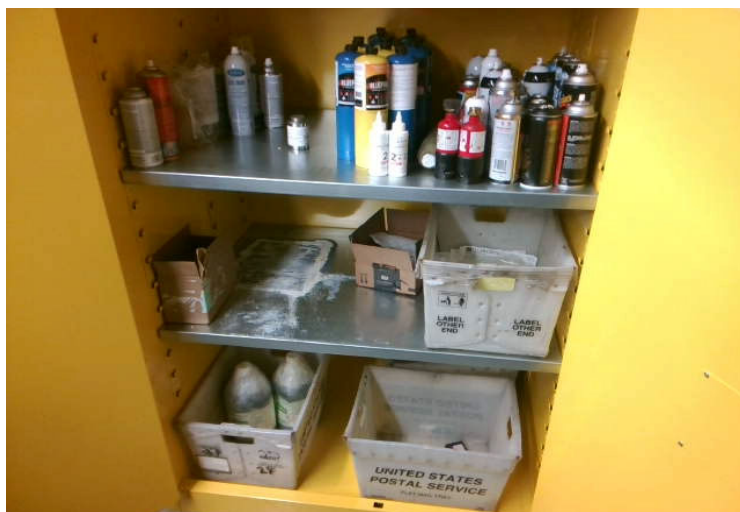
IMG-20220309120249249181942.jpg

View of the contents inside the flammable storage cabinet marked as "Items for disposal only."

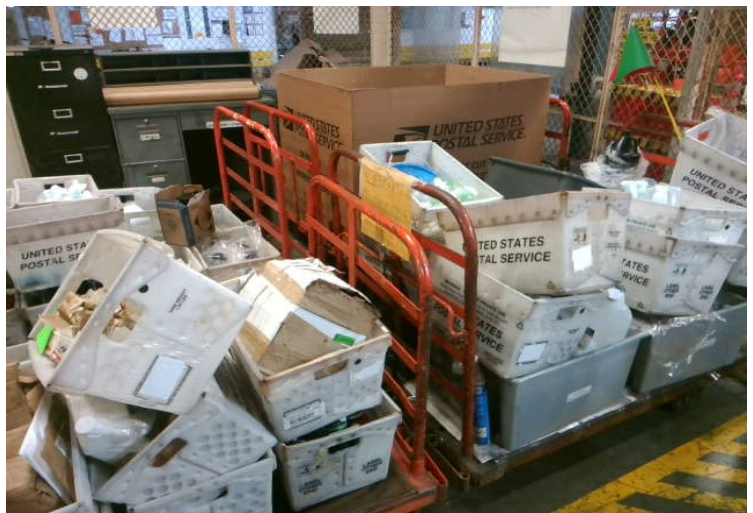
Another view of the same carts containing "Loose-in-the-Mail" waste.

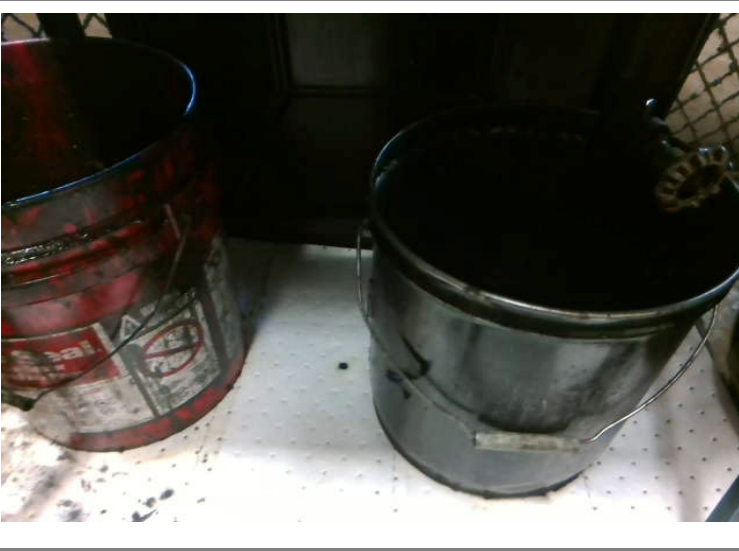
We went to the Maintenance Lube Area, across from the "Loose-in-the-mail" area and south of the Battery Shop. While there we saw two 5-gallon containers being used to accumulate used oil from the process of draining used oil filters. At the time of the inspection these two 5-gallon containers were not labeled with the words "Used Oil."

| <p>[Title]</p> <p>IMG-202203091220152015135134.jpg</p> <p>03/09/2022 12:20 PM (AKT)</p> <p>Jon Jones</p> <p>Seattle NDC Maintenance Lube Area</p> <p>No CBI</p> <p>No PII</p> <p>Close-up view of two, 5-gallon containers, being used to accumulate used oil from the process of draining used oil filters, that are not labeled with the words "Used Oil."</p> | |

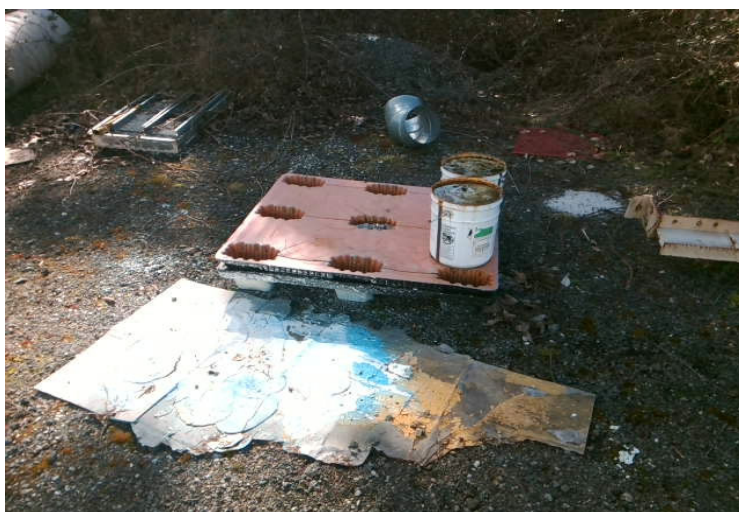
Closer view of the pallet which had two, 5-gallon containers labeled as containing solvent-based traffic paint adjacent to a piece of cardboard. Someone poured waste paint onto the cardboard to dry out the paint. This photo also shows areas adjacent to the pallet and cardboard where this paint had spilled directly onto the ground.

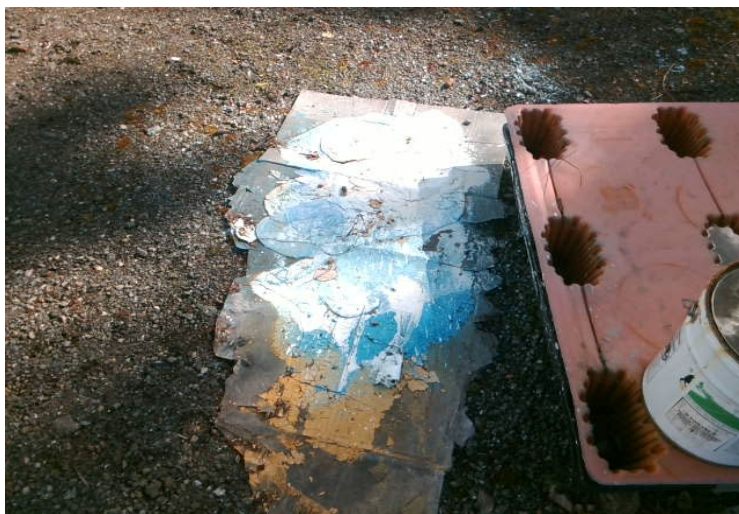
Another view of the solvent-based traffic paint that had been poured out onto a piece of cardboard.

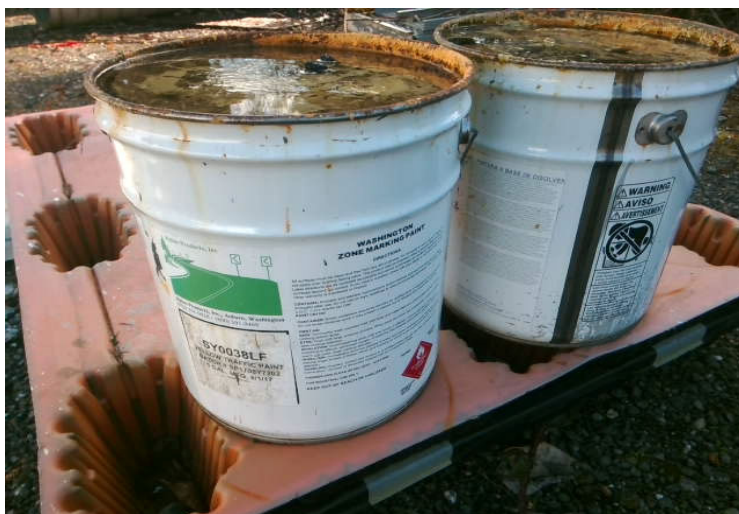
Close-up view of the 5-gallon containers, seen here on the pallet, that contain what appeared to be rainwater and paint scum floating on top of the water.
