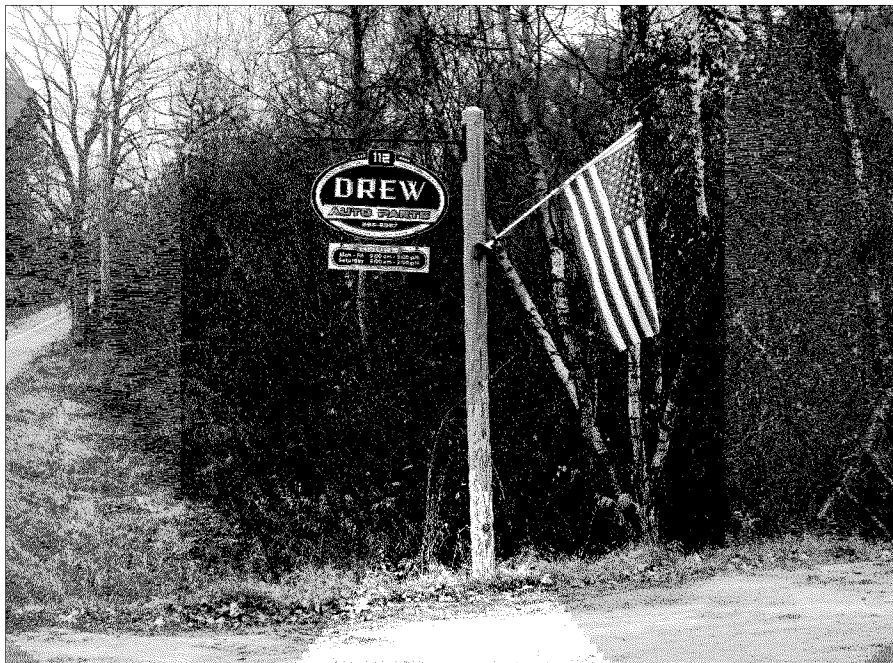
**Photograph 1.** Drew Auto Parts/Camaro Heaven 11/6/2023 21:01 DSCN0586.JPG

Description: Facility sign for Drew's Auto Parts, A Division of Camaro Heaven.
