**Region 6 - Enforcement & Compliance Assurance Division**  
**INSPECTION REPORT**

| Inspection Date(s): | June 26 – 29, 2023 | |
| Regulatory Program(s) | Large Quantity Generator | |
| Facility Name: | <b>Quala Rail and Specialty</b> | |

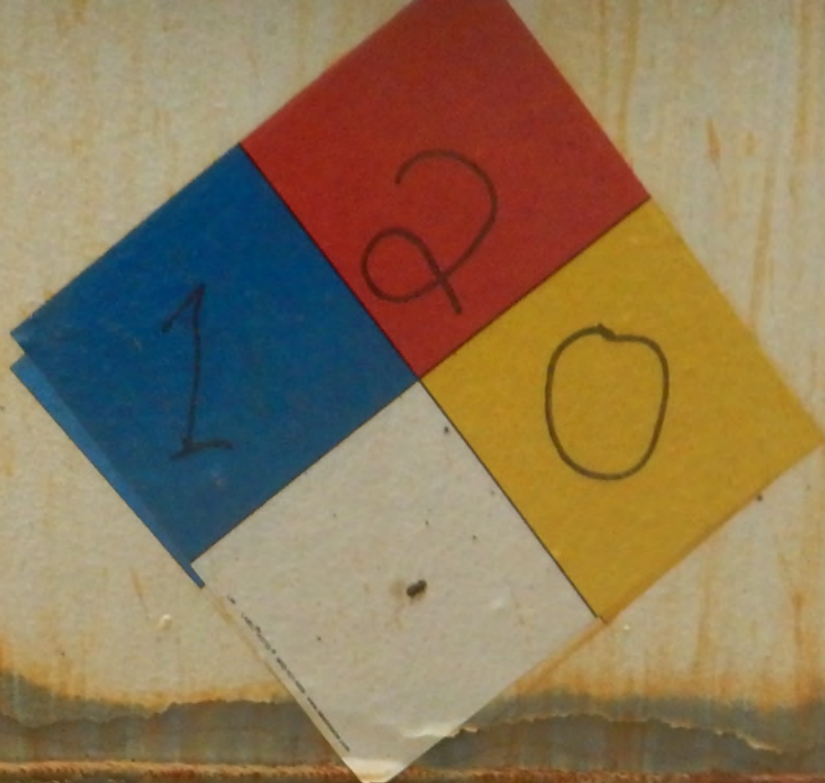
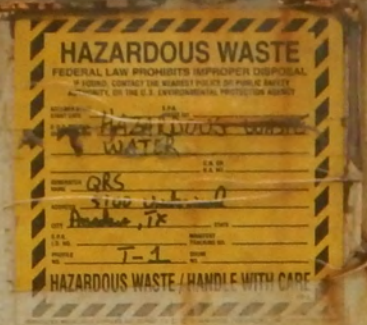
Photo 25

- On June 26, 2023, we found one unlabeled 275-gallon tote of hazardous waste in the rail and specialty wash area. See photo 25.
- On June 26, 2023, we found one unlabeled 275-gallon tote of hazardous waste in the rail and specialty wash area. See photo 30.

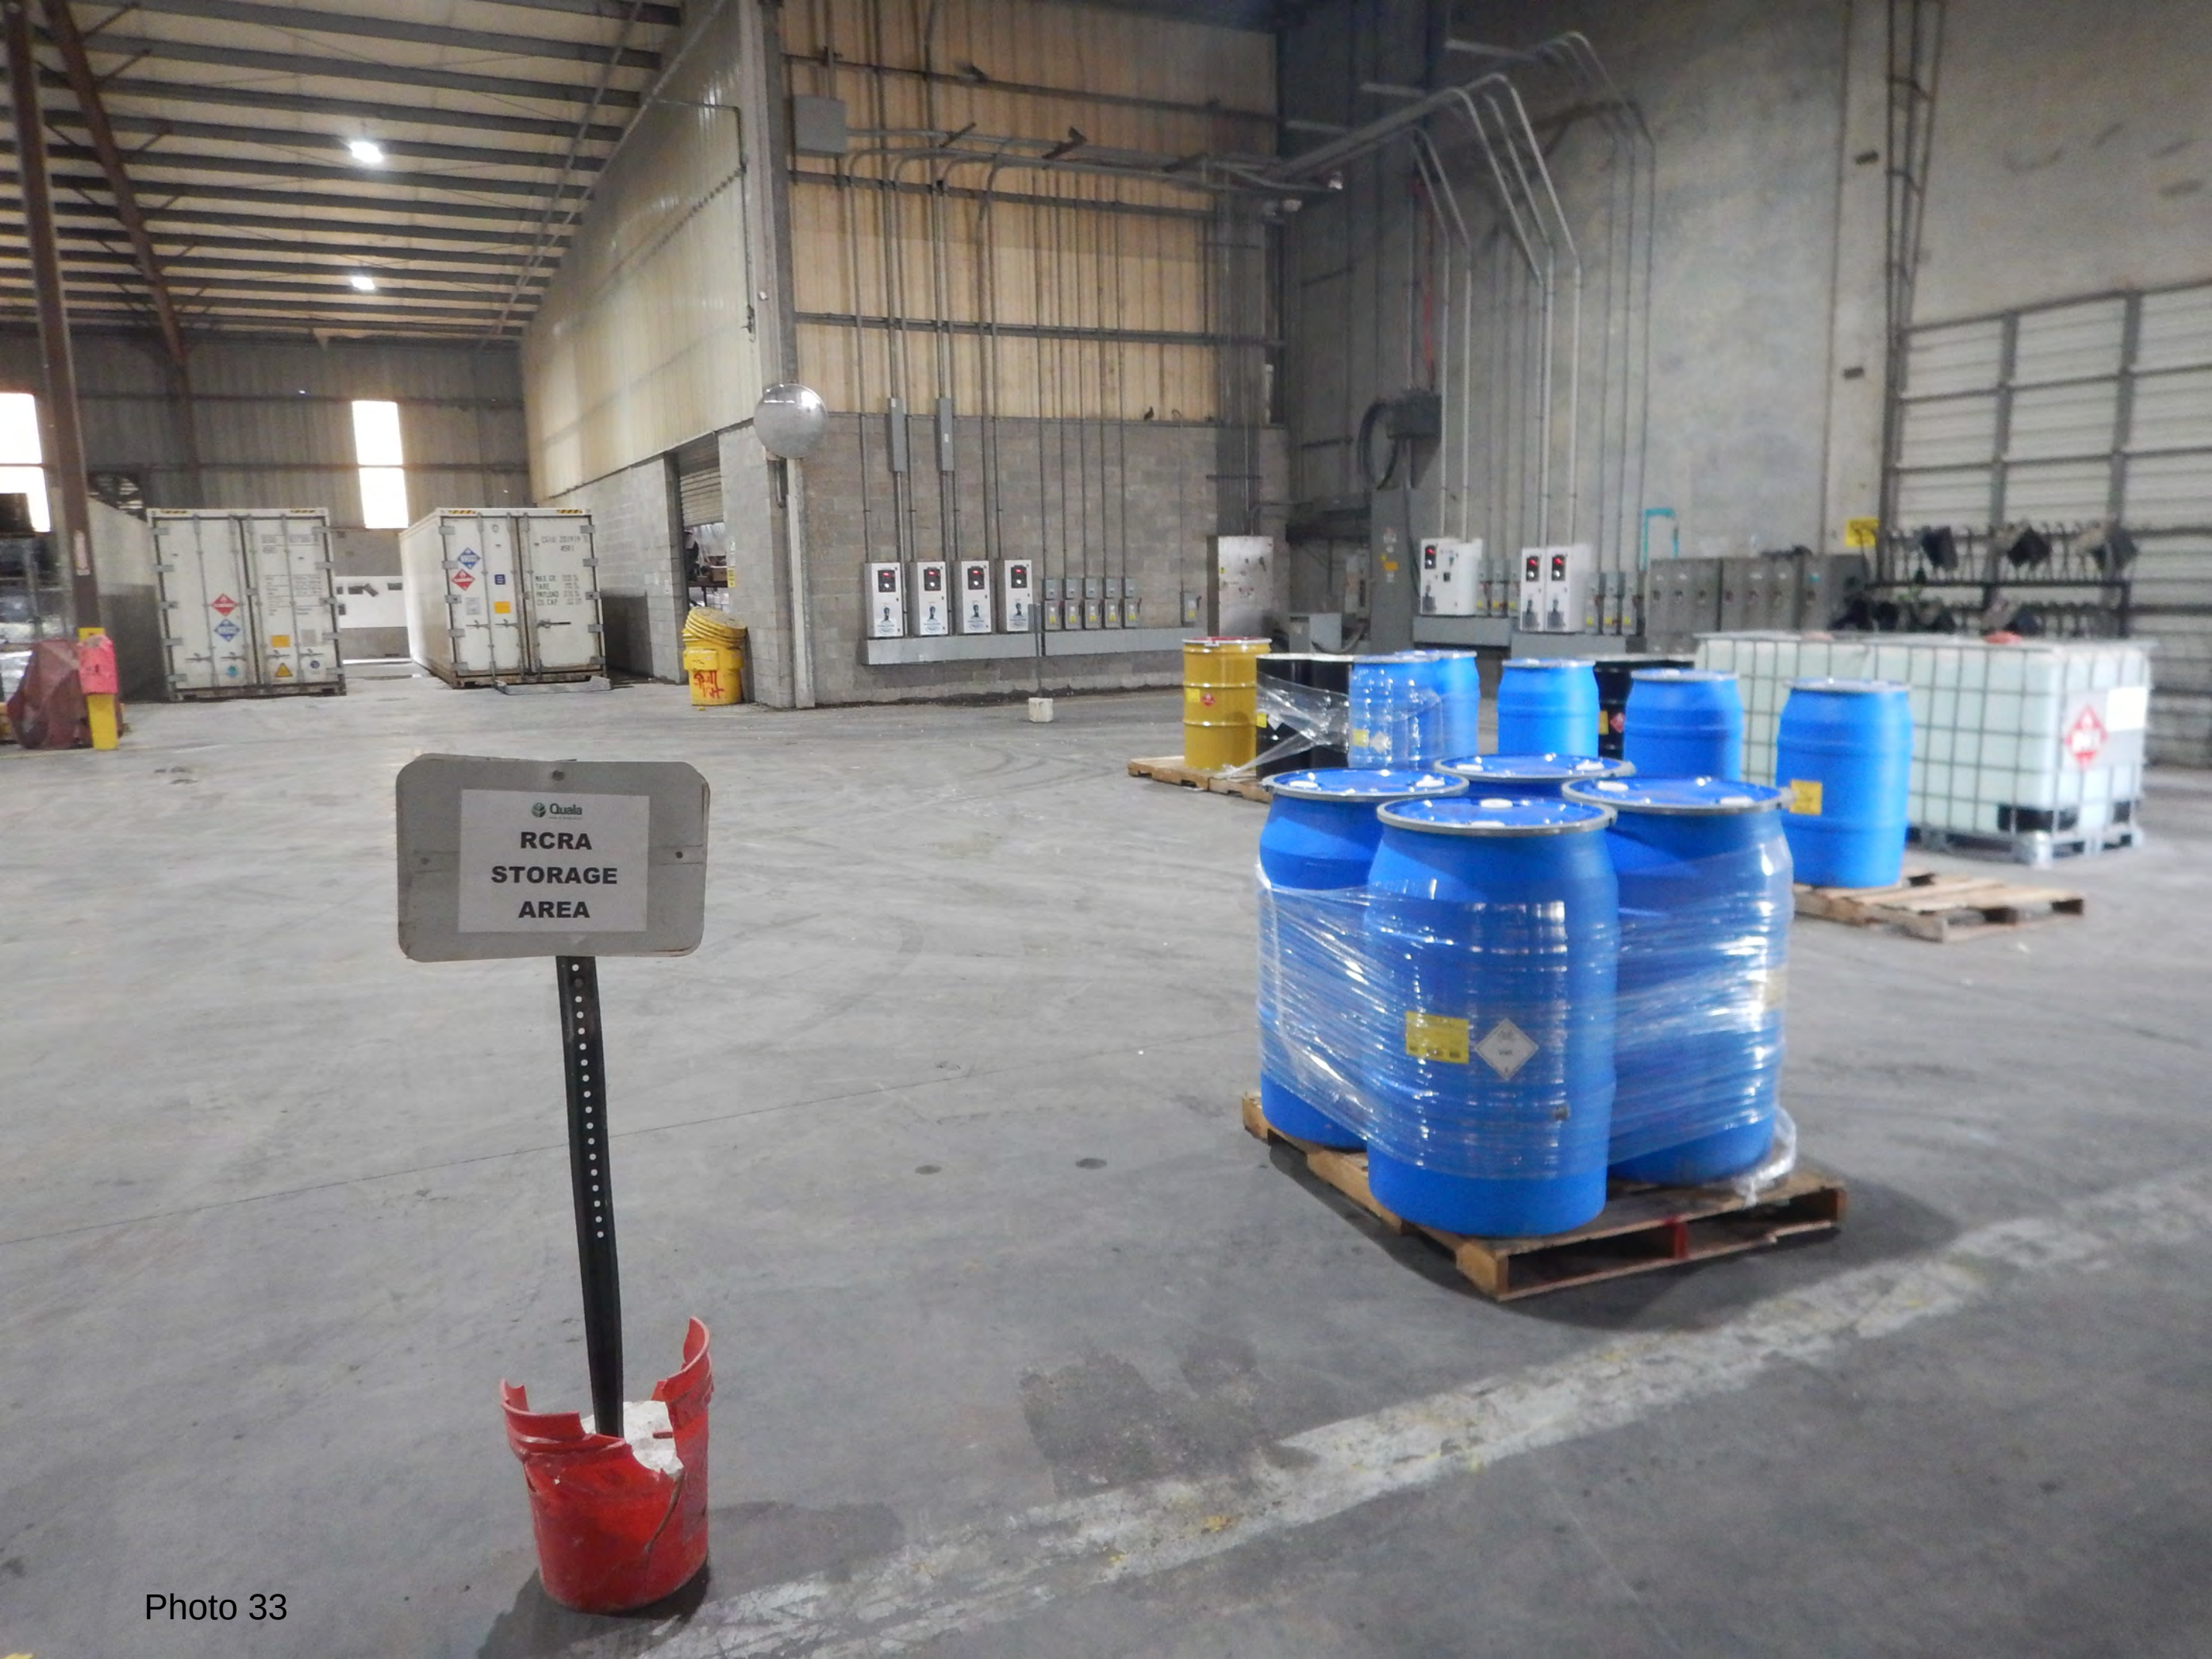
Photo 32

The hazardous waste generator standards require large quantity generators to protect hazardous waste containers from accidental release and generally operate their facility in a manner which minimizes the risk of fire or explosion. During this inspection, we observed that the facility has designated an area near high voltage electrical panels for the accumulation of flammable hazardous waste. See photos 32 and 33.

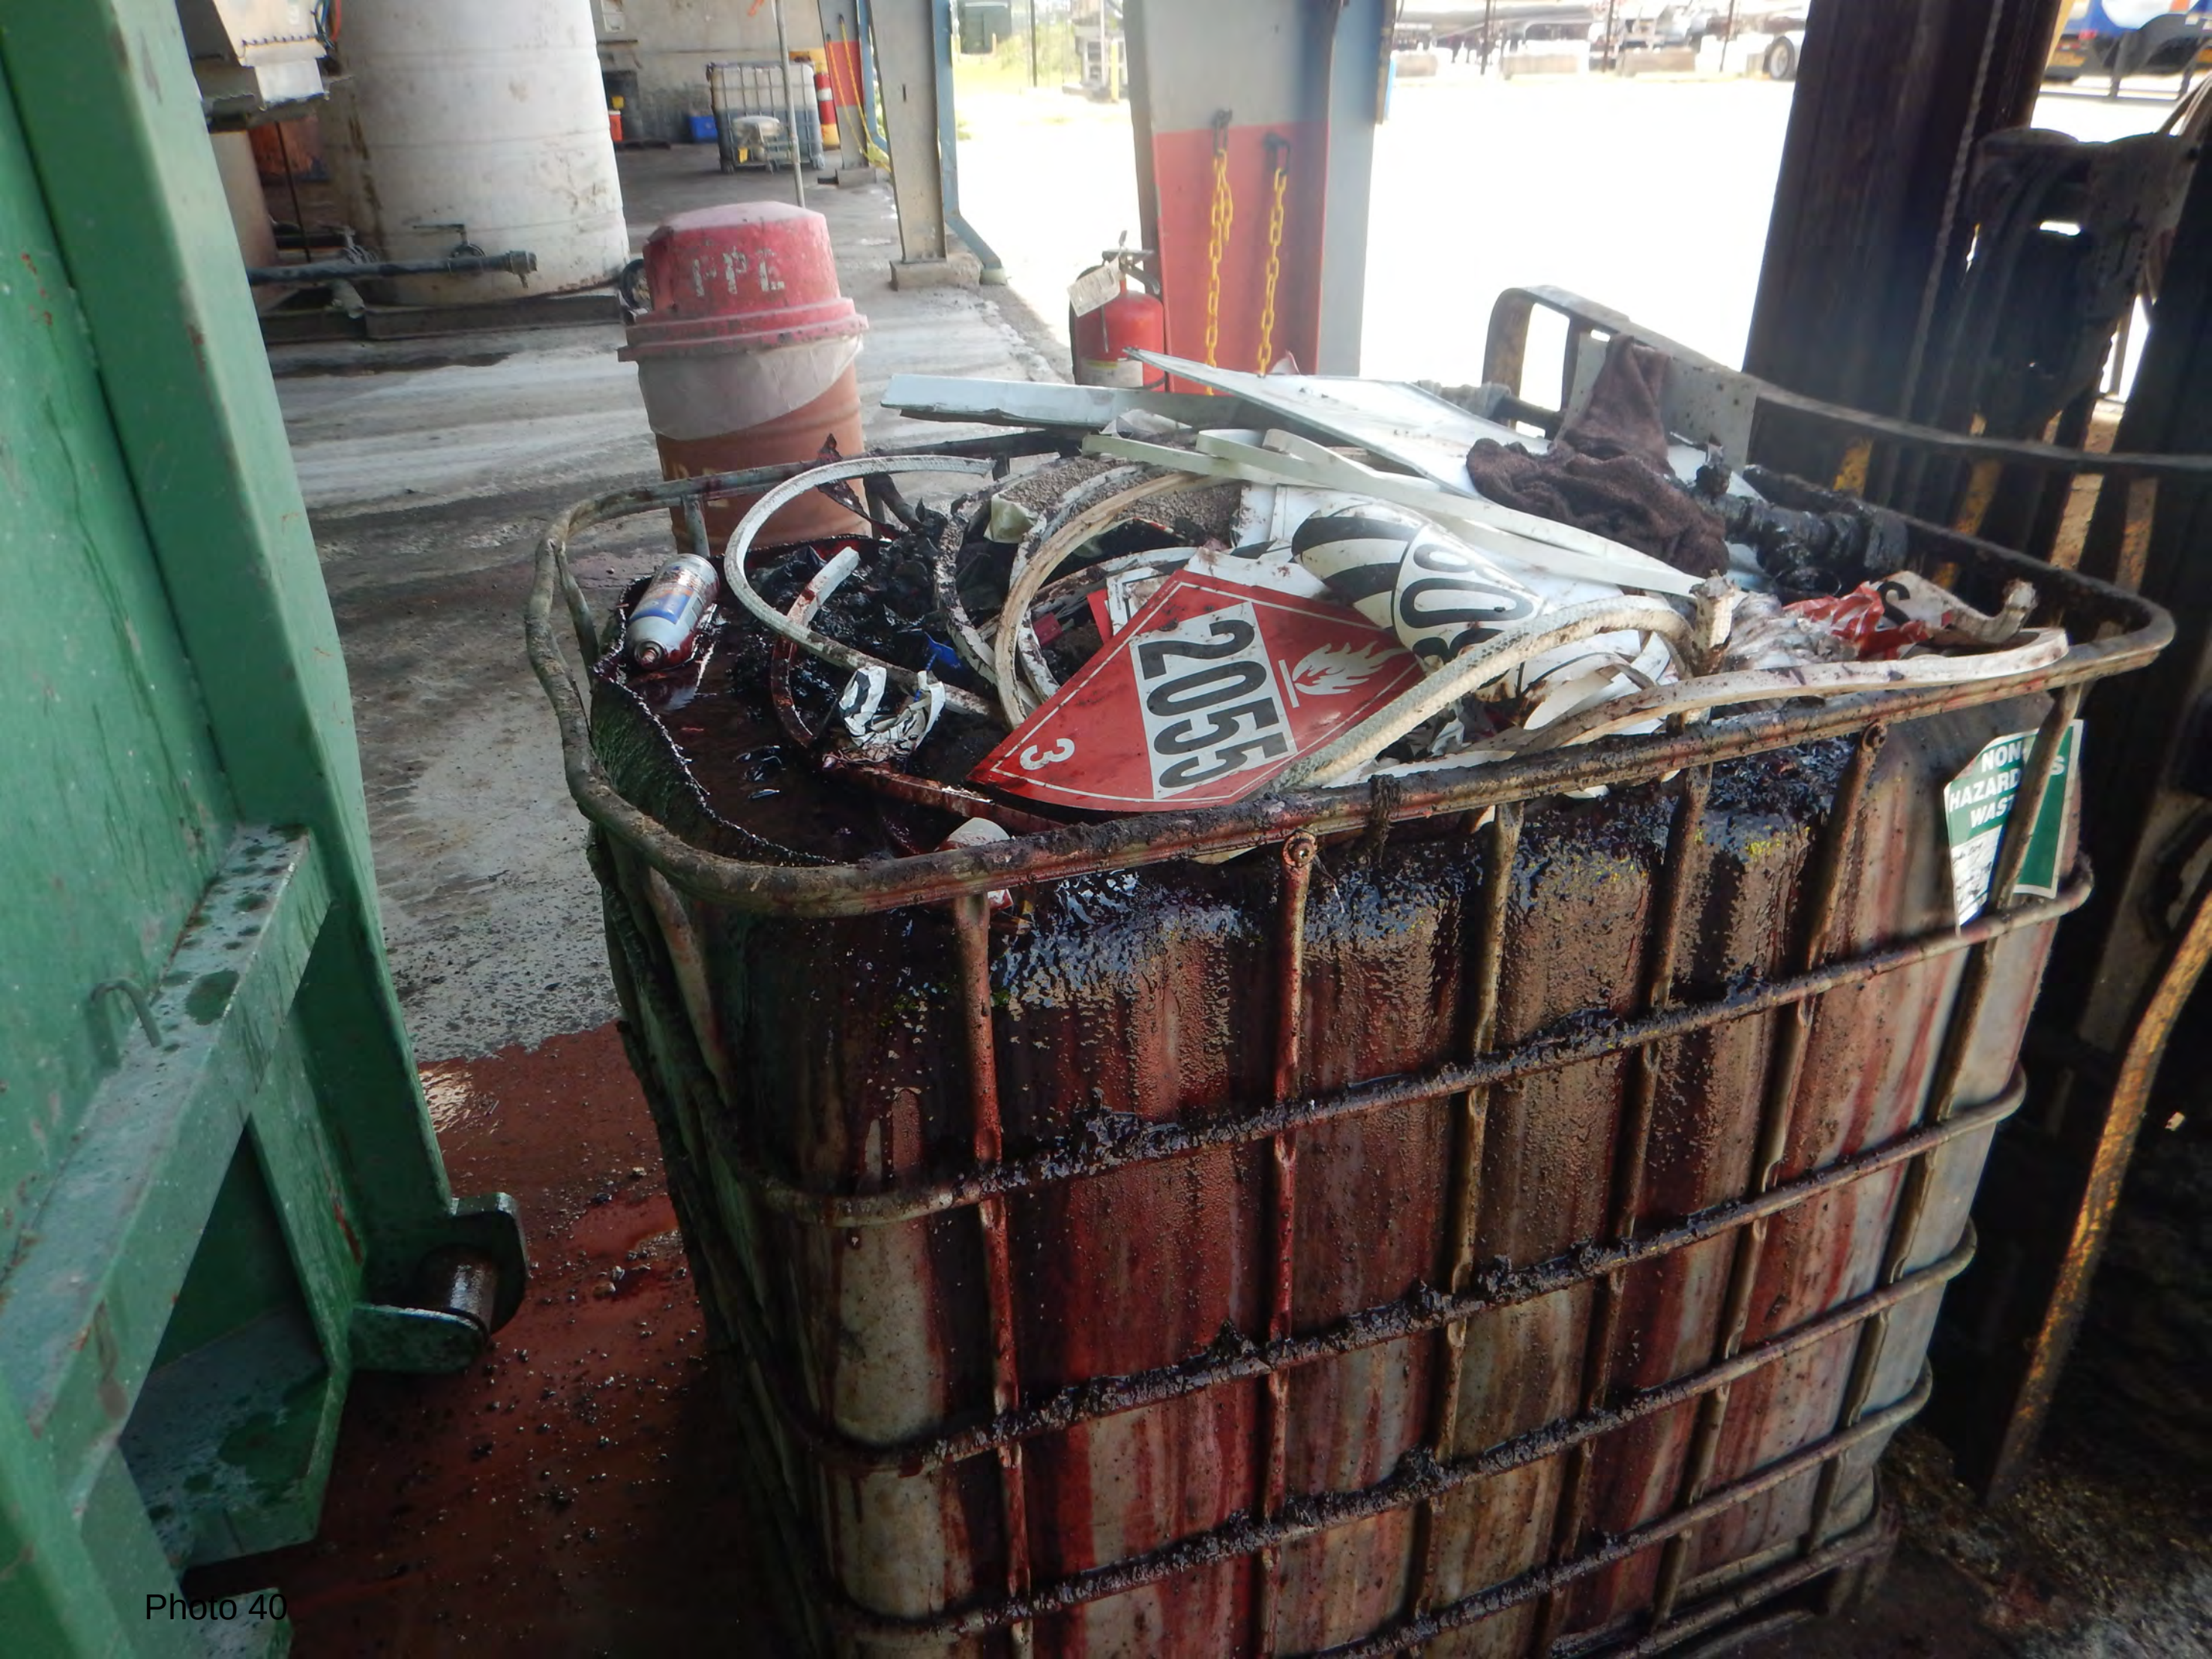
Photo 40

| Photo Number | File Name | | Date | Time | Photographer | Description |
|---|---|---|---|---|---|---|
| 40 | DSCN1098 | .JPG | 27-Jun-23 | 1046 | John Penland | Open container in the trailer wash area which is the source of the spill depicted by photo 39. |
