## **RCRA Inspection Report**

Cymer-Dayton LLC  
411 Manufacturers Road  
Dayton, Tennessee 37321  
Rhea County

EPA ID: TND981023674  
NAICS: 325199 - All Other Basic Organic Chemical  
Manufacturing

May 7, 2024, at 9:30 a.m. EDT

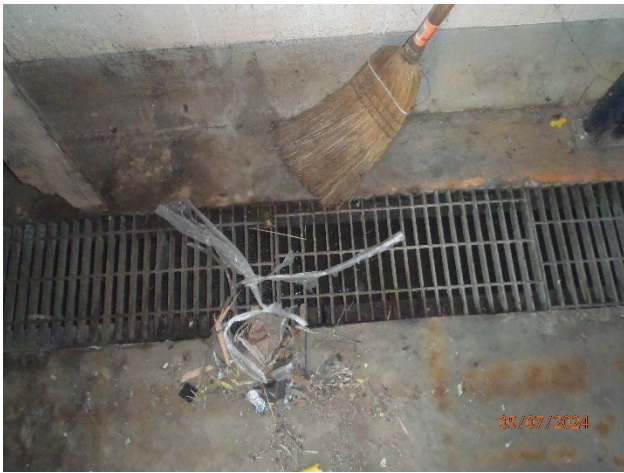
Picture 1 – Main Warehouse floor drain sump need pump out

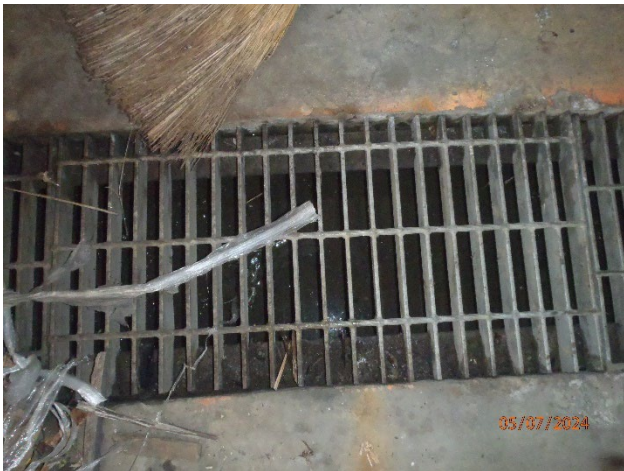
Picture 2 – Main Warehouse floor drain sump need pump out

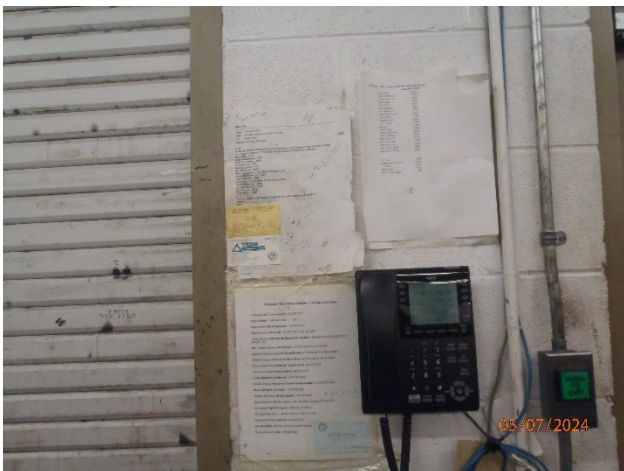
Picture 3 – Maintenance out of date emergency contact list

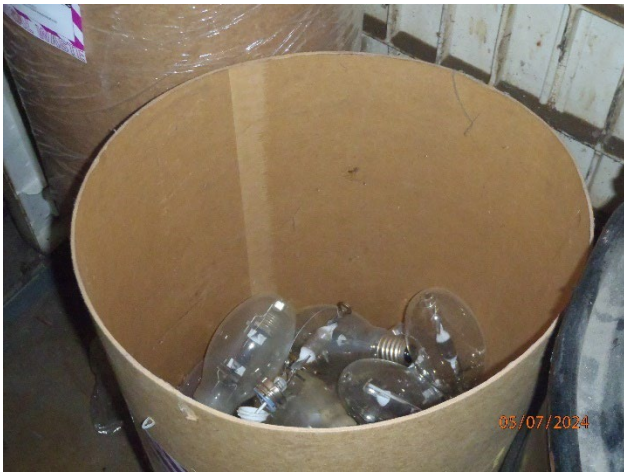
- x. Failure to close universal waste lamp containers:
  - A 4-foot box of universal waste lamps
  - A 3-foot fiberboard box of spent high intensity discharge lamps.

Picture 7 – Maintenance Universal Waste Storage open spent HID lamps

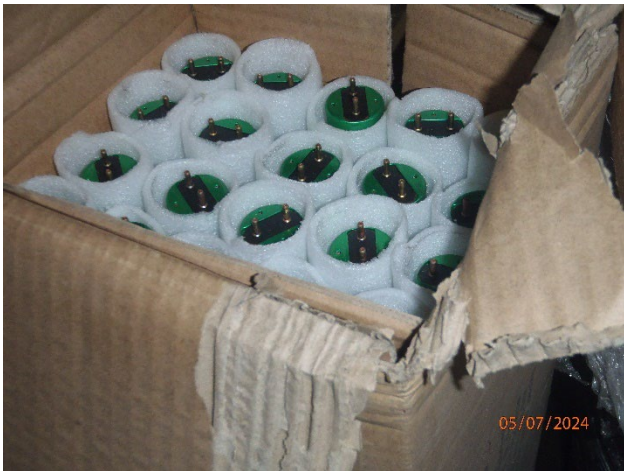
Picture 8 – Maintenance Universal Waste Storage open spent lamps

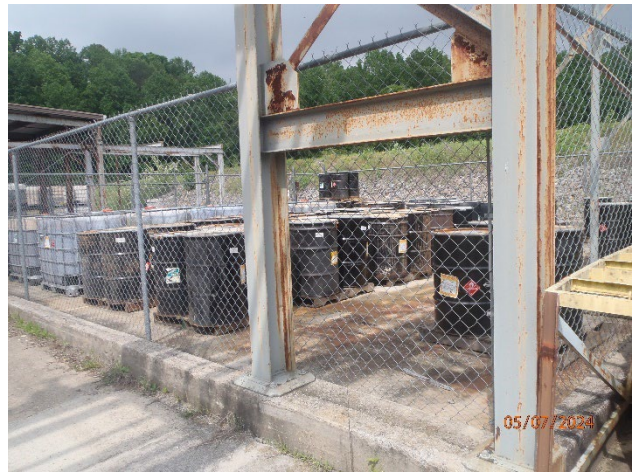
The central accumulation area (CAA) is a fenced in area with a locked gate (Pictures 10-12, 44). There is a ‘90 Day Hazardous Waste Storage Area’ sign near the gate (Picture 25). However, there were no ‘No Smoking’ signs posted along the fence. This is an area of concern.

Picture 10 – HWCAA no signs

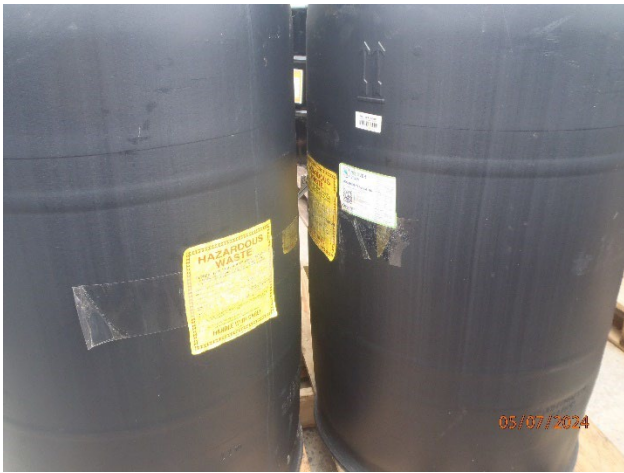
Picture 34 – HWCAA containers w/ damaged HW label

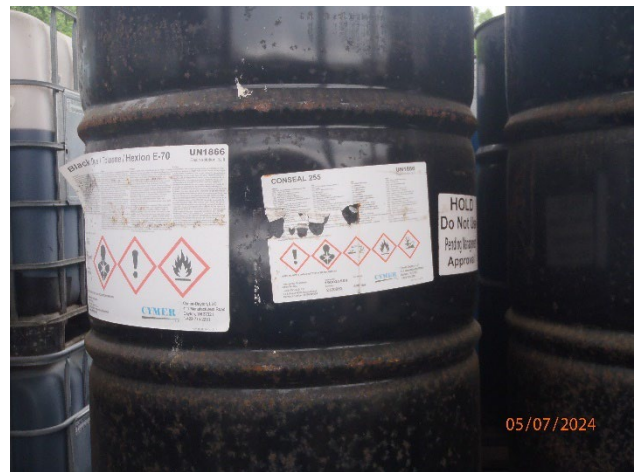
Next to the CAA was the flammable storage area (Picture 51). Facility representatives explained that product and raw material are stored in this area. The inspectors observed eight 55-gallon containers of black dye/toulene/Hexion E-70 resin solution (Pictures 48-49). On at least one of the containers, the inspectors observed a "REV. DATE 26-OCT-2017." Mr. Linn explained that the contents were off specification for the previous customer, but still viable. The containers of resin solution were marked as on 'Hold Do Not Use, Pending Management Approval'. Mr. Linn stated that the facility was currently negotiating with an auto racing company to purchase the resin solution. The condition of the containers and labels, in addition to the 10/26/2017 date, raises concerns about the length of time the containers have been stored. The inspectors

Picture 49 – Flammable Storage black dye/toluene resin solution

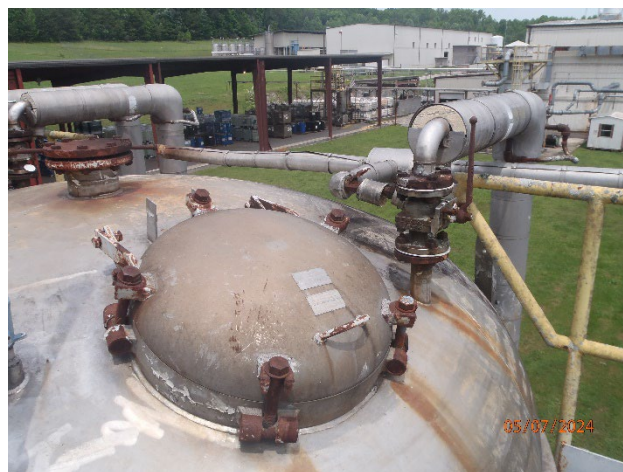
Picture 55 – Hazardous Waste T-61 missing BB tags

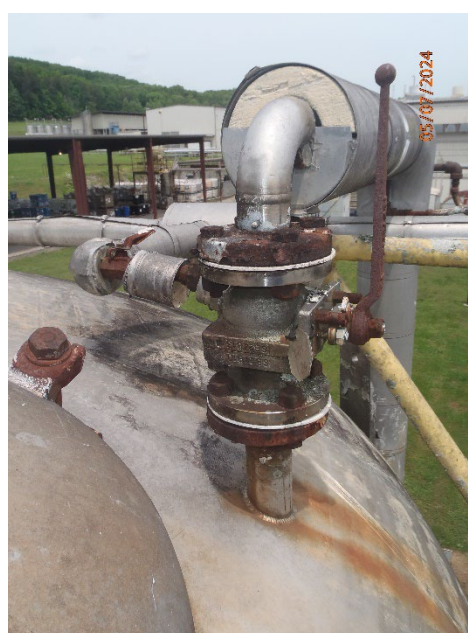
Picture 56 – Hazardous Waste T-61 missing BB tags

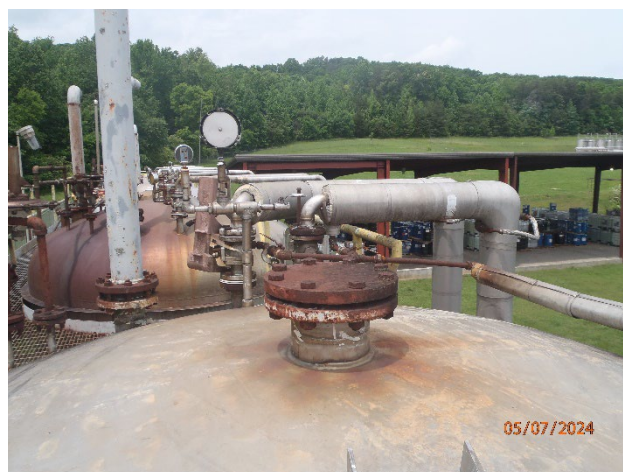
Picture 57 – Hazardous Waste T-61 missing BB tags

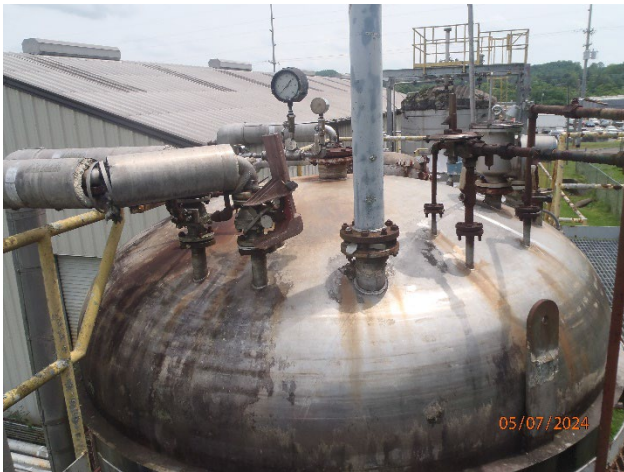
Picture 58 – Hazardous Waste T-61 missing BB tags

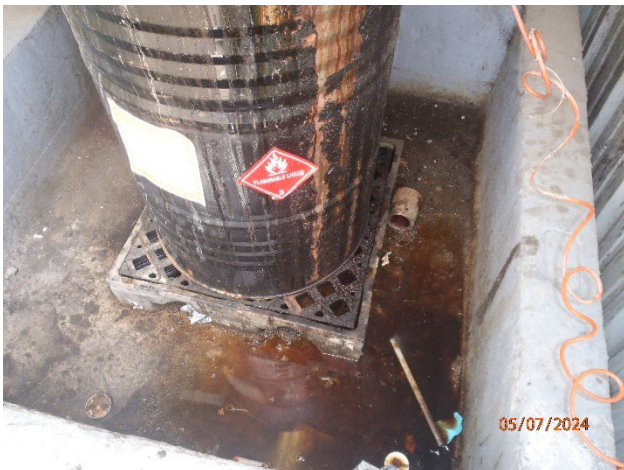
Picture 60 – Lab CAA secondary containment needs clean out

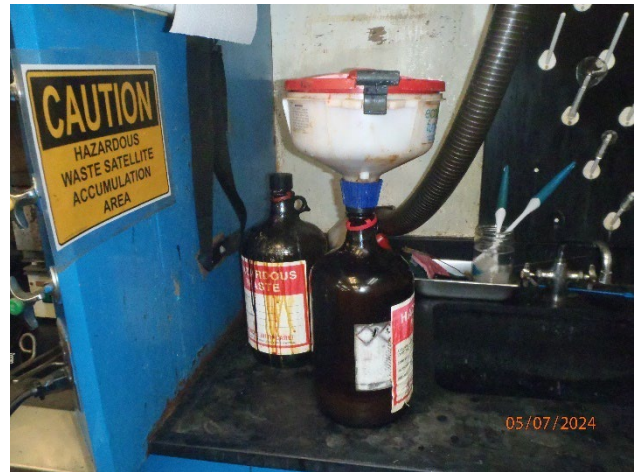
Picture 71 – Lab SAA containers

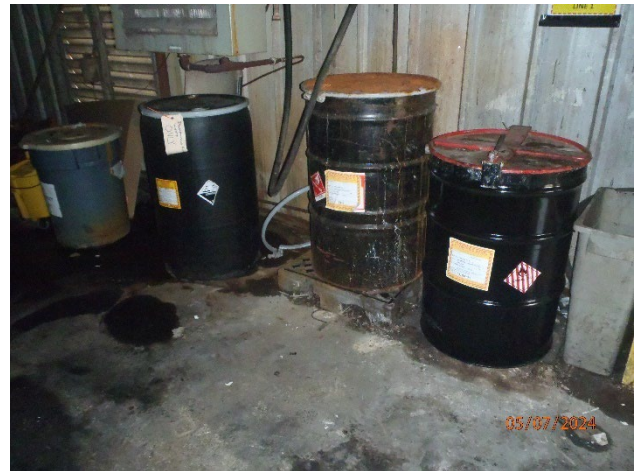
Flammable Liquid, D001, D035, F003, F005 (Picture 72). All containers were observed to be closed and labeled with indication of the hazards of the contents.

Picture 72 – Building 1 SAA

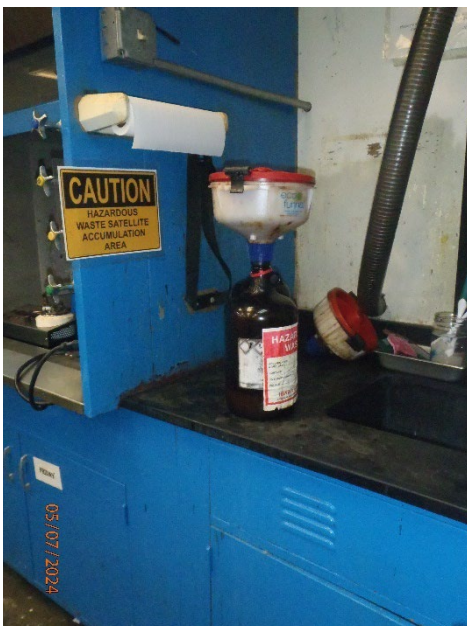
Picture 70 – Lab SAA containers

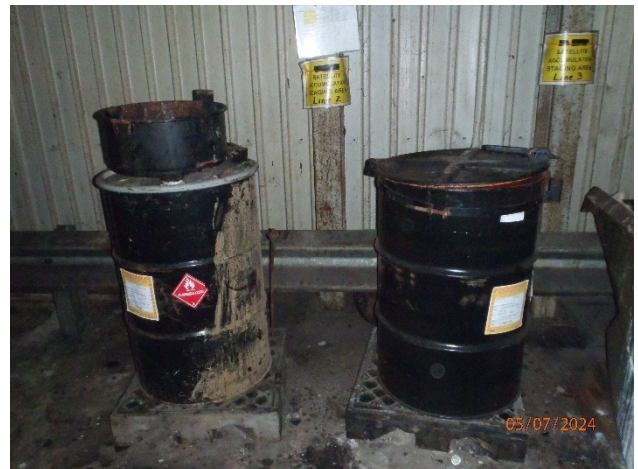
Picture 73 – Building 6 SAA open containers

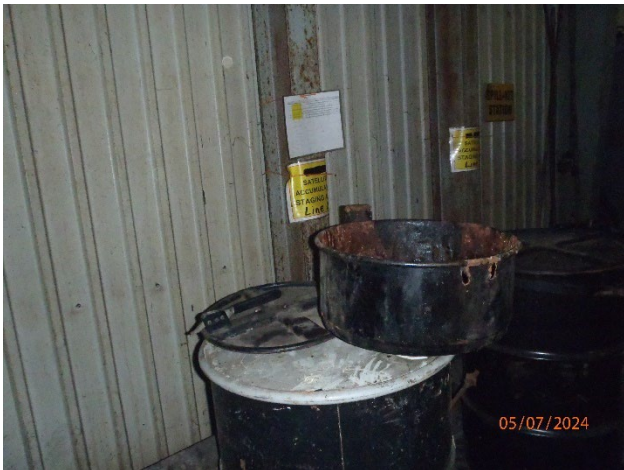
Picture 75 – Building 6 SAA open container

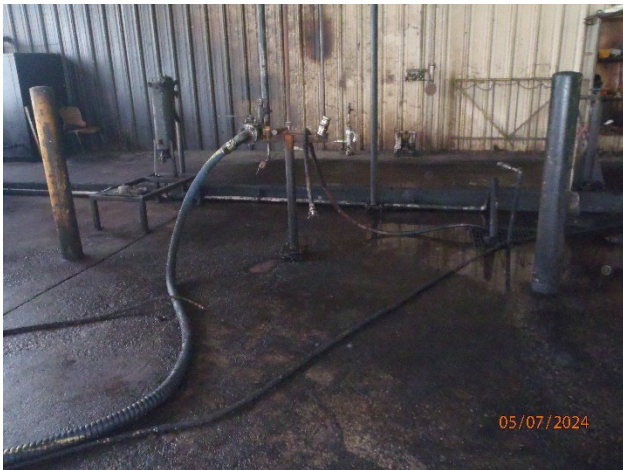
Picture 86 – Building 6 loading area with resin and water on ground

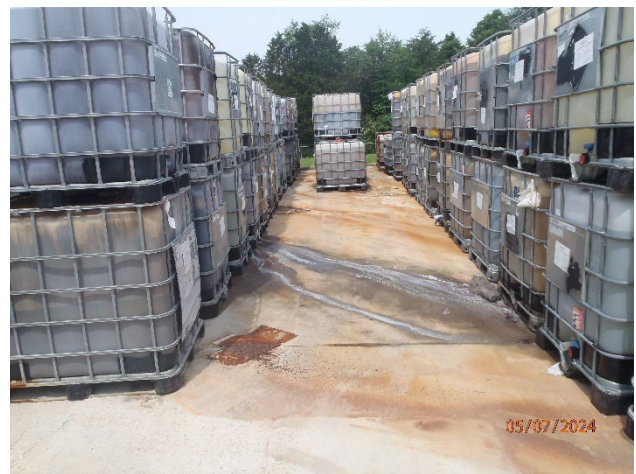
Picture 90 – Tanker Lot with clean out solvent release to ground

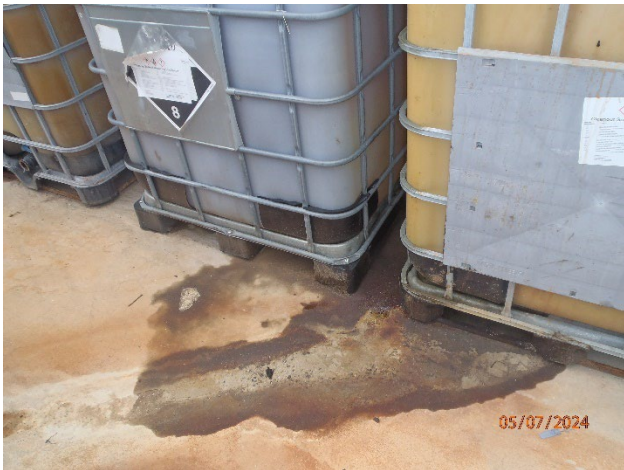
Picture 92 – Tanker Lot with clean out solvent release to ground
