## NPDES Compliance Inspection Report

**D. R. Johnson Lumber Co.**

**Permit # ORR221397**

**Inspection Date: January 26, 2021**

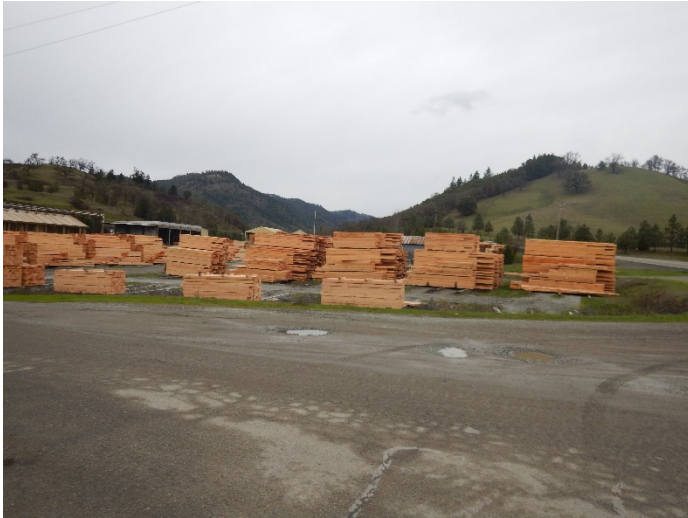
Photo #:01 (DSCN0493)

Description: Facing north, photo of storage area for milled lumber waiting to be sent to the planing mill.

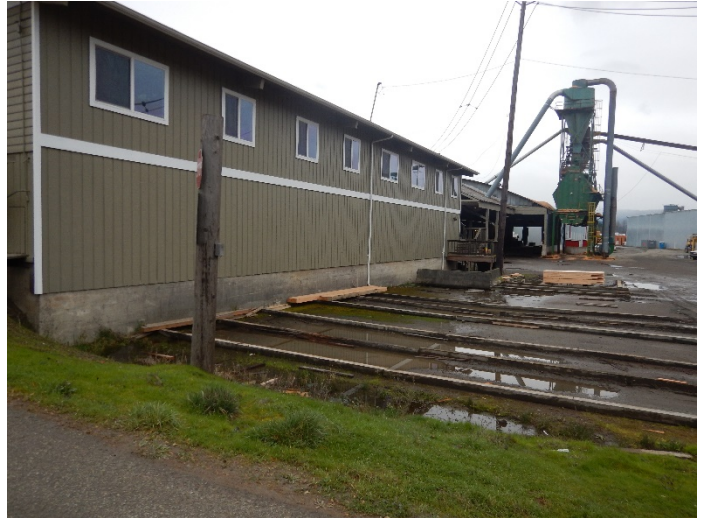
Photo #:02 (DSCN0494)

Description: Facing southwest, photo of log storage area called the “hot deck”.

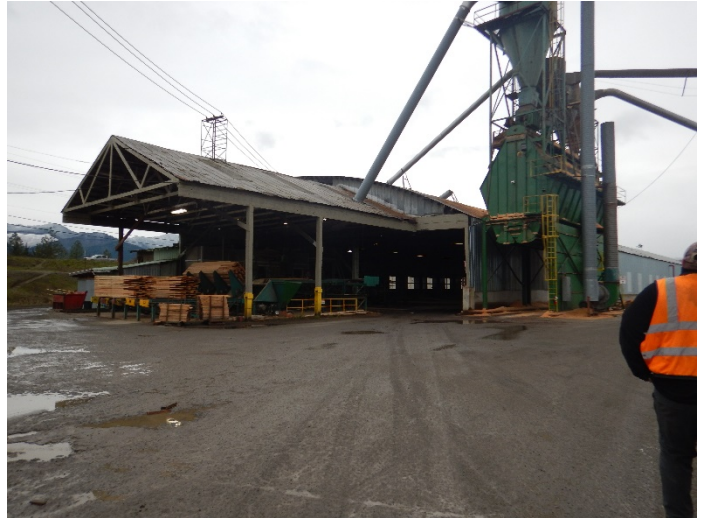
Photo #:04 (DSCN0496)

Description: Facing south, photo of planing mill.

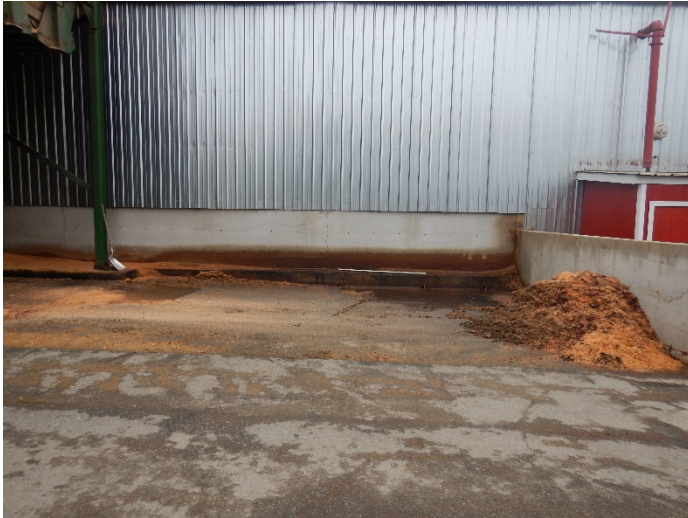
Photo #:05 (DSCN0497)

Description: Facing southeast, photo of shavings bin for the planing mill.

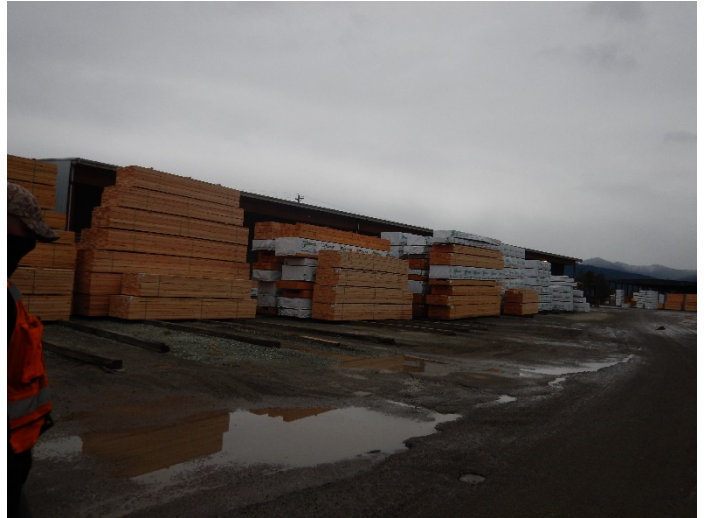
Photo #:06 (DSCN0498)

Description: Facing south, photo of finished lumber products.

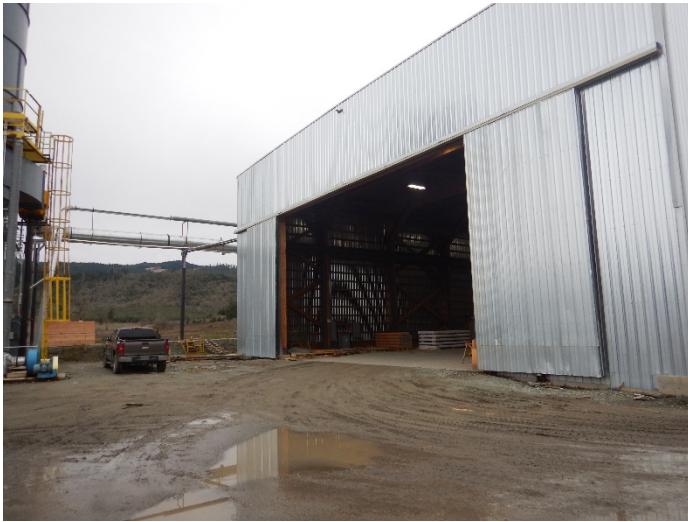
Photo #:07 (DSCN0499)

Description: Facing north, photo of Riddle Laminators building.

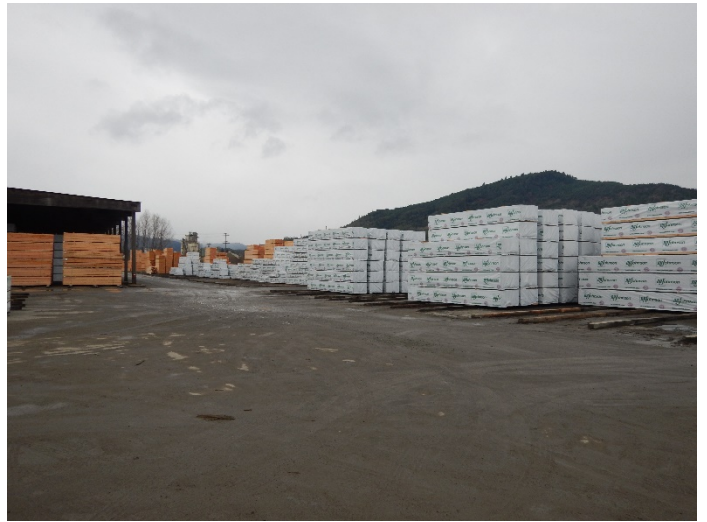
Photo #:08 (DSCN0500)

Description: Facing southwest, photo of finished lumber and structural beam products.

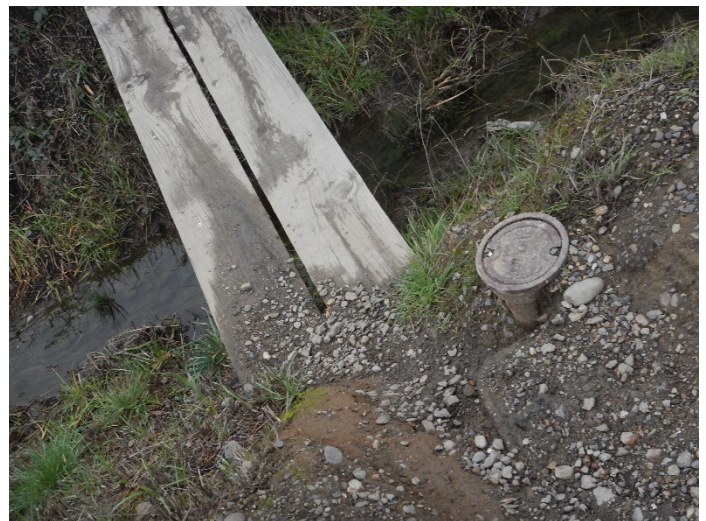
Photo #:16 (DSCN0508)

Description: Photo of an old water meter for the City of Riddle. Catwalk present over roadside drainage ditch leading to Outfall 003.

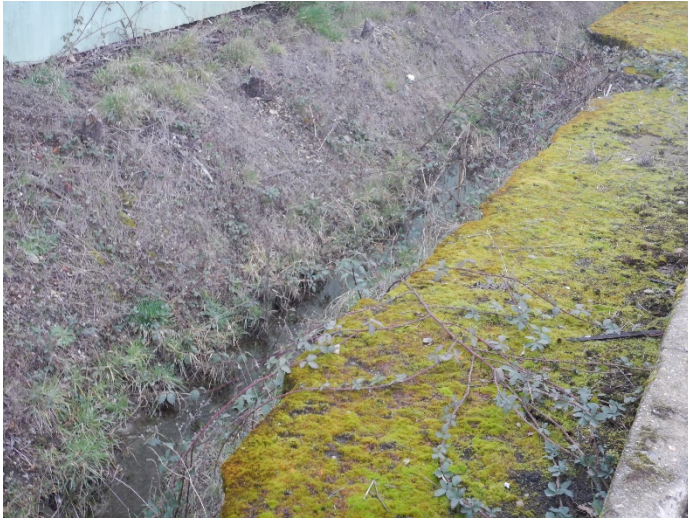
Photo #:17 (DSCN0509)

During my review of the facility, I noted the presence of a fair amount of litter and discarded items along the roadside ditch that ultimately contributes to Outfall 003. Mr. Blankenship picked up the trash that he could carry as we walked along the drainage ditch. I mentioned that regular litter pick-up was an important component of Good Housekeeping. He explained that he regularly picks up litter himself and instructs his employees to do the same when they see any, but that it’s difficult to

Description: Facing northeast, photo of the roadside drainage ditch leading to Outfall 003. Old moss-covered pavement present along the edge, between the Pruner road and the ditch.

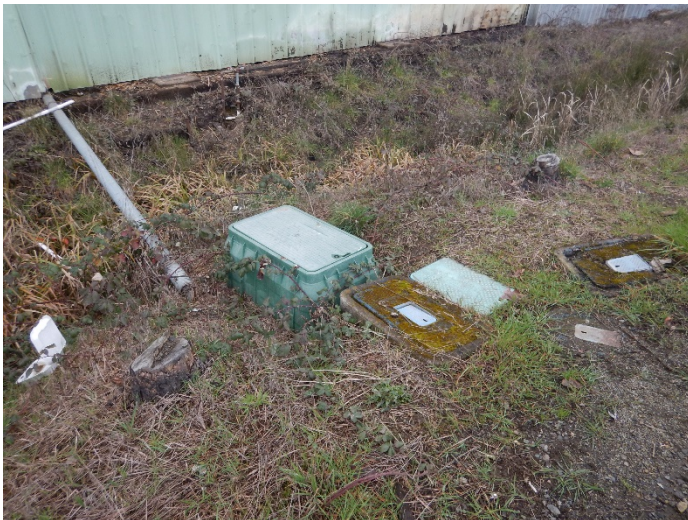
Photo #:19 (DSCN0511)

Description: Facing north, photo of the City of Riddle water valve for all of the on-site buildings.

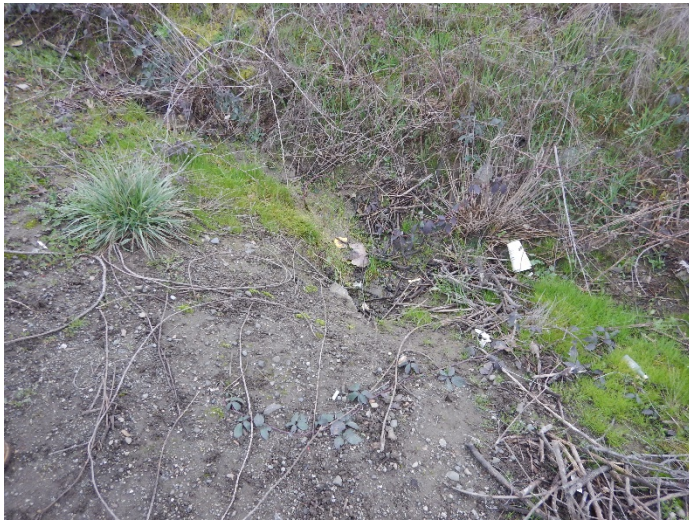
Photo #:21 (DSCN0513)

Description: Facing southeast, photo of the settling ditch on the opposite side of Pruner Road. According to facility representatives, stormwater does not leave this ditch. The land is owned by D.R. Johnson Lumber Co. and is considered part of the facility.

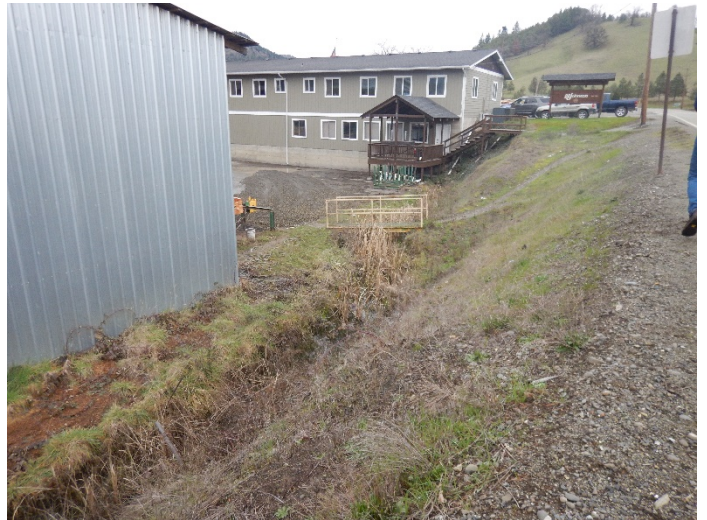
Photo #:22 (DSCN0514)

Description: Facing northeast, photo of the starting point of the roadside drainage ditch leading to Outfall 003.

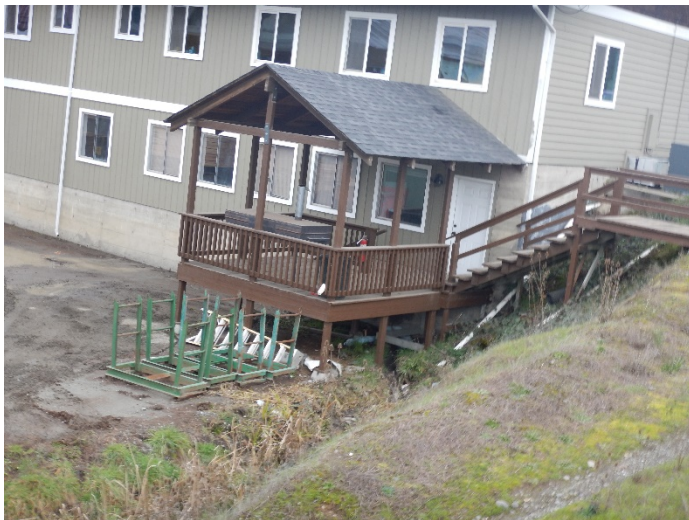
Photo #:23 (DSCN0515)

Description: Facing northeast, photo of the starting point of the roadside drainage ditch leading to Outfall 003. The ditch begins under the stairs of the office building.

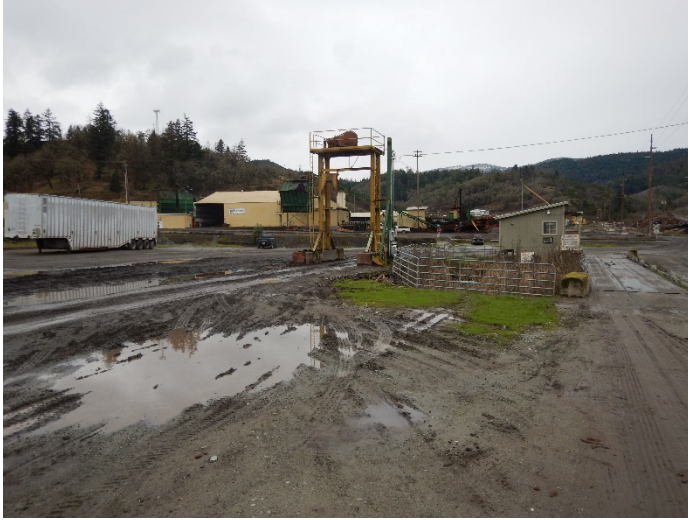
Photo #:25 (DSCN0517)

Description: Facing west, photo of the log scale, settling pond, and truck scale.

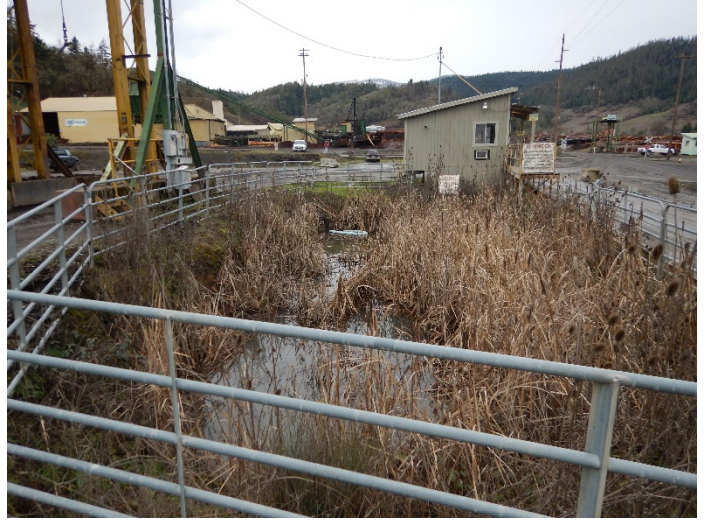
Photo #:26 (DSCN0518)

Description: Facing west, photo of the settling pond that drains into Outfall 001. The pond is cleaned out every other year.

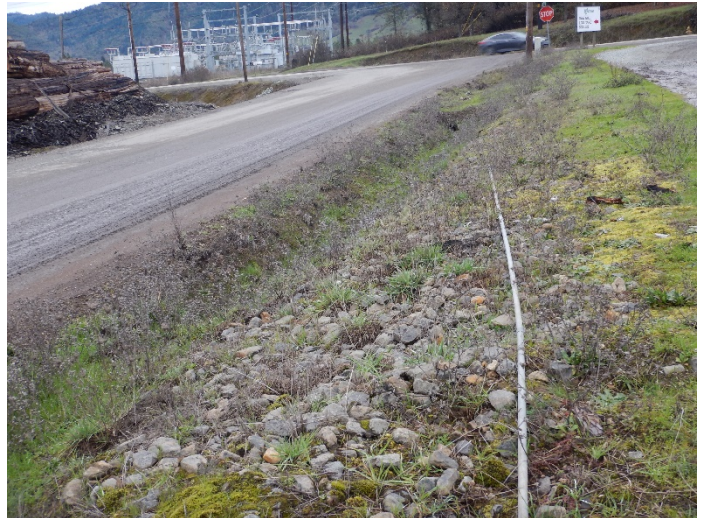
Photo #:28 (DSCN0520)

keep up with the sheer quantity of trash left behind by people who drive and walk on Pruner Road. I noted a similar issue with the drainage ditch leading to Outfall 001, alongside Boyer Road. He stated that he would put forth greater effort to exhibit Good Housekeeping following the inspection.

Description: Facing east, photo of the drainage ditch leading away from Outfall 001.

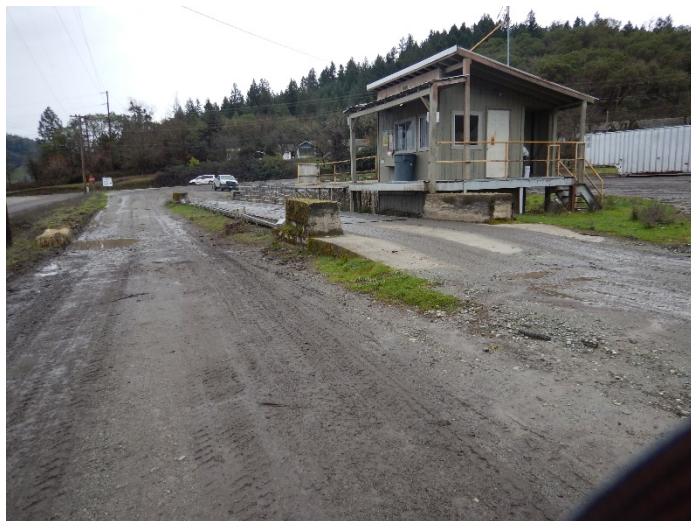
Photo #:32 (DSCN0524)

Description: Facing east, photo of truck scale.

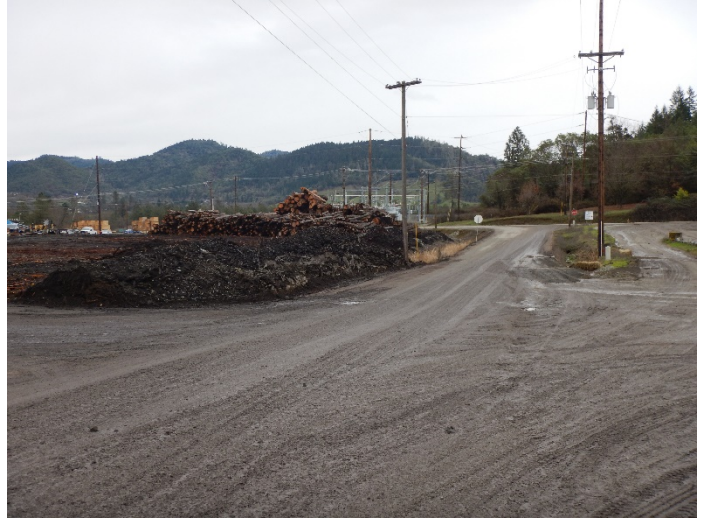
Photo #:34 (DSCN0526)

Description: Facing east, photo of C&D Lumber stock piles along Boyer Road.

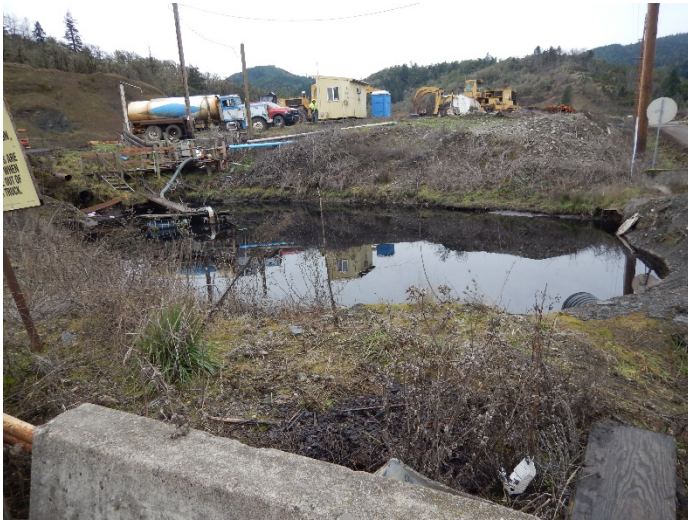
Photo #:37 (DSCN0529)

Description: Facing west, photo of log irrigation pond. Water is pumped from this pond to be sprayed onto logs stored in the log yard.

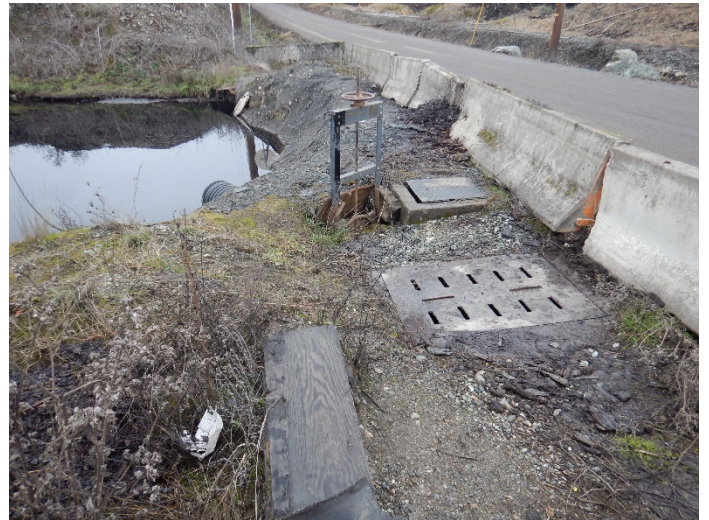
Photo #:38 (DSCN0530)

Description: Facing northwest, photo of gate and catch basin. The water from the irrigation pond is routed to the catch basin prior to discharge from Outfall 002. Stormwater samples are taken here.

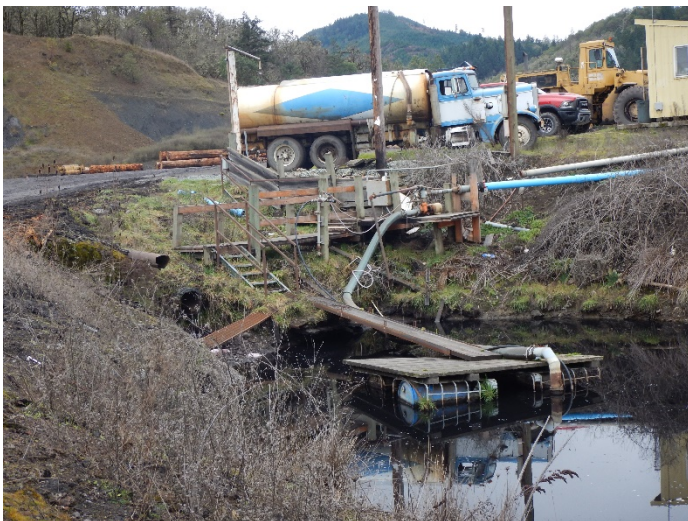
Photo #:39 (DSCN0531)

Description: Facing west, photo of pump system for irrigation pond. The log yard stormwater is routed back into the pond via the drains on the left.

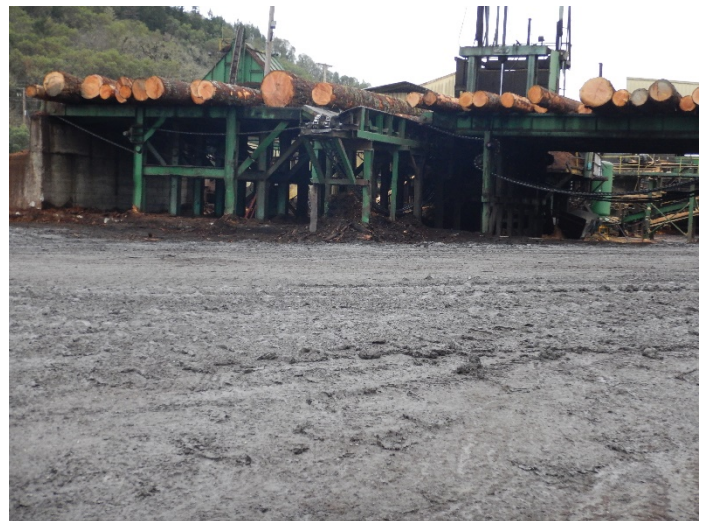
Photo #:40 (DSCN0532)

Description: Facing south, photo of the sawmill.

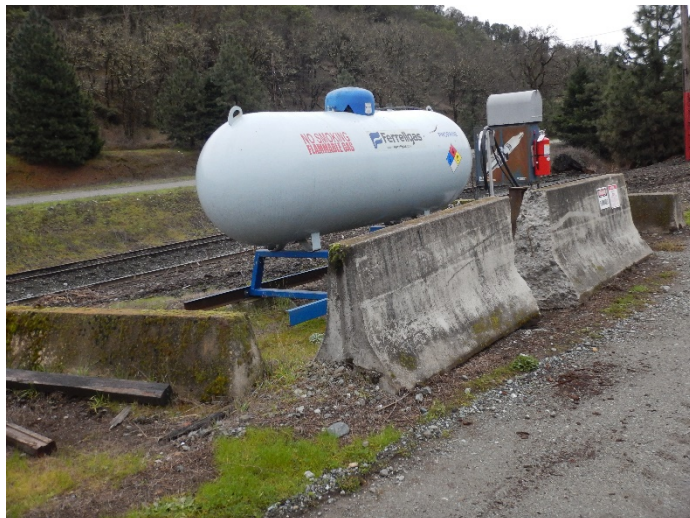
Photo #:42 (DSCN0534)

Description: Facing southeast, photo of the propane tank near the maintenance shed and sawmill area.

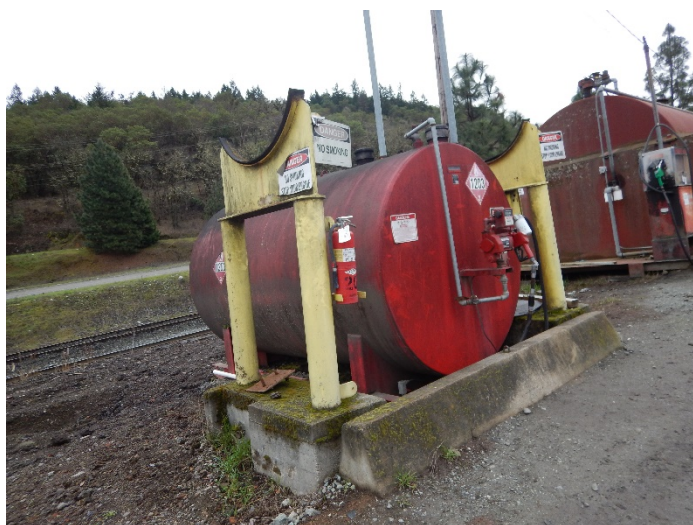
Photo #:43 (DSCN0535)

Description: Facing southeast, photo of the double-walled gasoline tank used for refueling on-site equipment and vehicles. Log trucks are fueled off-site.

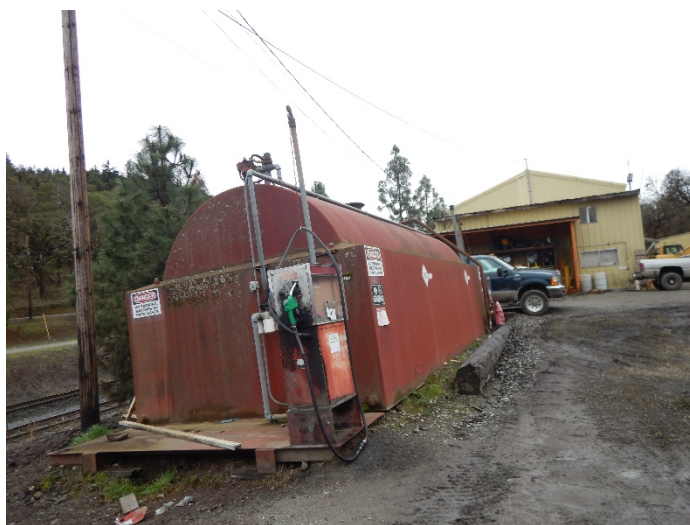
Photo #:44 (DSCN0536)

Description: Facing south, photo of double-walled diesel tank used for refueling on-site equipment and vehicles. Log trucks are fueled off-site.

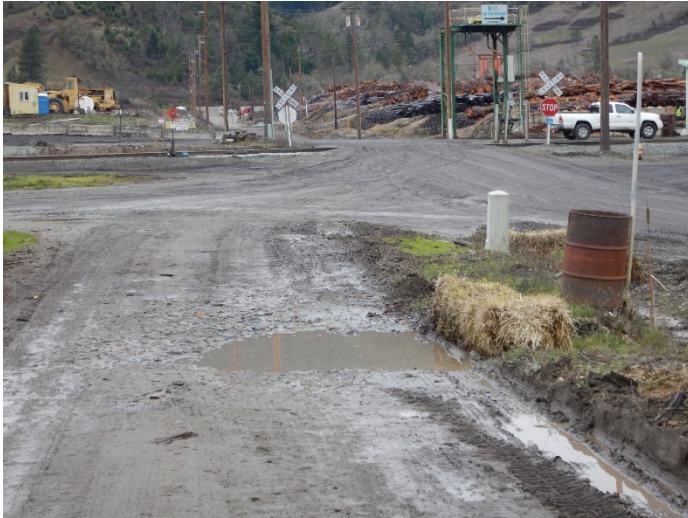
Photo #:45 (DSCN0537)

Description: Facing northwest, photo of straw bale used as a BMP for pooling stormwater near Outfall 001.
