# NPDES Compliance Inspection Report

## Quinault National Fish Hatchery

**NPDES Permit Tracking Number  
# WAG130005**

**Inspection Date: July 28, 2023**

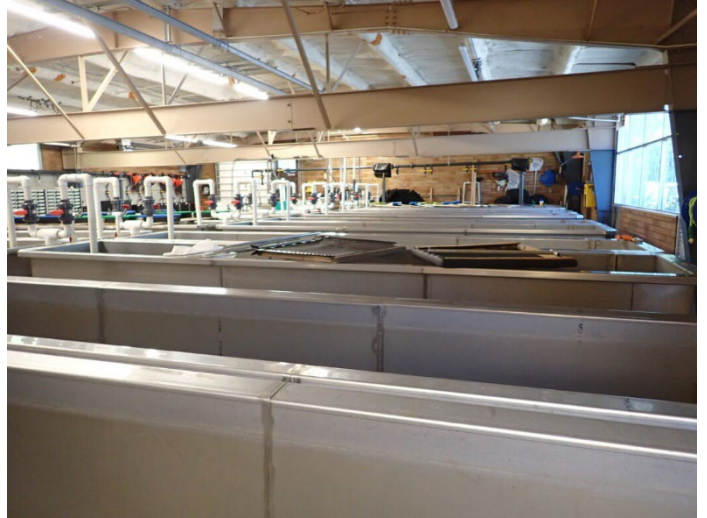
Photo #:09 (P7280246)

Description: Facing east, photo of the adult pond raceways, some of which had coho salmon and steelhead trout in them.

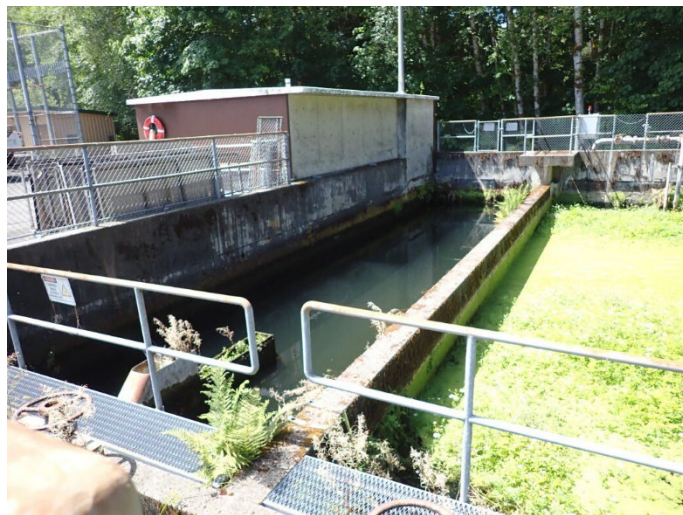
Photo #:13 (P7280265)

Next to the spawning building was an area the Facility calls “E Bank” containing six dual purpose ponds that can hold both adult and juvenile fish (**Photo 13**). Cleaning in these ponds is conducted three times per week using a pump, and cleaning water is pumped into the Facility’s inline settling basin located adjacent to “E Bank”. I observed growth in the inline settling basin in which the Facility planned to clean (**Photo 14**). Drawdown effluent of the inline settling basin is pumped to one of the sludge lagoons.

Description: Facing south, photo of the Facility's "E Bank" of six dual use holding ponds. At the time of inspection, these ponds contained juvenile fish.

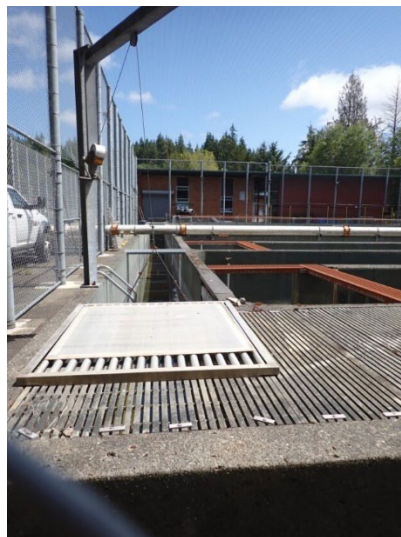
Photo #:17 (P7280281)

Description: Facing northwest and looking down, photo of the Facility's fish ladder that leads to the spawning building. This fish ladder does not contain any boards.

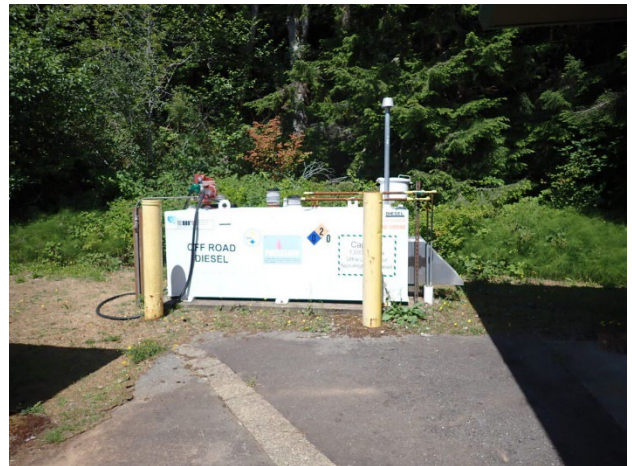
Photo #:23 (P7280294)

Description: Facing northwest, photo of the Facility's diesel and gas station used to fuel vehicles and small gas-or diesel-powered equipment.
