## **RCRA Inspection Report**

Bonnell Aluminum, Inc.  
State Highway 53  
Carthage, Tennessee 37030

EPA ID#: TND047000898  
NAICS #: 331314 – Secondary smelting and  
Alloying of Aluminum

May 9, 2024, 9:36 AM

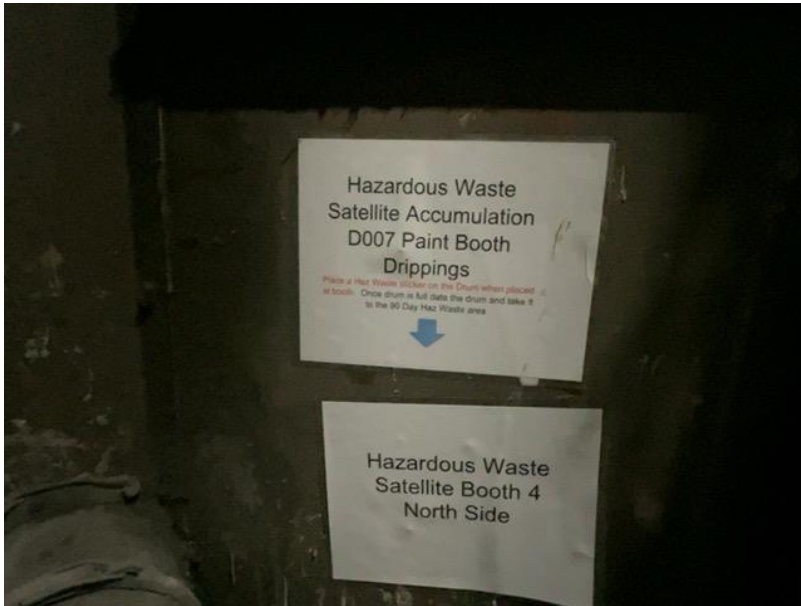
exhibits the hazardous characteristic of toxicity for chromium. Inspectors observed a 55-gallon SAA container of hook ash in this area labeled “Hazardous Waste” (Photo 10). The word toxic was marked on the label, but facility representatives informed inspectors they would add a placard for clearer indication.

Photo 10 – SAA container for hook ash generated in the paint line.

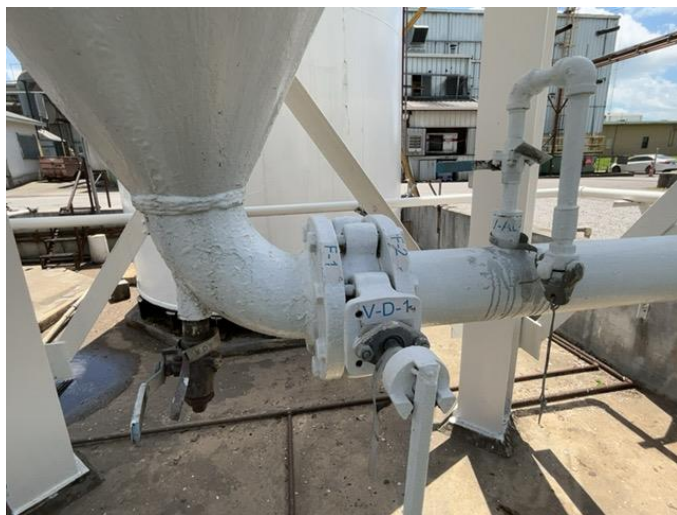
Photo 16 – Hazardous waste solvent tank. This tank was marked with an NFPA diamond on the other side.

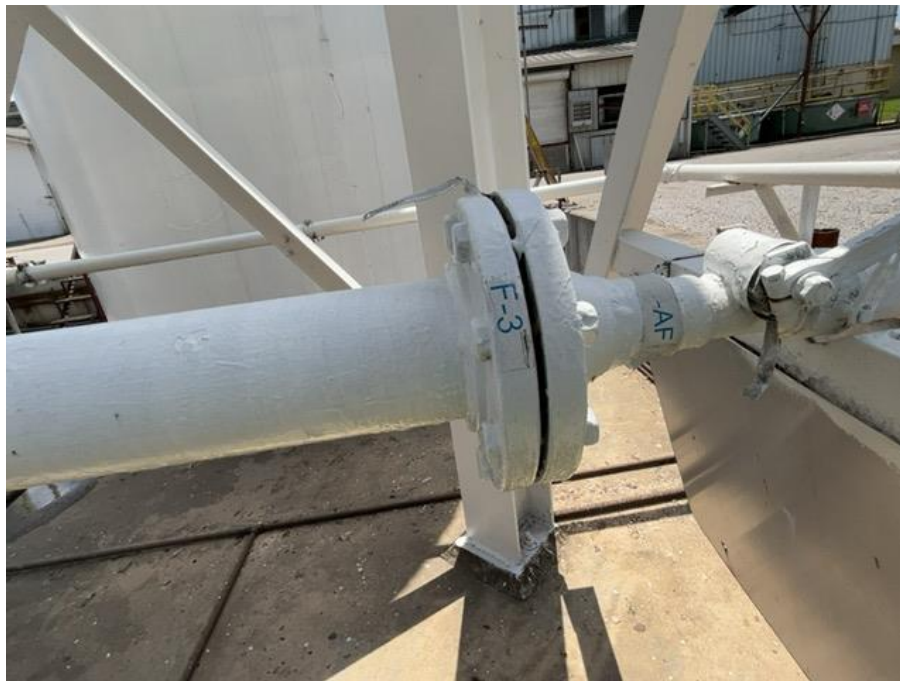
Photo 17 – BB equipment tagging on the hazardous waste tank equipment
