**Region 6 - Enforcement & Compliance Assurance Division**  
**INSPECTION REPORT**

| Inspection Date(s): | 09/13/2022 | |
| Company Name: | <b>Laguna Development Corporation</b> | |
| Facility Name: | <b>Casa Blanca Wastewater Treatment Plant (WWTP)</b> | |

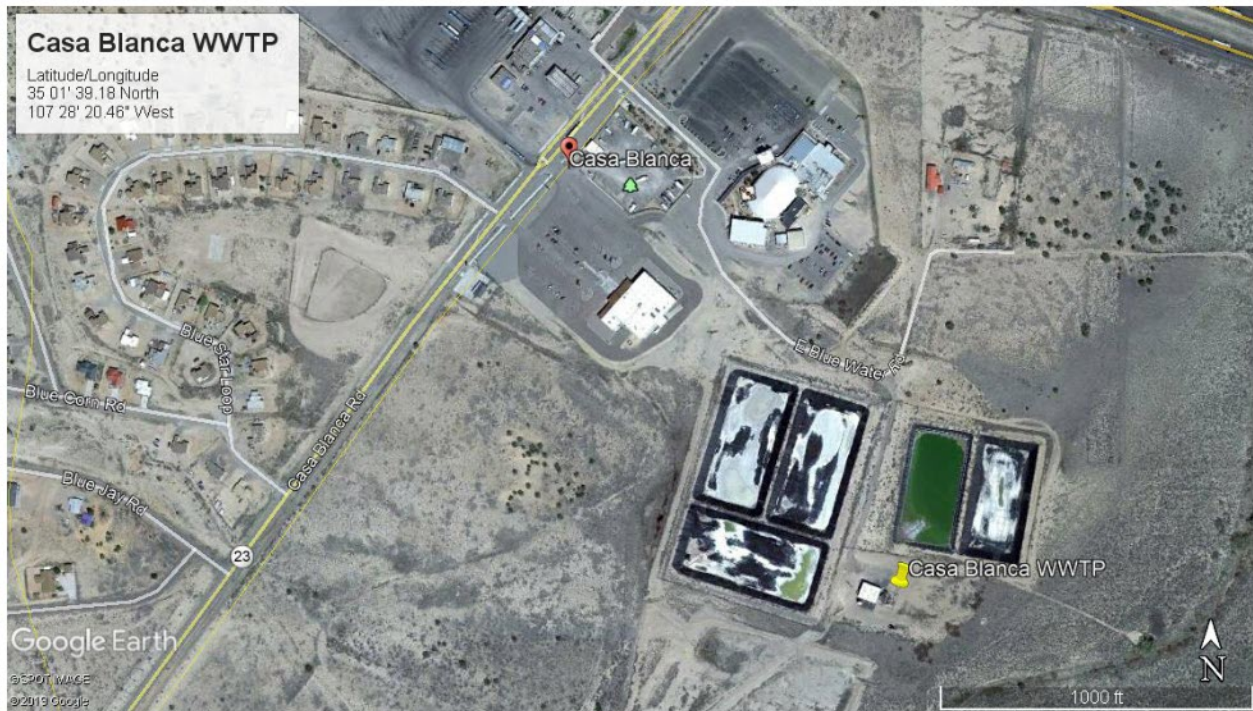
**Aerial Image #1:** Overall view of the Laguna Development Corporation- Casa Blanca Wastewater Treatment Plant location. Note: the evaporative lagoon cells. Aerial from Google Earth Maps.
