Region 10 Enforcement and Compliance Assurance Division

**INSPECTION REPORT**

| <b>Regulatory Program:</b> | CWA NPDES/Industrial Stormwater | |
| <b>Facility Name:</b> | Maddens Facility | |

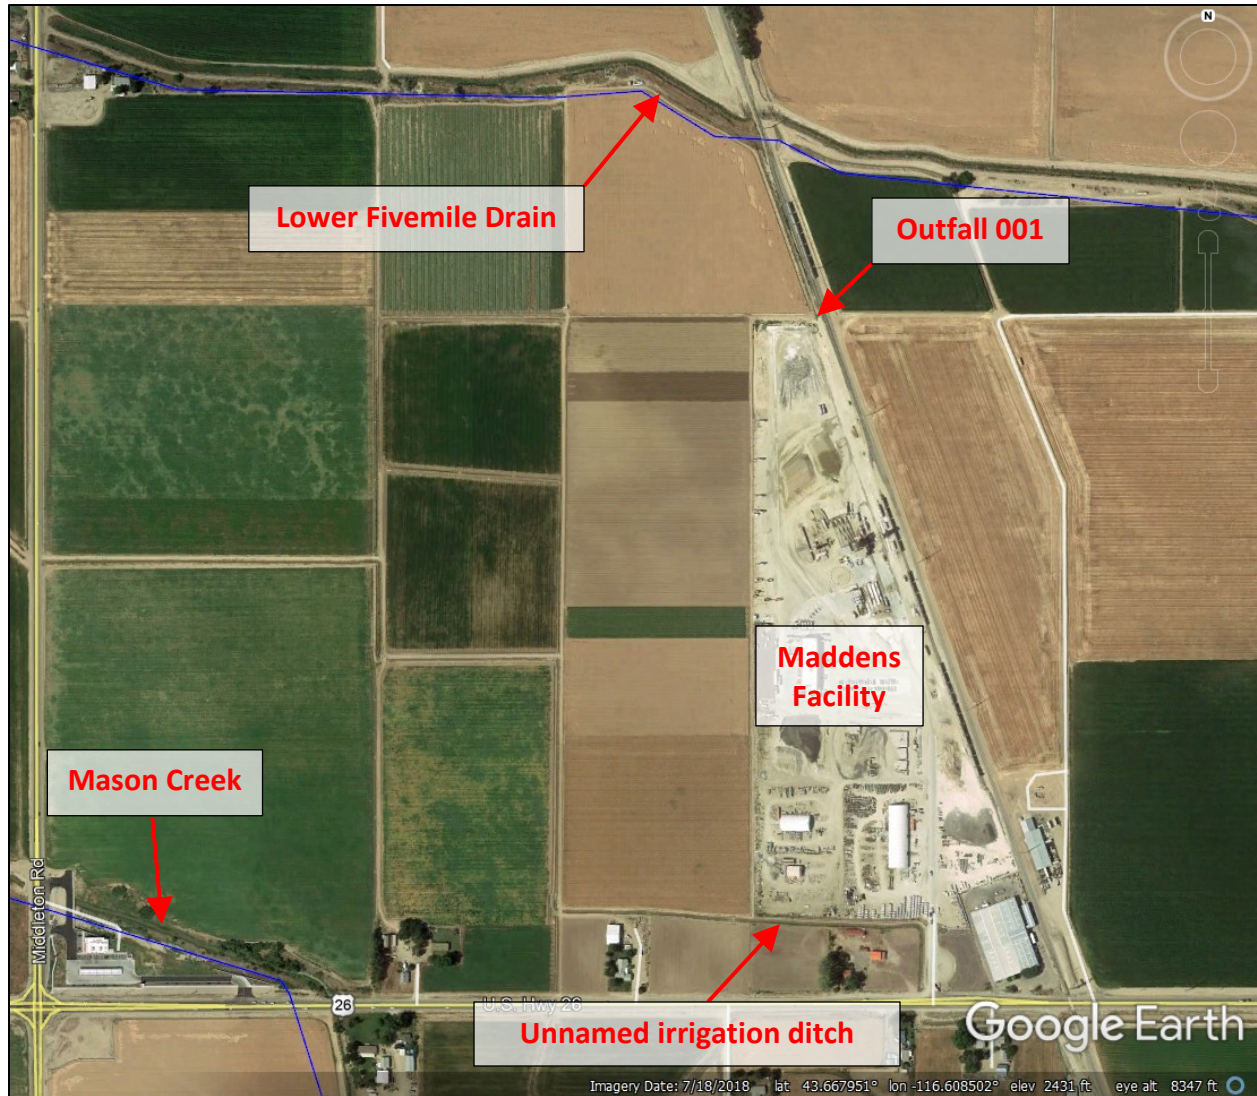
**Exhibit 1.** Google Earth Pro image of the Facility (imagery date: 7/18/2018). Facility features and boundaries are approximated for reference.

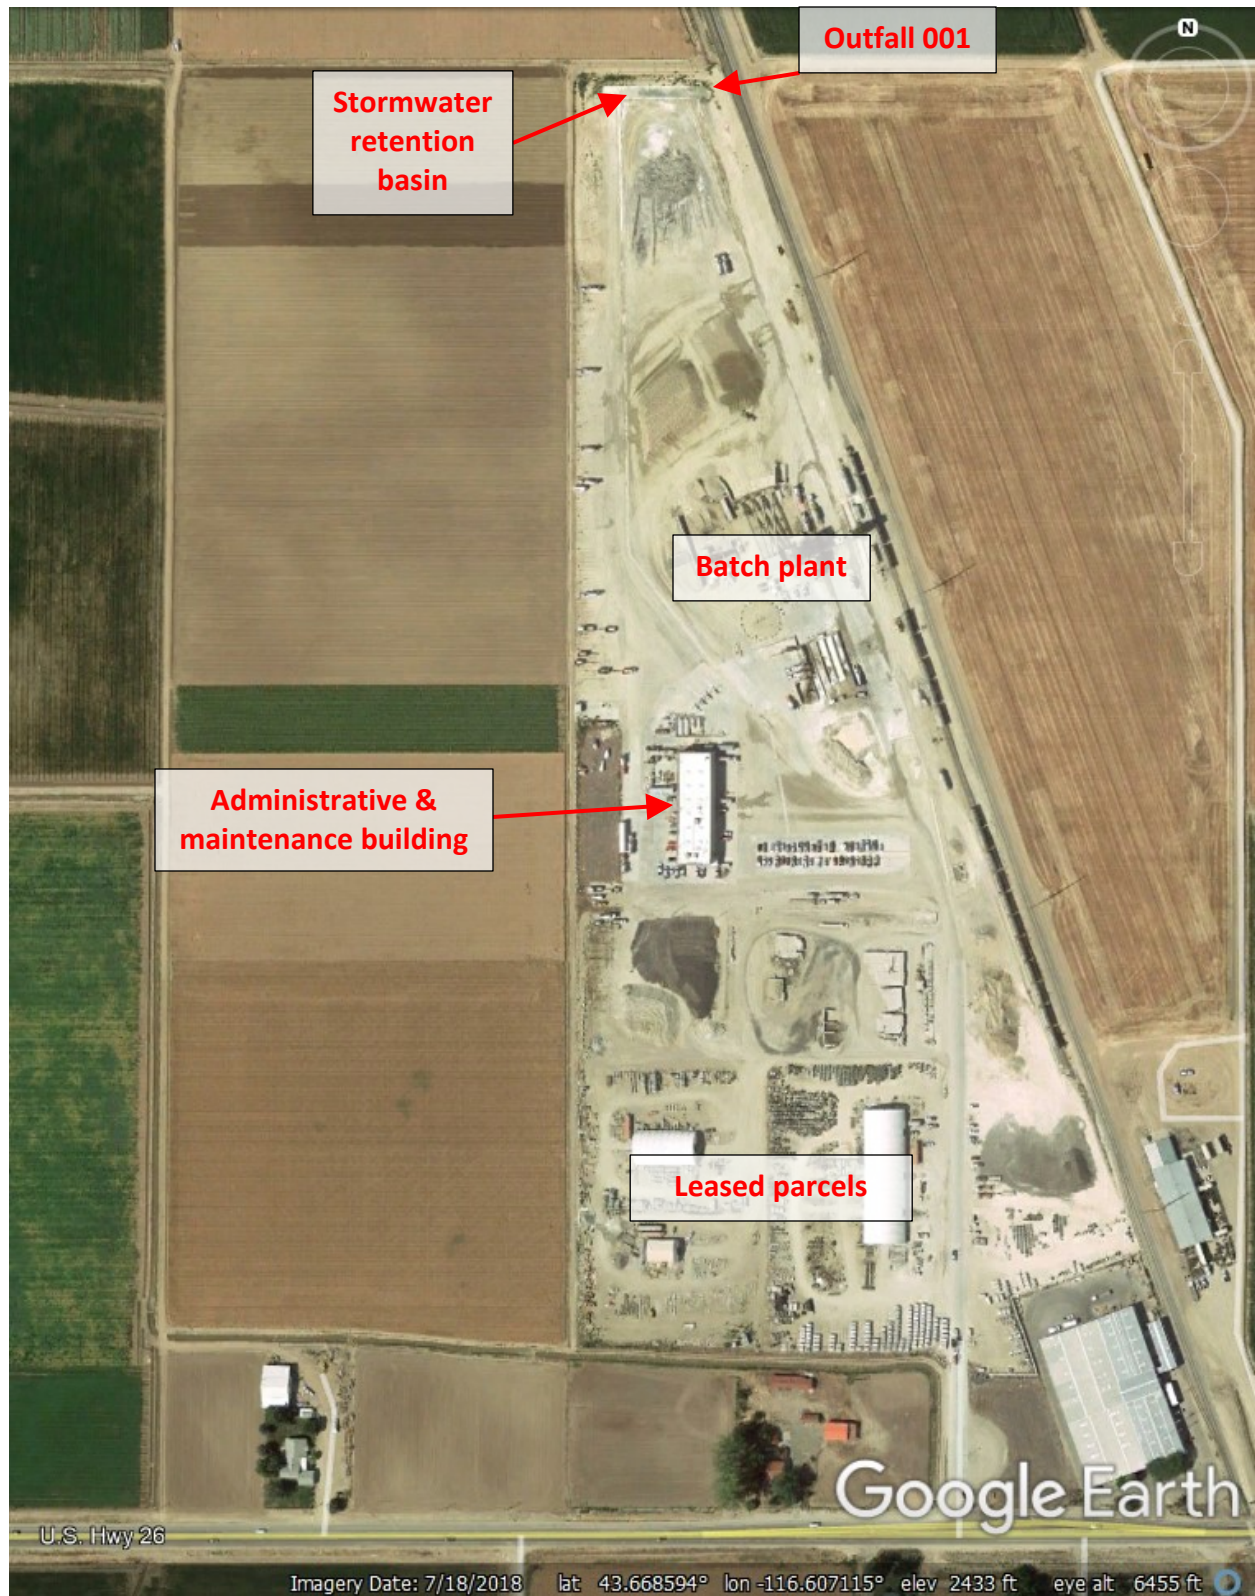
**Exhibit 2.** Google Earth Pro image of the Facility (imagery date: 7/18/2018). Facility features are approximated for reference.
