**CWA COMPLIANCE EVALUATION INSPECTION REPORT  
U.S. ENVIRONMENTAL PROTECTION AGENCY, REGION 5**

**Purpose:** Compliance Evaluation Inspection

Heusinkveld Farms, LLP.  
17526 County 5  
Spring Valley, Minnesota 55975  
Fillmore County  
43.60994321103799, -92.28757527146949

**Date of Inspection:** 04/28/2025

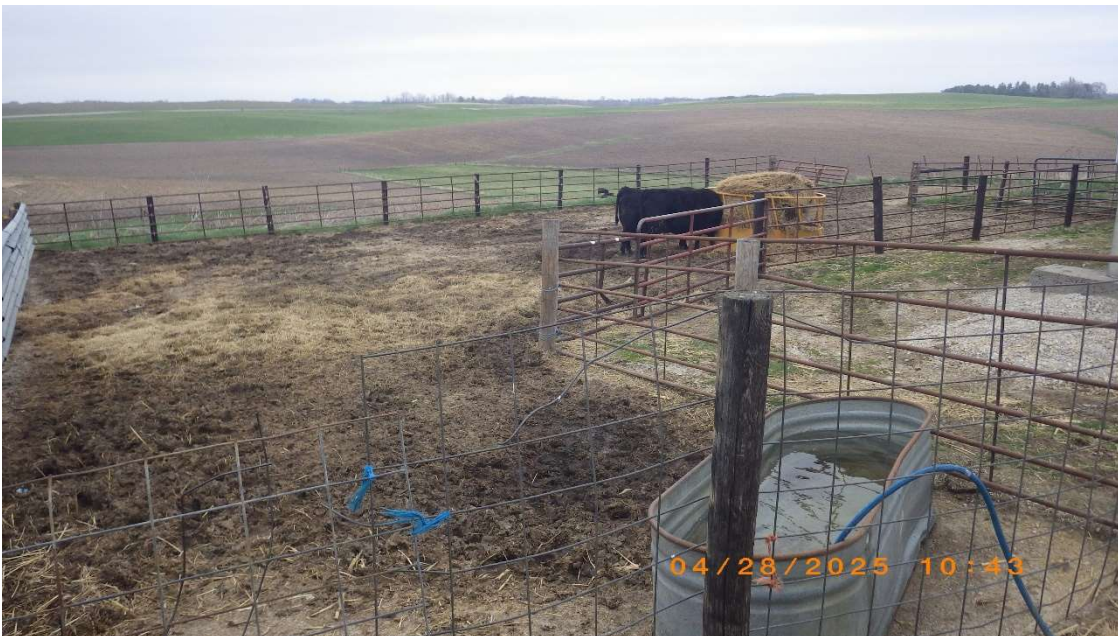
6: RIMG0006

At approximately 10:30 AM, the interview portion of the inspection was completed, and the walk-through of the Facility began. The Inspectors began the walk-through at the Office and walked northeast to the southeast corner of the Machine Shed. The Inspectors then walked north between the Machine Shed Calf Barn 1 to the outdoor lot north of the Machine Shed. The Inspectors observed that the outdoor lot was partially denuded (photos 1-4). The Inspectors then walked back around the south end Calf Barn 1 and observed calf hutches between Calf Barn 1 and Calf Barn 2 (photo 5). The Inspectors walked north between Calf Barn 1 and Calf Barn 2 and observed the outdoor lot at the north end of Calf Barn 2. The Inspectors observed that the lot was denuded (photo 6).

Description: Looking northeast across outdoor lot north of Calf Barn 2.

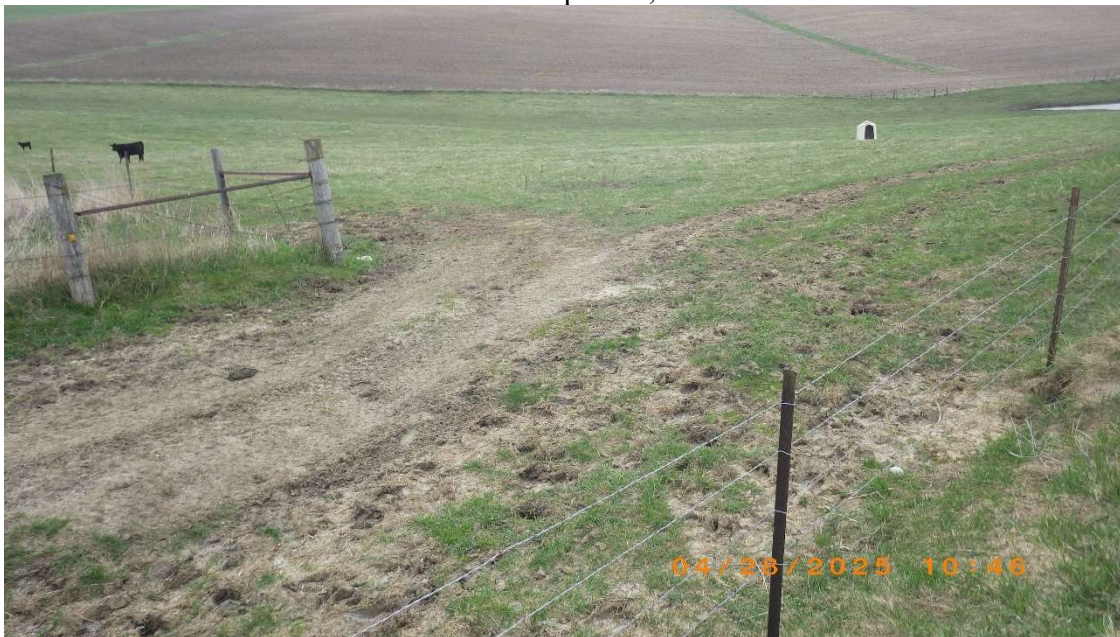
10: RIMG0010

Description: Looking east downhill from the northeast corner of the Feed Bunker.

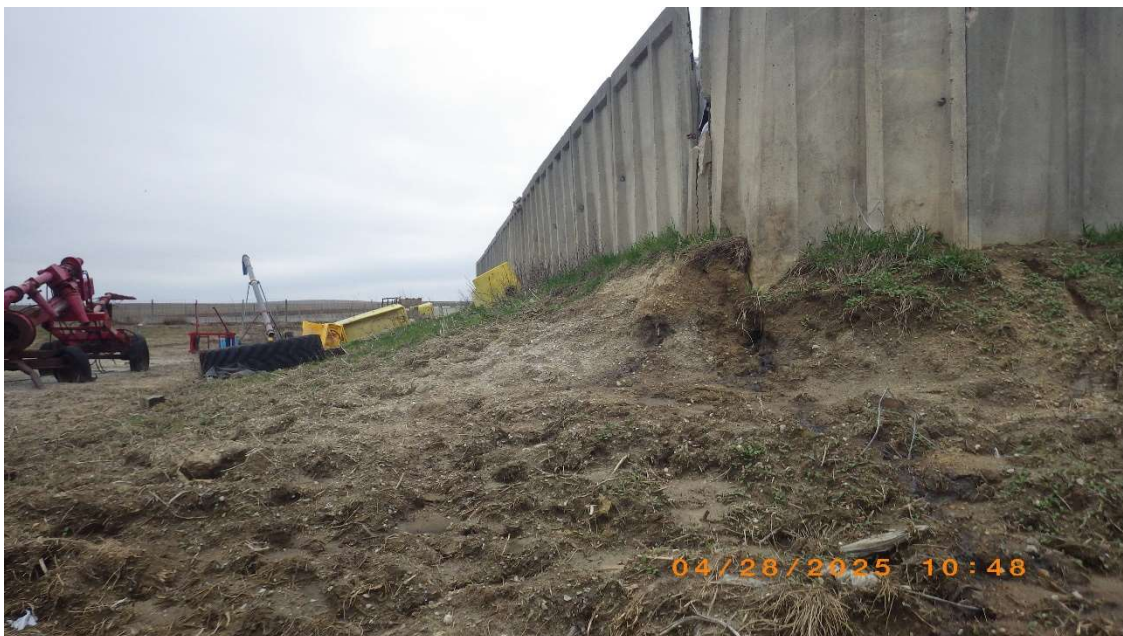
12: RIMG0012

The Inspectors then walked east and observed a white pipe protruding from the hillslope northeast of Calf Barn 2 (photos 7 and 8). The Operator identified the pipe as coming from calf milk room in Calf Barn 2. The Inspectors walked east along the north side of the Feed Bunker and observed a flow path with white colored liquid originating from the pipe from Calf Barn 2 (photo 9). The Inspectors observed that there was no liquid in the flow path approximately 130 feet from the source (photo 10). The Inspectors walked east to the northeast corner of the Feed Bunker and observed holes and erosional flow paths in the soil at the base of the northeast corner of the Feed Bunker with a dark color liquid and staining present (photos 11-13).

3. The white pipe from Calf Barn 2 may convey process wastewater.
4. The northeast corner of the Feed Bunker may be leaking leachate.
5. The erosional flow path east of the Big Pit may convey process wastewater toward the unnamed intermittent waterway to the east.

Description: Looking south along the east exterior wall of the Feed Bunker.

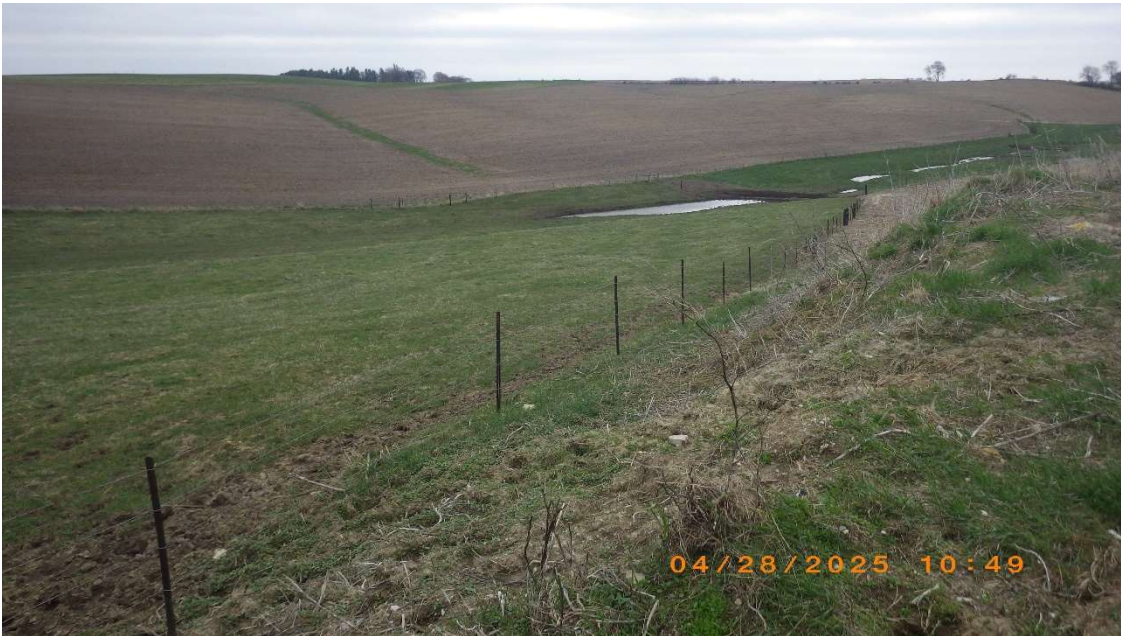
14: RIMG0014

Description: Looking east downhill from the area northeast of the Feed Bunker.

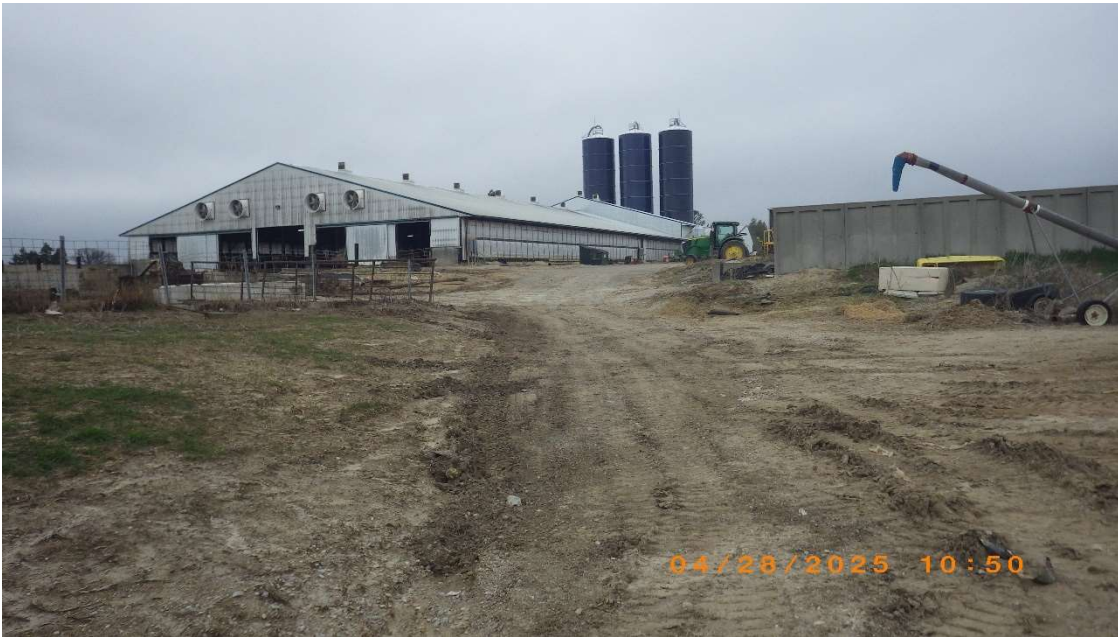
15: RIMG0015

The Inspectors walked south and observed an access road between the Feed Bunker and the Big Pit (photo 15).

Description: Looking southwest toward the east end of the Dairy Barn. The Feed Bunker is to the right and the Big Pit is to the left.

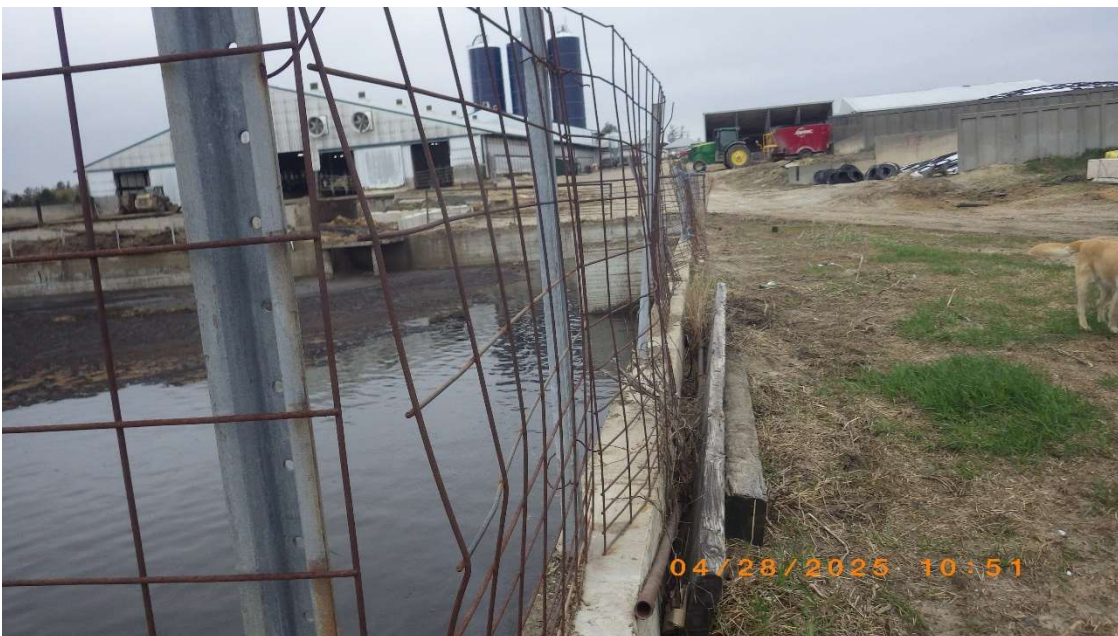
16: RIMG0016

The Inspectors walked southeast to the northeast corner of the Big Pit (photos 16 and 17). The Inspectors observed an erosional flow path from the access road east of the Big Pit into the crop field east of the Big Pit (photos 18 and 19).

Description: Looking west along the north end of the Big Pit

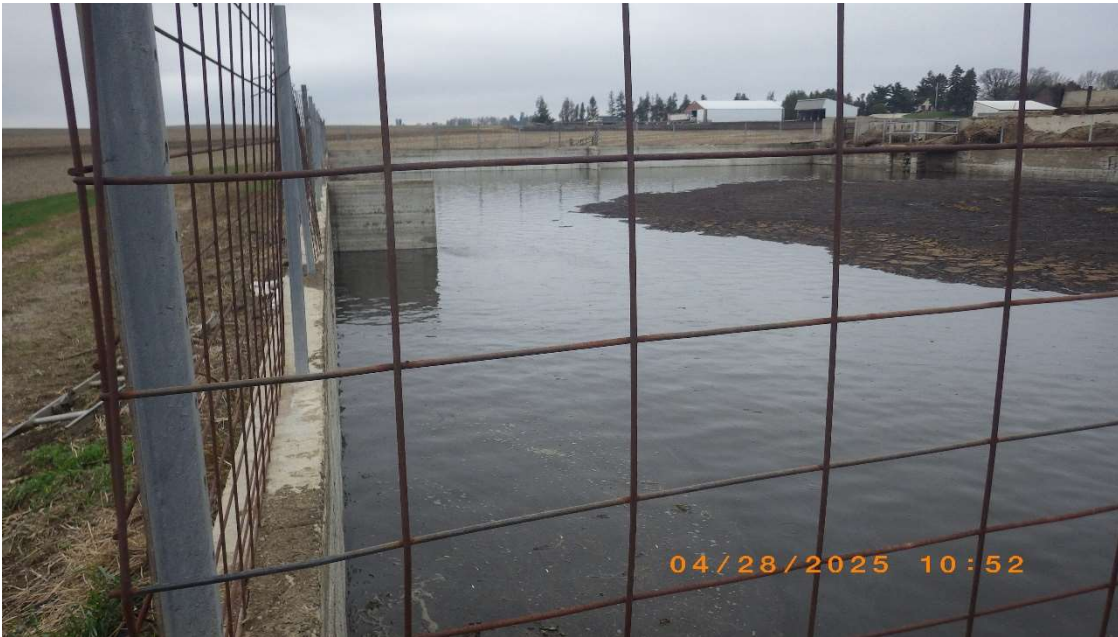
17: RIMG0017

Description: Looking South along the east side of the Big Pit.

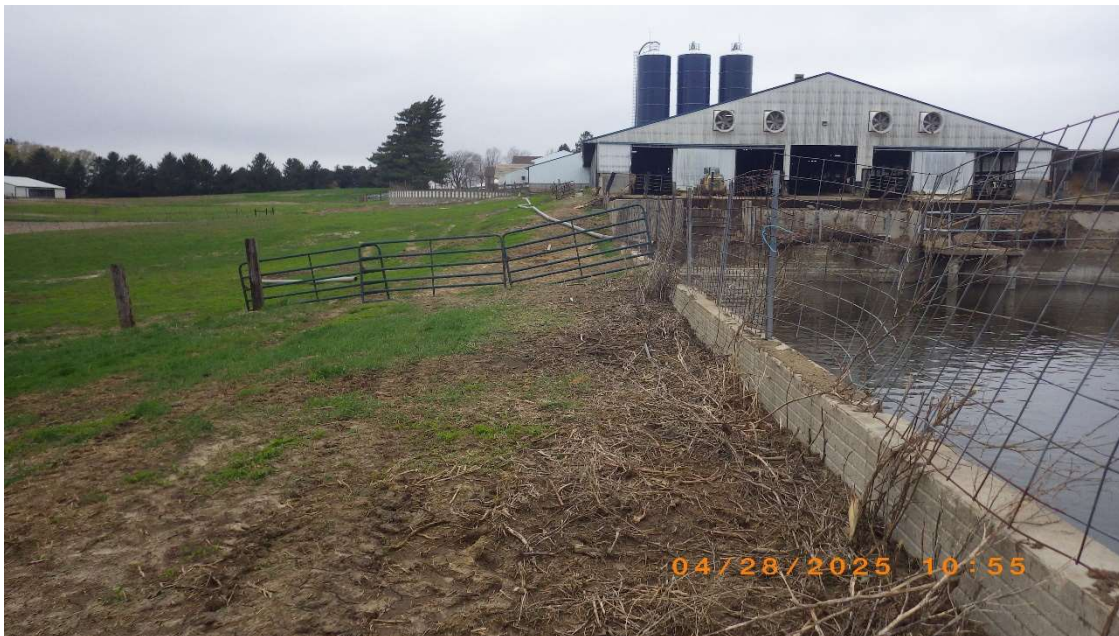
20: RIMG0020

The Inspectors walked around the east side of the Big Pit and then west along the south side of the Big Pit (photo 20). The Inspectors observed an erosional flow path along the fence to the south (photo 21). The Inspectors walked west and observed manure solids on the top of the wall of the Big Pit and on the ground on the south side of the Big Pit (photo 22). The Inspectors observed an erosional flow path to the south (photo 23). The Inspectors continued west and observed manure solids on the top of the wall of the Sand Pit and on the ground south of the south wall of the Sand Pit (photo 24). The Inspectors

Description: Looking west along the south side of the Big Pit.

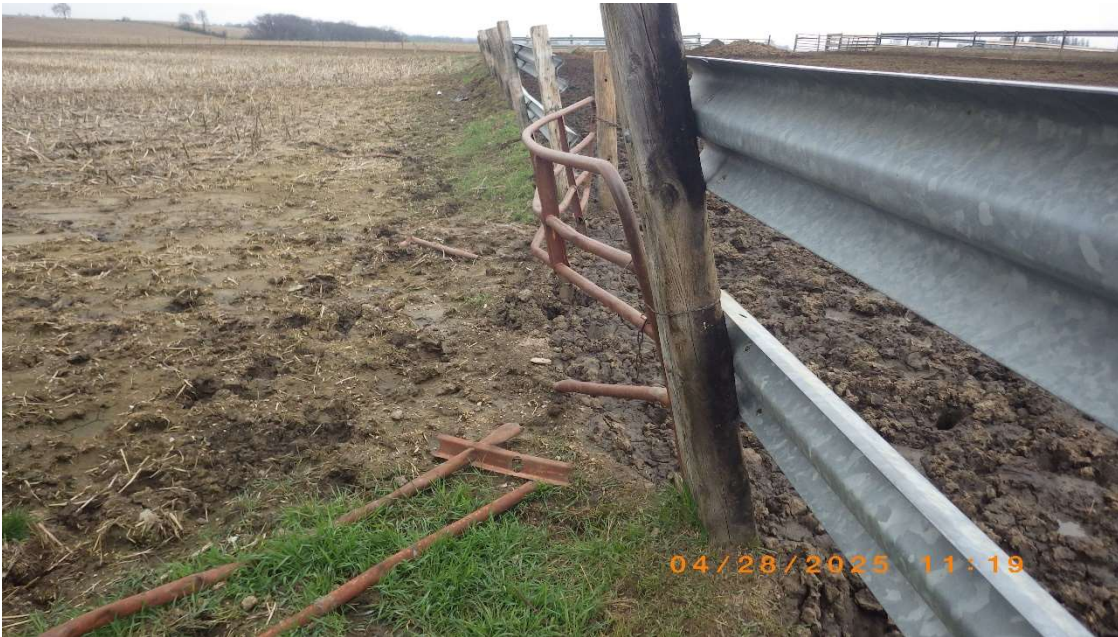
49: RIMG0049

The Inspectors then walked east along the north side of the denuded outdoor lot north of the Cattle Shed (photos 49-52). The Inspectors then walked south along the east side of the denuded outdoor lot north of the Cattle Shed (photo 53). The Inspectors then walked north and observed the south side of the outdoor lot north of the Cattle Shed (photos 54-55). The Inspectors then walked northwest around the southwest side of the Cattle Shed and Dry Cow Barns (photos 56 and 57).

Description: Looking east along the north side of the outdoor lot north of the Cattle Shed.

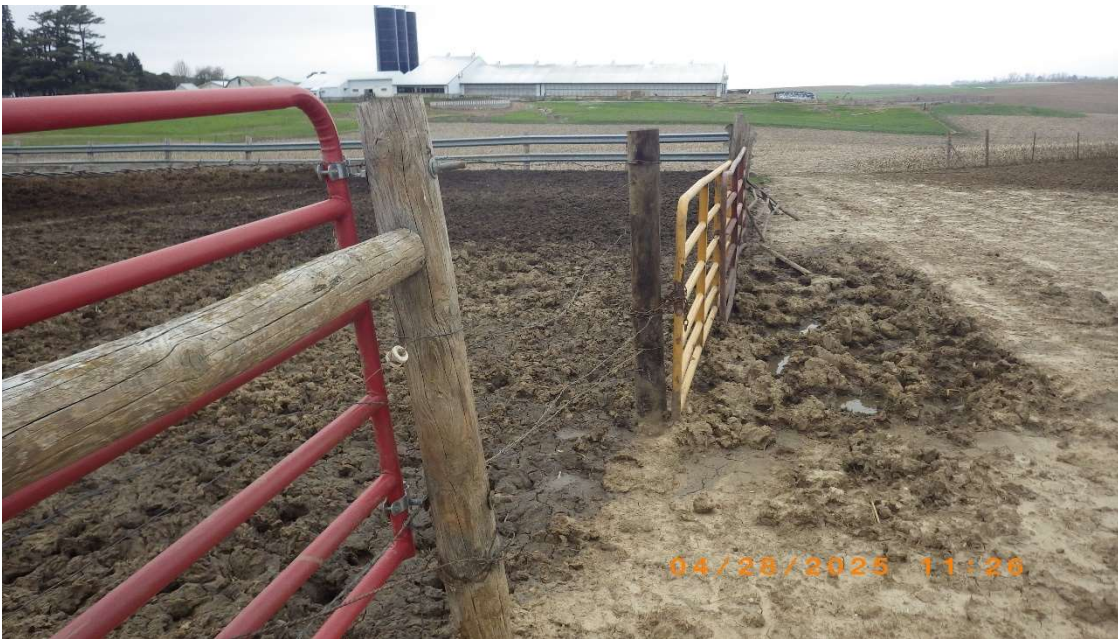
53: RIMG0053

Description: Looking north along the east side of the outdoor lot north of the Cattle Shed.

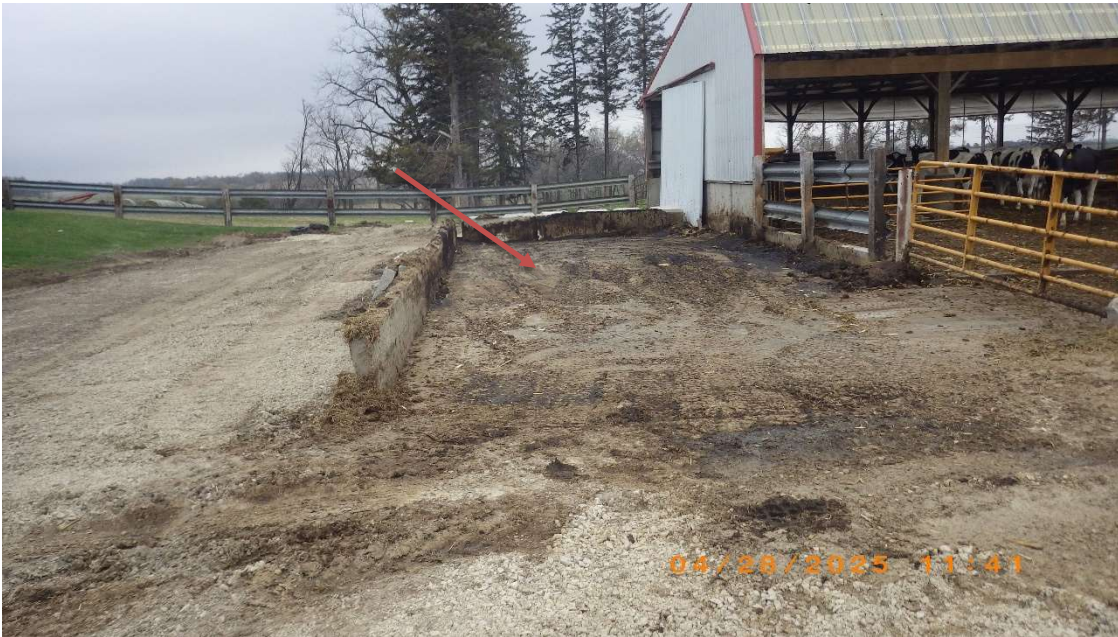
61: RIMG0061

Description: Looking north along the west side of the Bottom Barn. Note concrete manure stacking area (red arrow).

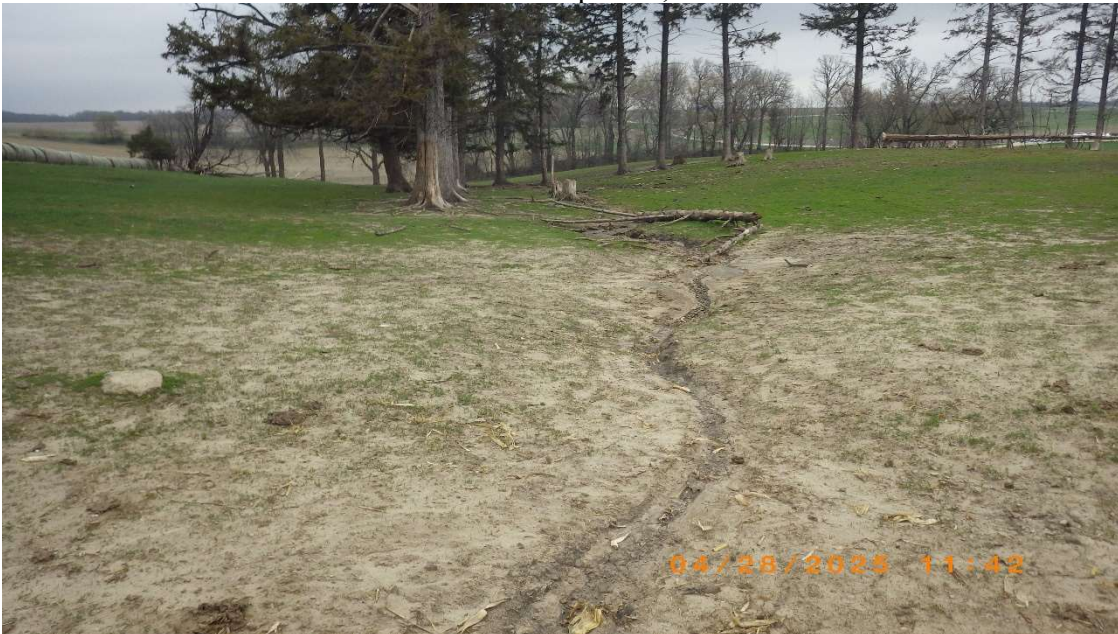
62: RIMG0062

Description: Looking north along erosional flowpath in the outdoor lot north of the Bottom Barn.

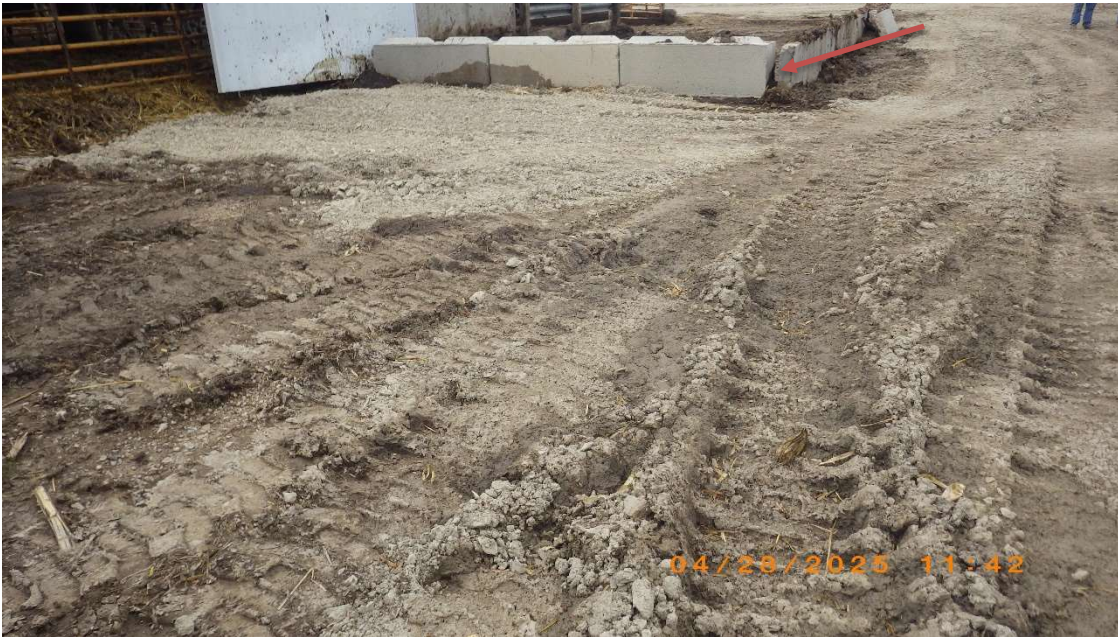
63: RIMG0063

Then Inspectors then walked north along the west side of the outdoor lots north of the Dry Cow Barns and crossed County 5 to the heifer site. The inspectors walked to the southeast side of the Bottom Barn and observed the partially denuded outdoor lot north of the Bottom Barn (photos 58 and 59). The Inspectors then walked back to the southeast corner of the Bottom Barn to the concrete outdoor lot on the south side of the Bottom Barn (photo 60). The Inspectors walked west and observed the manure stacking area to which the Bottom Barn manure is scraped (photo 61). The Inspectors walked north and observed an erosional flow path beginning at the fence to the outdoor lot north of the Bottom Barn (photo 62). The Inspectors observed that there were gaps between the west wall of the manure stacking area and concrete block wall at the north end of the manure stacking area (photo 63).

Description: Looking south along the west side of the Bottom Barn at the concrete manure stacking pad. Note gaps between the concrete barrier on the north end of the manure stacking pad and concrete wall on the west side (red arrow).

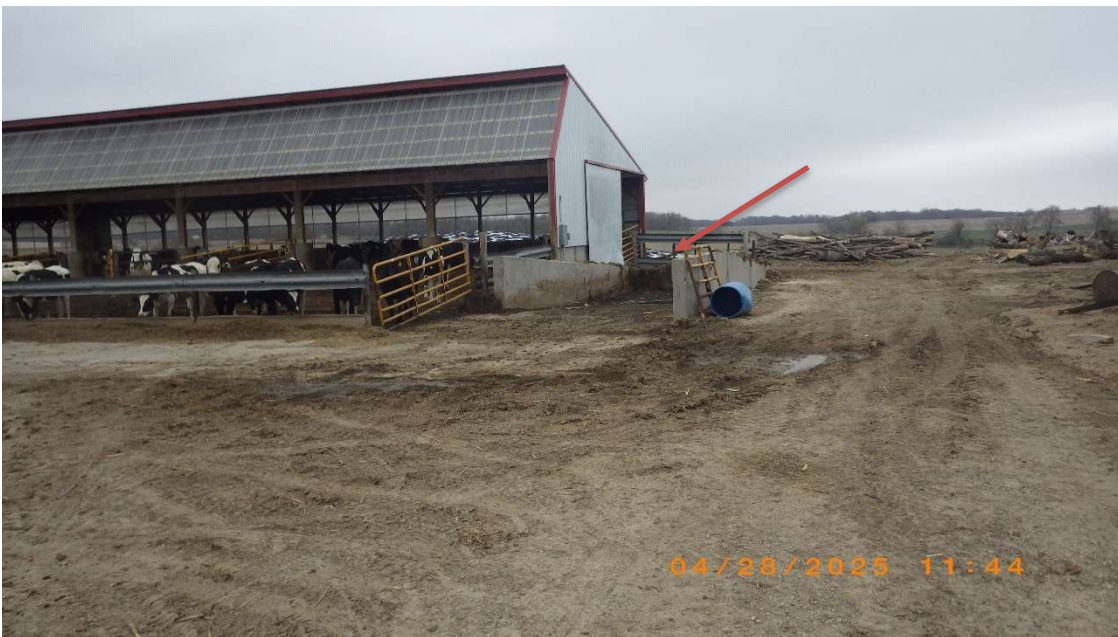
64: RIMG0064

The Inspectors then walked west around the south side of the hay barn to the southeast corner of the Top Barn. The Inspectors observed a recessed manure stacking area on the east end of the Top Barn (photo 64) and the outdoor lots on the south side of the Top Barn (photo 65).

Description: Looking north at the east side of the Top Barn. Note the recessed manure stacking area on the east side of the Top Barn (red arrow).

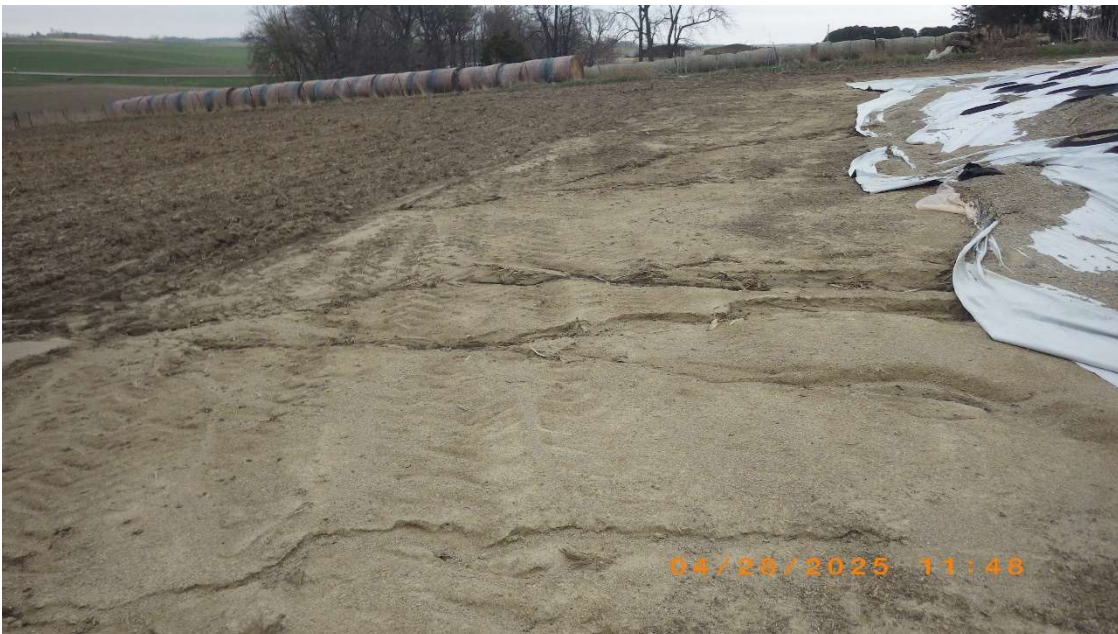
66: RIMG0066

The Inspectors then walked North on the east side of the Top Barn and around the silage mound north of the Top Barn. The Inspectors observed erosional flow paths from around the silage mound to the crop fields adjacent to the silage mound (photos 66-68). The Inspectors then walked to the west side of the Top Barn and observed a flow path with dark colored liquid and staining from the 15,000-gallon pit on the west side of the Top Barn to the adjacent crop field (photos 69-71). The Inspectors observed the outdoor lots on the south side the Top Barn (photo 72).

Description: Erosional flowpaths into the adjacent crop field from silage mound north of the Top Barn.

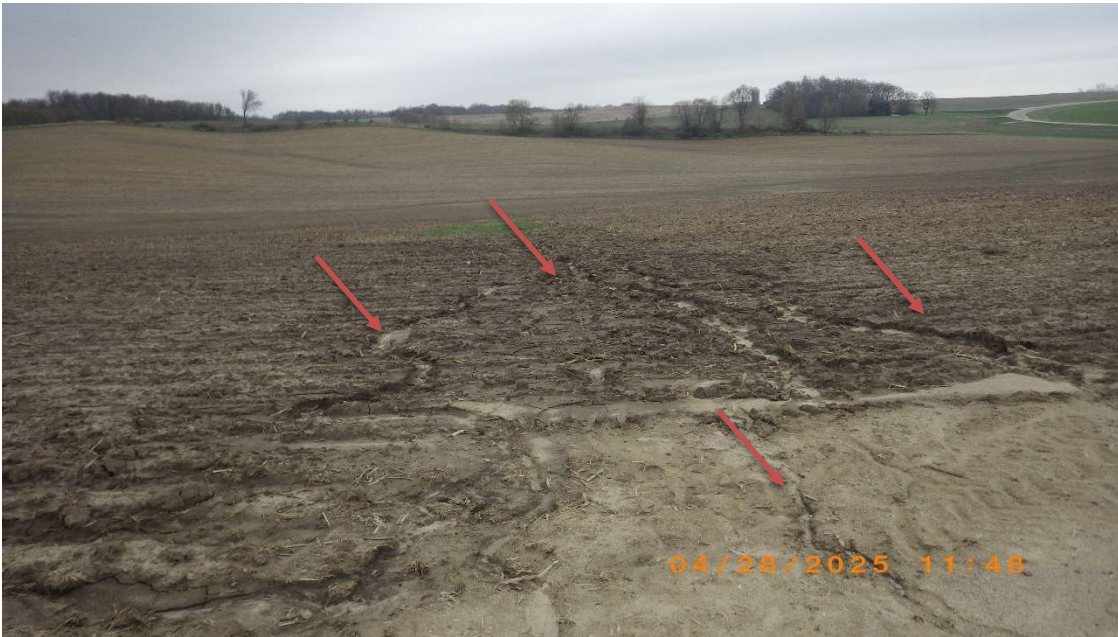
67: RIMG0067

Description: Looking north from the north side of the silage mound north of the Top Barn. Note erosional flowpaths (red arrows).

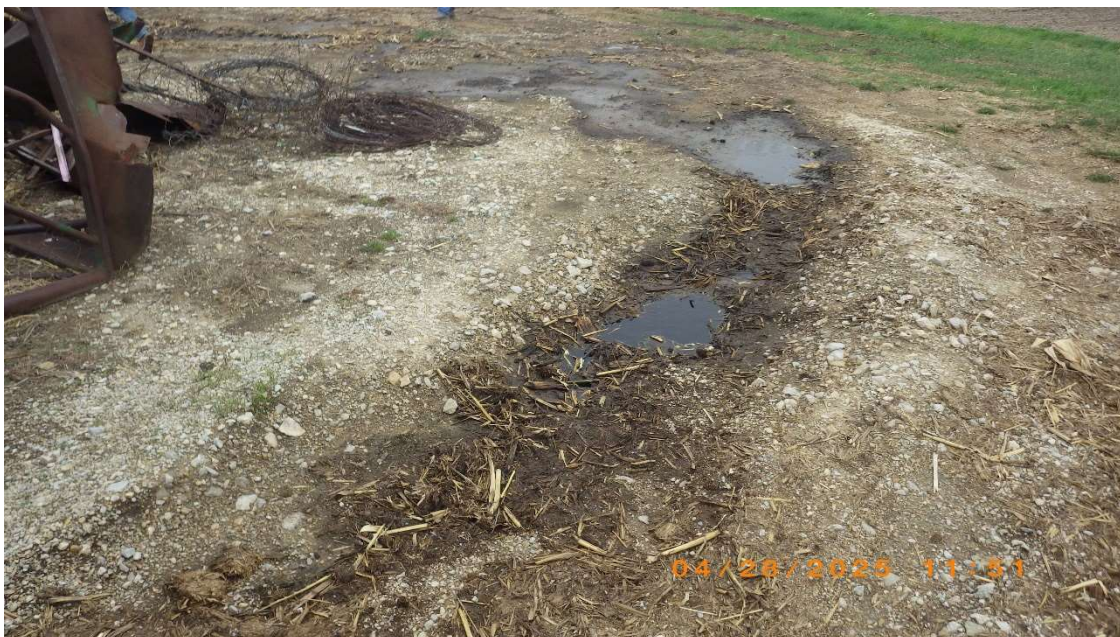
69: RIMG0069

Description: Flowpath toward adjacent crop field with dark colored liquid from the manure storage pit on the west side of the Top Barn.

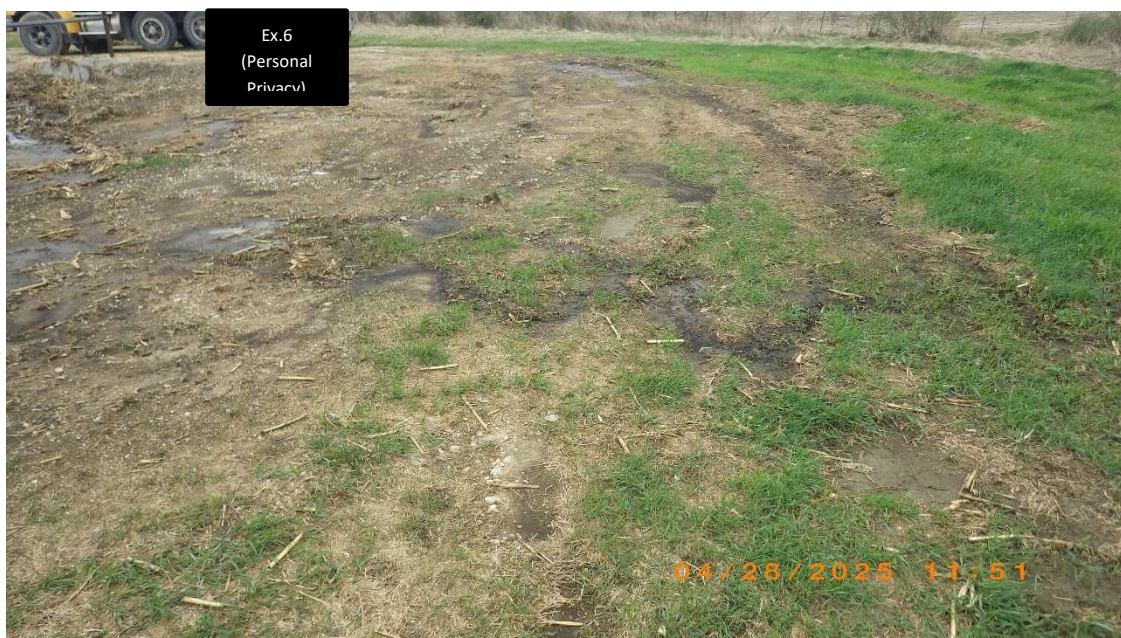
70: RIMG0070

Description: Flowpath with dark colored liquid from the manure storage pit on the west side of the Top Barn toward the adjacent crop field.

Location: West side of the Top Barn.

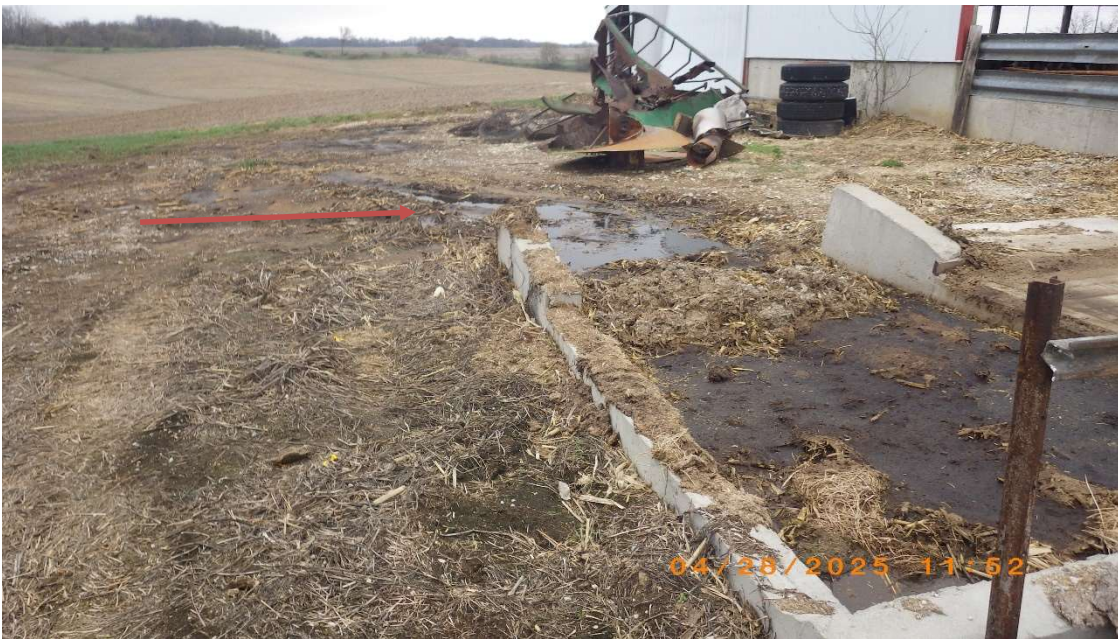
71: RIMG0071

Description: Looking north along the west side of the manure storage pit on the west side the Top Barn. Note flowpath with dark colored liquid (red arrow).

Location: Southwest corner of the manure pit on the west side of the Top Barn.

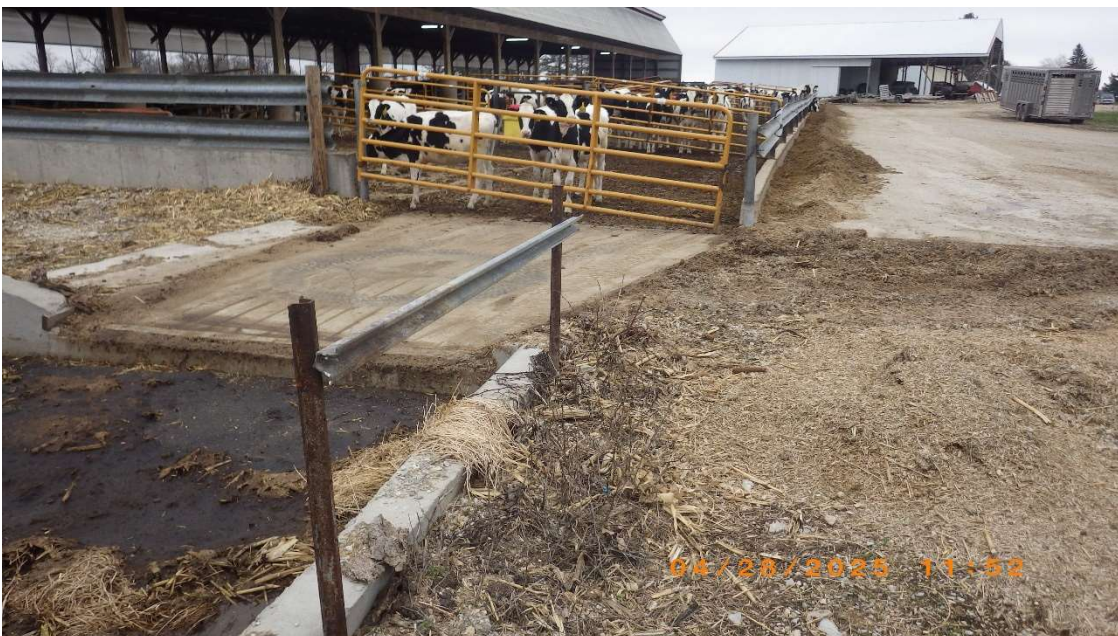
72: RIMG0072

Description: Looking east along the north side of the outdoor lots on the south side of the Top Barn.

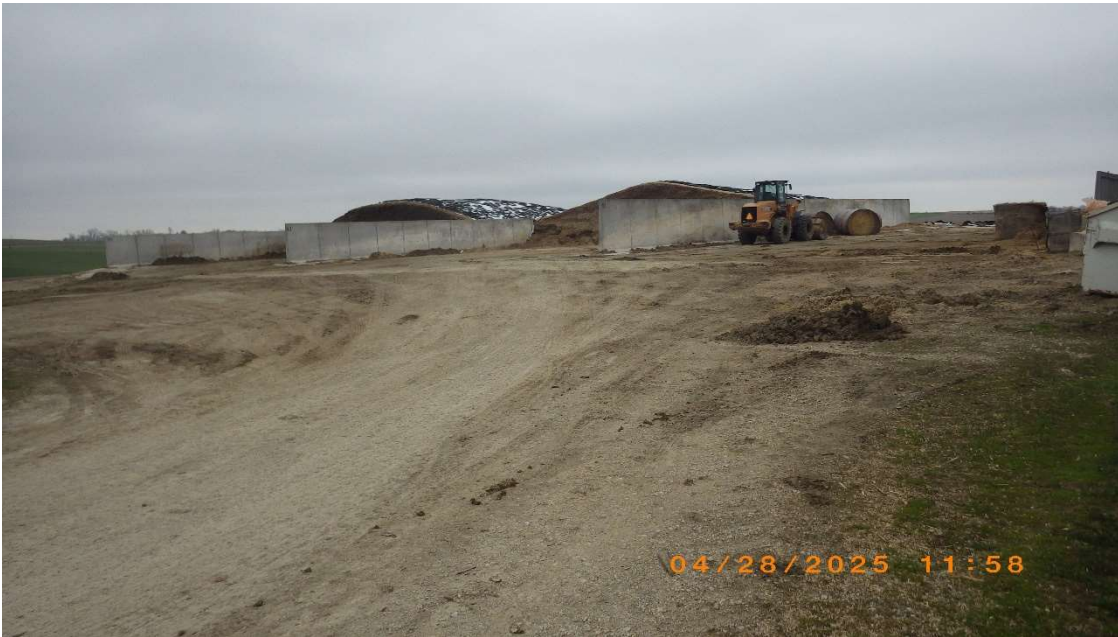
73: RIMG0073

Description: Looking northeast at the North Silage Pad.

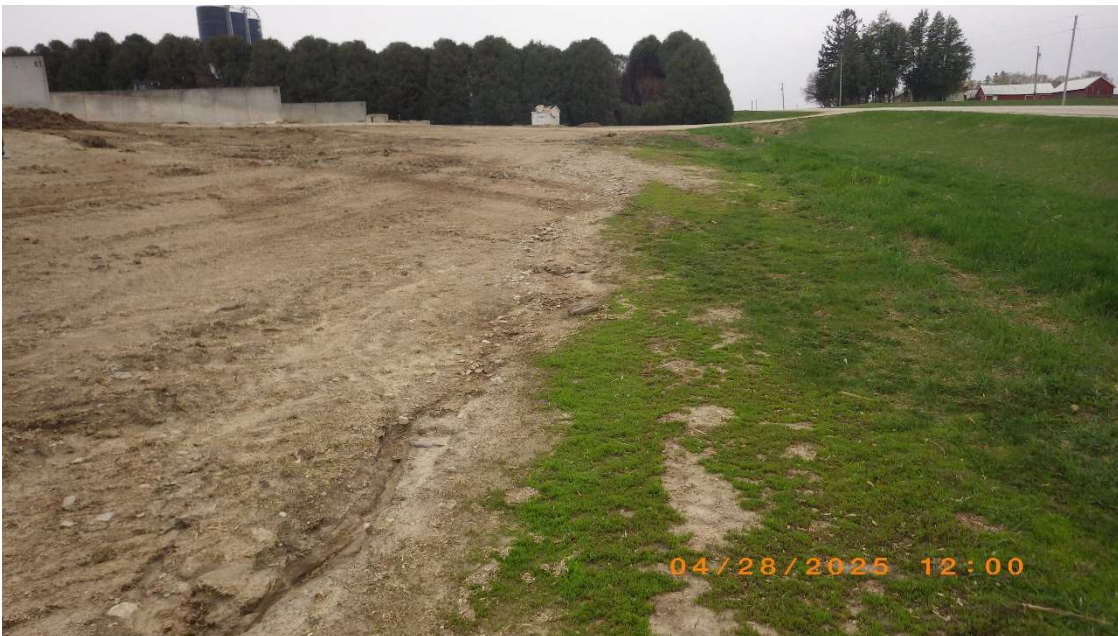
74: RIMG0074

Description: Looking south along the west side of the North Silage Pad.

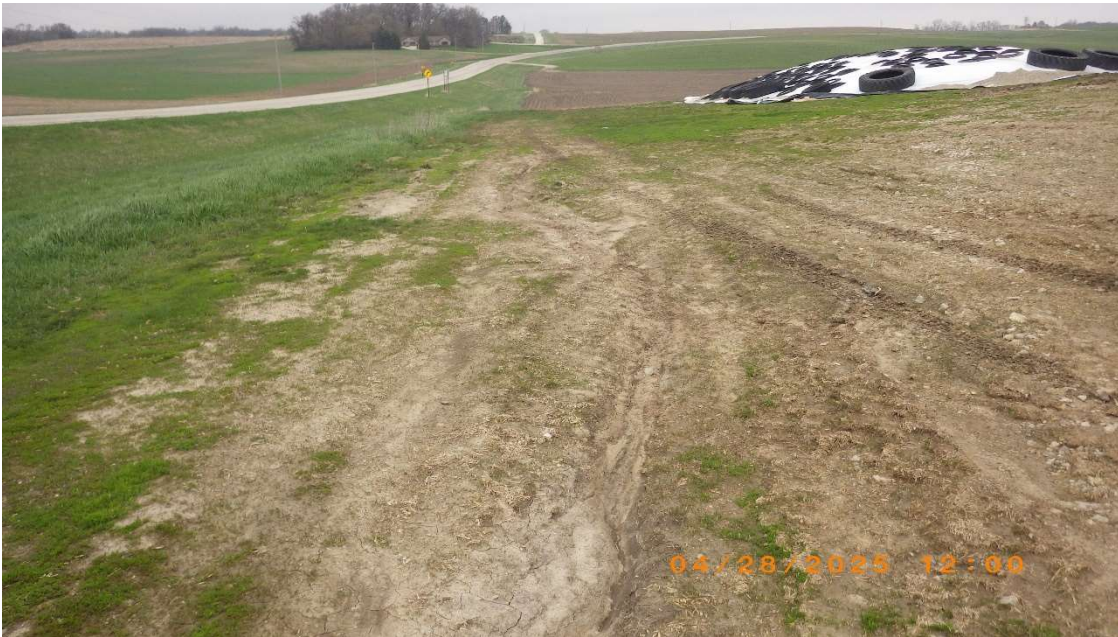
75: RIMG0075

Description: Looking north along County Road 5 from the northwest corner of the North Silage Pad. Note silage mound north of the North Silage Pad.

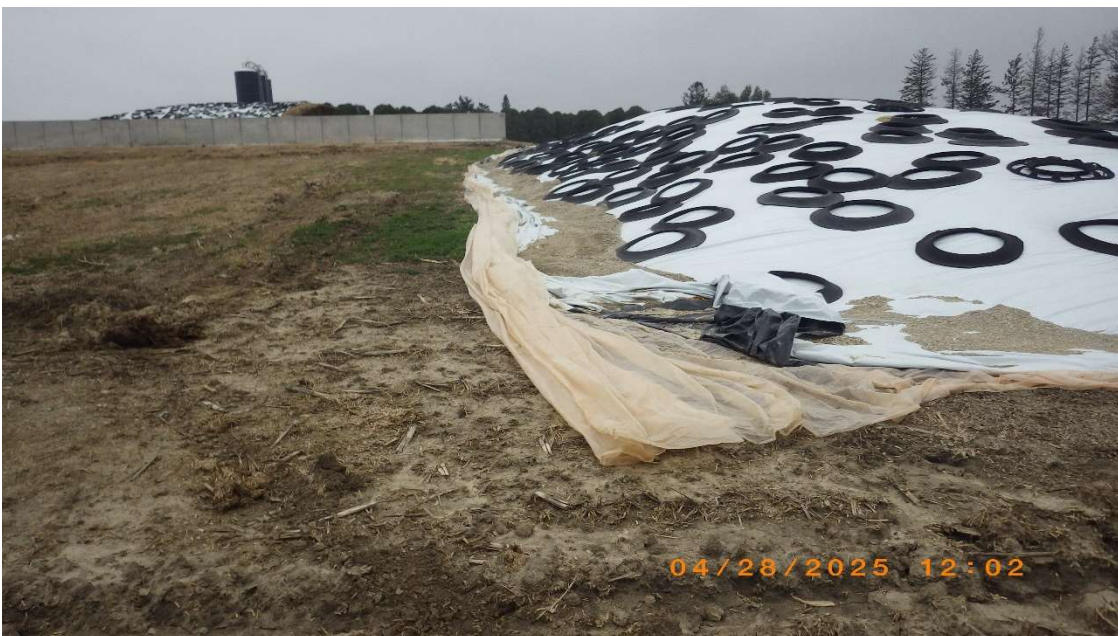
76: RIMG0076

Description: Looking south along the east side of the silage mound north of the North Silage Pad.

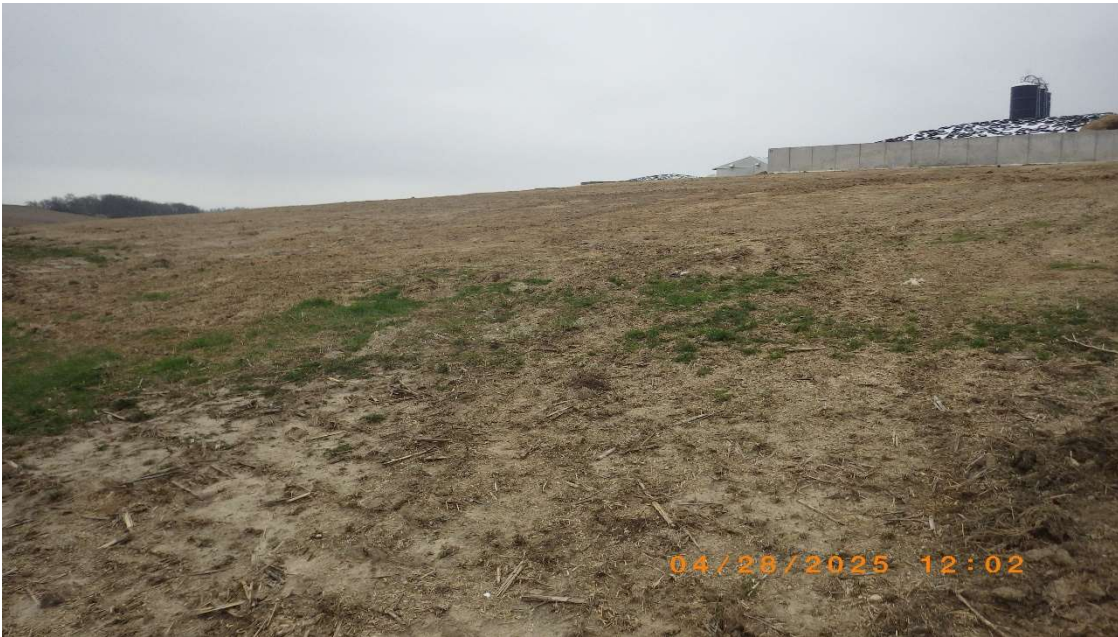
77: RIMG0077

Description: Looking southeast at the south side of the North Silage Pad.

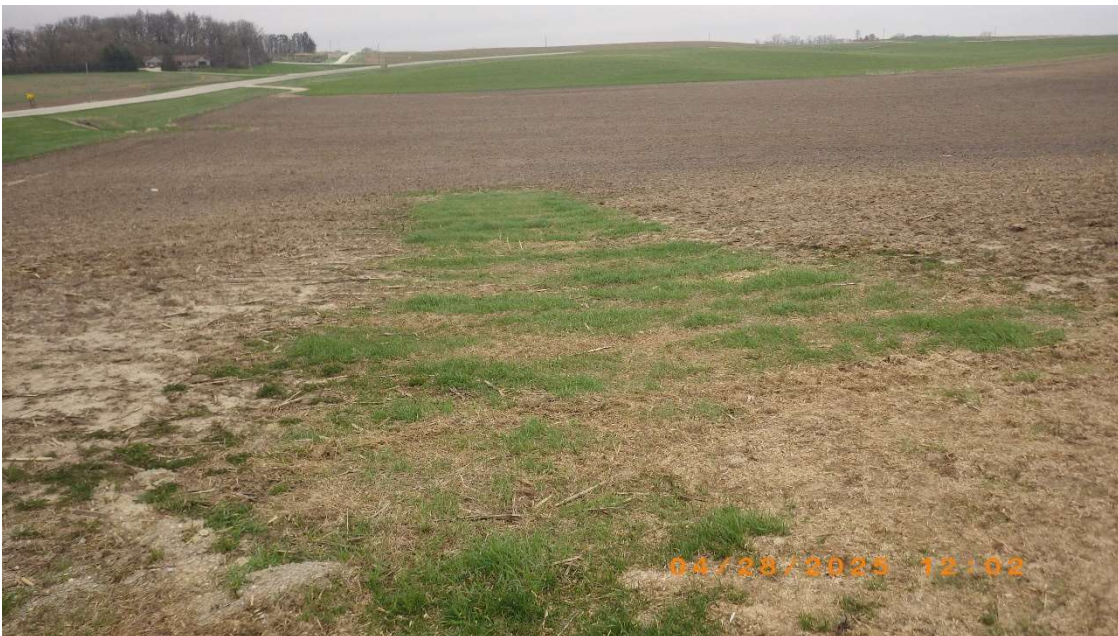
78: RIMG0078

Description: Looking north into the crop field north of the silage mound north of the North Silage Pad.

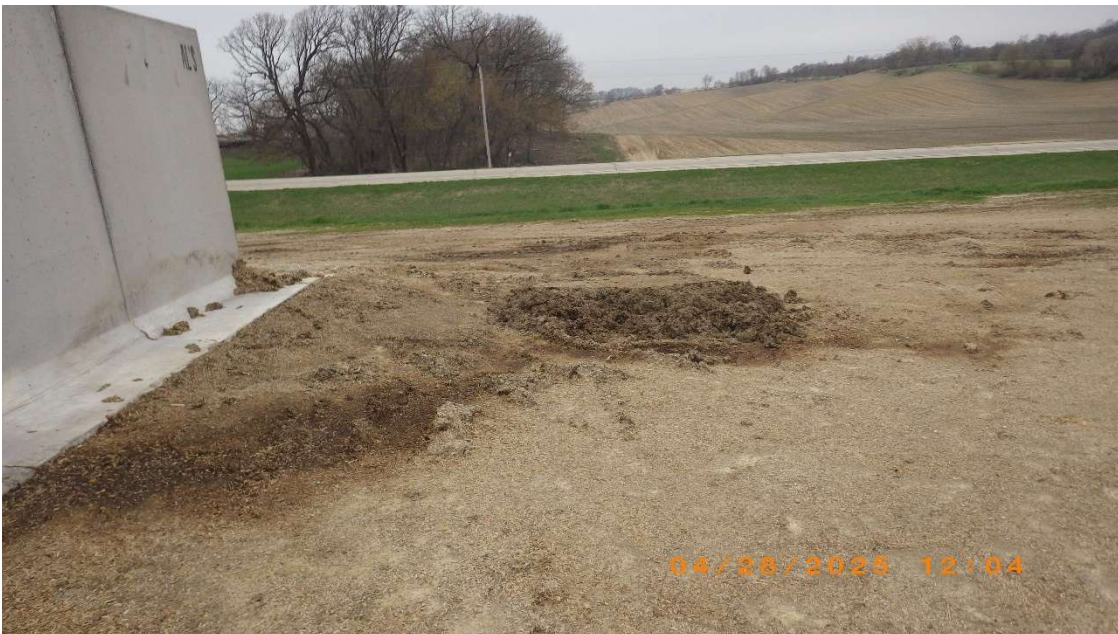
80: RIMG0080

Description: Looking west from the northwest corner of the North Silage Pad.

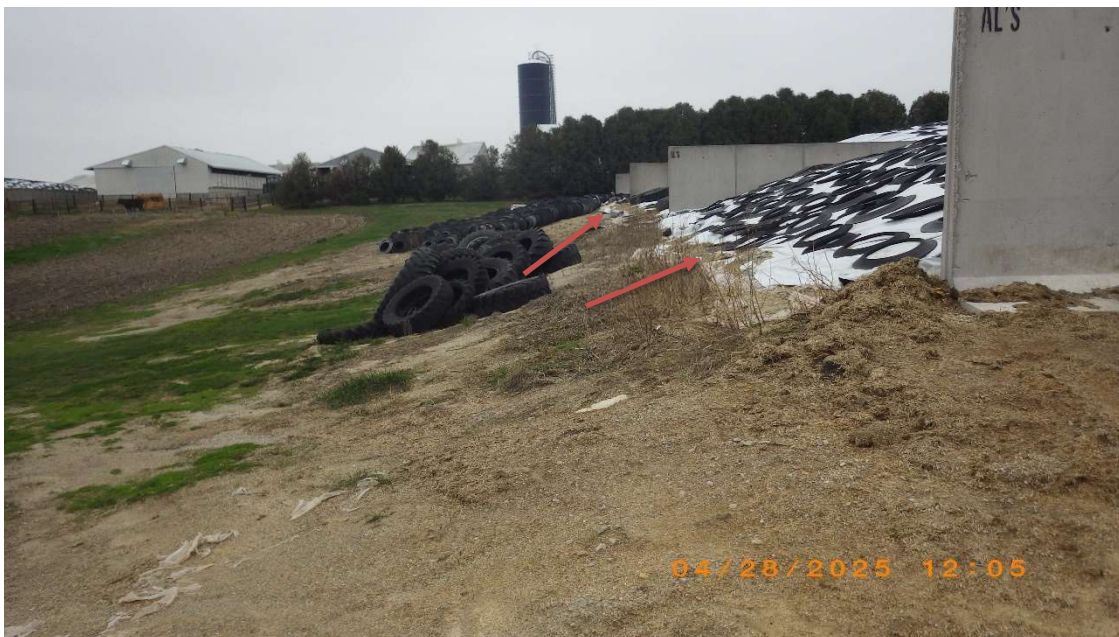
81: RIMG0081

The Inspectors then walked east to the east side of County 5 and north to the southwest corner of the North Silage Pad (photo 73). The Inspectors walked north along the west side of the North Silage Pad and observed erosional flow paths along the west side of the North Silage Pad to the crop field to the north (photos 75 and 75). The Inspectors then walked north to the north end of the silage mound north of the North Silage Pad (photos 76-78). Then Inspectors then walked south to the north side of the North Silage Pad. The Inspectors observed staining at the seams of the north wall of the North Silage Pad (photos 79-80). The Inspectors then walked south on the east side of the North Silage Pad and observed erosional flow path with dark staining from east side of the North Silage Pad to the crop field to the east (photos 81-84).

Description: Looking north along the east side of the North Silage Pad. Note the silage extending beyond the edge of the pad (red arrows).
