**CWA COMPLIANCE EVALUATION INSPECTION REPORT  
U.S. ENVIRONMENTAL PROTECTION AGENCY, REGION 5**

**Purpose:** Compliance Evaluation Inspection

Heusinkveld Farms, LLP.  
17526 County 5  
Spring Valley, Minnesota 55975  
Fillmore County  
43.60994321103799, -92.28757527146949

**Date of Inspection:** 04/28/2025

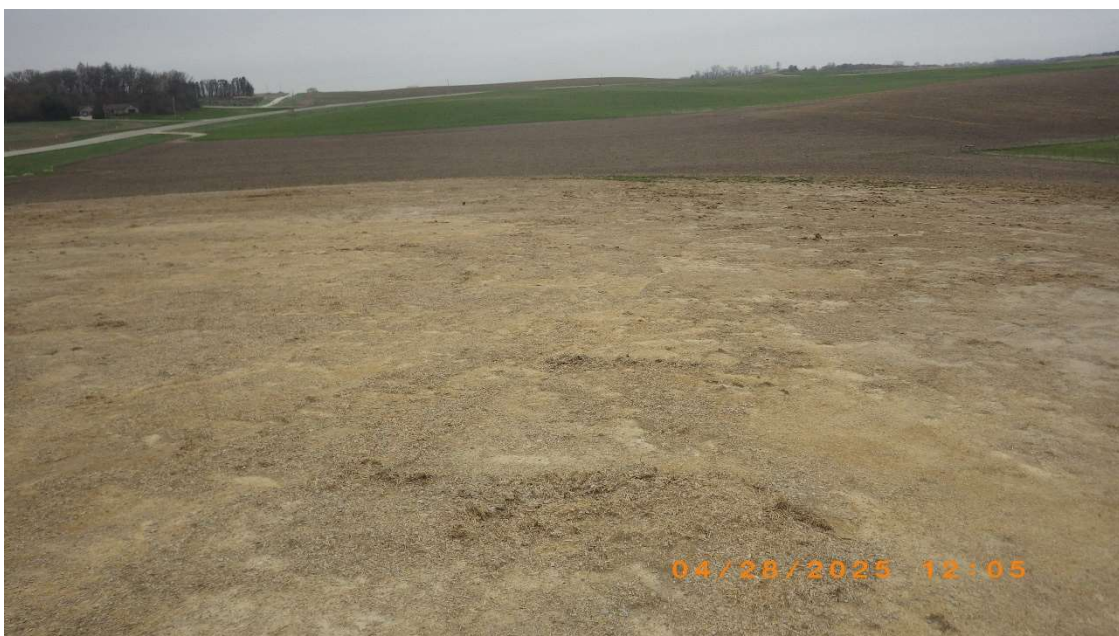
82: RIMG0082

The Inspectors then walked east to the east side of County 5 and north to the southwest corner of the North Silage Pad (photo 73). The Inspectors walked north along the west side of the North Silage Pad and observed erosional flow paths along the west side of the North Silage Pad to the crop field to the north (photos 75 and 75). The Inspectors then walked north to the north end of the silage mound north of the North Silage Pad (photos 76-78). Then Inspectors then walked south to the north side of the North Silage Pad. The Inspectors observed staining at the seams of the north wall of the North Silage Pad (photos 79-80). The Inspectors then walked south on the east side of the North Silage Pad and observed erosional flow path with dark staining from east side of the North Silage Pad to the crop field to the east (photos 81-84).

Description: Looking north from the northeast corner of the North Silage Pad.

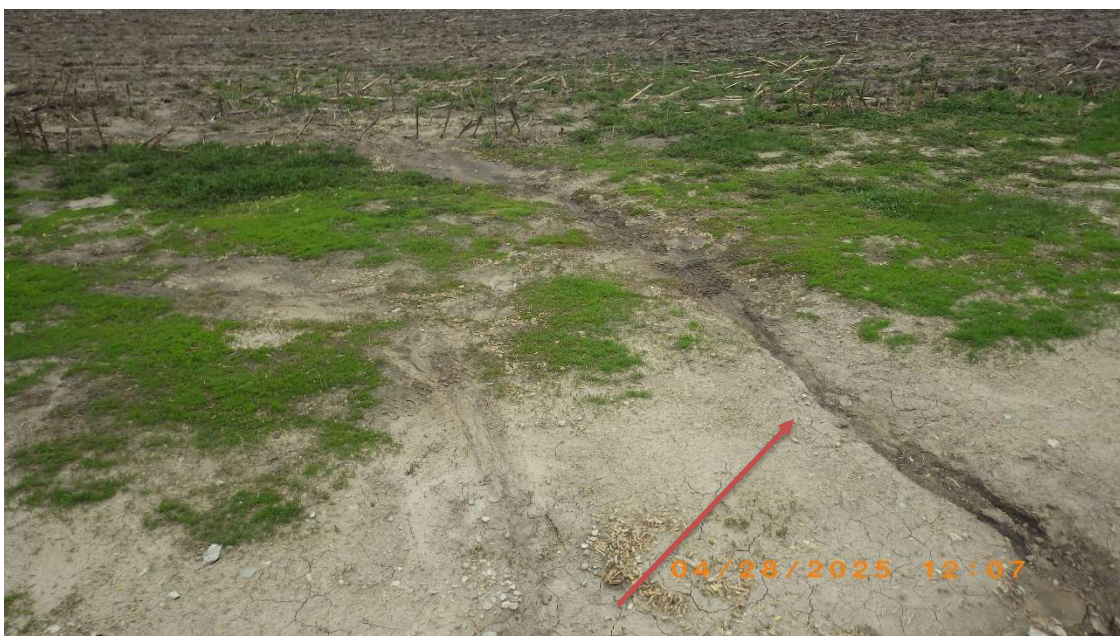
84: RIMG0084

Description: Looking east from the east side of the North Silage Pad. Note erosional flowpath into the adjacent crop field (red arrow).
