## RCRA COMPLIANCE EVALUATION INSPECTION REPORT

TAV Holdings, Inc.  
3311 Empire Boulevard SW  
Atlanta, Georgia 30354  
EPA ID # GAD033537663

October 6, 2021

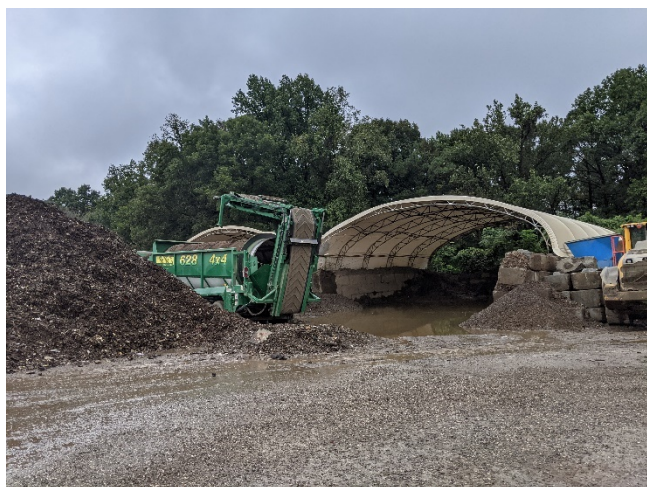
The facility tour began in the receiving area. Several piles of ASR, solid waste, were observed in this area (Figures 48 and 49). The solid waste in this area is stored in open piles that are exposed to weather elements. The area had received rainfall in the days prior to the inspection and the solid waste piles were wet. Water contaminated with small particles was observed flowing from the south to the north where the outdoor processing, storage and Receiving Area are located. The water was observed to be pooling in the area immediately east of the Receiving Area (Figures 87 and 88). This area is known as the Jig Storage.

Figure 48: PXL\_20211006\_140722625.jpg – Receiving Area

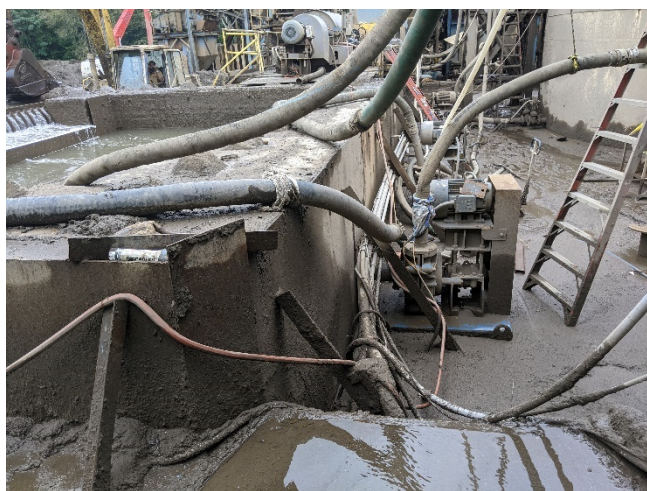
*Figure 66: PXL\_20211006\_145946590.jpg – Process wastewater and sludge flowing from the process onto the ground in the wastewater treatment area*

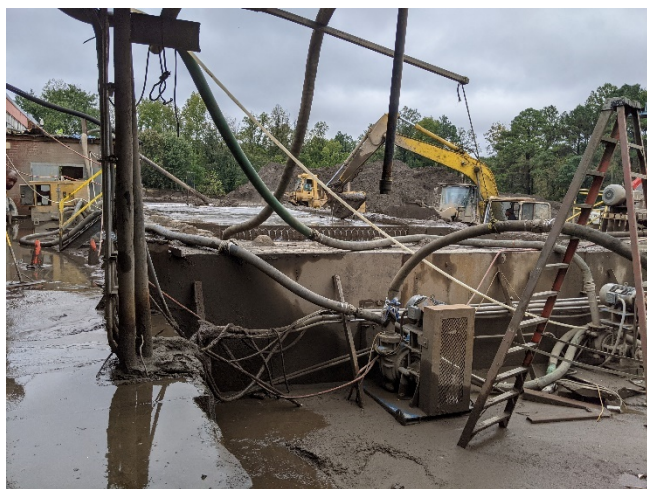
*Figure 72: PXL\_20211006\_151016463.jpg - Wastewater Treatment Area*

The processes all include the use of water. The facility collects stormwater in several areas at the facility and uses it in the processes. Much of the process water is swept out the doors of the process building, where it accumulates in low lying areas and it is pumped to a tank where flocculant is added to aid in the precipitation of solids from the water. The solids are removed by a backhoe and placed back into the processing. From the clarifier the water is pumped to a large tank. At the time of the CEI, the clarifier and the tank were observed to be overflowing. The secondary containment in the Wastewater Treatment (WWT) Area could not be properly inspected due to the accumulation of sludge on the surface. Figures 71 – 79 illustrate the condition of this area at the time of the CEI.

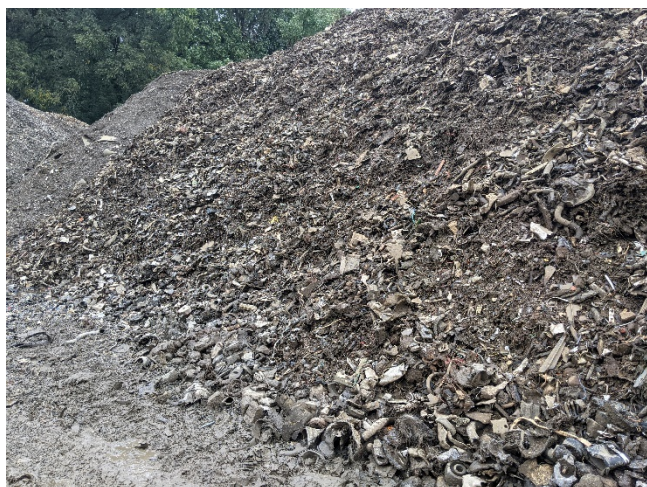
*Figure 87: PXL\_20211006\_153116223.jpg –  
Receiving Area*

The inspectors reviewed the sources of the water and found that stormwater and operation process water, from the processing of the solid waste, was being swept out of the building. Due to holes in the roof and inadequate containment, both sources of water flow through the facility from south to north and collect in the asphalt area seen in Figures 87 and 88.

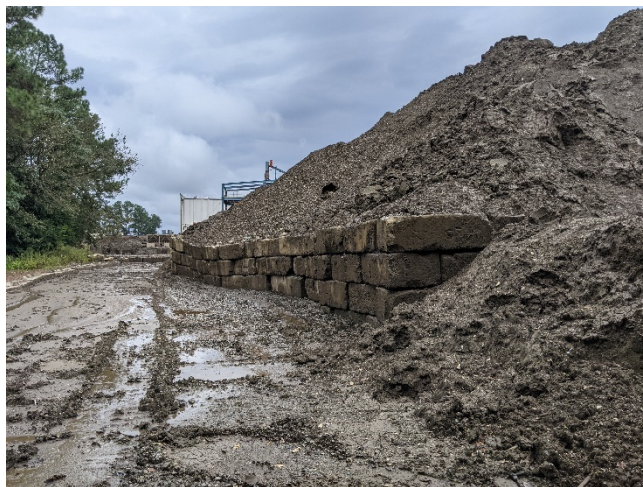
*Figure 97: PXL\_20211006\_181046518.jpg –  
Rear side of solid waste pile near Outfall 3*

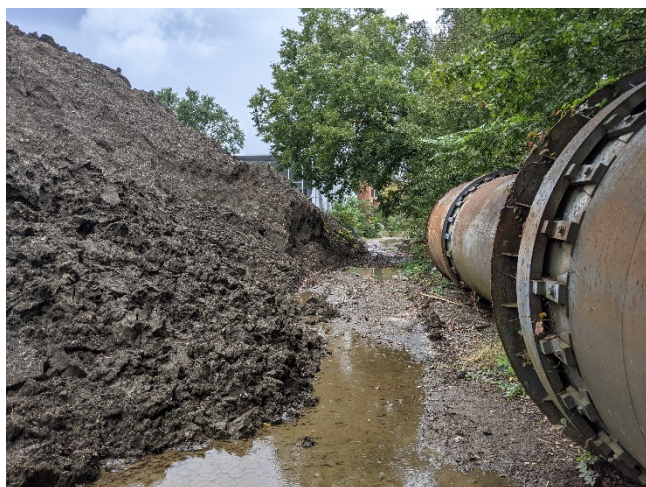
*Figure 98: PXL\_20211006\_181114686.jpg –  
Rear side of solid waste pile near Outfall 3*
