**Re: Ryan Homes/NVR Inc. - Hawk Pointe Area 2  
EPA Compliance Evaluation Inspection (CEI), May 15, 2024  
NJPDES 5G3 Permit Number NJG0333433**

**COMPLIANCE EVALUATION INSPECTION REPORT**

<b>Program:</b> Construction Stormwater	<b>Inspection Type:</b> Compliance Evaluation Inspection
<b>Permittee Name:</b> Hawk Pointe Area 2 (Ryan Homes/NVR)	<b>NPDES/ICIS No.:</b> NJG0333433
<b>Inspection Entry Date:</b> May 15, 2024 <b>Inspection Entry Time:</b> 12:20 PM	<b>Inspection Exit Date:</b> May 15, 2024 <b>Inspection Exit Time:</b> 2:15 PM
<b>Facility Inspected:</b> Hawk Pointe Area 2 11 Limestone Blvd Washington Twp, NJ 07882	<b>Lat, Long:</b> 40.756951, -74.986148 <b>NAICS / SIC Code:</b> 1522: General Contractors: Residential Buildings, Other Than Single-Family
<b>EPA Representative(s):</b> Christina Palmrose-Krieger, EPA Region 2, 212-637-4049, <a href="mailto:Palmrosekrieger.Christina@epa.gov">Palmrosekrieger.Christina@epa.gov</a> Mikhail Mohammed, EPA Region 2, 212-637-4265, <a href="mailto:Mohammed.Mikhail@epa.gov">Mohammed.Mikhail@epa.gov</a> Patrick Whalen, EPA Region 2, 212-637-4290, <a href="mailto:Whalen.Patrick@epa.gov">Whalen.Patrick@epa.gov</a>

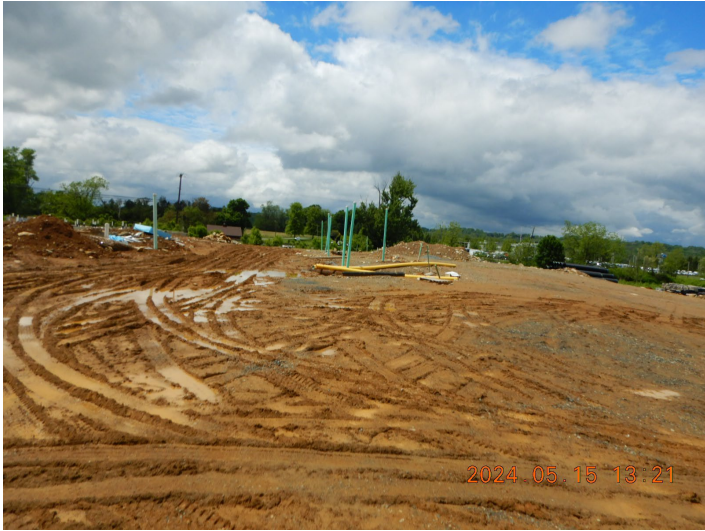
DSCN3284	Stormwater and disturbed soil south of Limestone Blvd facing west towards Route 31; foundation of Asbury Farms apartment building
DSCN3285	Stormwater and disturbed soil south of Limestone Blvd facing west towards Route 31; foundation of Asbury Farms apartment building
DSCN3286	Construction material and debris along south east portion of the Site

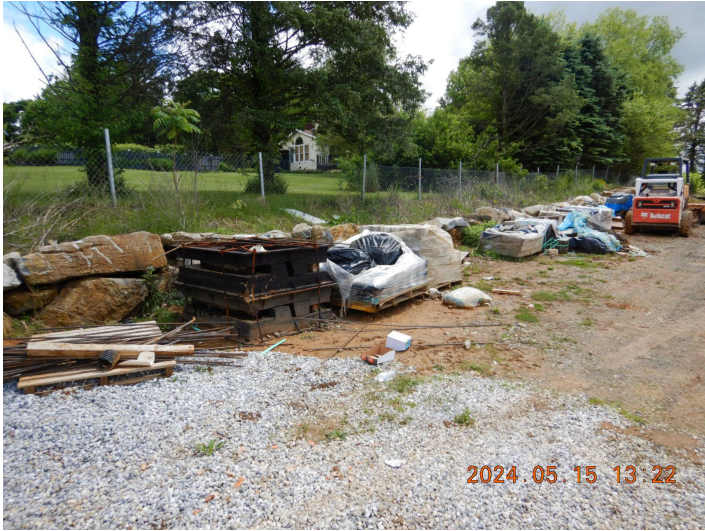
DSCN3287	Construction material and debris along south east portion of the Site
DSCN3288	Asbury Farms apartment building foundation in southern section of the Site
DSCN3289	View along the construction road running north to south to Limestone Blvd; facing northeast
DSCN3290	View along the construction road running north to south to Limestone Blvd; facing southwest to Rymon Rd entrance
DSCN3291	Sediment and dust seen on Rymon Rd entrance
DSCN3292	Sediment and dust seen on Rymon Rd entrance; track-out controls in need of maintenance
DSCN3293	Construction entrance/exit on Rymon Rd
DSCN3294	Construction entrance/exit on Rymon Rd
DSCN3296	Silt fencing in need of repair on southern edge of Site
DSCN3297	Silt fencing in need of repair on southern edge of Site
DSCN3298	Silt fencing in need of repair on southern edge of Site along Route 31
DSCN3299	Silt fencing in need of repair on southern edge of Site along Route 31

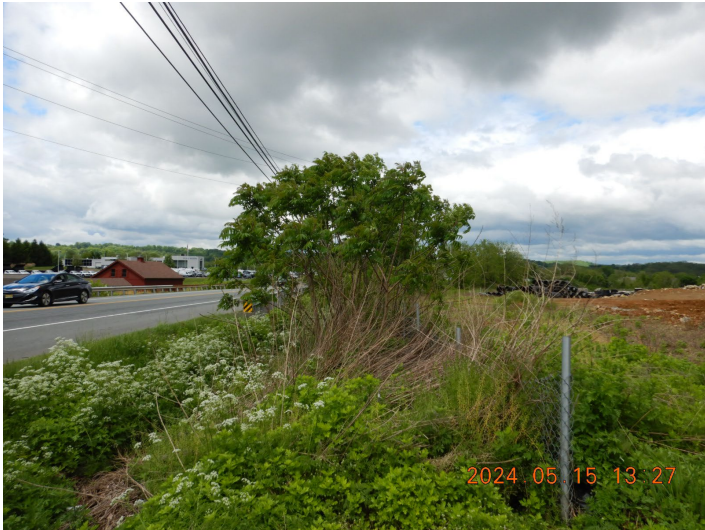
DSCN3301	Silt fencing in need of repair on southern edge of Site along Route 31
DSCN3302	Silt fencing in need of repair on southern edge of Site along Route 31
DSCN3303	Silt fencing in need of repair on southern edge of Site along Route 31
DSCN3304	Silt fencing in need of repair on southern edge of Site along Route 31
DSCN3305	Silt fencing in need of repair on southern edge of Site along Route 31
DSCN3306	Slope where stormwater runs towards Route 31; silt fencing in need of repair
DSCN3307	Slope where stormwater runs towards Route 31; silt fencing in need of repair
DSCN3308	Silt fencing in need of repair along Route 31
DSCN3309	Silt fencing in need of repair along Route 31
DSCN3310	Silt fencing in need of repair along Route 31; stormwater and sediment pooling in down silt fencing
DSCN3311	Silt fencing in need of repair along Route 31; stormwater and sediment
