# SERVICE BULLETIN

No. Q1010 under BRAKES

## MANDATORY SAFETY CAMPAIGN

**BRAKE ANTI-WHEEL LOCK WIRING**  
(R. RD. U and DM with MVSS121 Anti-Lock System)

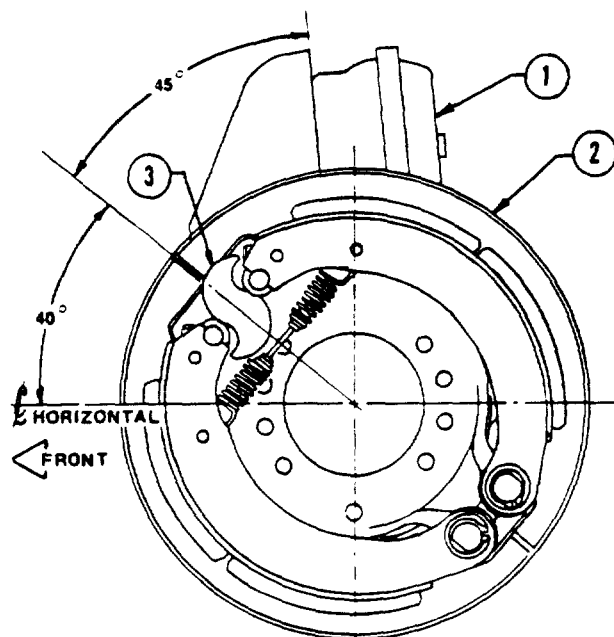
FIGURE 3

1. BRAKE CHAMBER  
2. BRAKE ASSEMBLY, 16-1/2 X 5 CAM (L.H. SHOWN)  
3. BRAKE CAMSHAFT

- c. Transfer spiders, camshafts and brake chambers to the side opposite the one they were originally installed on. Be sure cam and chamber are oriented as shown in Figure 3. Complete the assembly using a new inner wheel seal.

Do not transfer brake drums and shoes. These parts must remain on same side as originally installed and shoes must also be installed in same position, (i.e. primary & secondary).

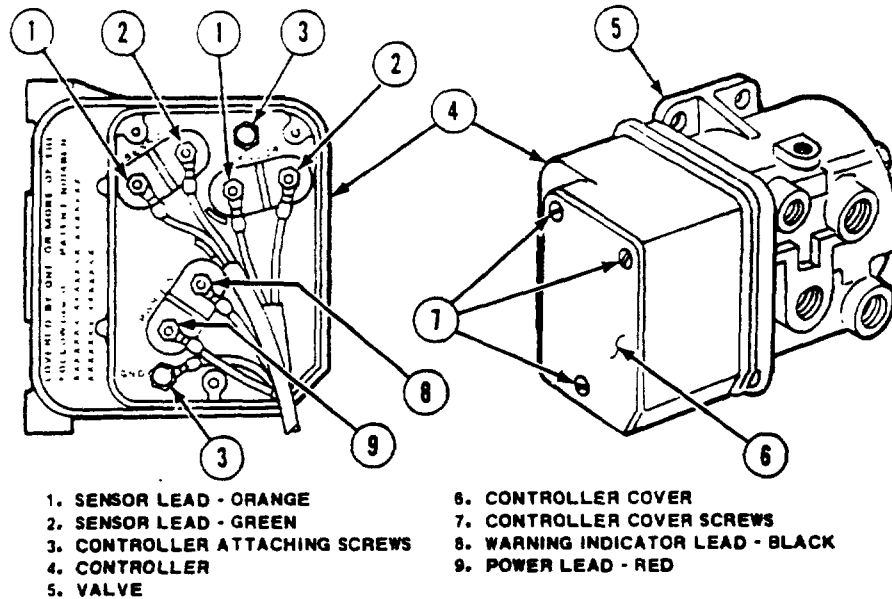
FIGURE 2  
MODEL 1200 CONTROLLER/VALVE ASSEMBLY

**PURPOSE** To notify the field of need to recall certain of these vehicles to inspect and where necessary replace the controller. An electrical malfunction in these controllers can cause a "no brake condition" on the axle being controlled by the affected anti-wheel lock controller.

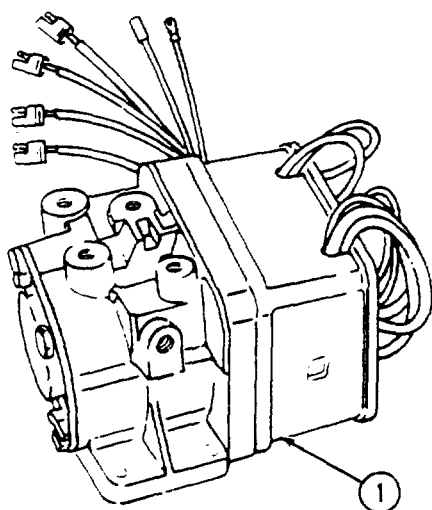
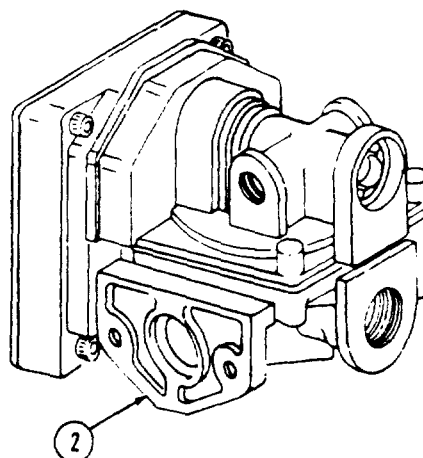
FIGURE 1  
IDENTIFYING VALVE/CONTROLLER ASSEMBLIES

1. EATON VALVE/CONTROLLER ASSEMBLY  
2. BENDIX VALVE/CONTROLLER ASSEMBLY

Two systems, Eaton and Bendix are involved. With Eaton systems, two complete new valve/controller assemblies are used. With Bendix systems, only one new valve/controller assembly is required and a new controller is to be installed on present valve. Figure 1 illustrates the two types of valve/controller assemblies.

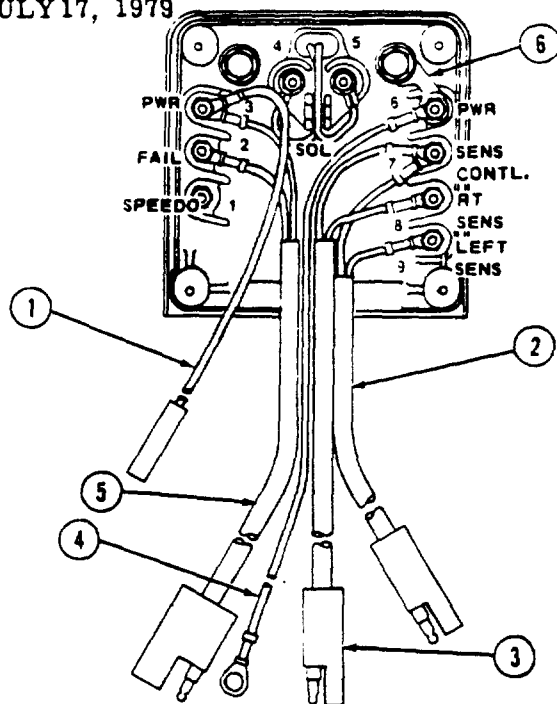
FIGURE 3  
BENDIX CONTROLLER CONNECTIONS -  
TWO-SENSOR UNIT WITH NEGATIVE GROUND  
EATON SYSTEM

1. CONTINUITY WIRE (RED)
2. WHEEL SPEED SENSOR LEAD, L.H.
3. WHEEL SPEED SENSOR LEAD, R.H.
4. GROUND WIRE (WHITE)
5. POWER/WARNING LEAD (LARGE CONNECTOR)
6. GROUND LINK

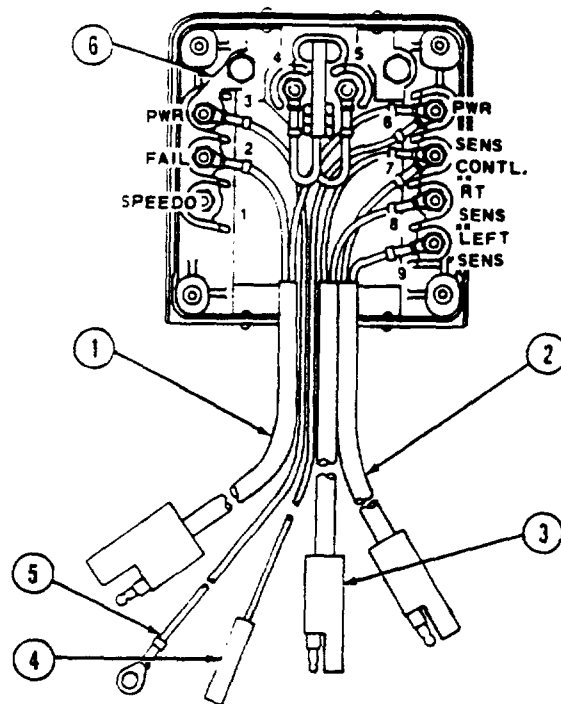
FIGURE 4  
BENDIX CONTROLLER CONNECTION -  
TWO-SENSOR UNIT WITH POSITIVE GROUND

1. POWER/WARNING LEAD (LARGE CONNECTOR)
2. WHEEL SPEED SENSOR LEAD, L.H.
3. WHEEL SPEED SENSOR LEAD, R.H.
4. CONTINUITY WIRE (RED)
5. GROUND WIRE (WHITE)
6. GROUND LINK
