# NPDES Compliance Inspection Report

## Woodgrain Millwork Nampa, Idaho

NPDES Permit Tracking Number  
# IDR053086

Inspection Date: March 1, 2024

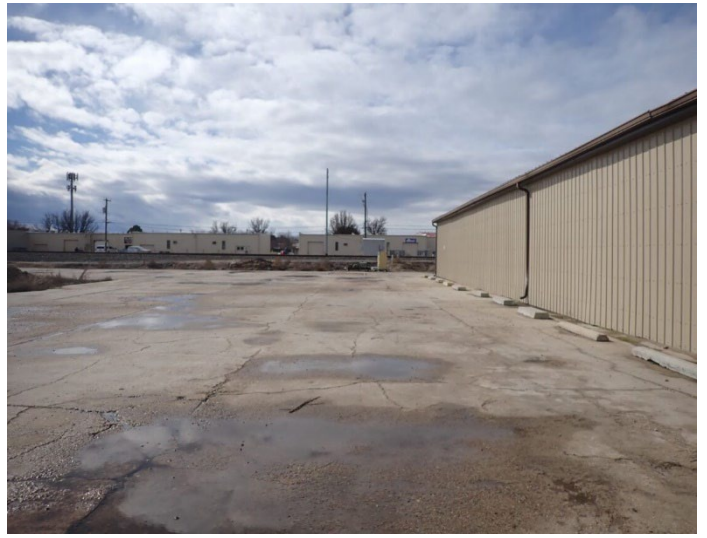
Photo #:05 (P3010261)

Description: Photo of some debris in the facility's southern parcel.

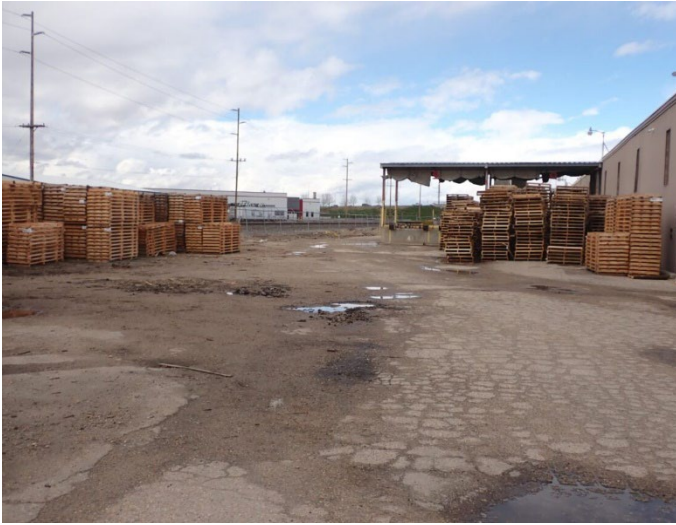
Photo #:09 (P3010285)

We proceeded North across West Karcher Road into the Facility's truck gate on the southwestern corner of the Facility's northern parcel where vehicle traffic enters and exits the Facility (**Photo 9** and **Photo 10**). We observed stormwater pooling just outside the truck gate and along empty glue container storage just inside the gate (**Photo 10**). We continued Northwest along the western perimeter of the Facility's northern parcel. We observed vehicle traffic corridors (**Photo 9** and **Photo 11**) and plastic debris on the ground (**Photo 12**). Mr. Wood explained there were windy conditions in the past couple of days that may have brought debris and garbage into the Facility. We also observed some of the Facility's scrap metal bins that are picked up and recycled or disposed of as needed by United Metal (**Photo 13**). The Facility had waste oil that is pumped out by Master Rooter and spent antifreeze tanks awaiting pick-up (**Photo 14**). We did not see any spill kits in the vicinity of the waste oil and spent antifreeze. We went inside the Facility's production building (Building 6) and observed the containers of waste paint and machinery washwater that is pumped out by a local waste vendor for proper offsite disposal (**Photo 15**). We then observed the "boneyard" of outdoor storage of various materials on impervious ground on the northwestern corner of the Facility (**Photo 16**). Stormwater in this area may not discharge to Indian Creek based on its location and drainage direction into another impervious area serving as an empty lot located directly East of the boneyard on the northeastern corner of the Facility. However, it appeared vehicle traffic occurred in the boneyard based on tire track presence (**Photo 16**).

During the inspection, we observed stormwater pooling just outside the Facility’s main truck gate where vehicle traffic enters and exits that can lead to offsite tracking of sediment from vehicles.

Description: Facing northwest, photo of the northwestern perimeter of the facility just inside the facility's northern parcel truck gate.

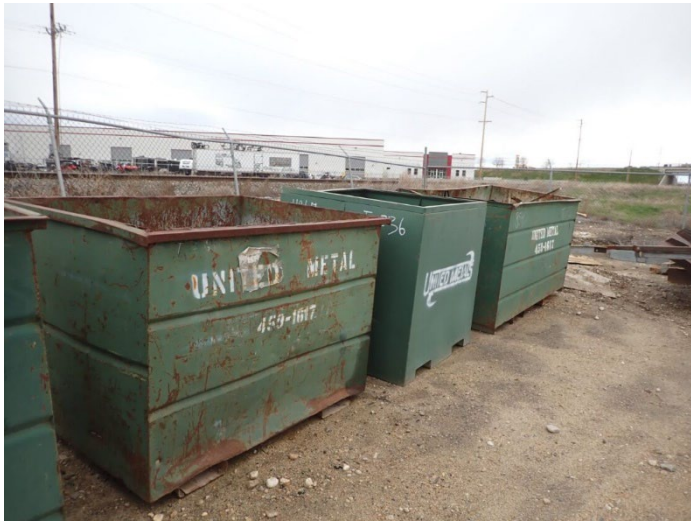
Photo #:13 (P3010298)

Description: Facing northwest, photo of the facility's metal bins picked up by United Metal for disposal when requested by the facility.

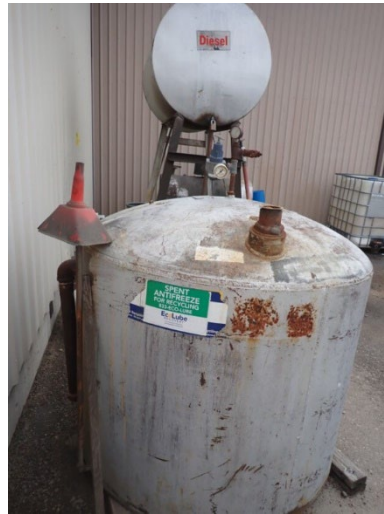
Photo #:14 (P3010303)

Description: Facing southeast, photo of spent antifreeze tank and oil tank at the facility. Waste oil collects in secondary containment below the diesel tank and is pumped out into a waste vendor truck for proper disposal.

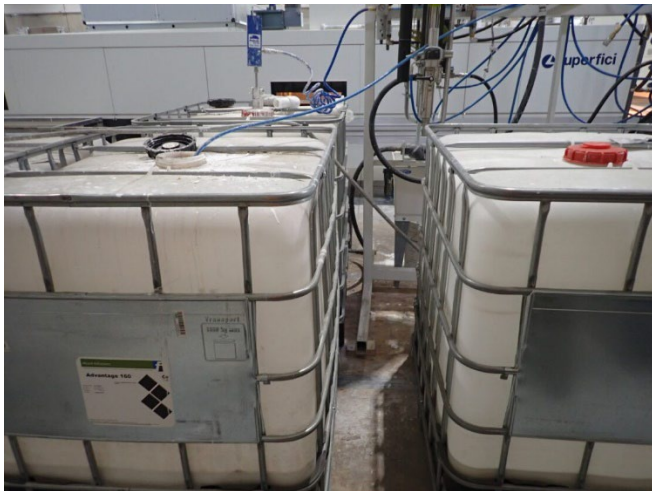
Photo #:15 (P3010311)

Description: Photo of waste paint and washwater totes located inside the facility's production building. The waste paint and machinery washwater is pumped out by a waste vendor truck for proper disposal.

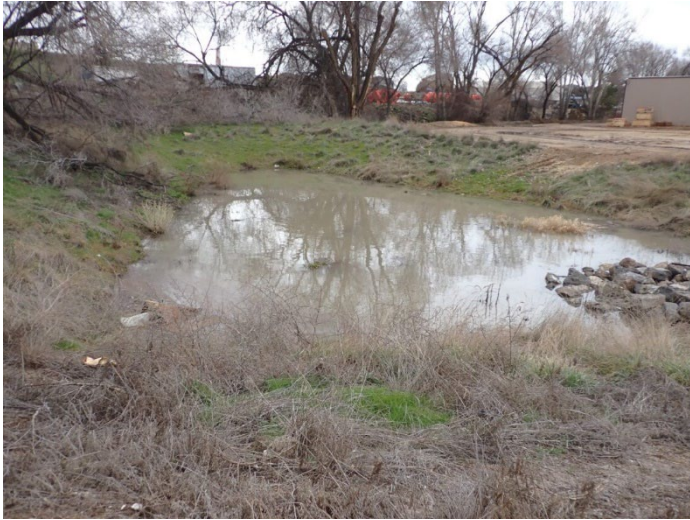
Photo #:17 (P3010324)

As we made our way Southeast on the northeastern part of the Facility, we observed the Facility's stormwater retention basin that receives water from a pipe connected to a drain on the East side of the basin (**Photo 17**, **Photo 18**, and **Photo 19**). According to the Facility's SWPPP, the retention basin is designed to capture and contain the majority of stormwater onsite and retain up to the 25-year storm. The Facility is generally graded for sheet flow to drain to the retention pond. To the East of the retention basin, we observed some of the Facility's chip bins and immediate vehicle traffic corridor on the eastern perimeter (**Photo 20**). We walked to the western side of the Facility's sawdust loading bin and observed sawdust on the ground (**Photo 21**). The Facility utilizes a dust collection system consisting of routine sweeping, shoveling, and vacuuming around the loading area and baghouse. The Facility owns a sweeper truck and uses it as needed. Facility personnel inspect blowers and vacuums onsite on a weekly basis. Truckloads of sawdust are also taken offsite for disposal. Additionally, Facility personnel conduct weekly preventive maintenance inspections of their assigned areas to verify their areas are clean and orderly as part of general housekeeping practices.

Description: Facing southeast, photo of the facility's stormwater retention basin that receives stormwater discharge from a drain East of the basin.

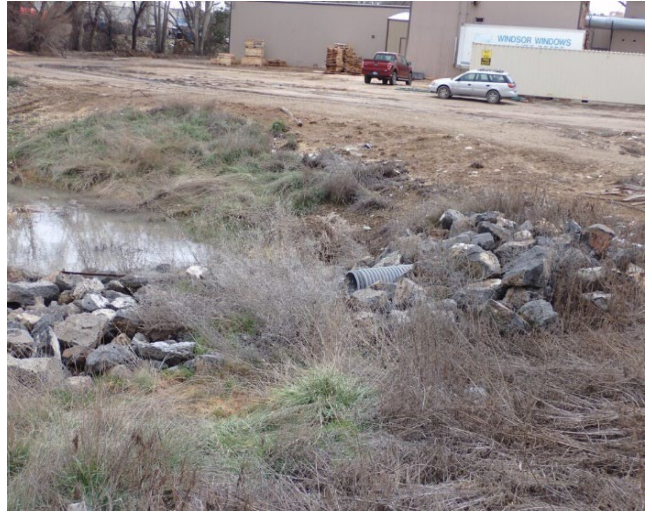
Photo #:18 (P3010326)

Description: Facing southeast, photo the facility's stormwater retention basin pipe that discharges stormwater that enters a drain East of the basin.

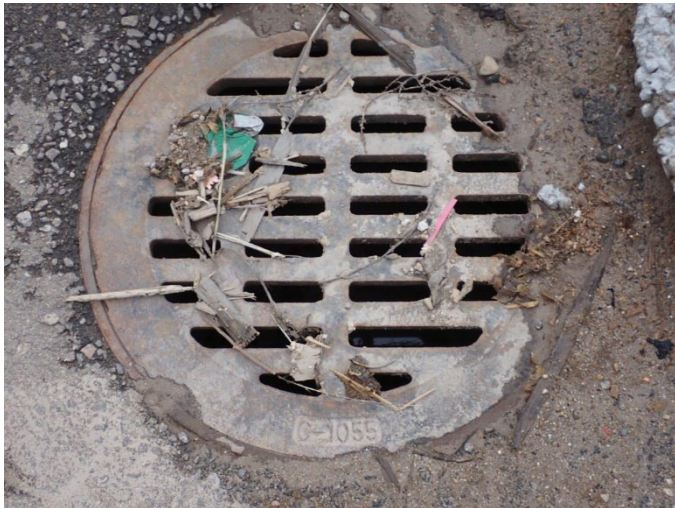
Photo #:19 (P3010328)

Description: Photo of the stormwater drain that discharges to the facility's stormwater retention basin.

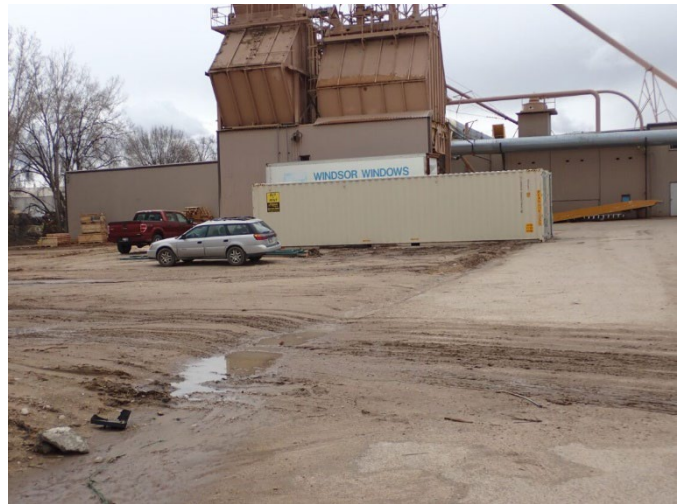
Photo #:20 (P3010331)

Description: Facing southeast, photo of chip bins at the facility and immediate vehicle traffic area in the eastern perimeter.

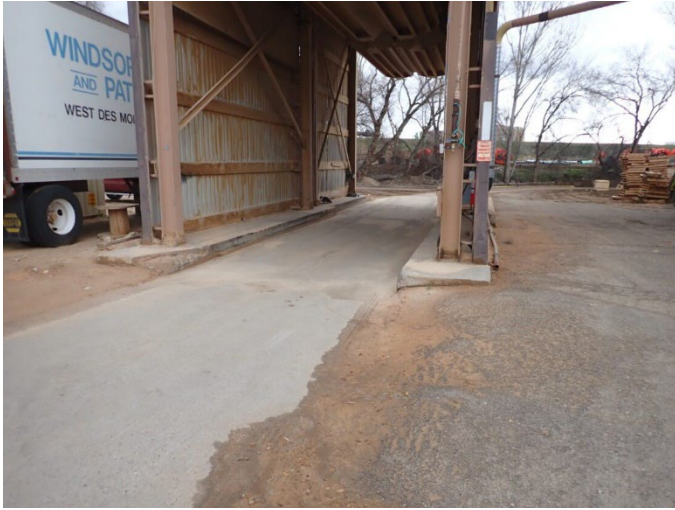
Photo #:21 (P3010339)

Description: Facing northeast, photo of the sawdust loading bay under the facility's chip bin.

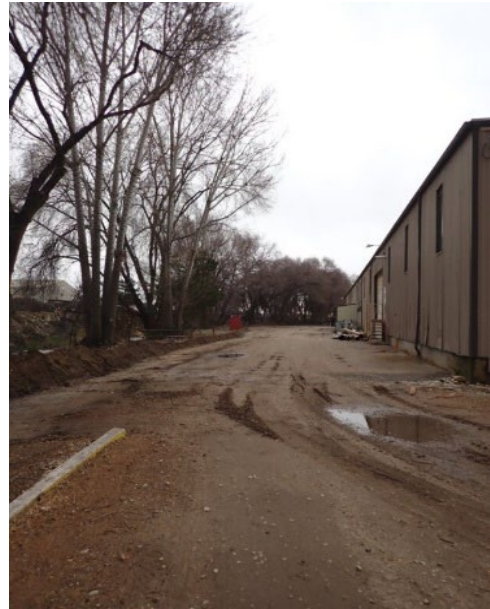
Photo #:22 (P3010345)

We then returned to the eastern perimeter of the Facility and observed the Facility's berm along this perimeter's edge adjacent to Indian Creek (**Photo 22**). The berm diverts water to the Facility's retention pond including sheet flow from Buildings 5 and 6. Along the Facility's eastern perimeter during the site walkthrough, we observed two other discharge pipes into Indian Creek, one from a rooftop downspout and one unnamed open discharge pipe with a metal screen (**Photo 23**, **Photo 24**, **Photo 35**, and **Photo 36**). The unnamed discharge pipe was not identified in the Facility's SWPPP, and no active discharge was observed from it at the time of inspection. We also observed the Facility's compliance monitoring outfall (SW1) on the eastern perimeter that discharges stormwater into Indian Creek from a storm drain located in the central part of the Facility's northern parcel (**Photo 26** and **Photo 32**). Discharges through this outfall first pass through a sand and oil water separator. The discharge pipe for this outfall was slightly underwater (**Photo 26**). Mr. Wood indicated the pipe was underwater for most of the last quarter. Mr. Wood conducts sampling at this outfall by taking a grab sample using a lab supplied plastic container. Mr. Wood said he refrigerates the samples and drives them to Analytical Laboratories in Boise. Mr. Wood measures discharge temperature using a thermometer.

We observed loose material that make up a berm serving as a BMP along the Facility’s eastern perimeter in the northern parcel. Additional possible erosion and destabilization was observed adjacent to Indian Creek on the Facility’s eastern perimeter near a gated path leading to the Facility’s eastern parking area.

Description: Facing southeast, photo of the facility's eastern perimeter with a berm on the perimeter's edge adjacent to Indian Creek.

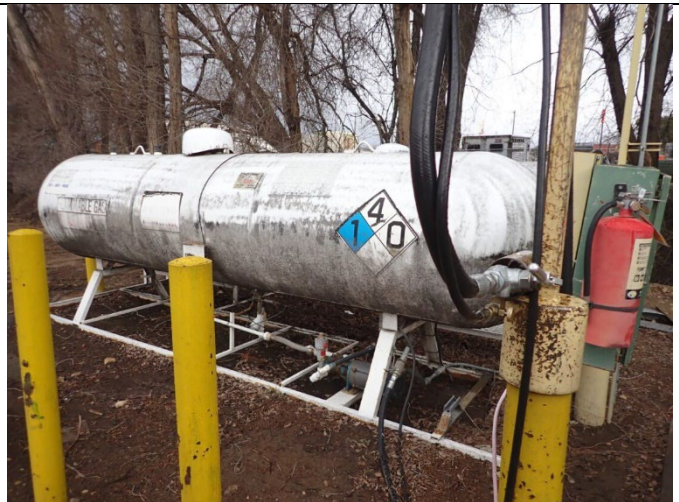
Photo #:28 (P3010361)

As we continued walking South along the Facility's eastern perimeter, we observed additional material temporarily stored outside (**Photo 25**), an uncovered dumpster (**Photo 27**), and a fuel tank located adjacent to the western bank of Indian Creek but inside the Facility's eastern perimeter berm (**Photo 28** and **Photo 29**). We did not see a spill kit in the vicinity of the fuel tank. We observed possible erosion from loose material from the Facility's eastern perimeter berm behind the fuel tank depicted in Photo 29 (**Photo 30**). Additional possible erosion and destabilization was observed adjacent to Indian Creek on the Facility's eastern perimeter near a gated path leading to the Facility's eastern parking area (**Photo 31**). Mr. Wood explained that small mammals called rock chucks may be digging holes or burrowing at the Facility and may be causing the possible destabilization, but he hasn't had issues with erosion or destabilization at the Facility.

Description: Facing northeast, photo of a fuel tank at the facility's eastern perimeter.

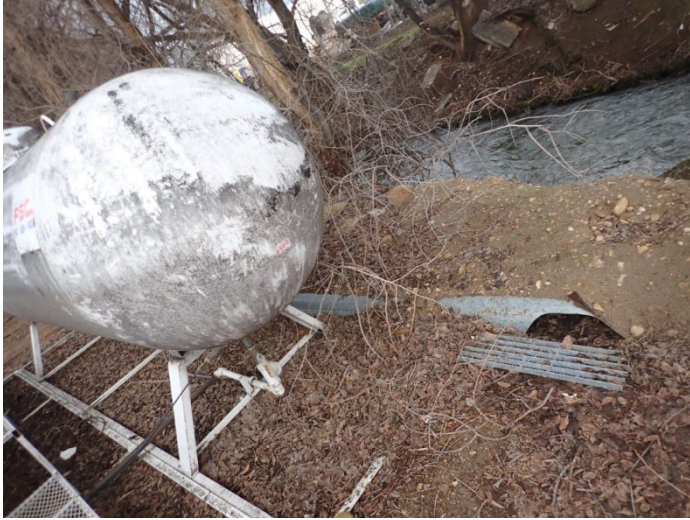
Photo #:29 (P3010362)

Description: Facing north, photo of the facility's eastern perimeter fuel tank with Indian Creek adjacent to it.

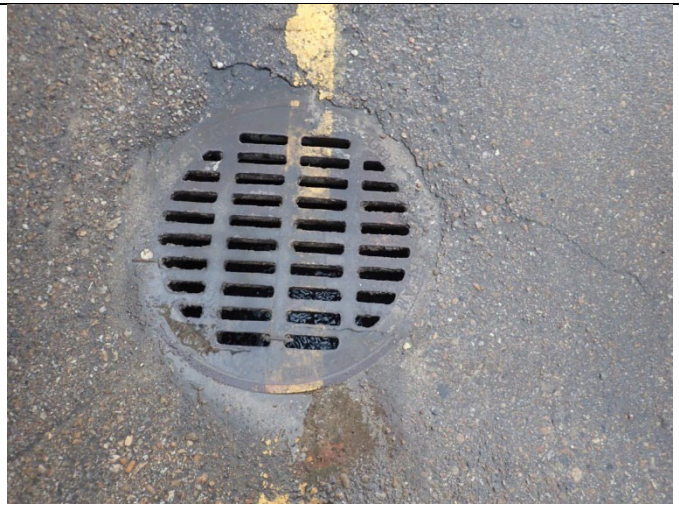
Photo #:32 (P3010379)

We turned to the Southwest to observe the industrial area in the central part of the Facility where we observed the SW1 outfall storm drain, portable toilets, and fire house (**Photo 32** and **Photo 33**). We walked Southeast through the central part of the Facility, stopped in Building 5 to briefly observe the door trimming process, and then headed to the southeastern area of the Facility's eastern perimeter in the northern parcel. In this area, we observed another unnamed pipe that may or may not discharge into Indian Creek (**Photo 34**), but the source of potential discharge was unknown to Mr. Wood. There was no active discharge coming from this pipe at the time of inspection. On the southeastern exterior side of Building 3, we also observed a diesel storage tank with secondary containment that did not have proper and legible National Fire Protection Association (NFPA) hazard warning labeling (**Photo 39**). We did not see any spill kits in the vicinity of this diesel storage tank. We then crossed a small bridge into the eastern employee parking area and headed back to the main administrative building in the Facility's southern parcel. Along the way, we observed additional debris along the western bank of Indian Creek behind the Facility's break room (**Photo 40**). Mr. Wood explained there were windy conditions in the past couple of days that may have brought debris and garbage into the Facility. We did not see the required public sign illustrating

Description: Photo of the facility's storm drain that discharges to Outfall SW1.

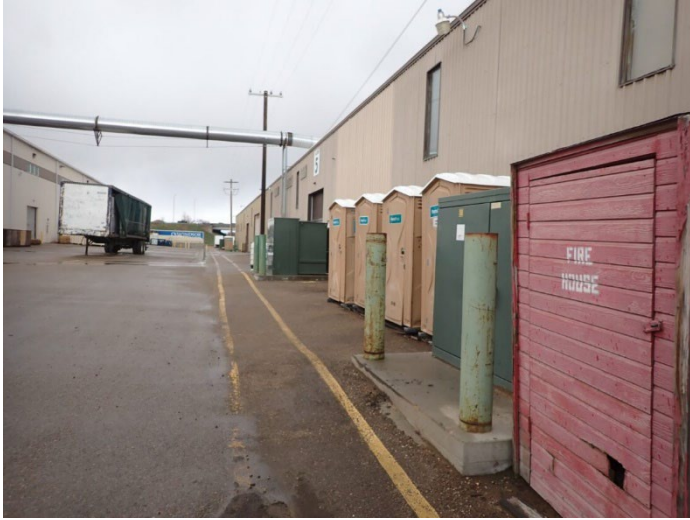
Photo #:33 (P3010380)

Description: Facing northwest, photo of portable toilets, fire house, and general industrial area close to the Outfall SW1 storm drain in the center of the facility.

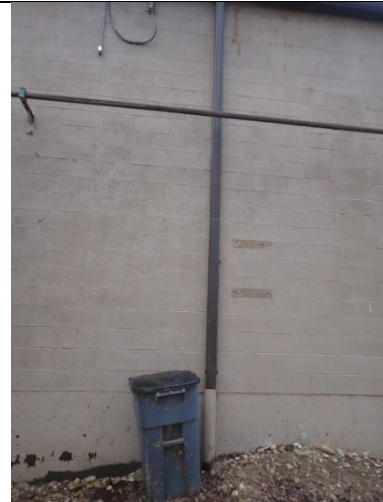
Photo #:36 (P3010394)

Description: Facing west, photo of the rooftop downspout connected to the discharge pipe depicted in Photo 35.

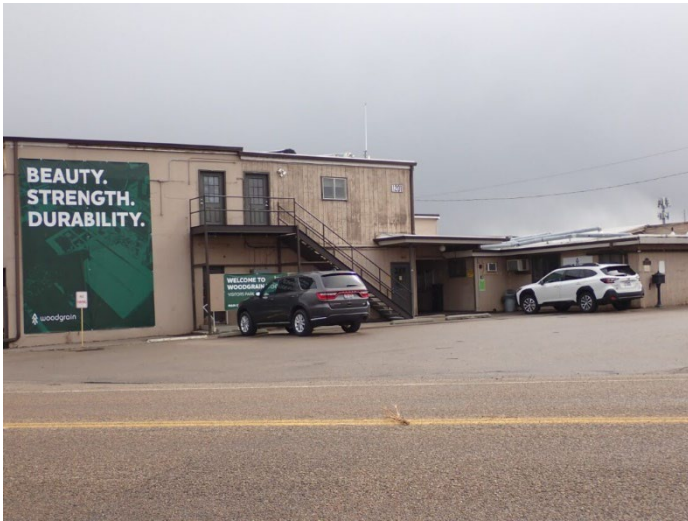
Photo #:37 (P3010405)

facility permit coverage during the site walkthrough nor upon returning to the Facility's administrative building (**Photo 37**). When I asked Mr. Wood about the sign, he indicated the Facility did not have one.

Description: Facing southeast, photo of the main entrance of the administrative building in the southern parcel of the facility.
