| Inspection Date(s): | 07/23/2019 | | |
| Media: | RCRA | | |
| Regulatory Program(s) | Subtitle C – Hazardous Waste | | |
| Company Name: | <b>M&amp;K Plating, Inc.</b> | | |

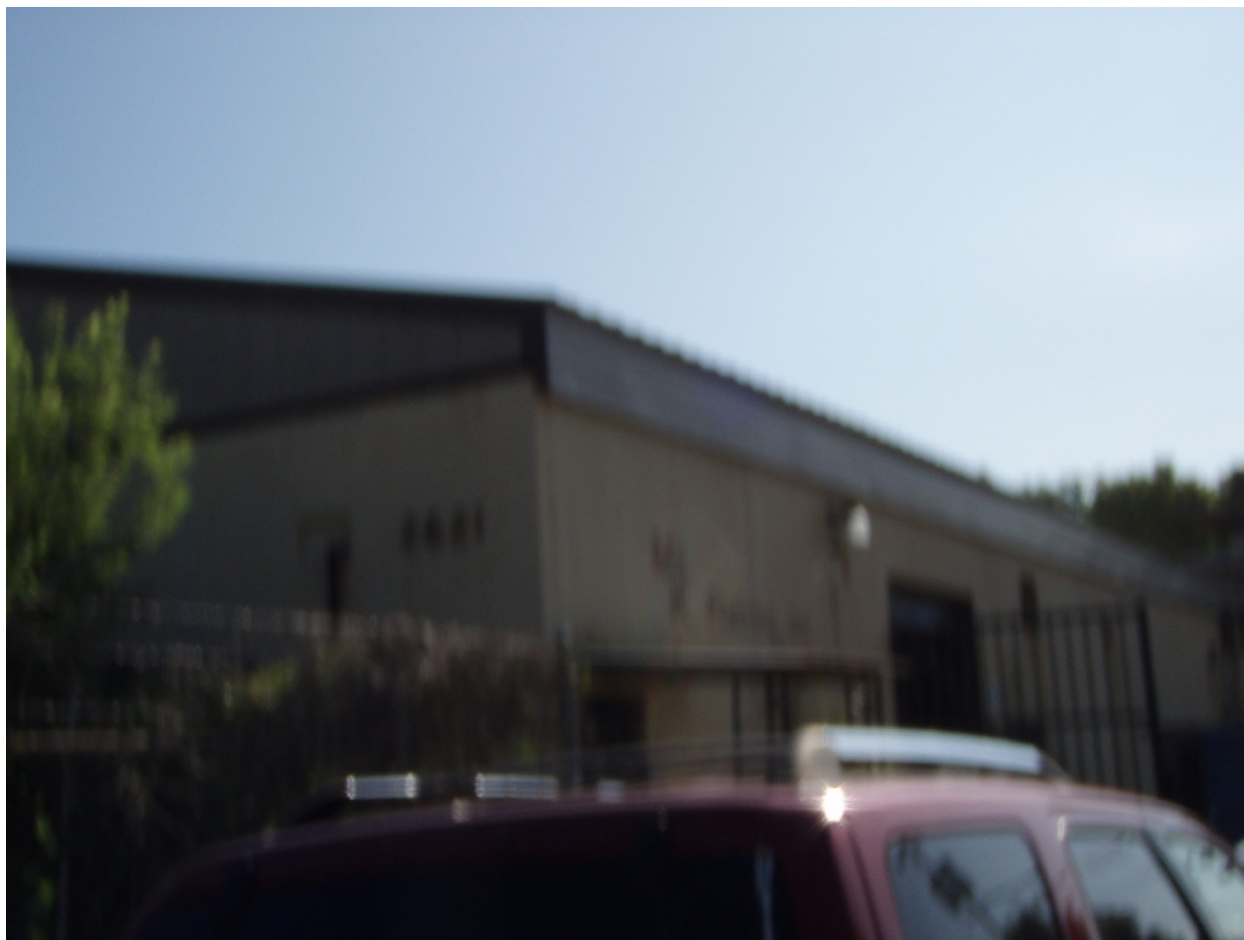
Photo File Name: P7230001

Description: View of wastewater treatment area (left). Receiving area is located off photo to the right.

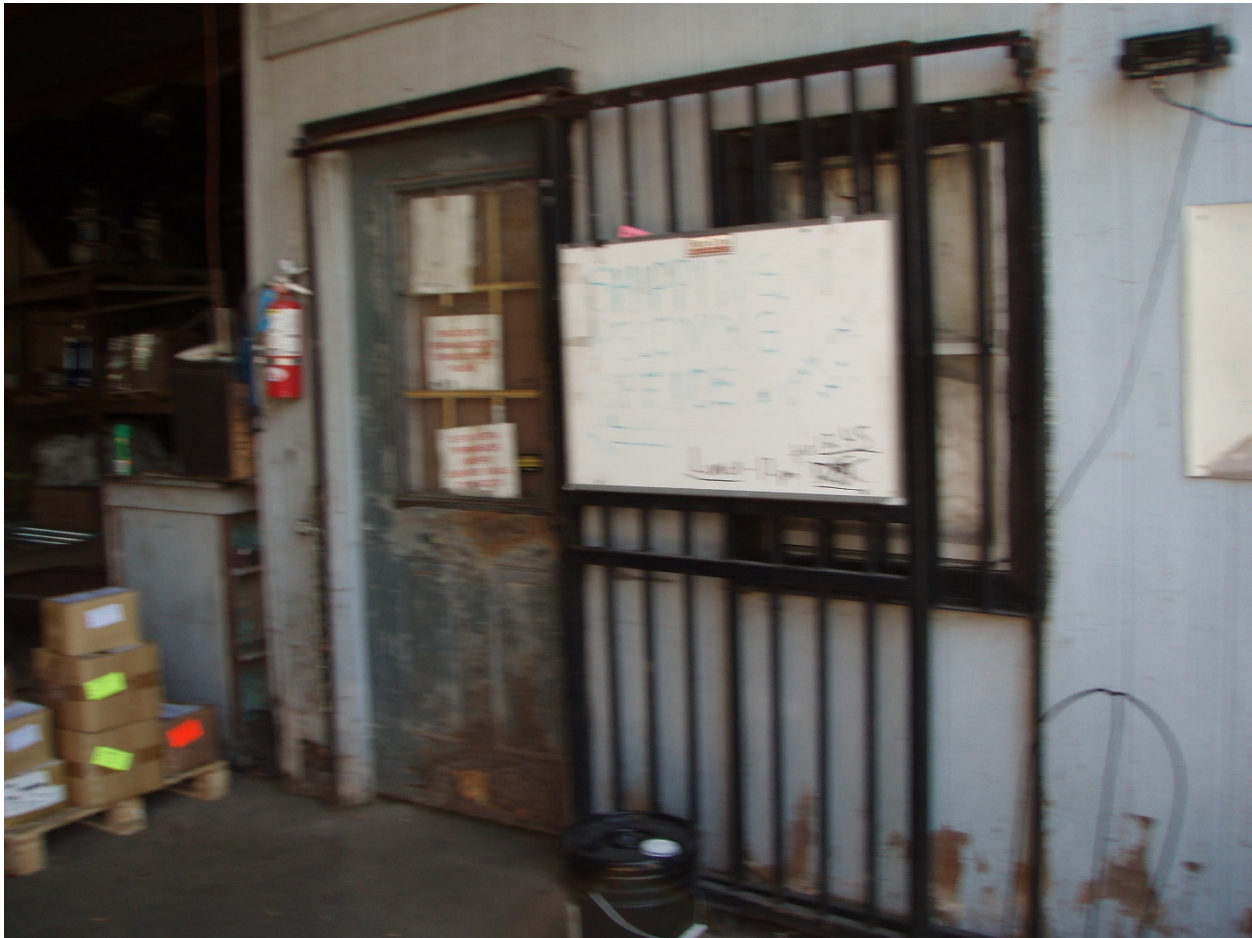
Photo File Name: P7230003

Description: Receiving office.

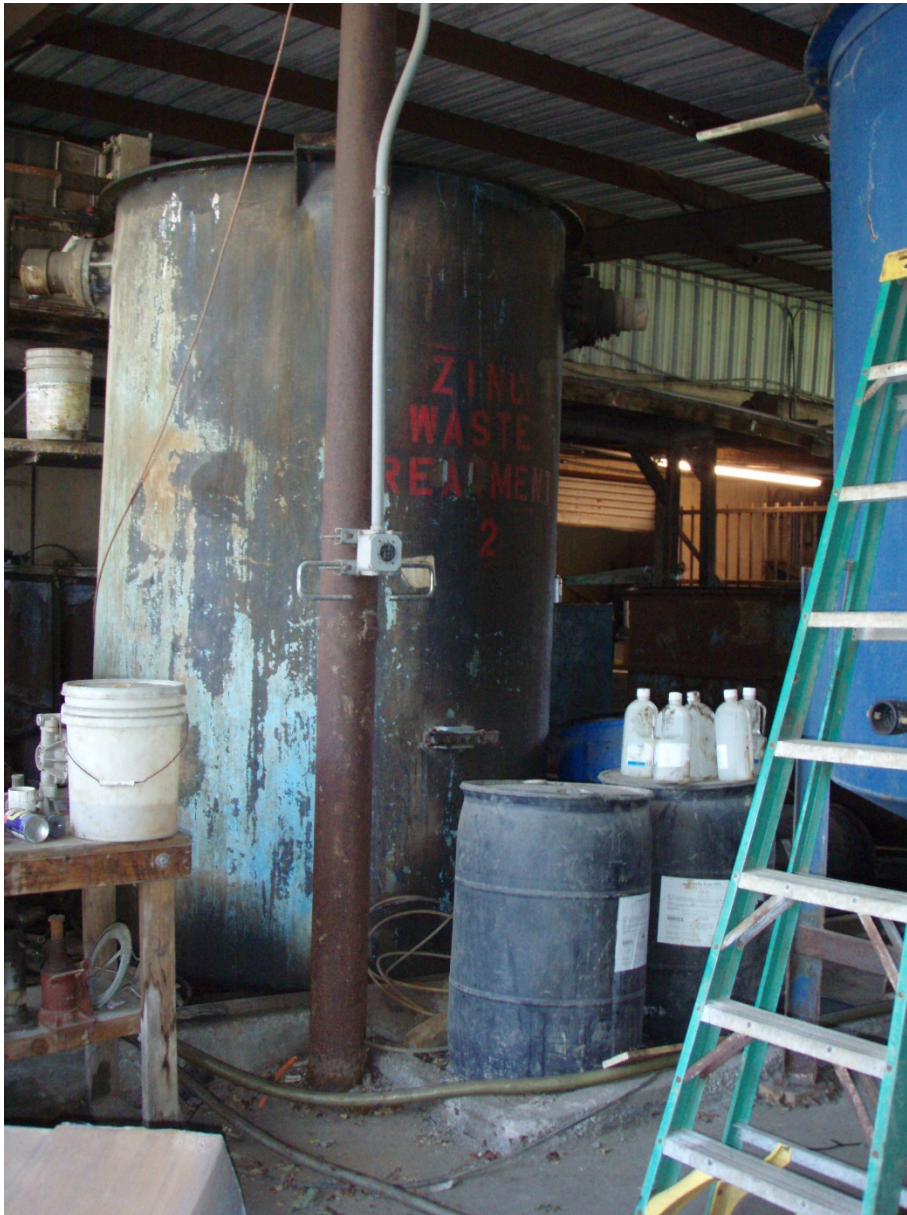
Photo File Name: P7230013

Description: Photo of wastewater treatment system. Shown: treatment tank for concentrates.

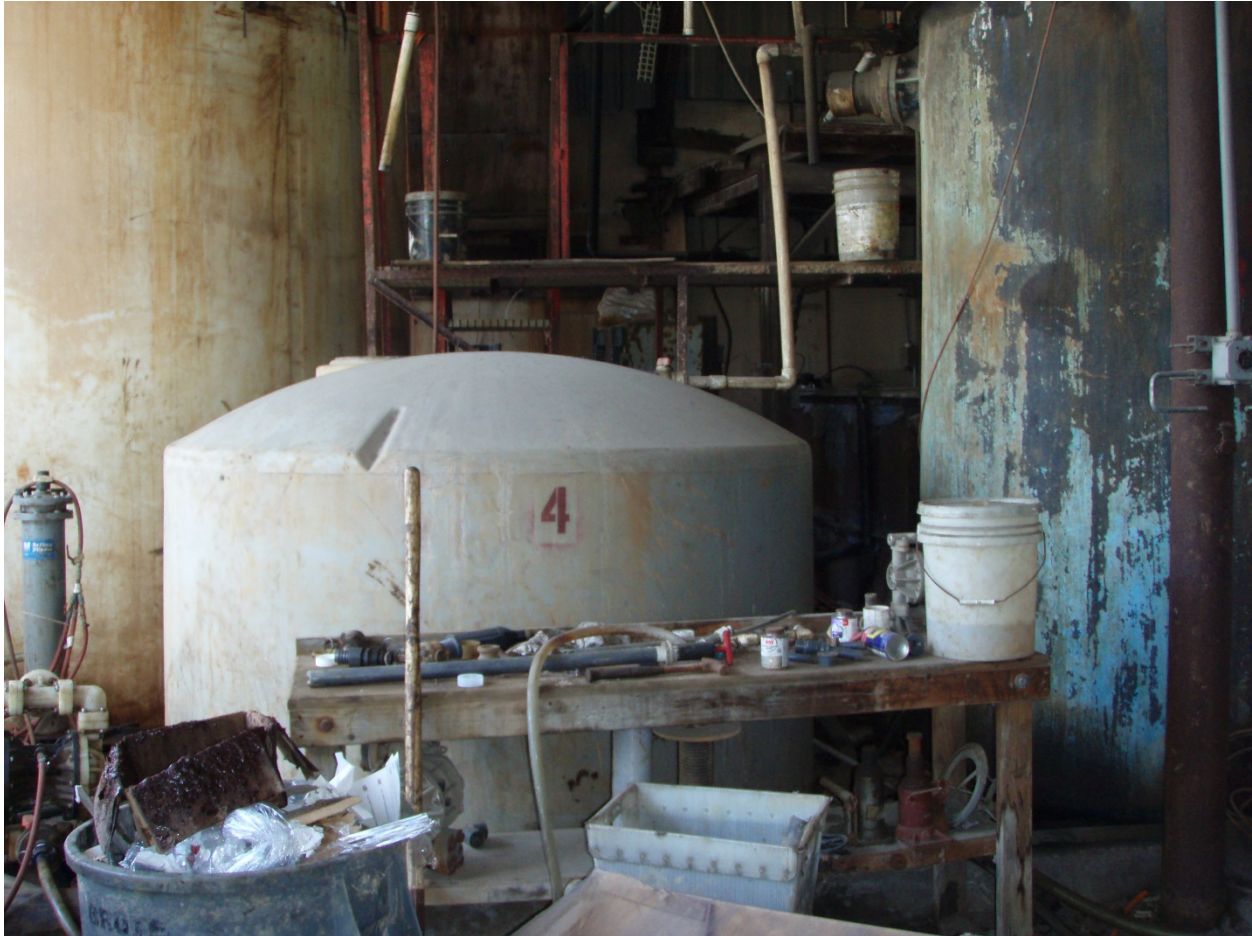
Photo File Name: P7230014

Description: Photo of wastewater treatment system. Shown: tank typically used for treated water (tank 5), filter (grey cylinder; center) and filter press (left). Photo lightened, and contrast lightened to show detail.

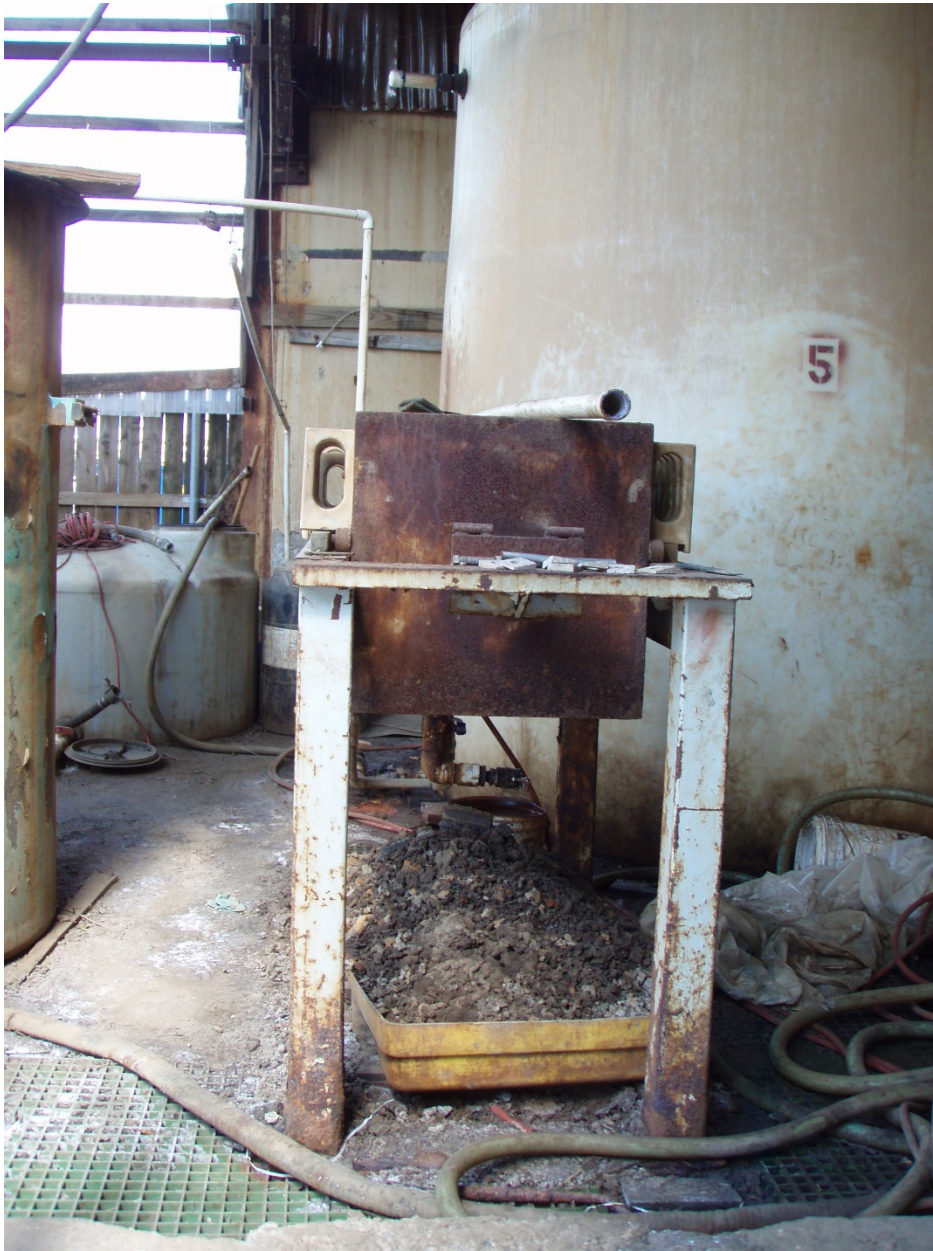
Photo File Name: P7230016

Description: Extra tanks brought in to hold treated wastewater prior to shipping off-site. Tank on left is metal and on the right is plastic.

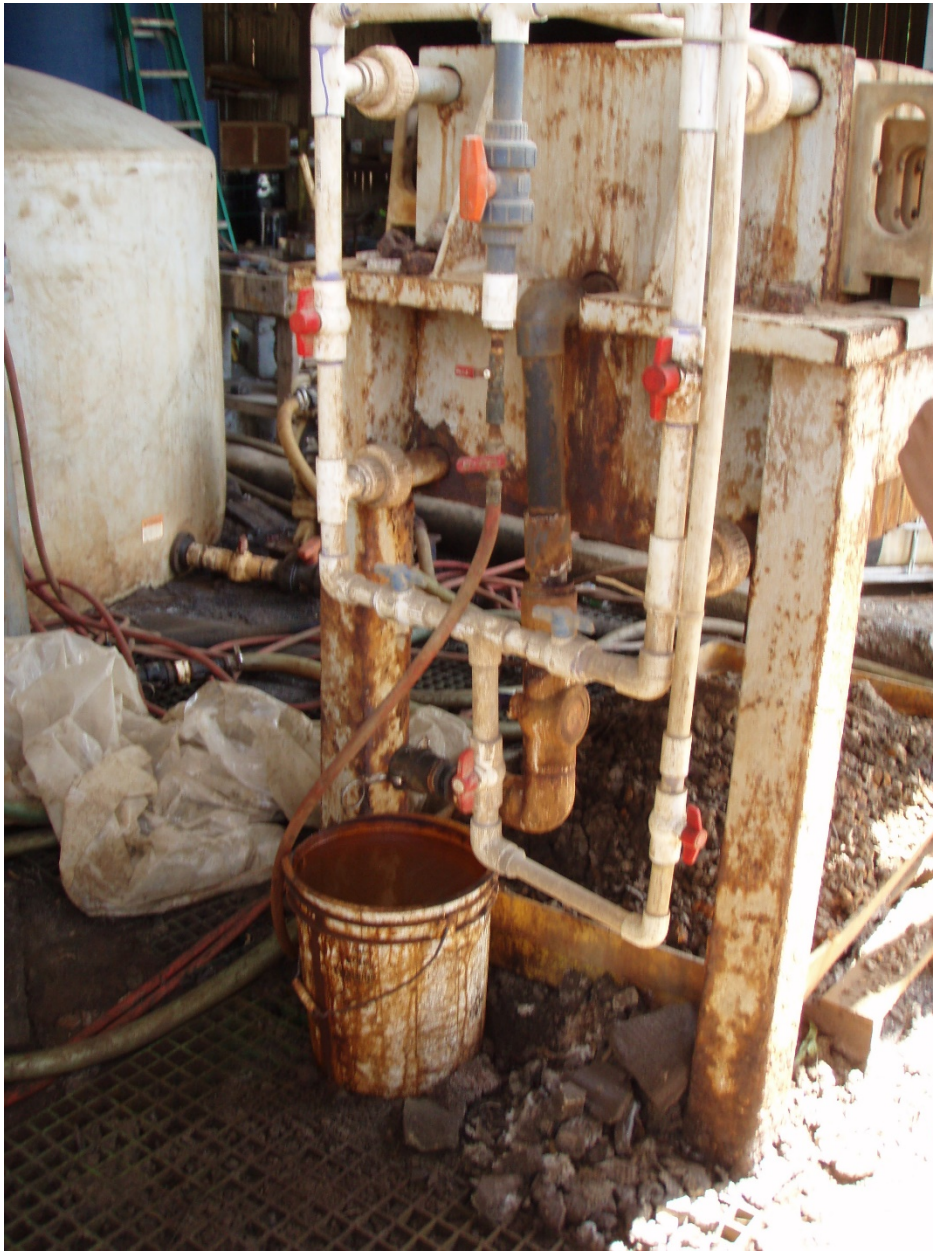
Photo File Name: P7230018

Description: Leak/spillage at connection to tank next to filter press. Tank is full of untreated wastewater per the owner.

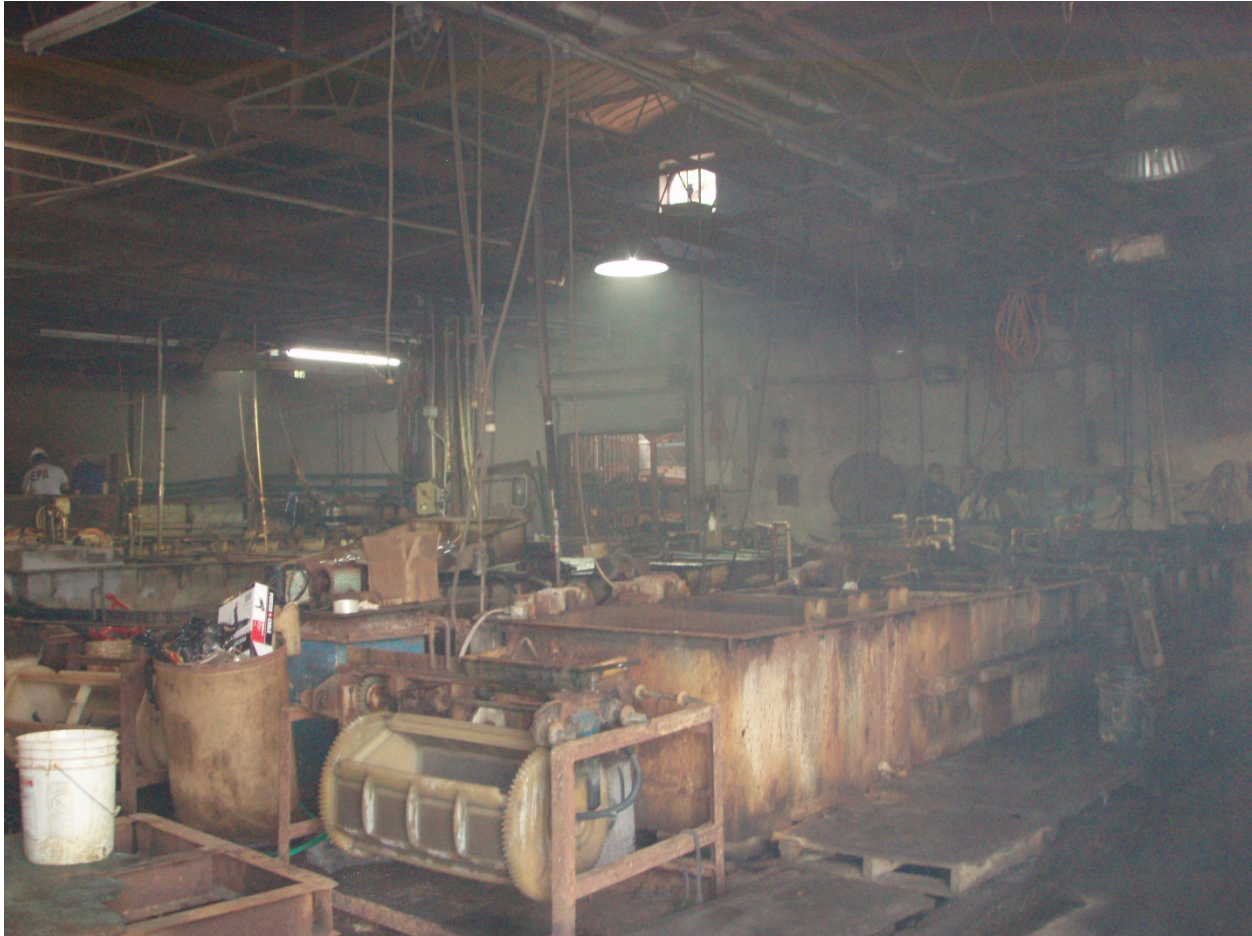
Photo File Name: P7230026

Mr. Curry identified two tanks being used to store electroplating wastewater and sludge: Tank 4 in barrel plating line #3 (Appendix C, photograph 25) and Tank 5 in the barrel plating line #1 (Appendix C, photograph 26). Mr. Curry said waste is held in the tanks until there is room in the WWTS. Normally the rinse water from the plating lines is piped directly to tanks in the WWTS for treatment, storage and disposal. Mr. Curry identified the hazardous characteristic of the untreated wastewater and sludge as D006 (cadmium), D007 (chromium), and F006. He said analytical testing for profiling the waste is conducted prior to disposal by the disposal firm hired by MKPI.

Description: City POTW outfall monitoring well/sump B. Located in front of facility
