## Hydrocarbons Tech Center Reactive Chemicals Handbook

## Hydrocarbons Reactive Chemicals Hazards

### ACETYLENE/ACETYLIDES

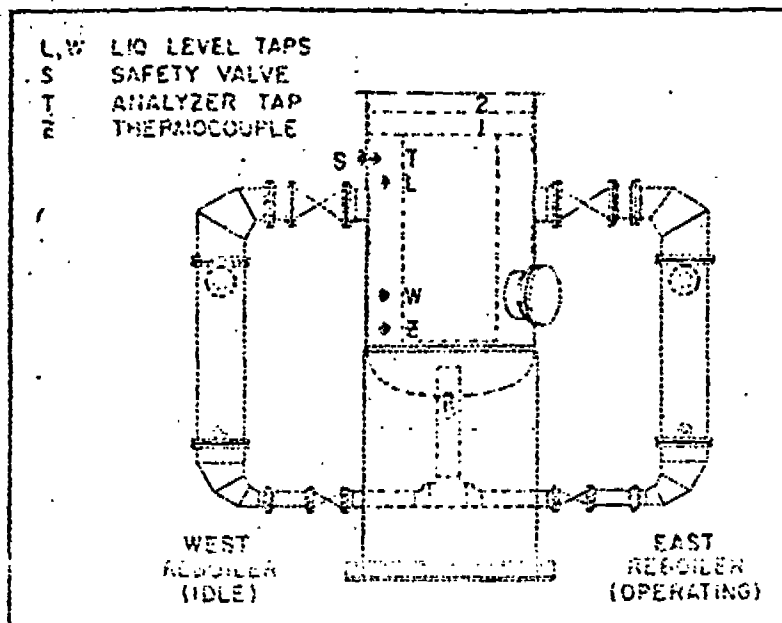
Figure 6. Refining column base elevation.

**System holdup**—During the eight hours and 23 minutes from 11 a.m. to 7:23 p.m., the base level in the refining column decreased. The chart on base liquid level recovered from the trend recorder indicated that the level had dropped to the elevation of the high side instrument tap, nozzle "W", by 2:30 p.m. (see Figure 6). Extrapolation of the decrease in liquid level predicted a level in the vicinity of the weld between the shell and bottom head at 7:23 p.m. This is just above the elevation of the riser which supplied liquid to the east reboiler (see Figure 6), but below that required to maintain natural circulation through the tubes. The calculated overall decrease in the amount of liquid in the column base is from 1,900 gal. at 11 a.m. to 540 gal. at 7:23 p.m.

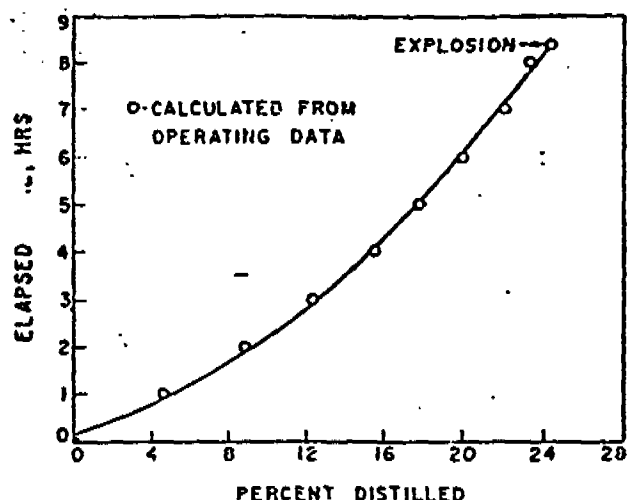
Figure 7. Passage of time prior to the explosion as a function of the per cent distilled from the system.

During the period of abnormal operation of the system prior to the explosion, a total of 10,300 lb. of overhead product was removed from the system. This is 24.4% of the material present originally in the system at 11 a.m. Figure 7 comprises the results of all holdup calculations, and indicates the passage of time from 11 a.m. as a function of the percent distilled from the system. This form of presentation is explained in the section of this article on unsteady-state operation.

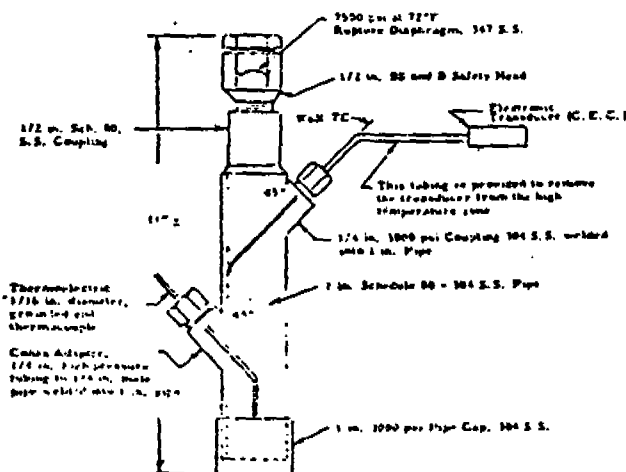
Figure 1. Normal stability test vessel.

The test vessel, shown in F-1, used has a capacity of 106 cc. of liquid. Its main body, constructed of 304 stainless steel, is a nominal 1 in. (the same size as the Texas City reboiler tubes) Schedule 80 pipe having an inside diameter of 0.956 in., and an outer diameter of 1.315 in. The bottom is closed with a 304 stainless steel, 3,000 lb./sq.in. pipe cap, and the top with a Black, Sivalls and Bryson 3,000 lb./sq.in., Type-1S, 1/2 in. screw-type safety head containing a 3-17 stainless steel rupture diaphragm rated at approximately 7,500 lb./sq.in. at a temperature of 72°F.

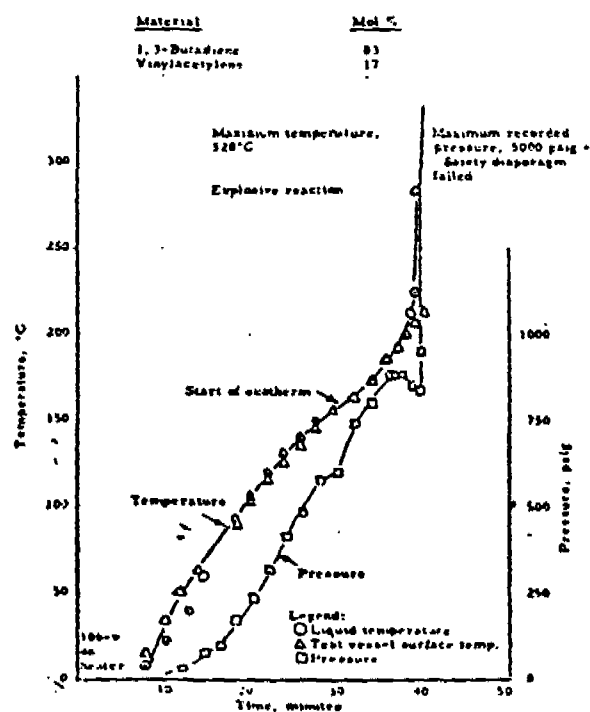
Figure 2. Thermal stability test of a vinylacetylene-butadiene mixture.

An illustration of the type of data obtained with a mixture containing 83 mol % BD in VA is shown in F-2. This material was heated at a rate of 5- to 10°C/min. exhibiting an exothermic reaction at a temperature of 158°C, and a pressure of 590 lb./sq.in. gauge. The temperature rose to 285°C at which point the reaction mixture explosively decomposed, and increased the pressure in the test vessel to failure of a safety diaphragm rated at 7,500 lb./sq.in. gauge at 72°F. From exotherm temperature to explosion temperature required about 10 min. elapsed time.

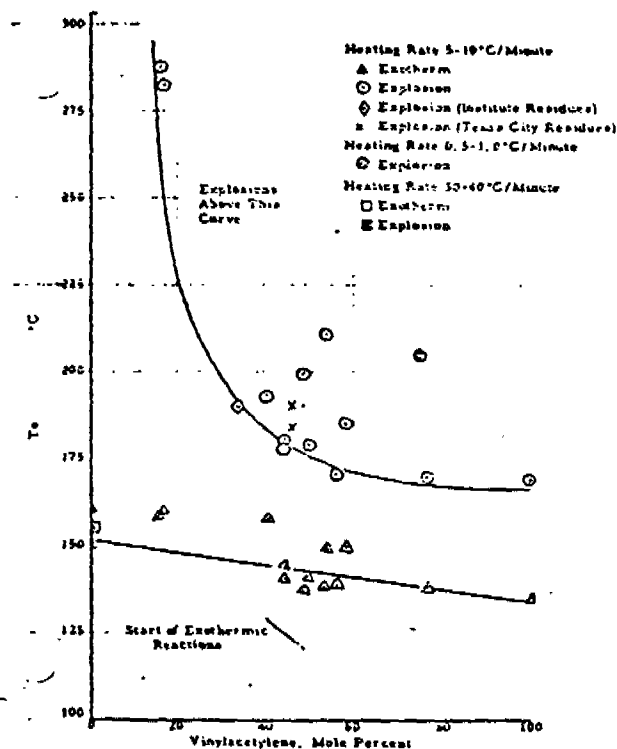
Figure 3. Thermal stability of vinylacetylene-butadiene mixtures.

specifically as being from the plant residue, were mixed in the laboratory from relatively pure BD, VA, n-pentane (n-P), cis-2-butene, and trans-2-butene. The major portion of the results shown in Figure 3, however, represent mixtures of refined BD and VA. Most samples exhibited an exothermic reaction beginning at a temperature of 135- to 145°C, with reaction being observed at a slightly lower temperature with increasing VA concentration. Explosions occurred at lower temperatures and pressures as the VA composition was increased.

indicate the potential exotherm and explosion temperatures. In more complex mixtures, like plant residues, the initiation of an exotherm was more difficult to distinguish on the heating curve. The explosion temperatures, however, did occur at predictable values and are included in Figure 3. It is presumed that the presence of more thermodynamically stable compounds than BD masked the inflection in the curve.

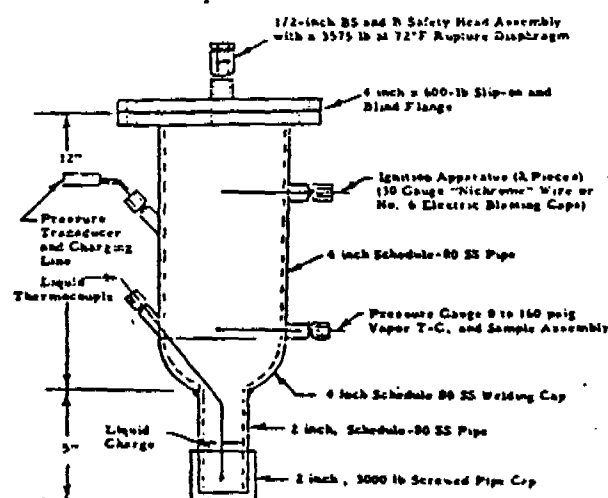
Figure 4. Positive-ignition test apparatus.

The liquid in this container was refluxed to maintain the proper test pressure by placing the 4" diameter section into a furnace consisting of a coiled 3000-Watt Calrod heater. The spiral-wound heating core was contained in an insulated 1-gallon paint can.

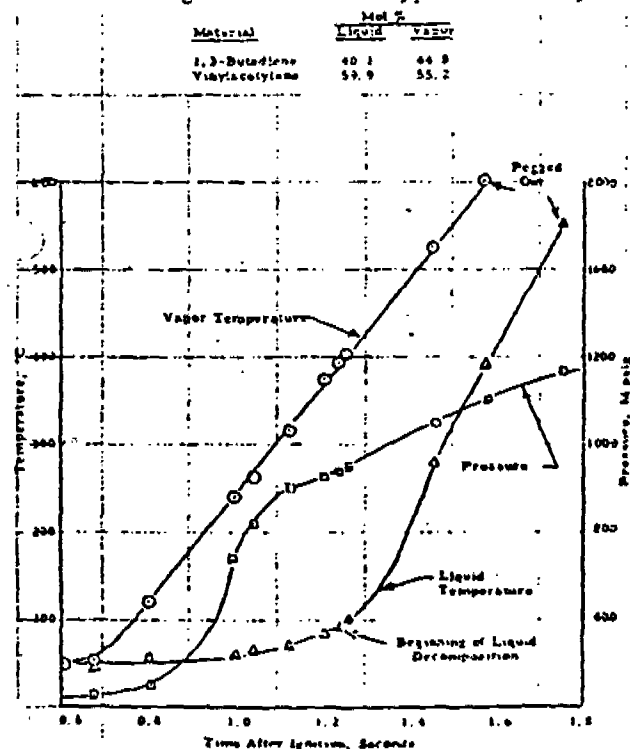
Figure 5. Typical positive-ignition test.

In laboratory mixture of BD-VA, vapor samples containing 53- to 55 mol % VA deflagrated in the vapor phase at 65 lb./sq.in. absolute pressure using the chrome-wire ignition source. A typical time delay to

develop the pressure and temperature required for decomposition of the liquid is illustrated in F-5. Again they are in fair agreement with those recorded in the thermal stability tests; an accurate reading is handicapped by the different time responses of the pressure transducer and the thermocouples.
