**UNITED STATES ENVIRONMENTAL PROTECTION AGENCY**  
**REGION 5**  
**77 WEST JACKSON BOULEVARD**  
**CHICAGO, ILLINOIS 60604**

**SUBJECT:** CLEAN WATER ACT INSPECTION REPORT  
*Heritage Thermal Services, Inc. 1250 St. George Street, East Liverpool, Ohio*

**NPDES Permit Number:** *OH0107298*

**Date(s) of Inspection:** July 30 through August 1 and August 27, 2024

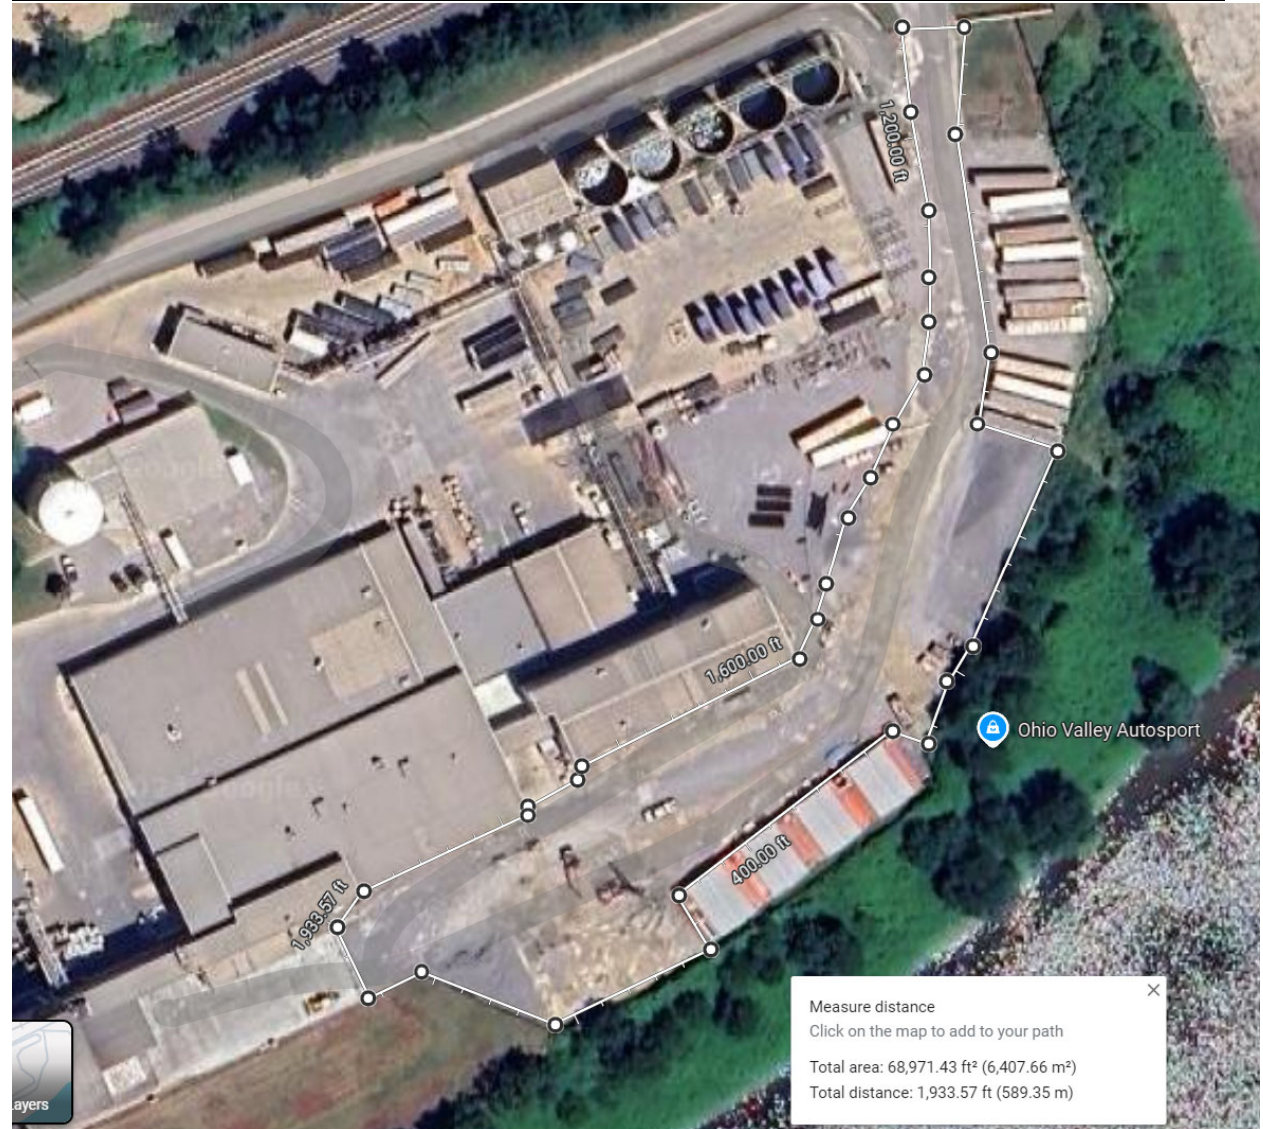
**AERIAL FROM GOOGLE ON 10/8/2024**

**APPROXIMATE AREA OF DISTURBANCE OBSERVED DURING THE INSPECTION: 68,971 SQFT OR 1.58 ACRES**

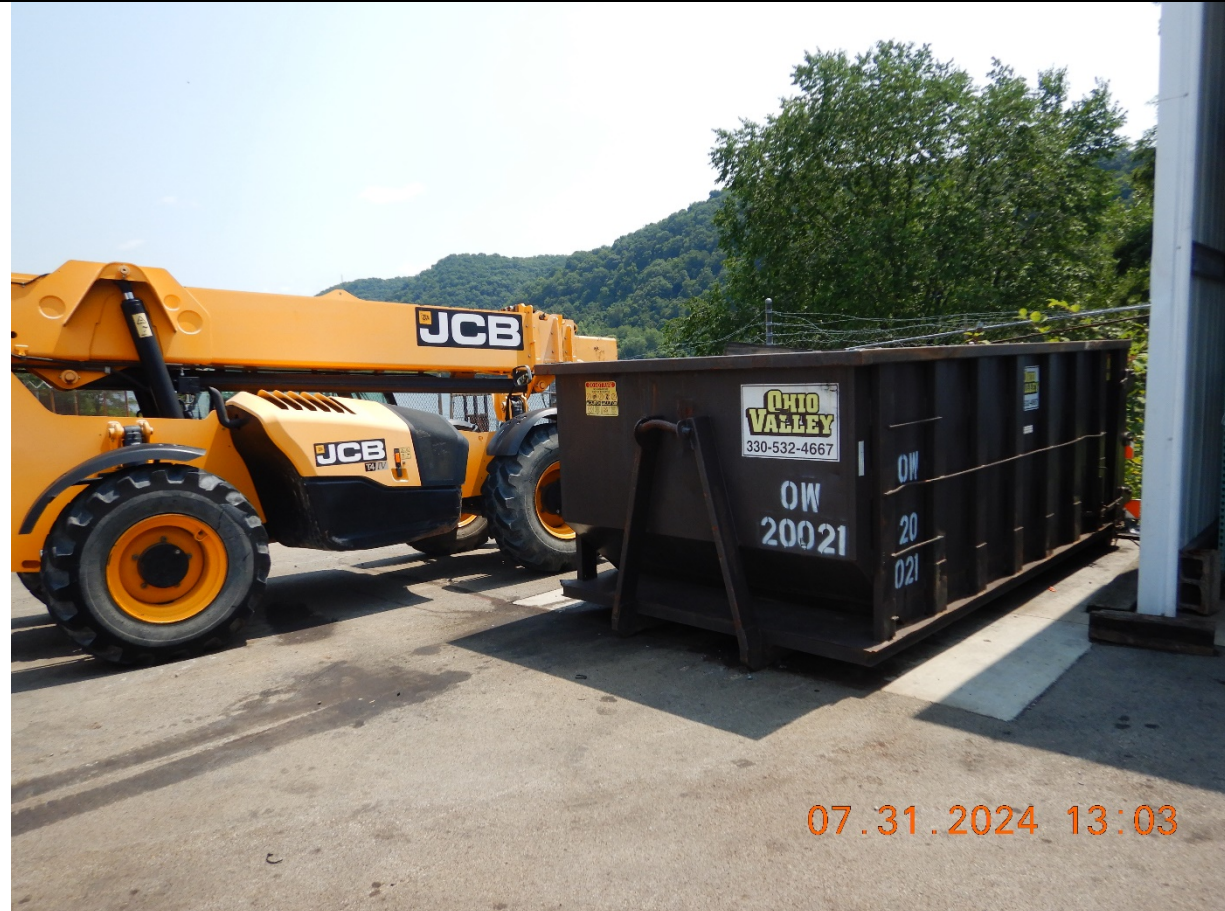
24: DSCN2221.JPG

permit application, this area is an Area 'B' drainage, however the VonRoll drawing, and the Area 'B' sewer map show the drainage in this area is tributary to Area 'A'.

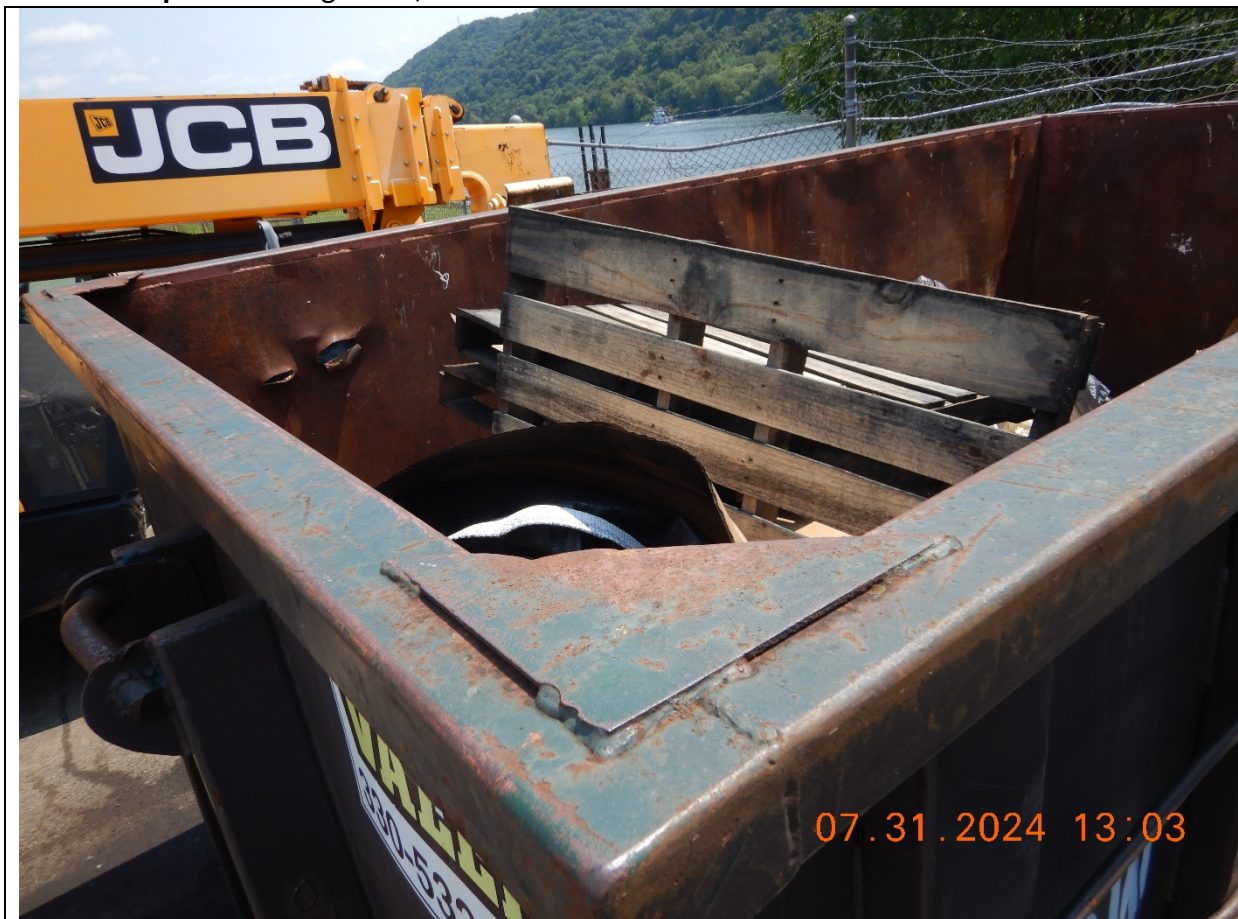
25: DSCN2222.JPG

a) Metal Fabrication “Brass Alley” which is tributary to the Ohio River. Jonathan Moody observed metal cutting equipment (Photo 28), and a dumpster (Photo 24) present in this area, as well as staining on the concrete (Photos 27-29) and a residual amount of water on the river side of the dumpster with a flow pattern toward the Ohio River (Photo 30). The refueling area associated with “Brass Alley” appears in the SWPPP which appears to be tributary to the Area ‘A’ sewers. The majority of “Brass Alley” including the metal fabrication (Photo 28), laydown (Photo 26), and dumpster (Photos 25) were not included in the SWPPP, nor the NPDES permit application.
