INSPECTION REPORT

| Type of Inspection | Compliance Evaluation Inspection (CEI) | | |
| Company Name | Portland Bolt & Manufacturing Company, Inc. | | |
| Type of Operation | Manufacturer of large, nonstandard anchor bolts and construction fasteners | | |

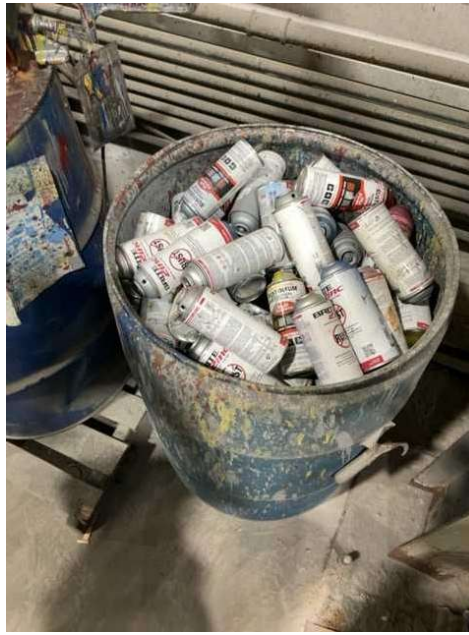
| Portland Bolt & Manufacturing Company, Inc./Galvanizing Department | | | 45.54459275, -122.71801132 |

| View of a facility notice, that is seen here affixed to the container, instructing facility personnel not to place waste aerosols in the area without puncturing them. | | | |

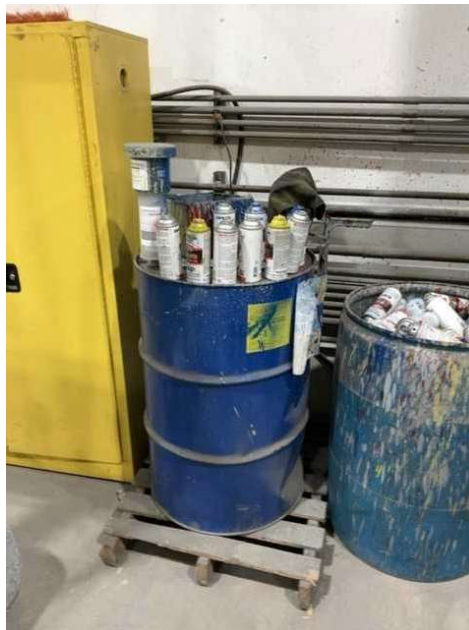
| Portland Bolt & Manufacturing Company, Inc./Galvanizing Department | | | 45.54454321, -122.71796331 |

| View of the empty aerosol cans that have been punctured. | | | |

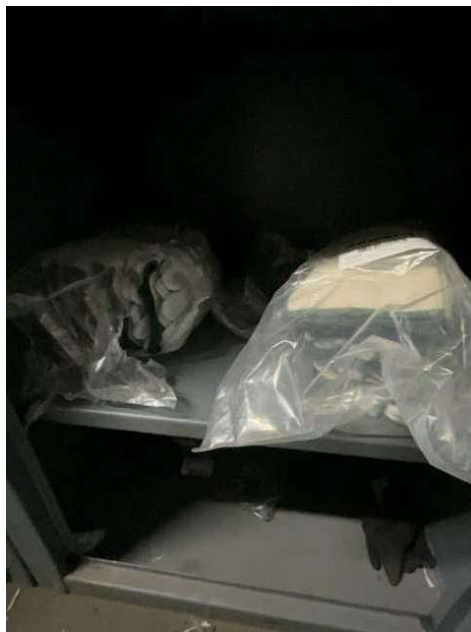
| Portland Bolt & Manufacturing Company, Inc./Lower Mezzanine Storage | | | 45.54448656, -122.71859996 |

| Close-up view of the labeling on the leather gloves. | | | |
