## MULTI-SECTOR GENERAL PERMIT NON-FILER INSPECTION CHECKLIST

| <b>Inspection Date(s):</b> | 2/7/2023 | |
| <b>Operator Name:</b> | Lebarron's Auto Salvage | |

**Appendix A. Aerial Map**  
**Clean Water Act Inspection**  
**Lebarrons Auto Salvage**

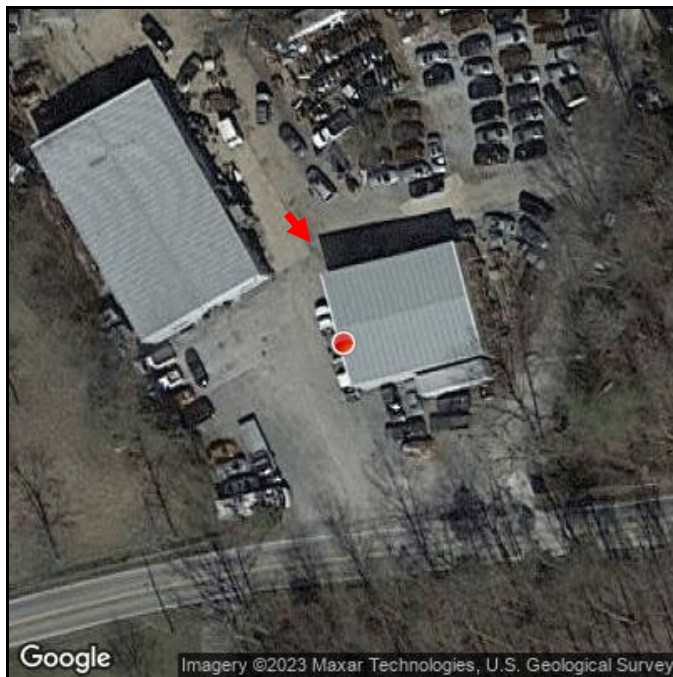
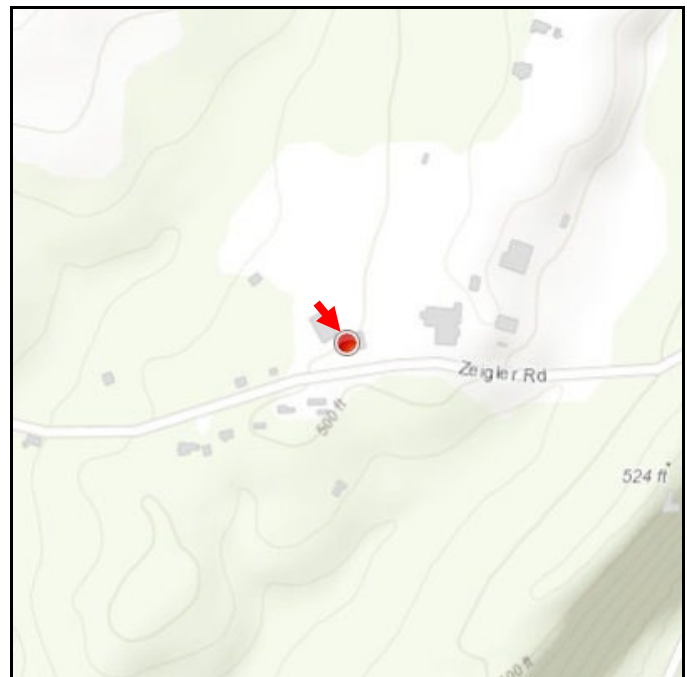
| Description | View of the Facility's indoor work area, storm drain, and approximately thirty (30) 55-gallon drums (empty and unmarked). Note the lack of inlet protection on the storm drain, as well as the salvage vehicles, debris, and petroleum product staining on the upgradient impervious surface. |

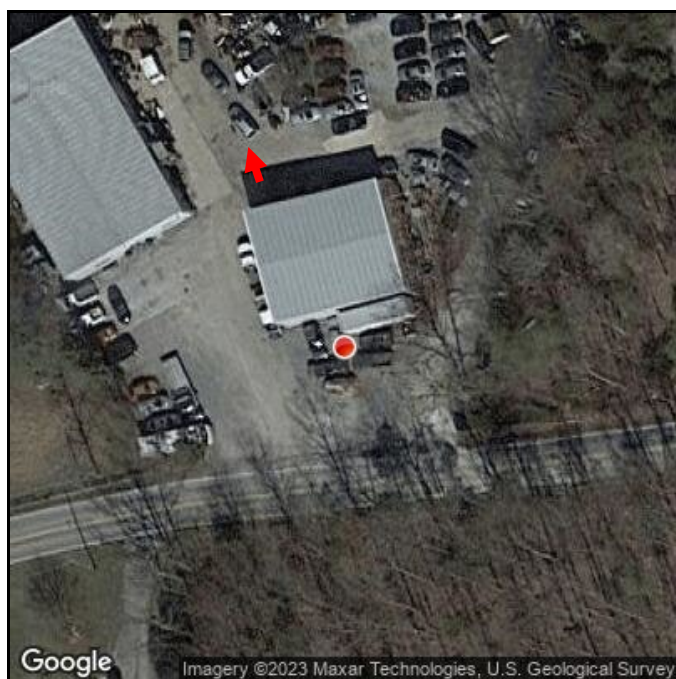
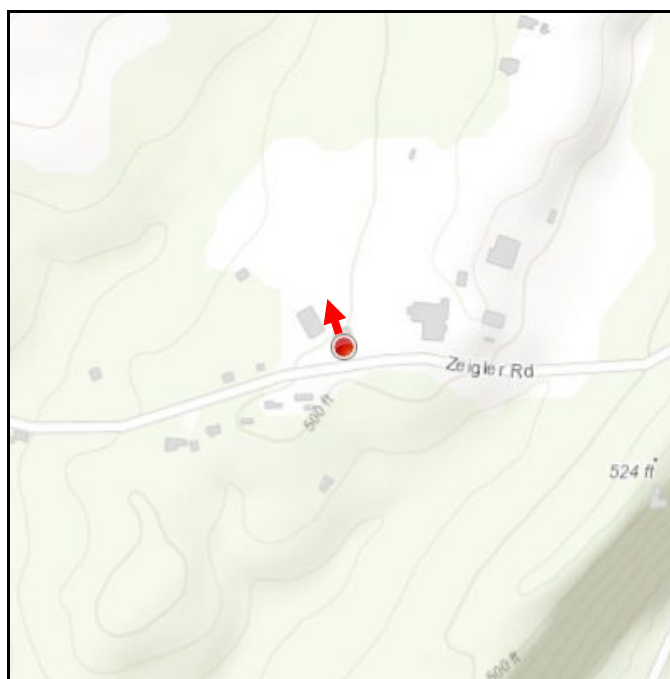
| Description | View of the storm drain adjacent to the indoor work area. Note the lack of inlet protection, as well as the salvage vehicles, debris, and petroleum product staining on the upgradient impervious surface. |

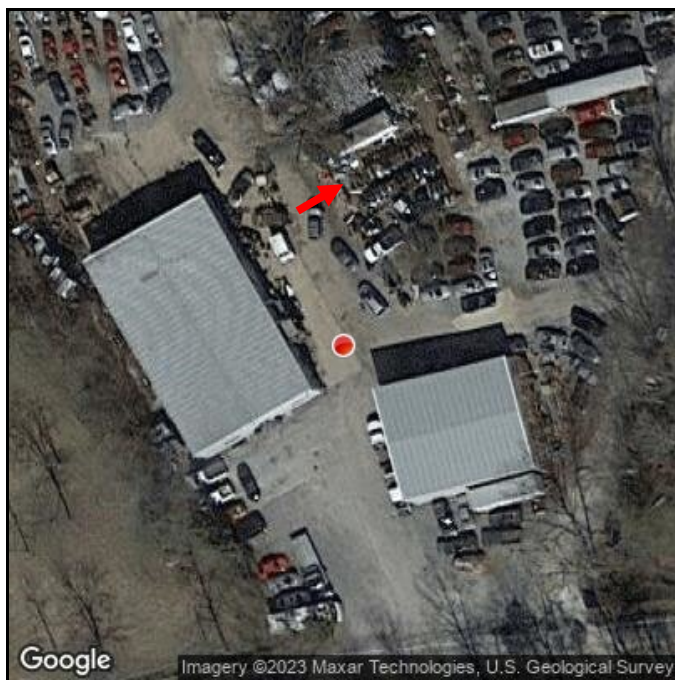
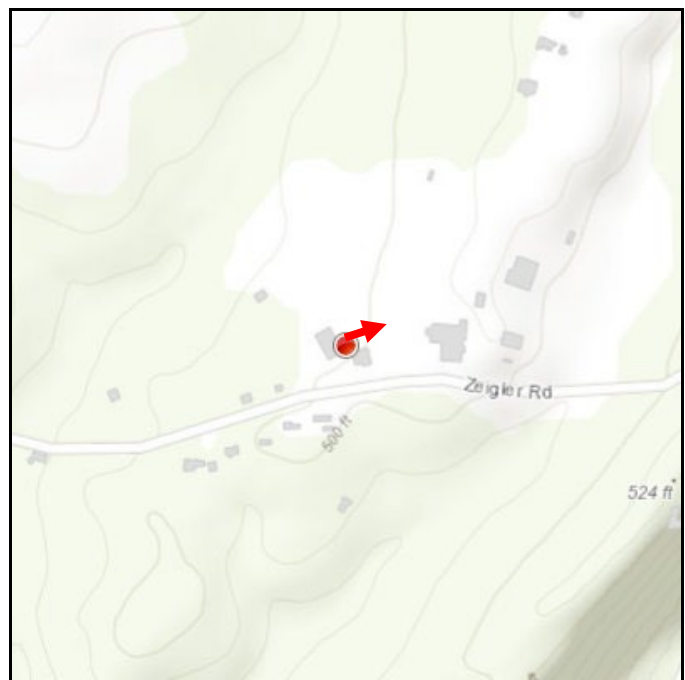
| Description | View of shipping containers used to store salvaged vehicle parts in the central area of the Facility. |

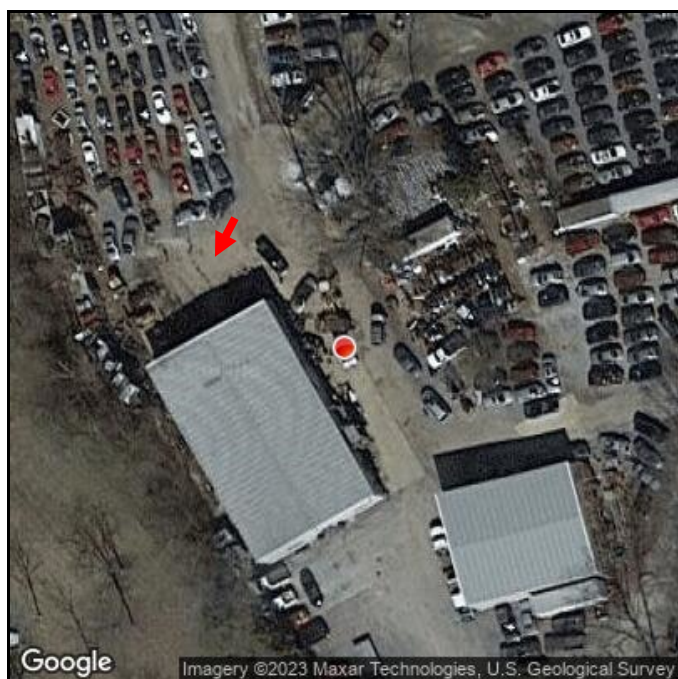
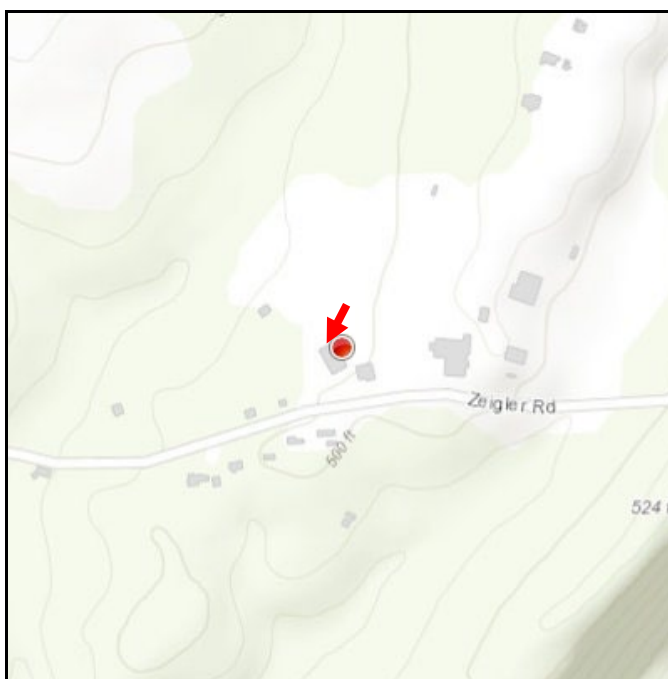
| Description | View of the back of the main office where 55-gallon drums, oil tanks, and salvage vehicle parts were stored directly on the ground without containment or overhead cover. |

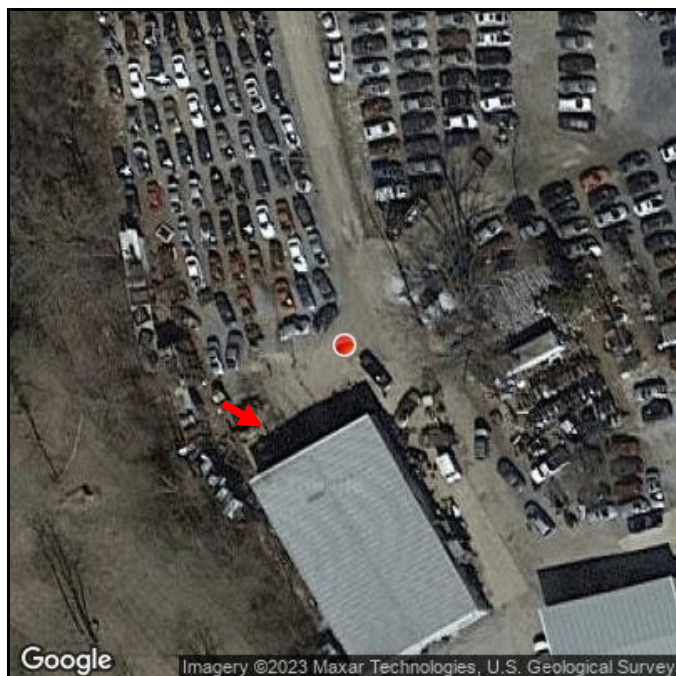
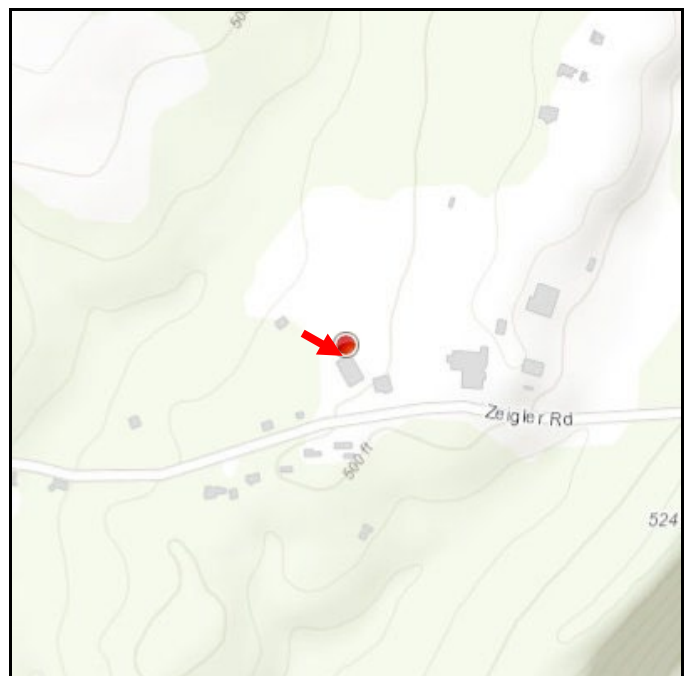
| SITE EVALUATION | |
|---|---|
| <b>Spills/Leaks Handling</b> | The EPA Inspection Team observed absorbent material scattered on top of spilled oil underneath the used oil tank at the Facility's main office building (refer to <u>Appendix B, Photograph DSCN1295</u> ).<br>The EPA Inspection Team observed petroleum product staining around the main office building (refer to <u>Appendix B, Photographs DSCN1294 &amp; DSCN1290</u> ). |

| Description | View of oil tanks at back of Facility's main office without secondary containment. Both contained liquid, one marked used oil. Note the absorbent underneath the used oil tank. |

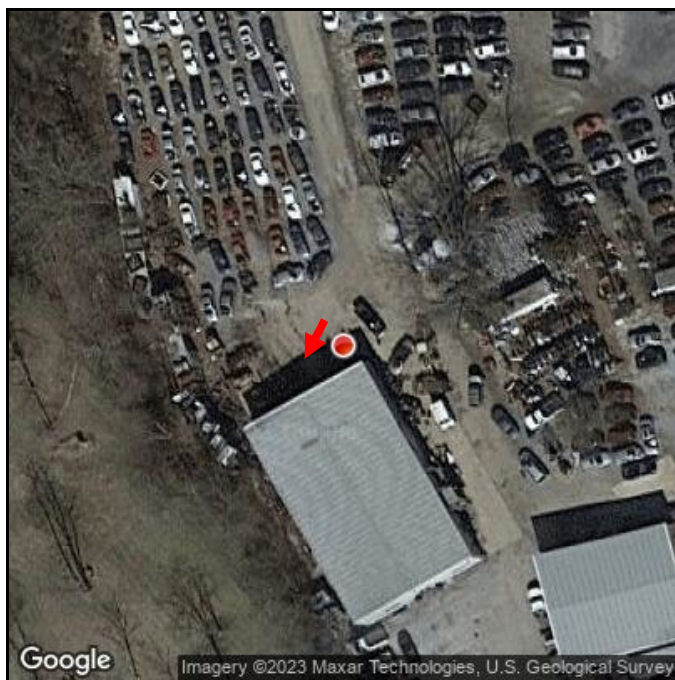
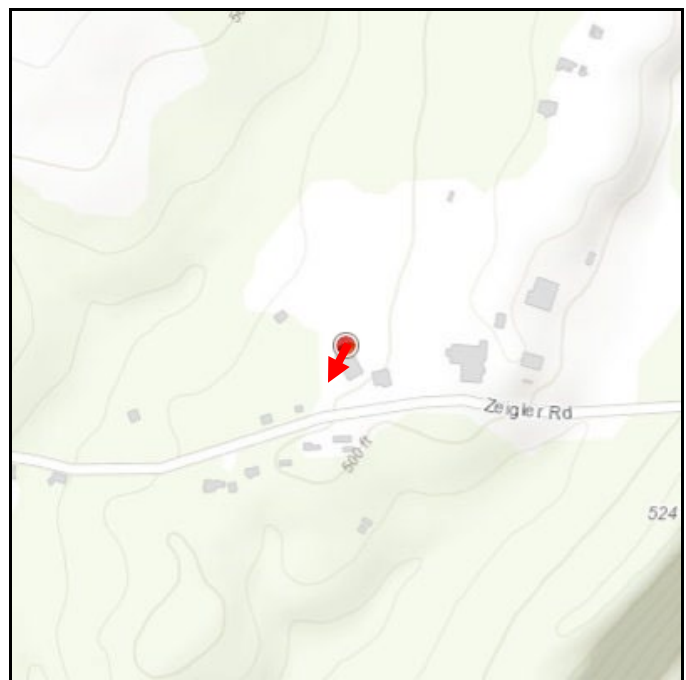
| Description | View of the back of the main office building with salvage vehicle parts, three (3) 55-gallon drums (empty and unmarked), and oil tanks (containing liquid, one marked used oil). Extensive staining throughout this area. |

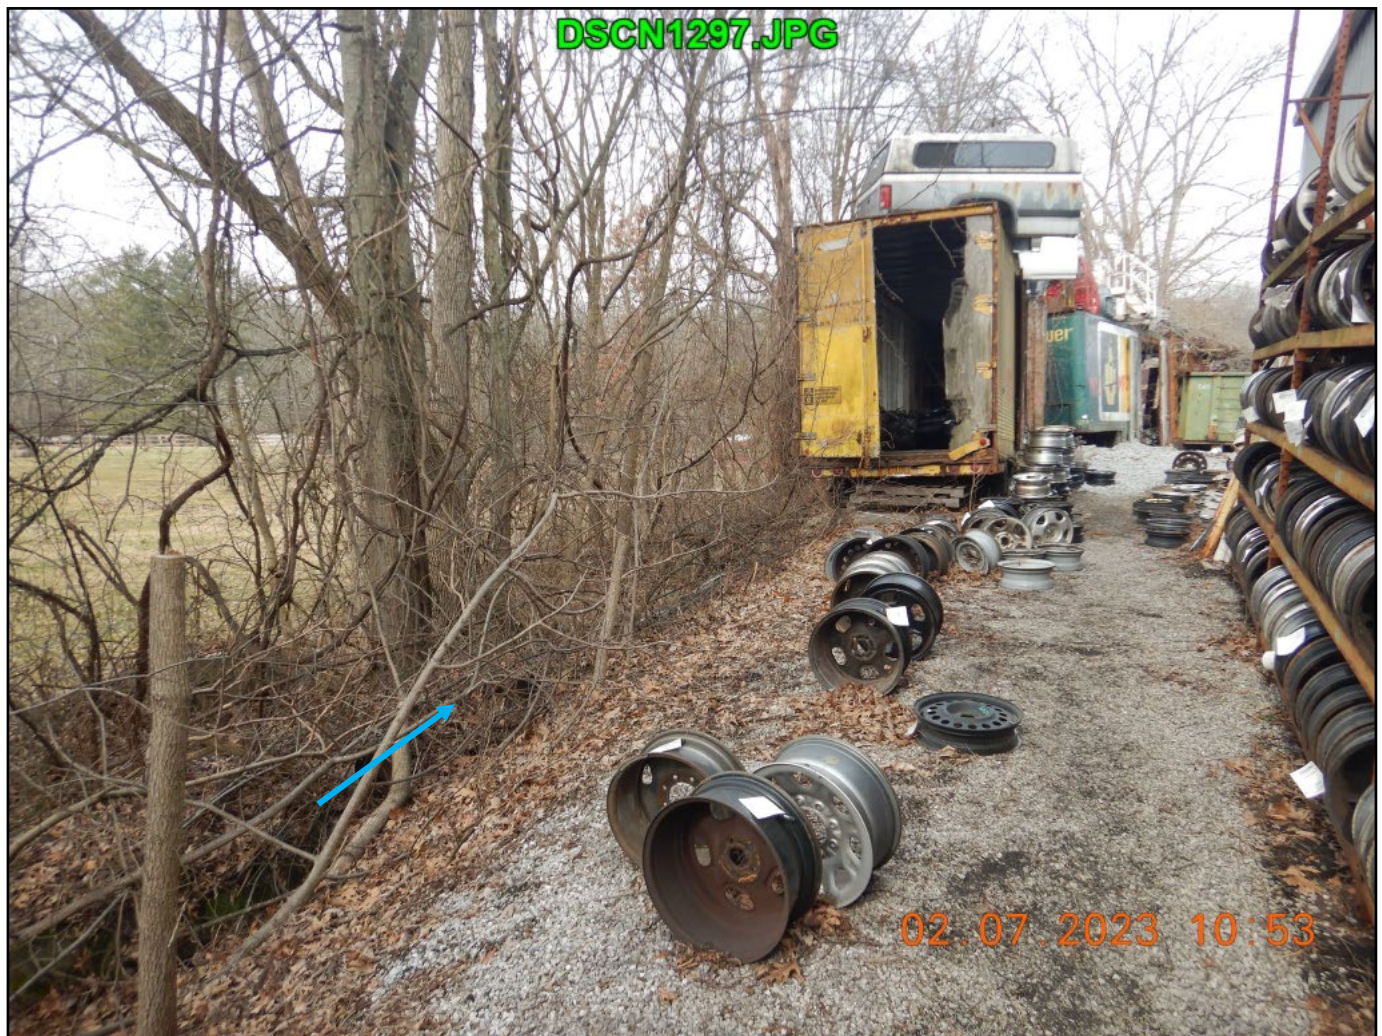
| Description | View of salvage vehicle parts stored west of Facility's main office. View of an unnamed tributary to Conewago Creek along Facility's west border. |

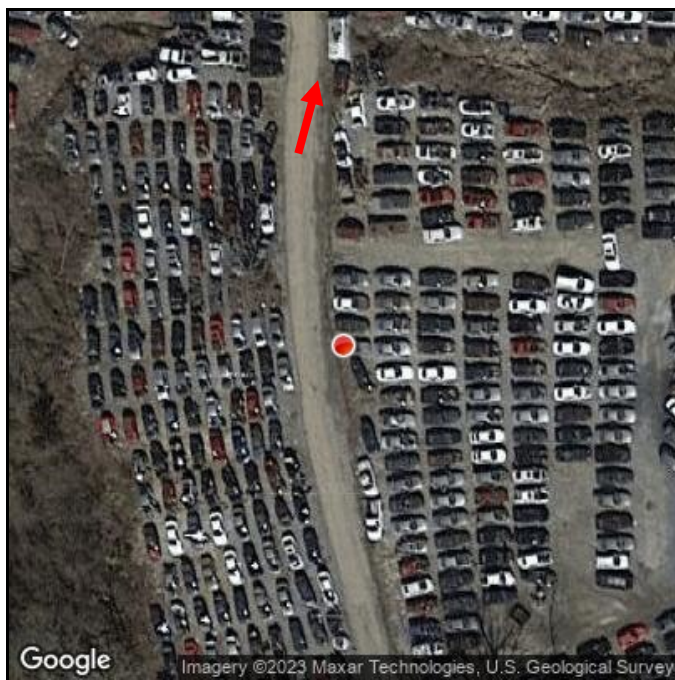
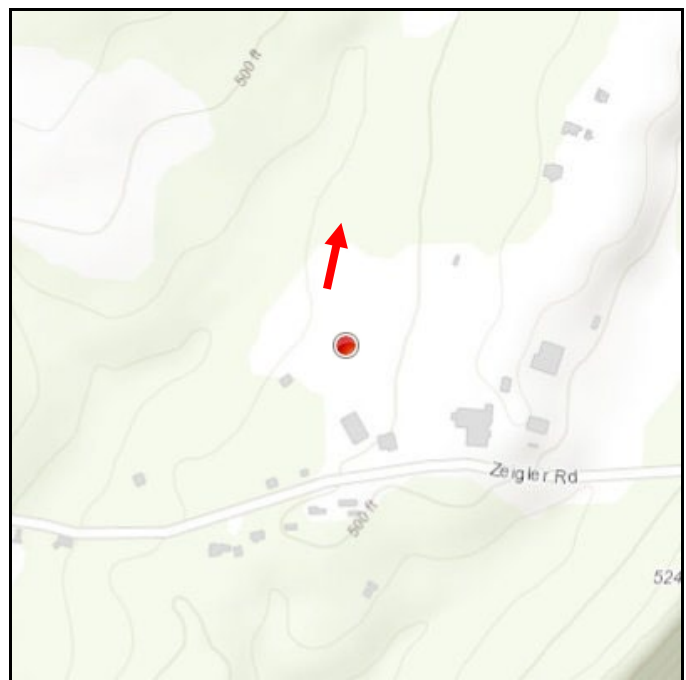
| SITE EVALUATION | |
|---|---|
| <b>Number and description of each potential Stormwater Discharge Point from the Facility</b> | The EPA Inspection Team observed at least four (4) discharge locations from the Facility to the unnamed tributary to Conewago Creek running through the Facility (refer to <u>Appendix A, Figure 1</u> , and <u>Appendix B, Photographs DSCN1300, DSCN1301, DSCN1302, DSCN1303, DSCN1331, &amp; DSCN1332</u> ). |

| Description | View of a discharge point to the unnamed tributary to Conewago Creek. View of salvage vehicles stored adjacent to the unnamed tributary to Conewago Creek. The white box truck spans across the unnamed tributary to Conewago Creek. |

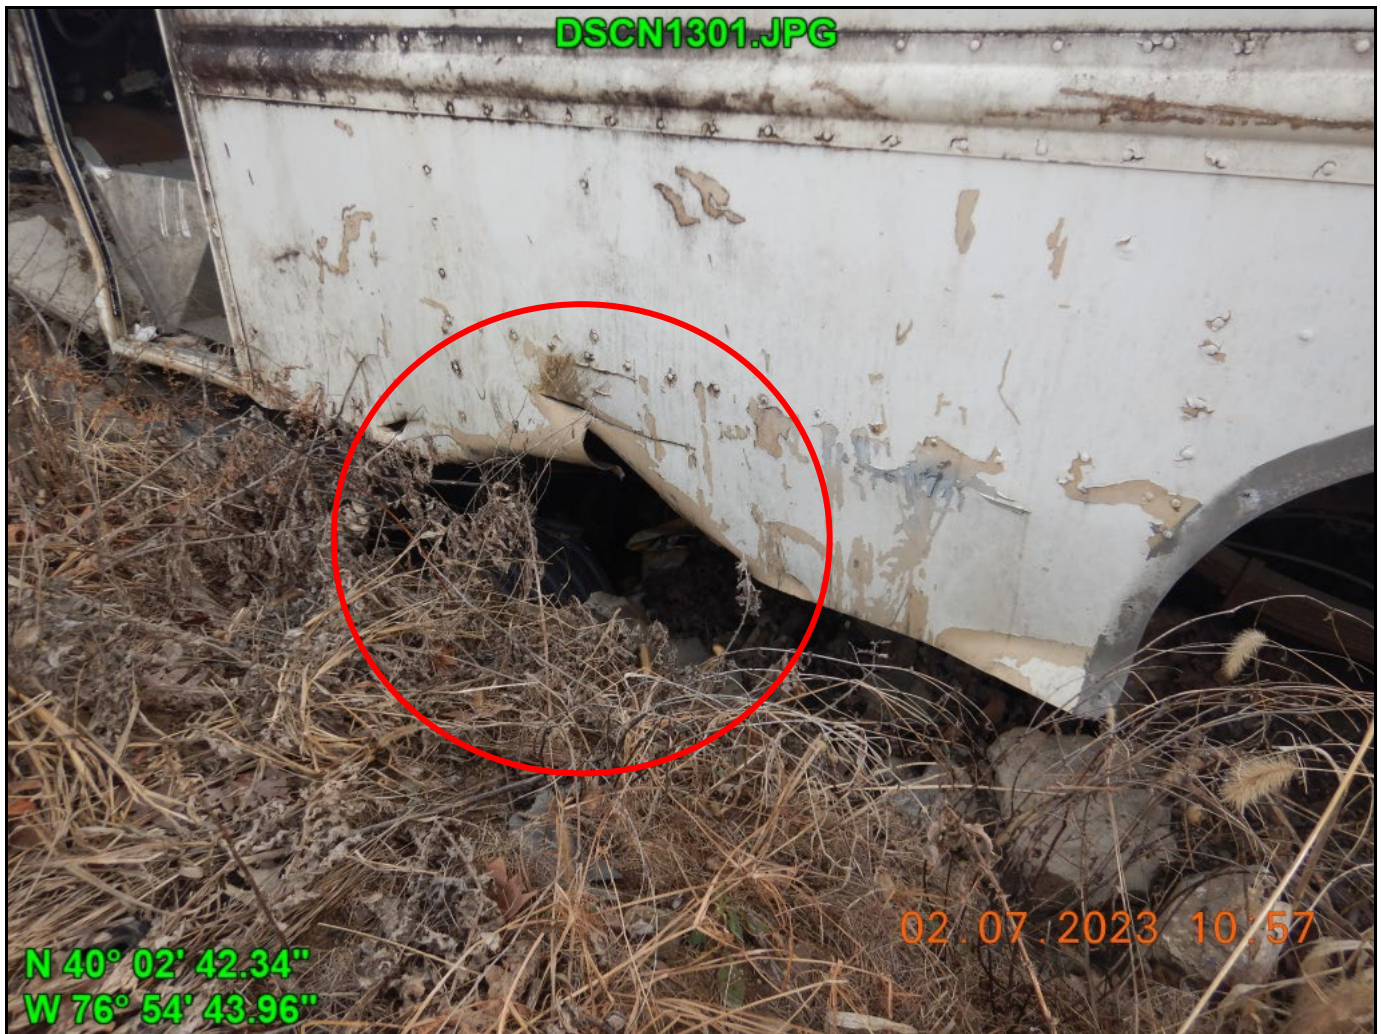
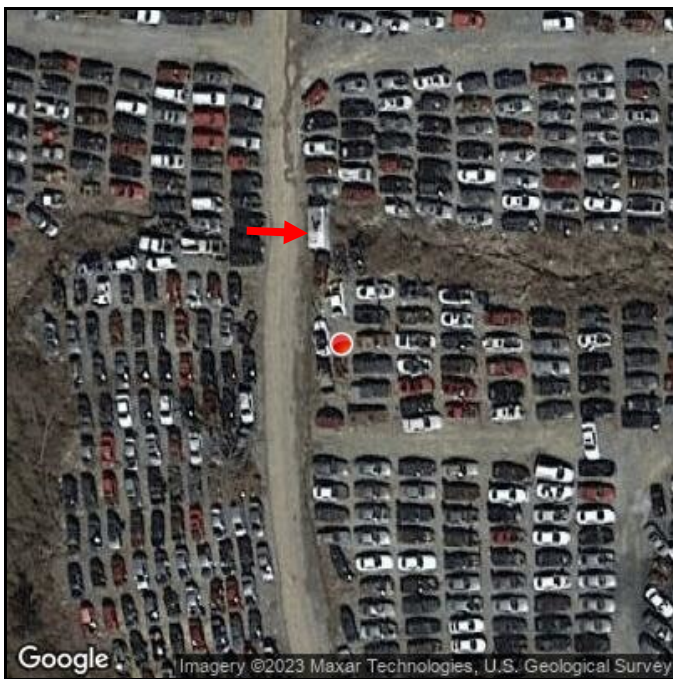
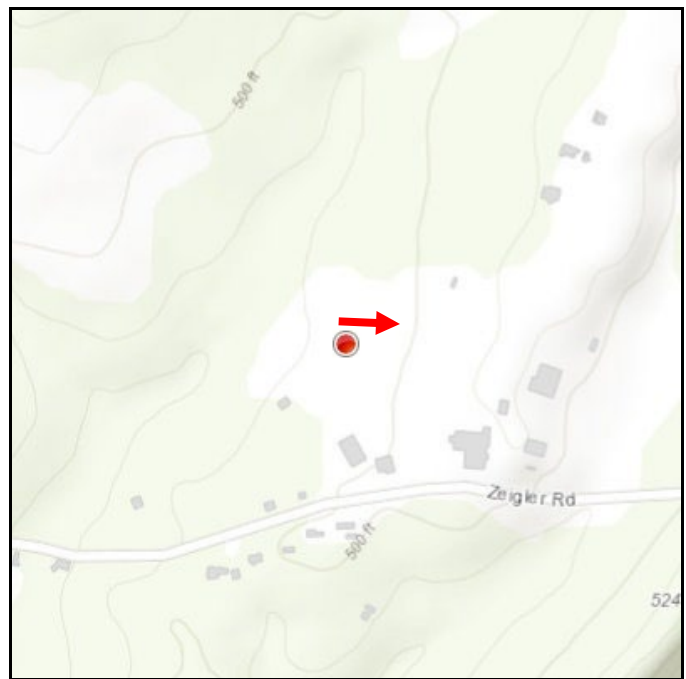
| Description | View of an unnamed tributary to Conewago Creek, underneath the white box truck in Photograph DSCN1300, which flows toward the photographer. |

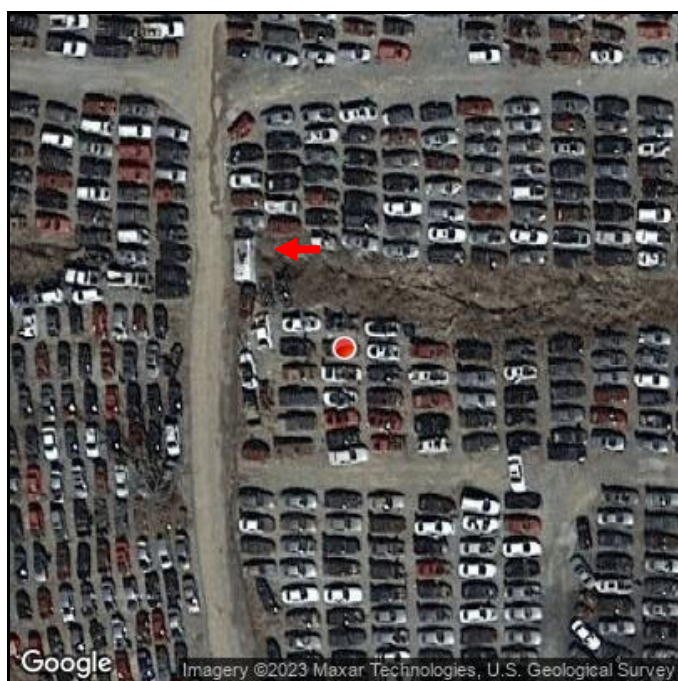
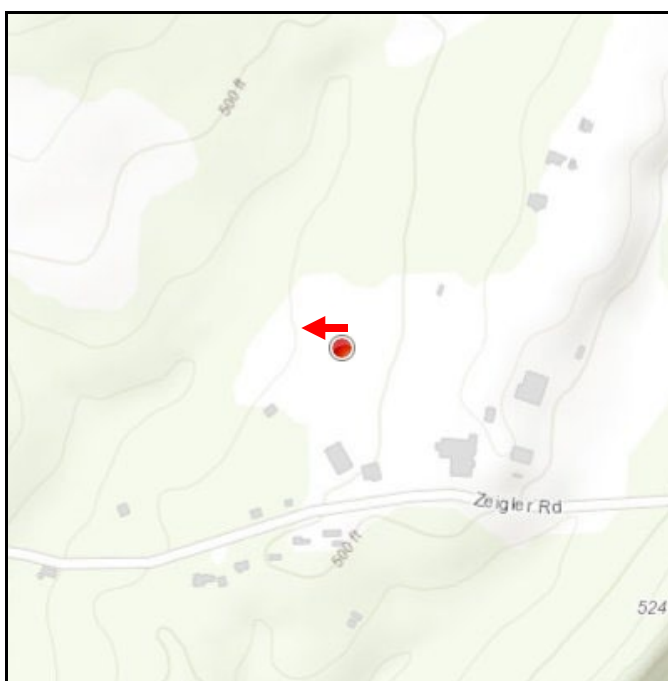
| Description | Additional view of discharge point to the unnamed tributary to Conewago Creek, running underneath a salvage vehicle into a culvert underneath the driveway. The unnamed tributary to Conewago Creek runs from east to west. |

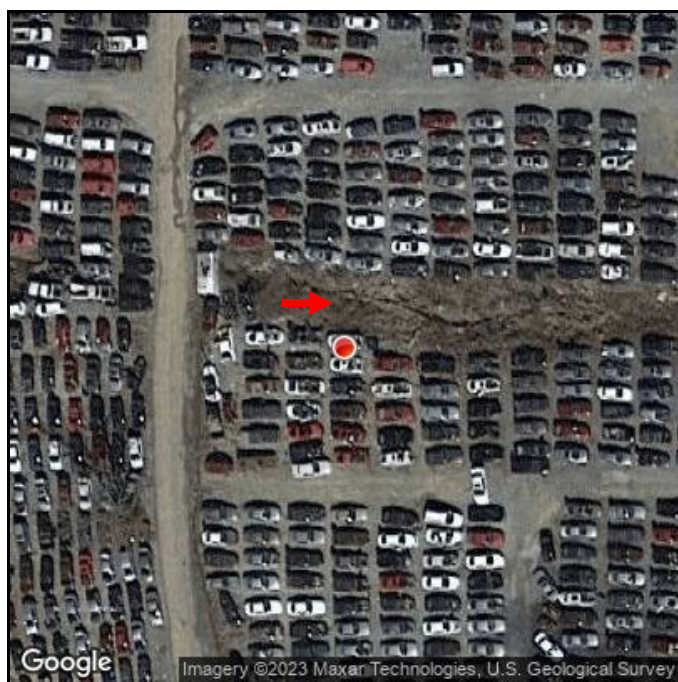
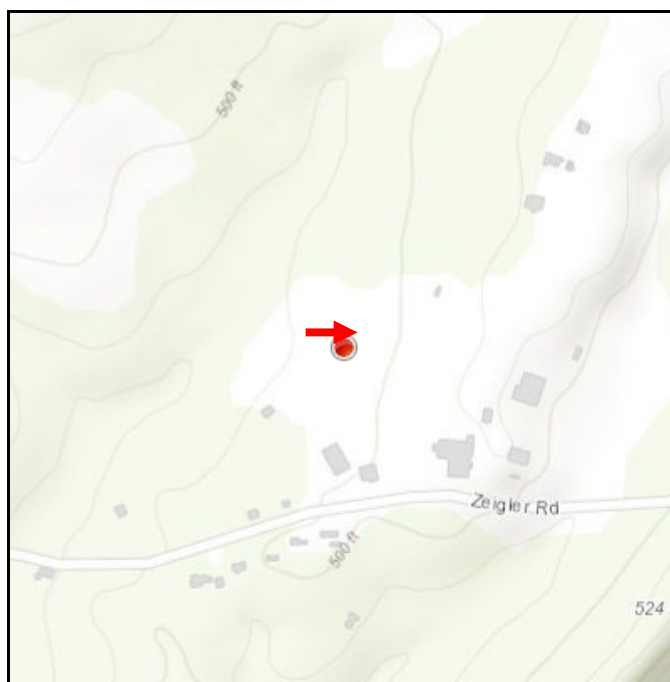
| SITE EVALUATION | |
|---|---|
| <b>Evidence of pollutants migrating offsite (stains, deposits, ponding) at discharge points, into Receiving Waters or in MS4</b> | The EPA Inspection Team observed orange-colored ponded water south of the unnamed tributary to Conewago Creek running through the Facility property (refer to <u>Appendix B, Photograph DSCN1304</u> ). The coloration was consistent with that of typical iron oxidizing bacteria.<br><br>The EPA Inspection Team observed debris around the unnamed tributary to Conewago Creek running through the Facility (refer to <u>Appendix B, Photographs DSCN1332 &amp; DSCN1334</u> ). |

| Description | View of orange-colored ponded water south of the unnamed tributary to Conewago Creek with metal scrap from salvaged vehicles. The coloration was consistent with evidence of iron oxidizing bacteria. |

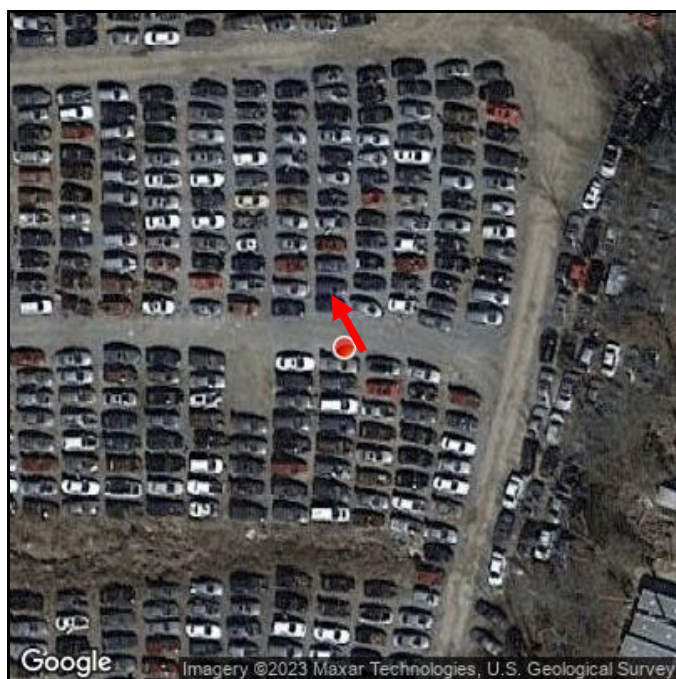
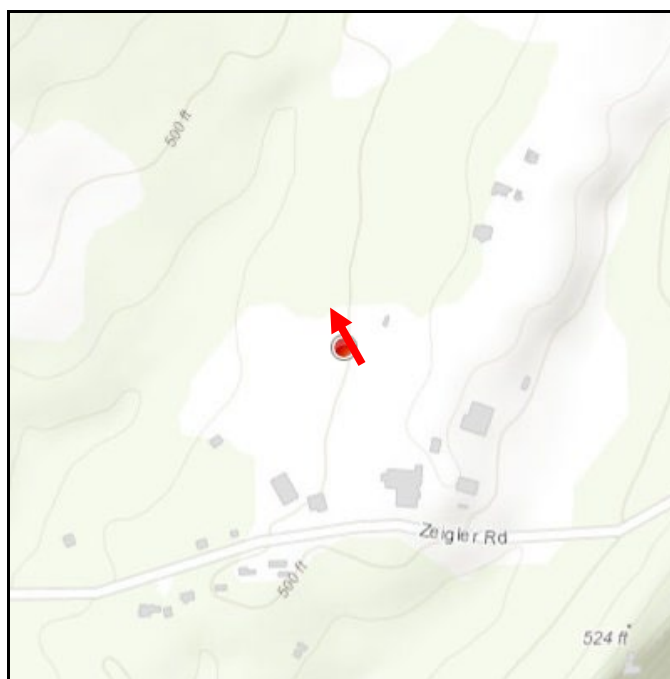
- c. The Facility did not have coverage under a Permit at the time of the inspection.
- 2) The EPA Inspection Team observed salvage vehicles still containing windshield washer fluid in the outdoor salvage vehicle storage area (refer to Appendix B, Photograph DSCN1305).

| Description | View of a salvage vehicle on the pervious surface in the north area of the Facility containing windshield wiper fluid. |

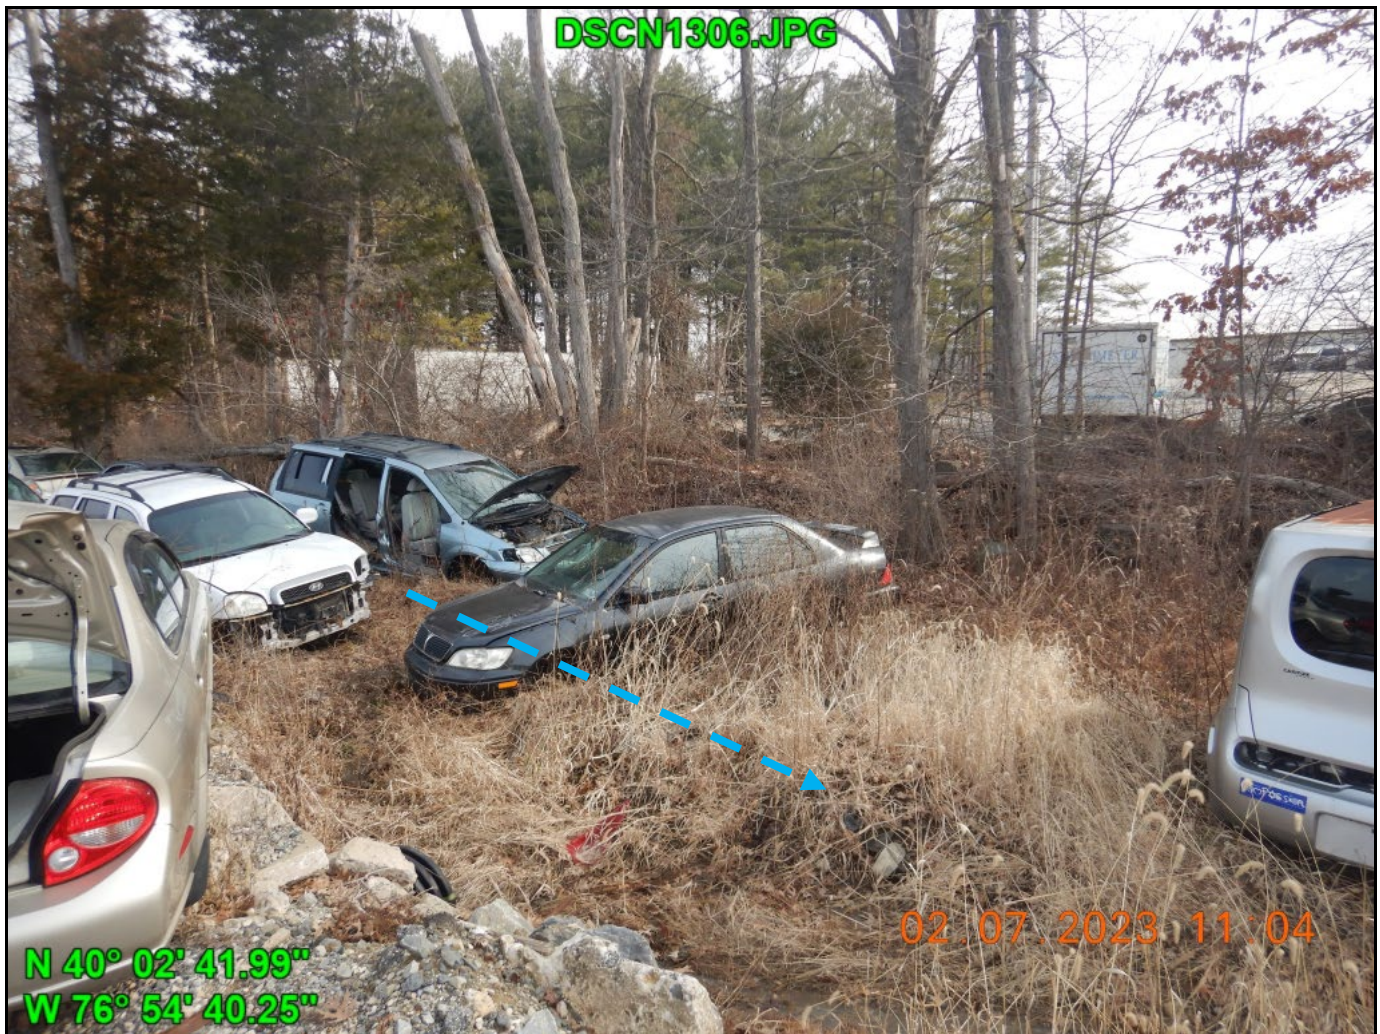
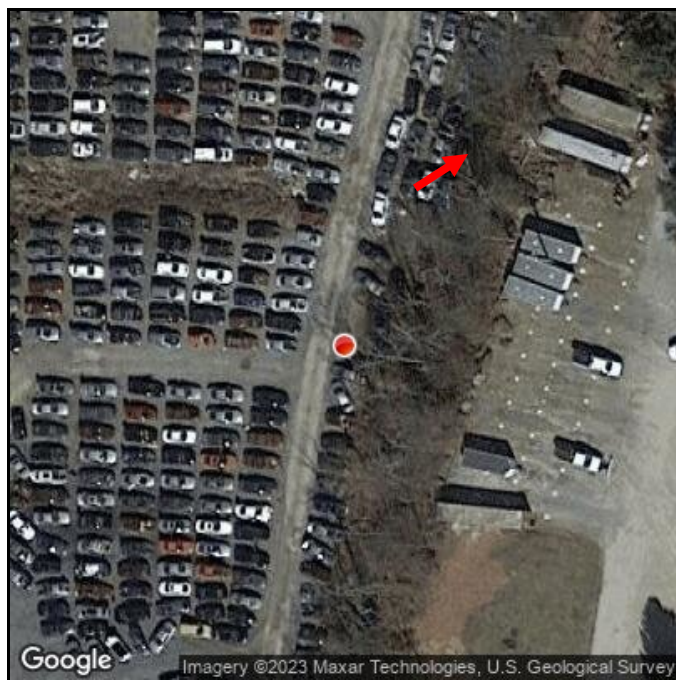
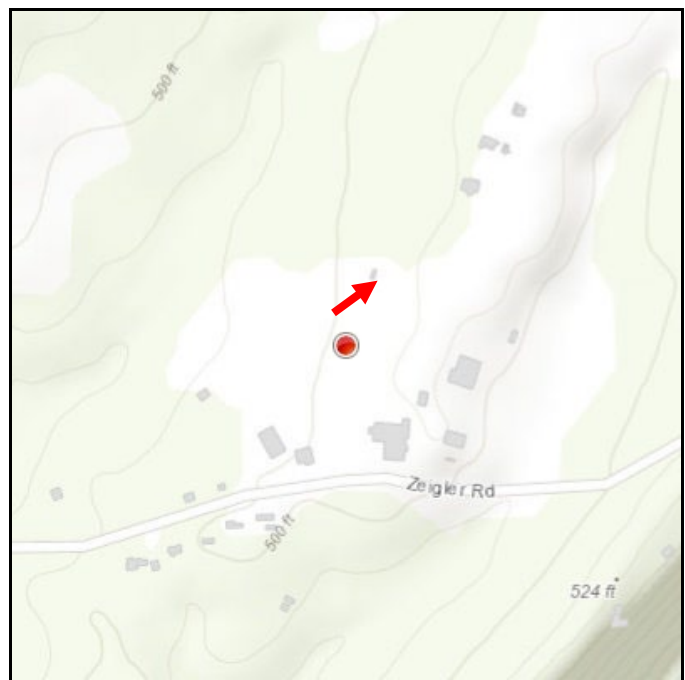
| Description | View of a ditch running to the unnamed tributary to Conewago Creek at Facility's eastern border, showing northern end of adjacent property which directs stormwater through the Facility |

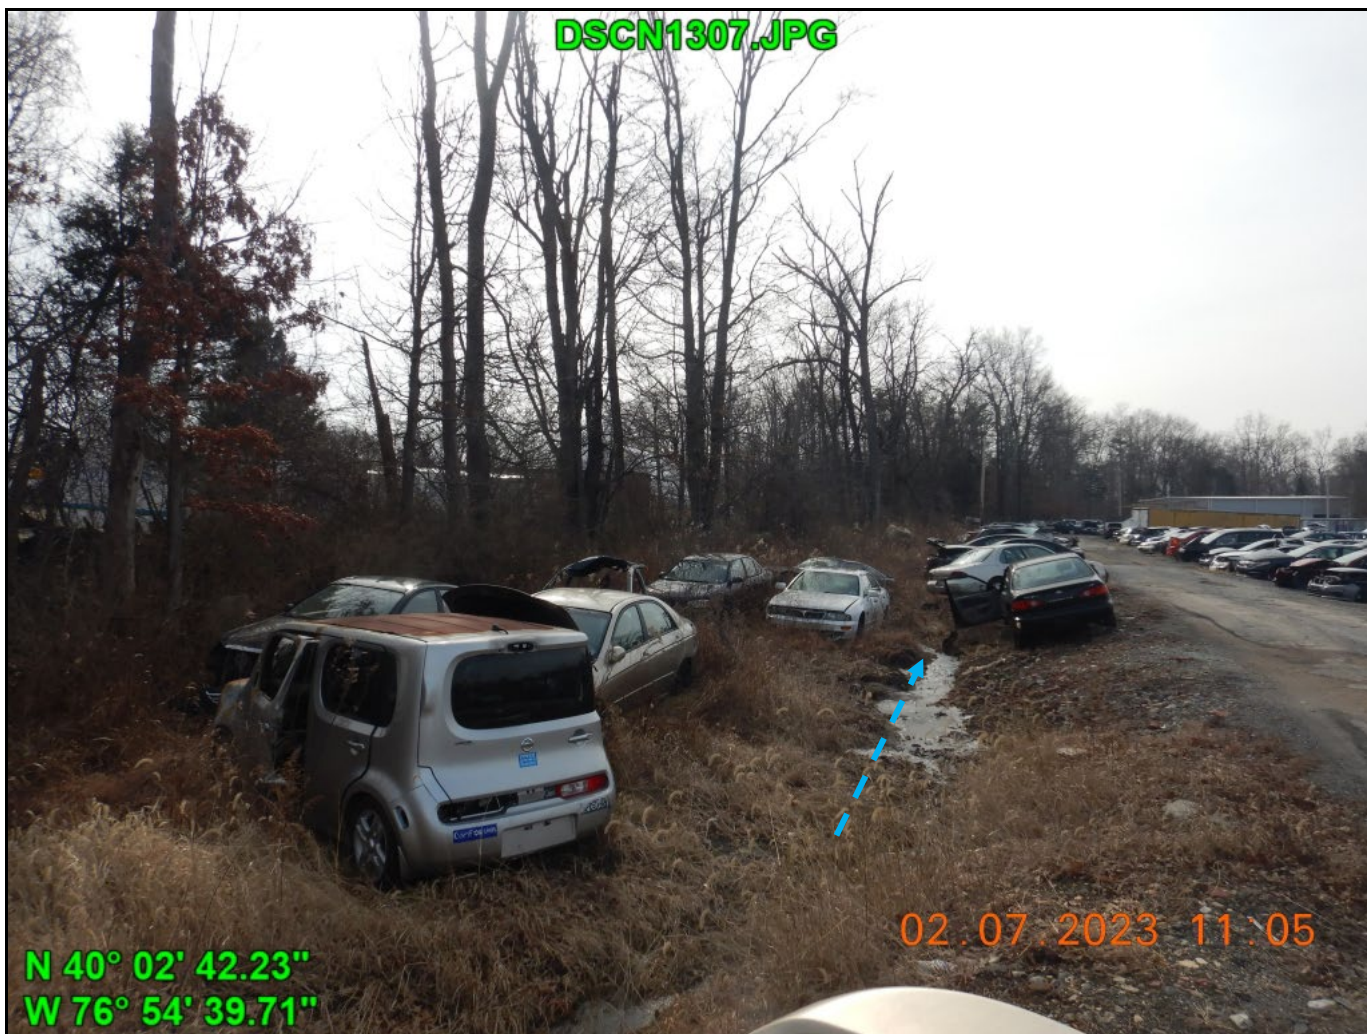
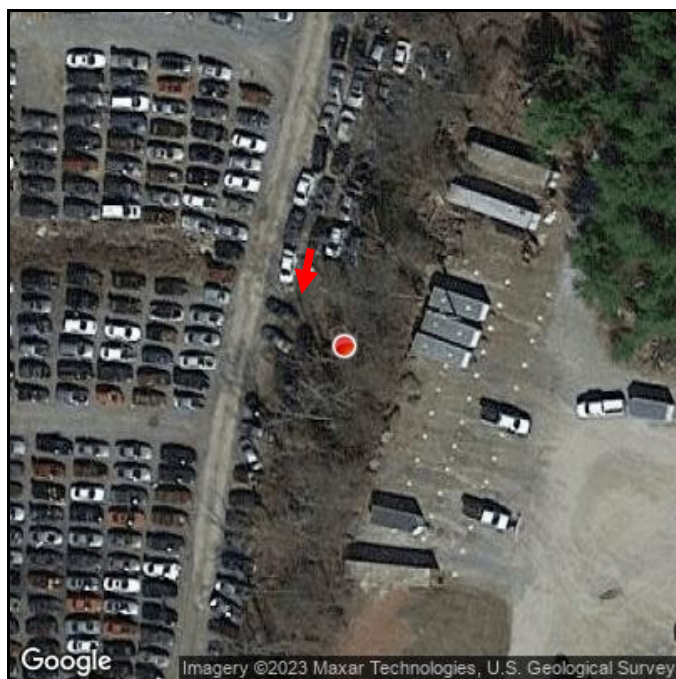
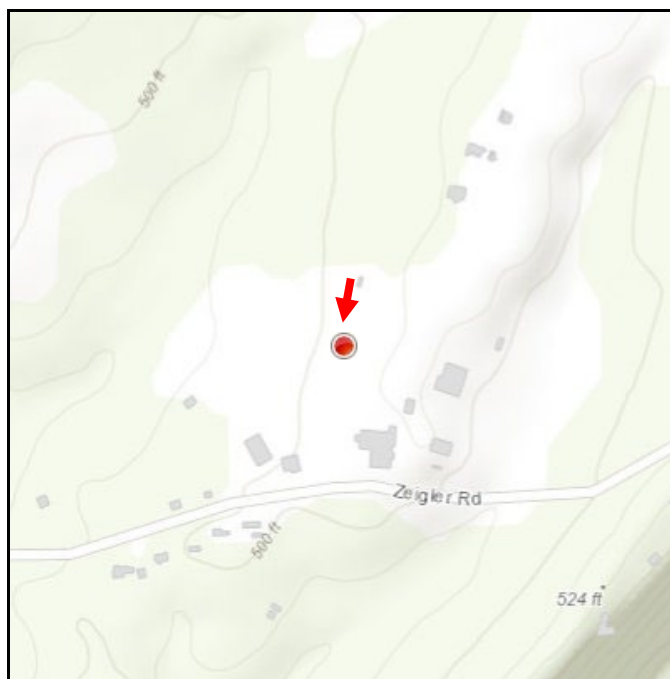
| Description | View of a ditch running to the unnamed tributary to Conewago Creek. |

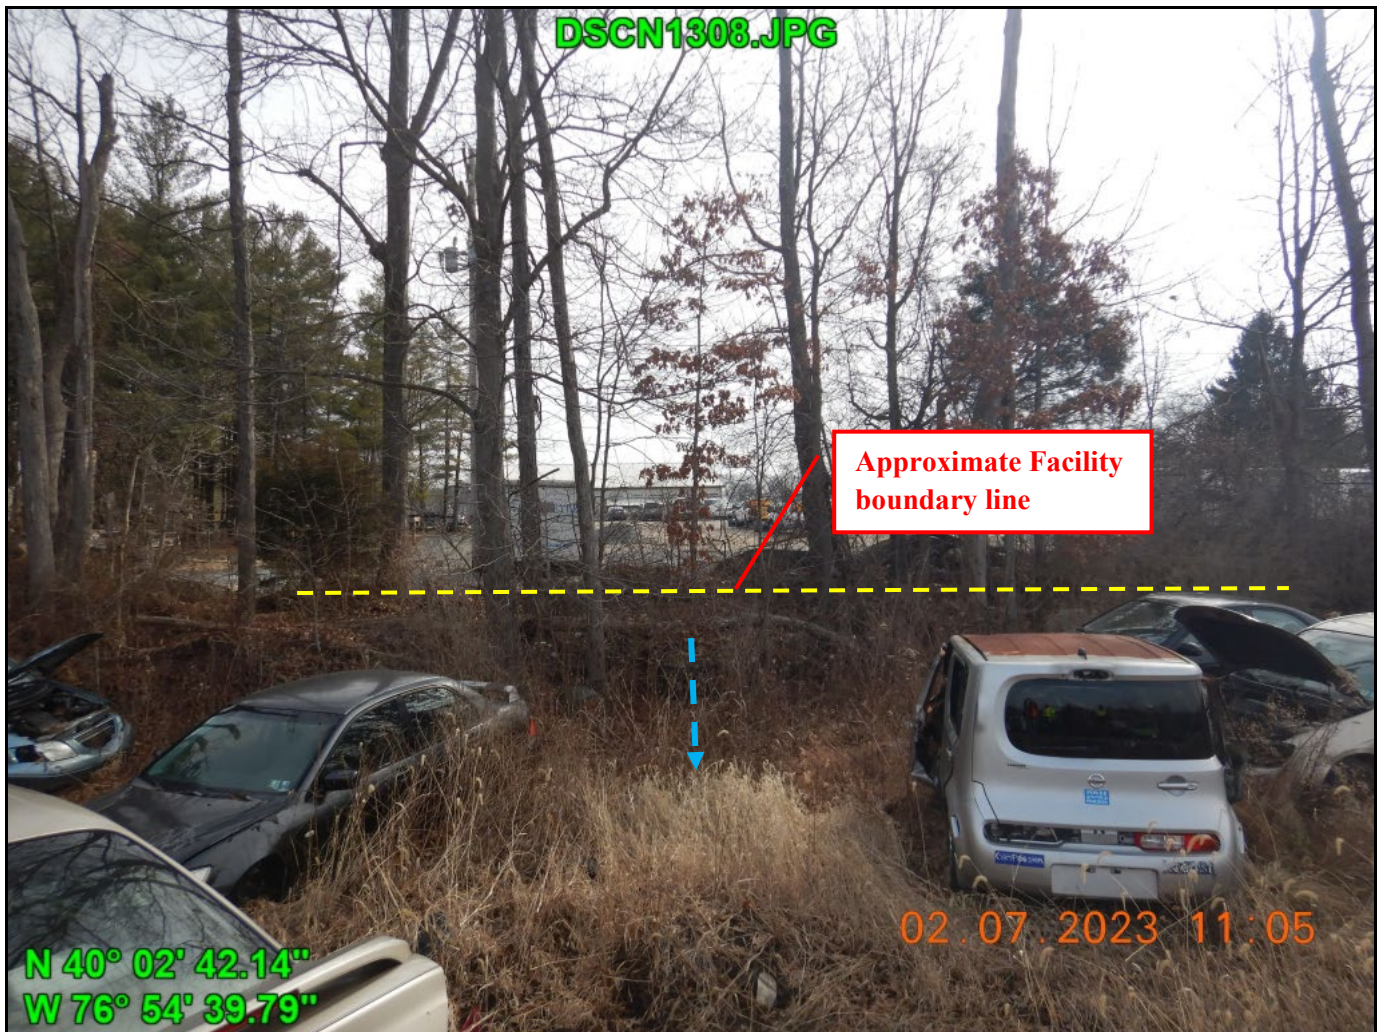
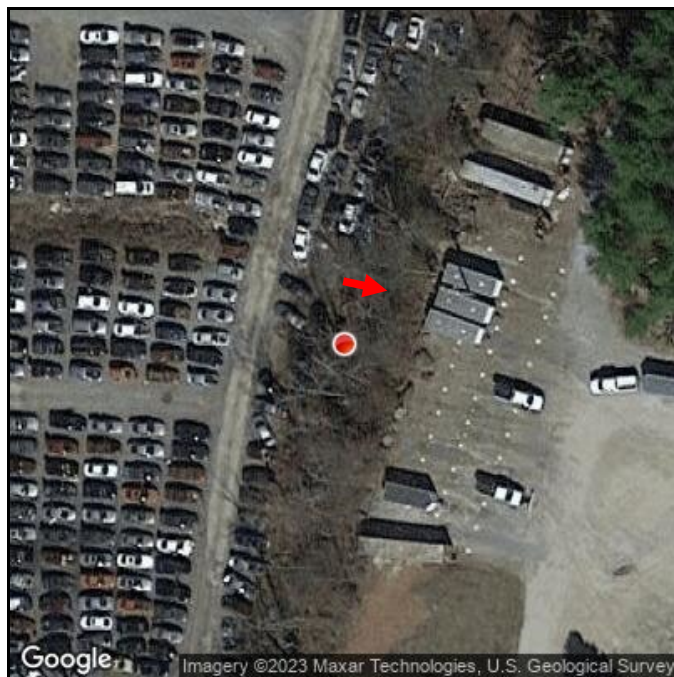
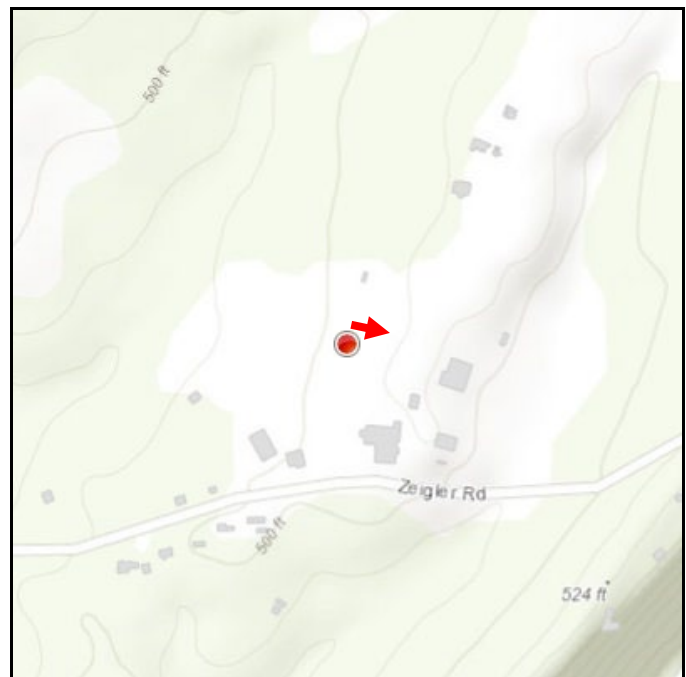
| Description | View, facing upstream, of the unnamed tributary to Conewago Creek, where it flows onto the Facility from a neighboring property. |
