## MULTI-SECTOR GENERAL PERMIT NON-FILER INSPECTION CHECKLIST

| <b>Inspection Date(s):</b> | 2/7/2023 | |
| <b>Operator Name:</b> | Lebarron's Auto Salvage | |

**Appendix A. Aerial Map**  
**Clean Water Act Inspection**  
**Lebarrons Auto Salvage**

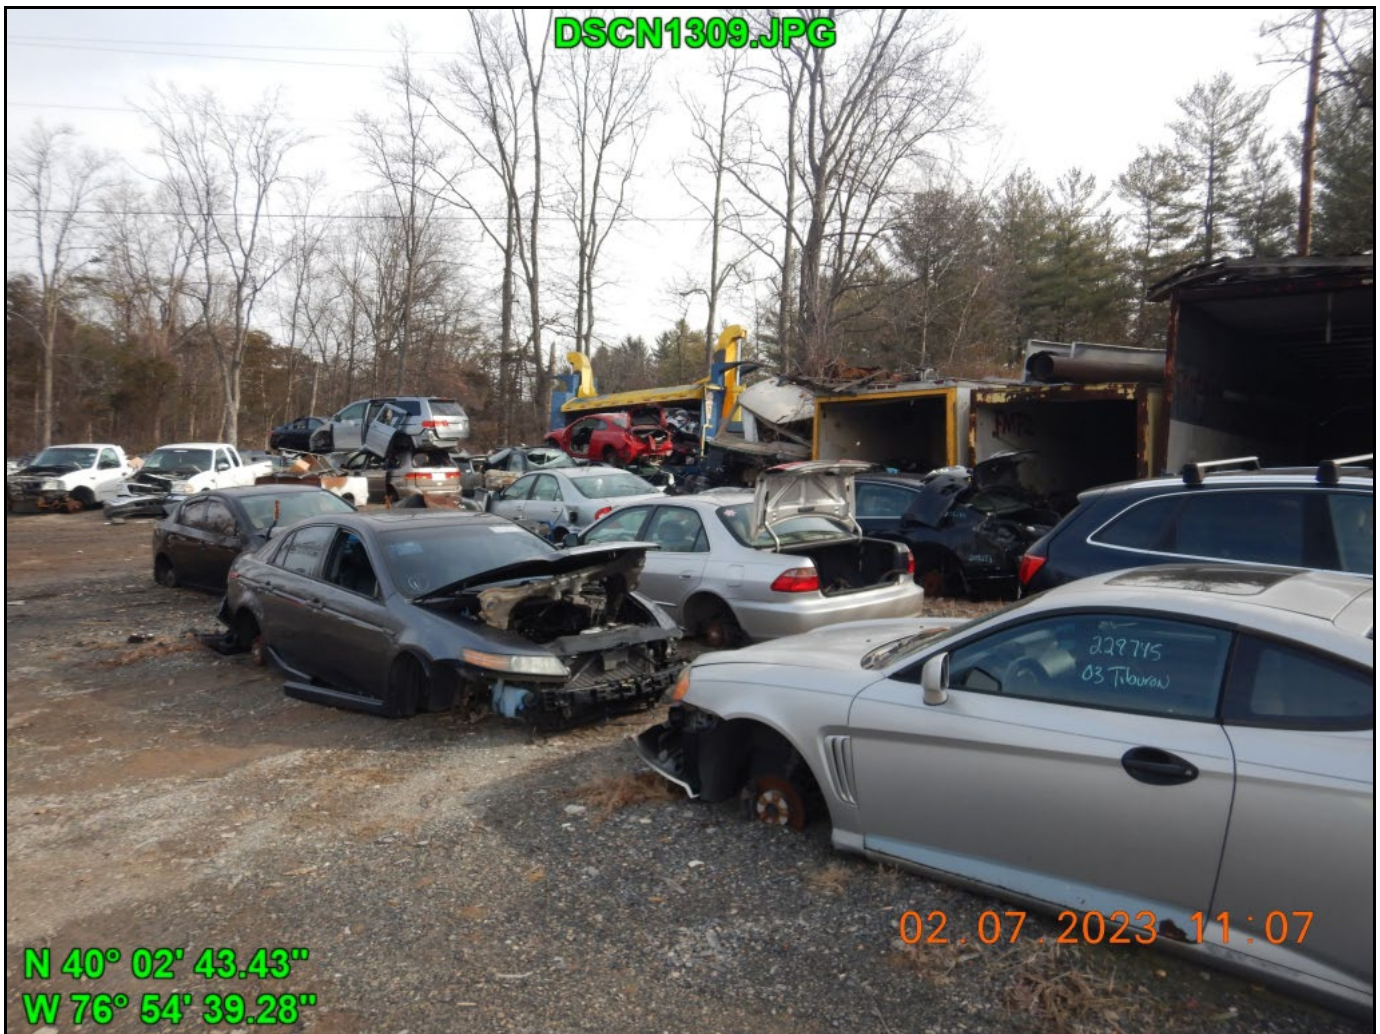
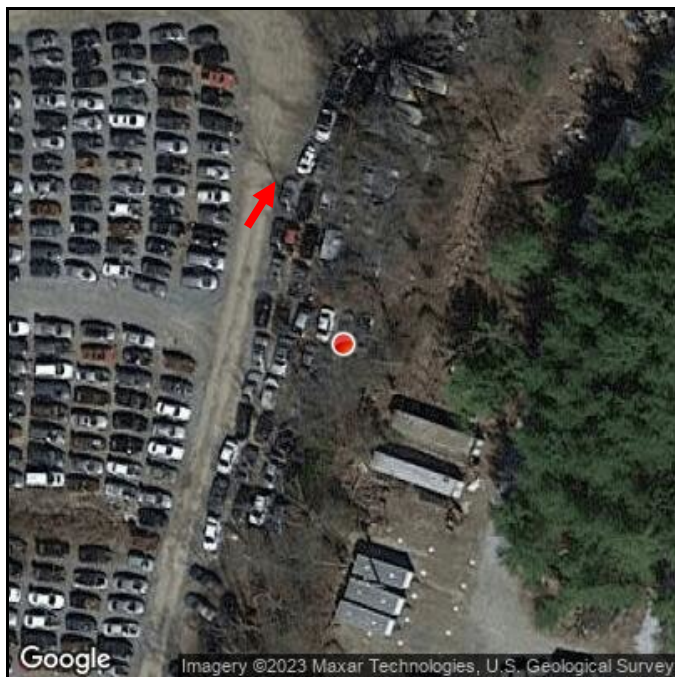
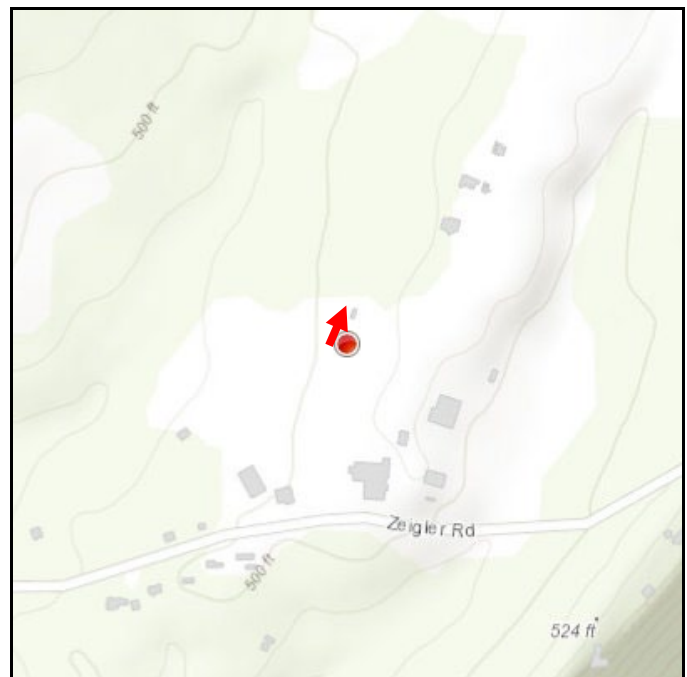
| Description | General view of salvage vehicle crusher in the northeast area of the Facility. |

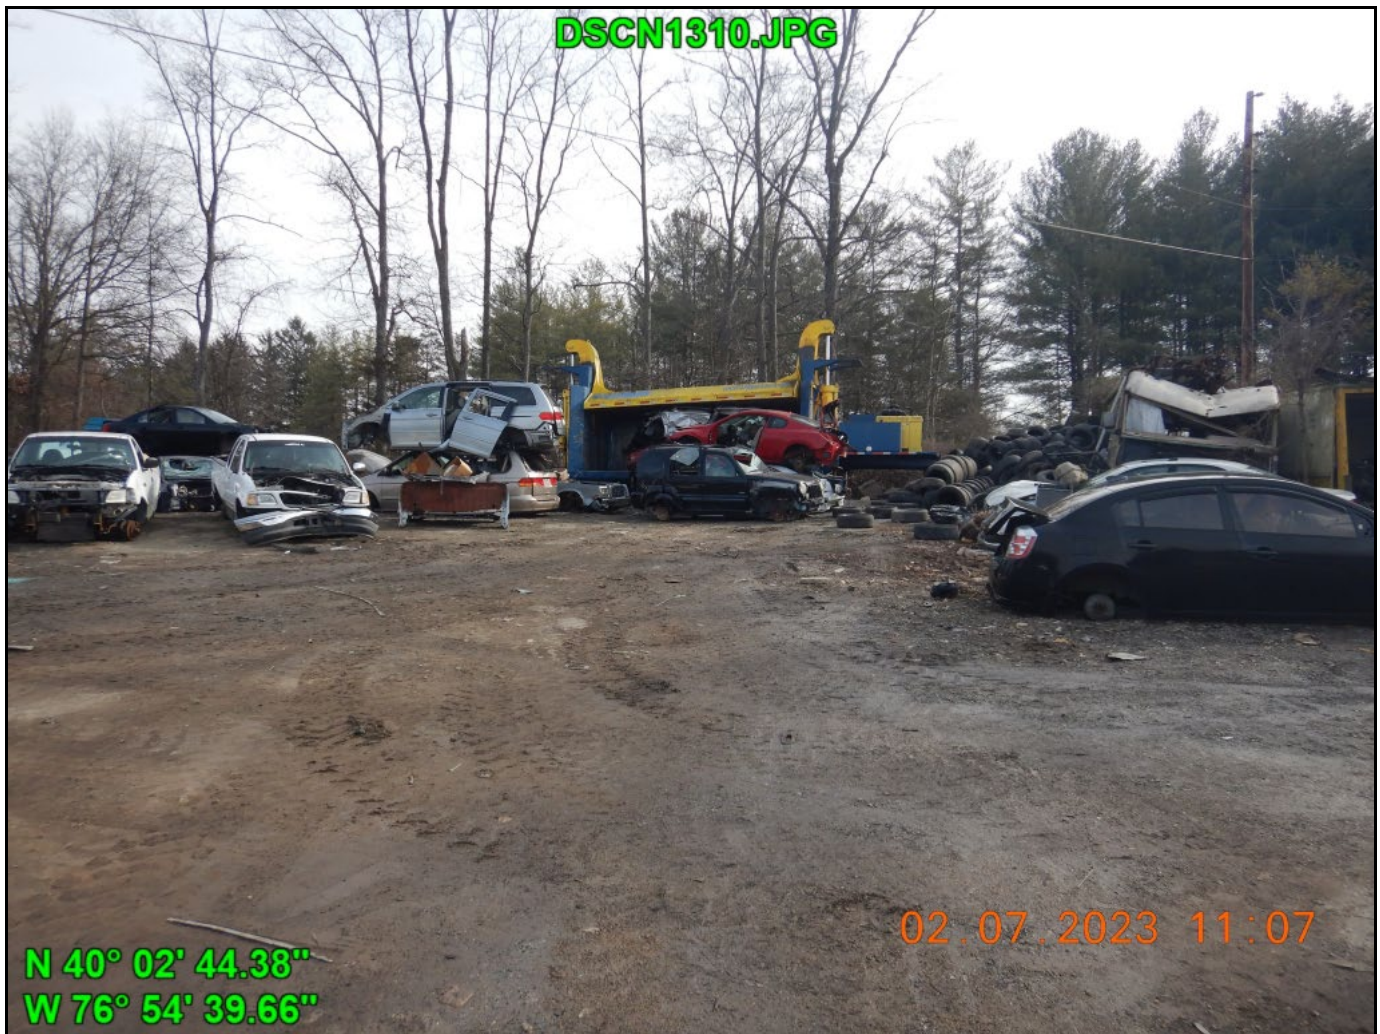
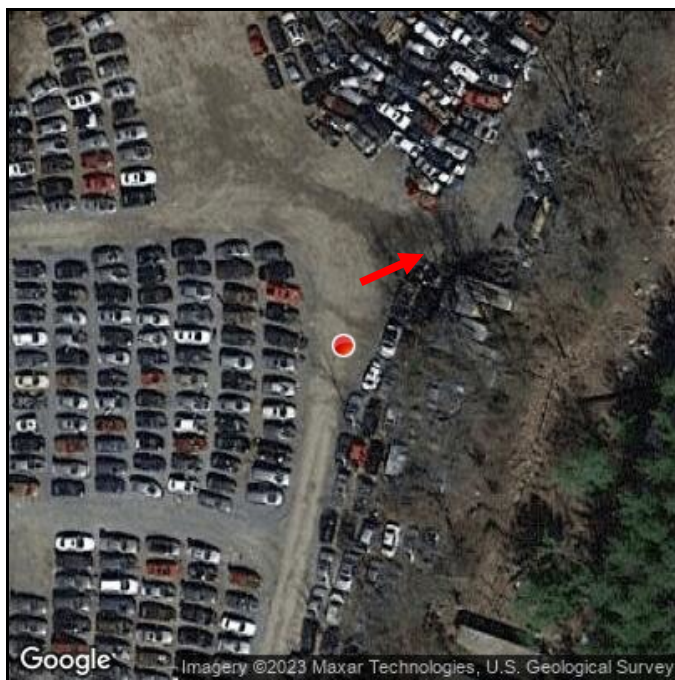
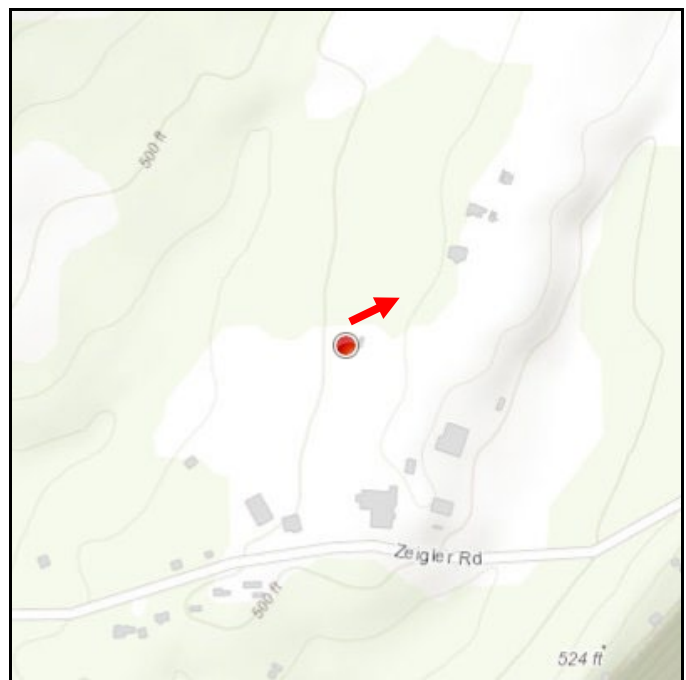
| Description | Additional view of the salvage vehicle crusher in the northeast area of the Facility. |

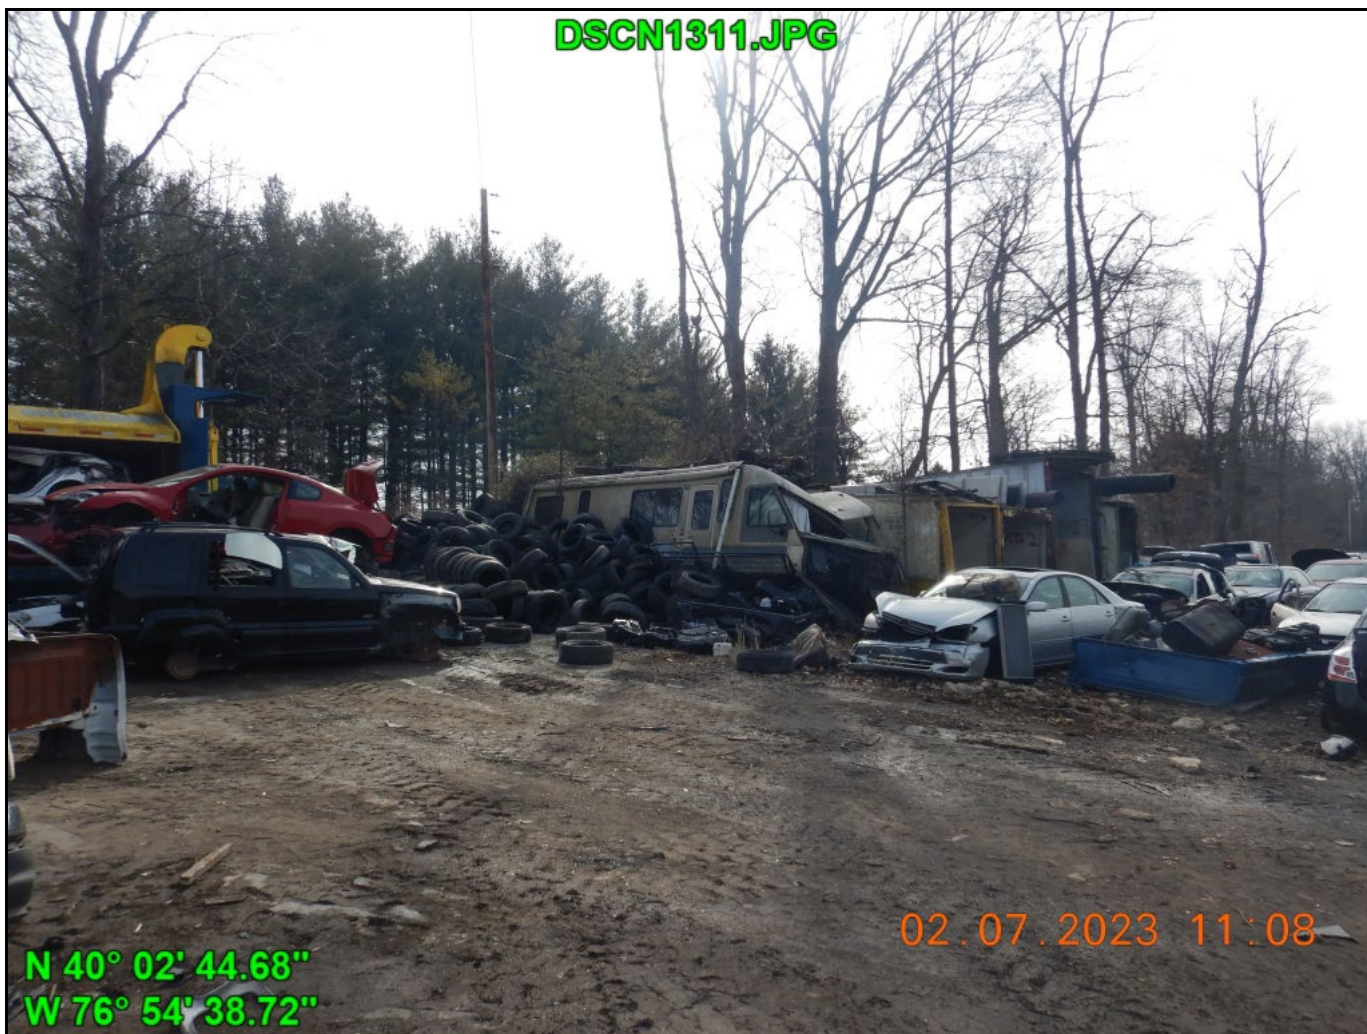
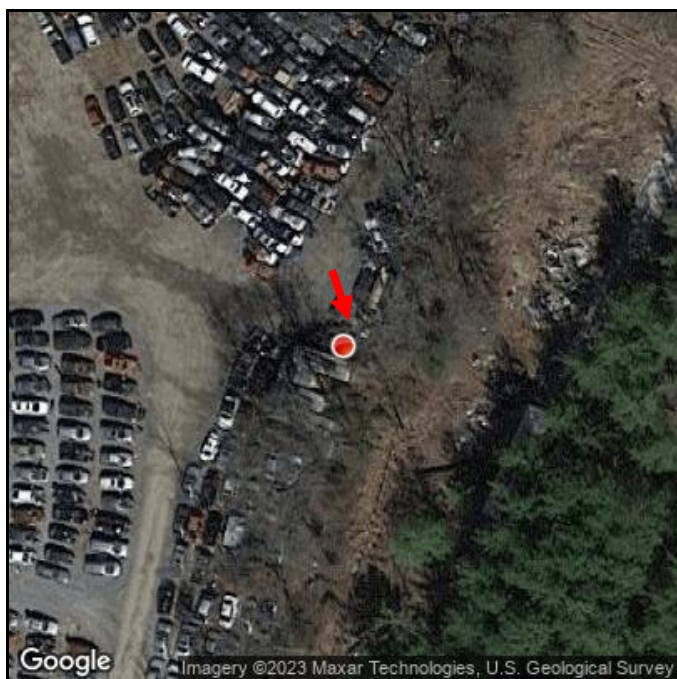
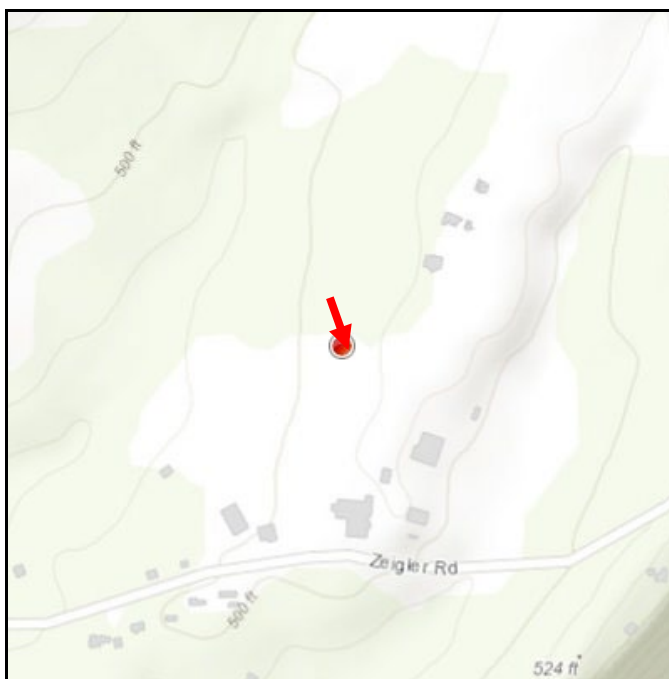
| Description | View of a tire pile near the salvage vehicle crusher in the northeast area of the Facility. |

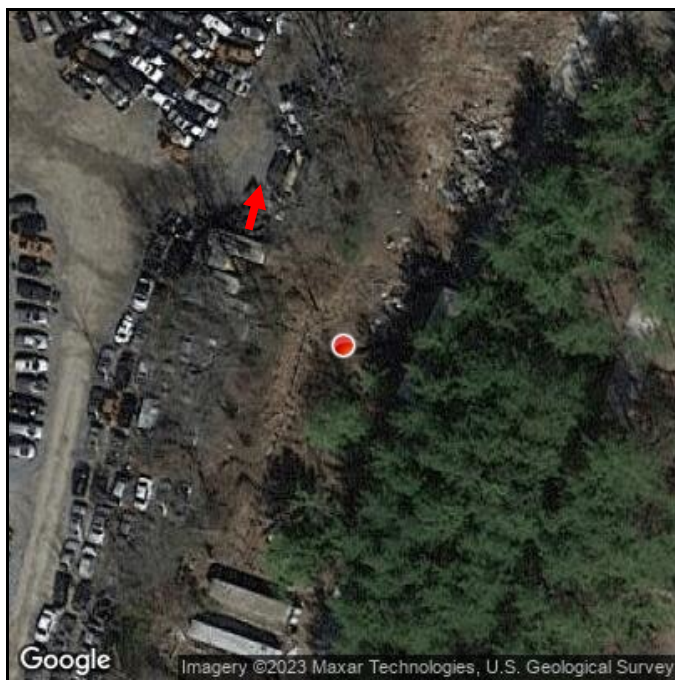
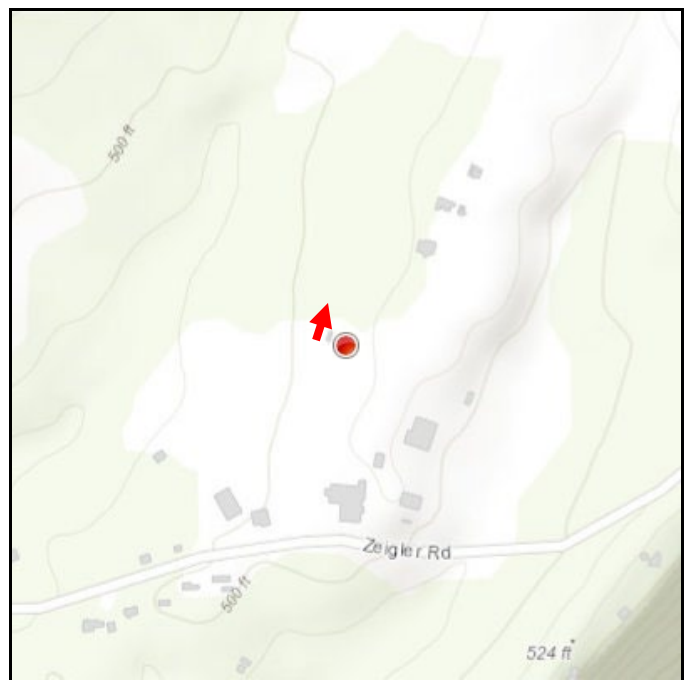
| Description | Additional view of salvage vehicle crusher with substantial debris surrounding the operation. |

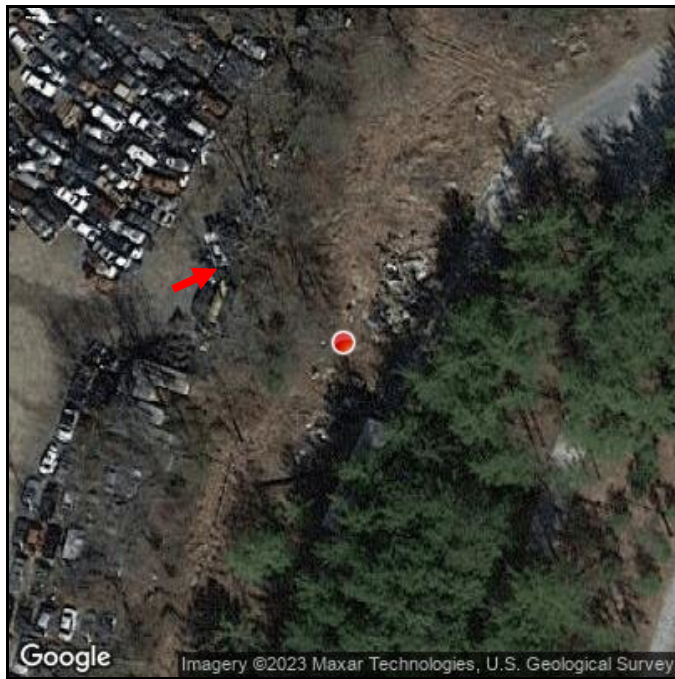
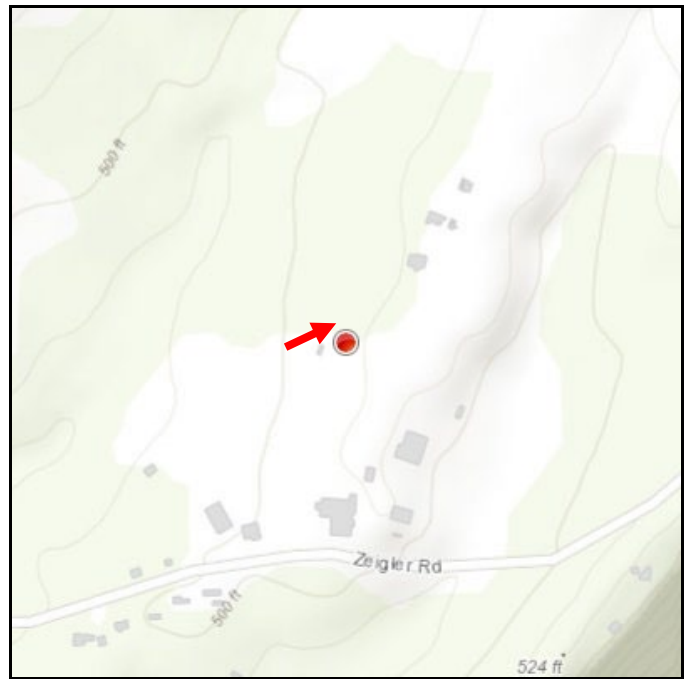
- 4) The EPA Inspection Team observed three (3) oil tanks at the Facility. One by the salvage vehicle crusher (refer to Appendix B, Photograph DSCN1313), which was empty, unmarked, and without containment nor under cover. The two oil tanks by the main office building (refer to Appendix B, Photographs DSCN1293, DSCN1295, & DSCN1296), both contained liquids, one of which was labeled as used oil, and neither of the oil tanks were in containment nor under cover.
- 5) The EPA Inspection Team observed orange-colored ponded water south of the unnamed tributary to Conewago Creek running through the Facility property (refer to Appendix B, Photograph DSCN1304). The coloration was consistent with that of typical iron-oxidizing bacteria.

| Description | View of an oil tank adjacent to the salvage vehicle crusher. The tank was empty, unmarked, and without containment or cover at the time of inspection. Empty fuel tank in the foreground. |

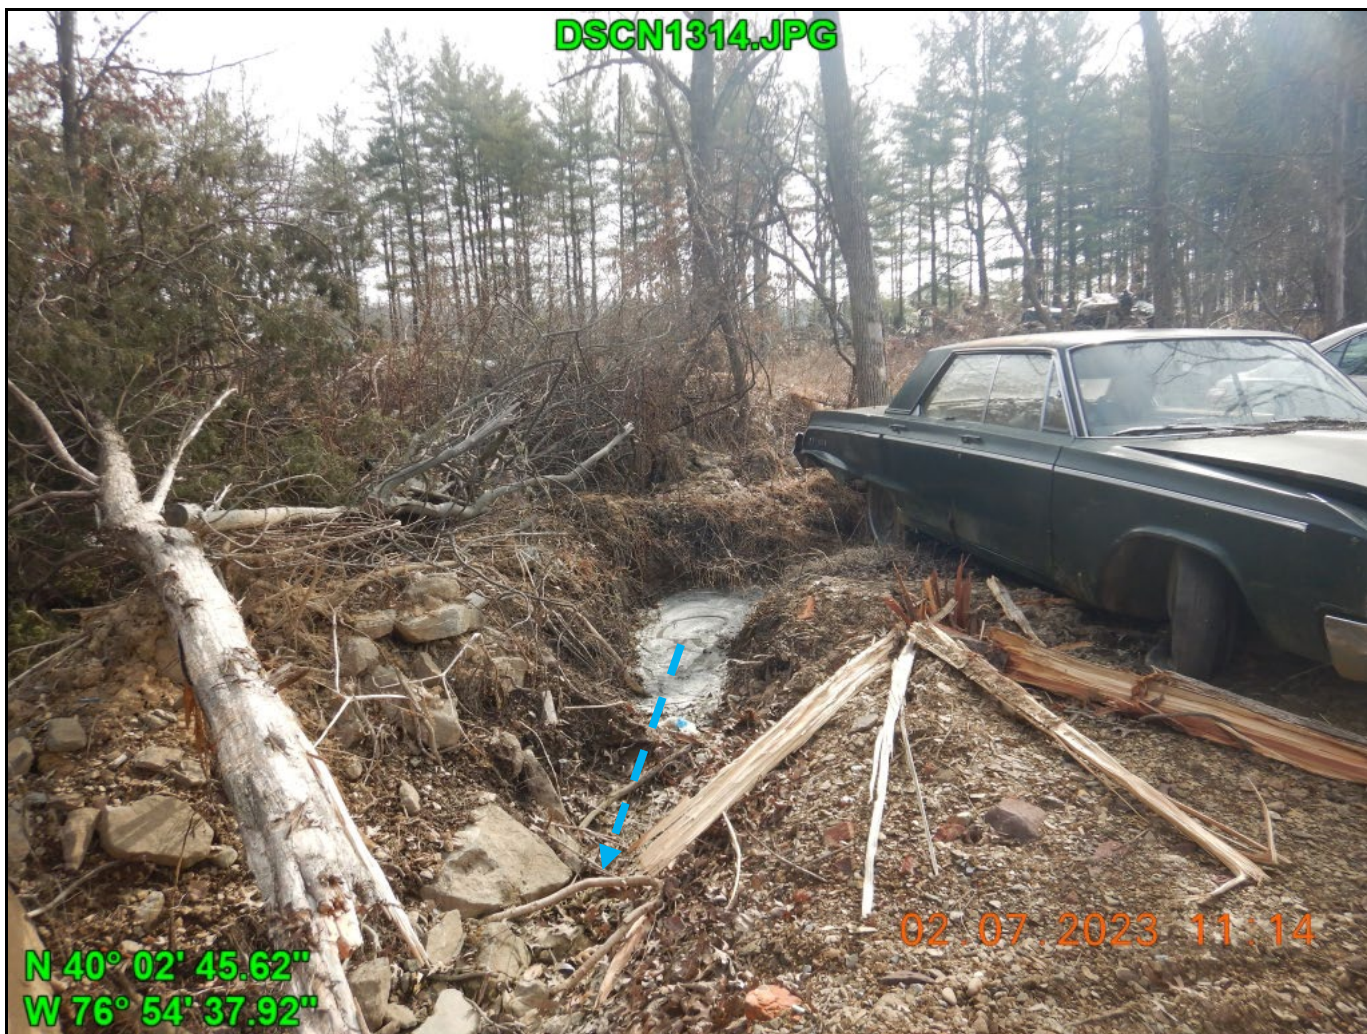
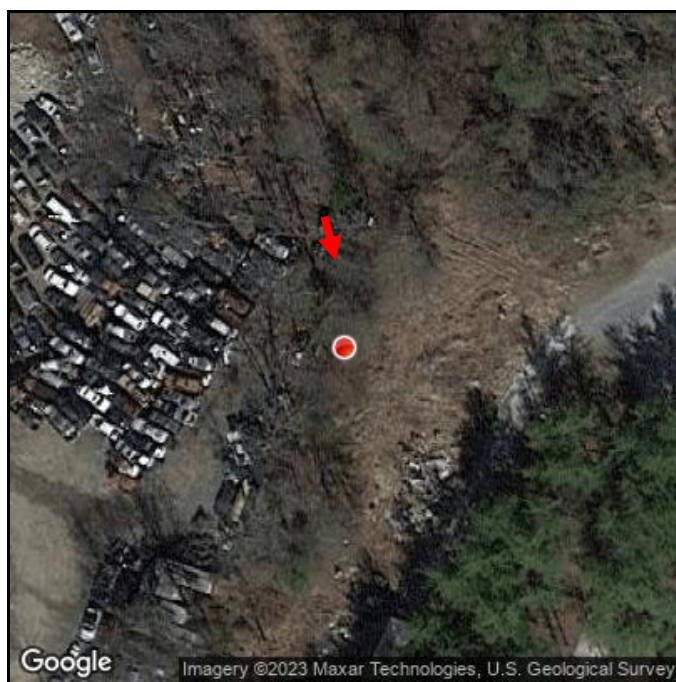
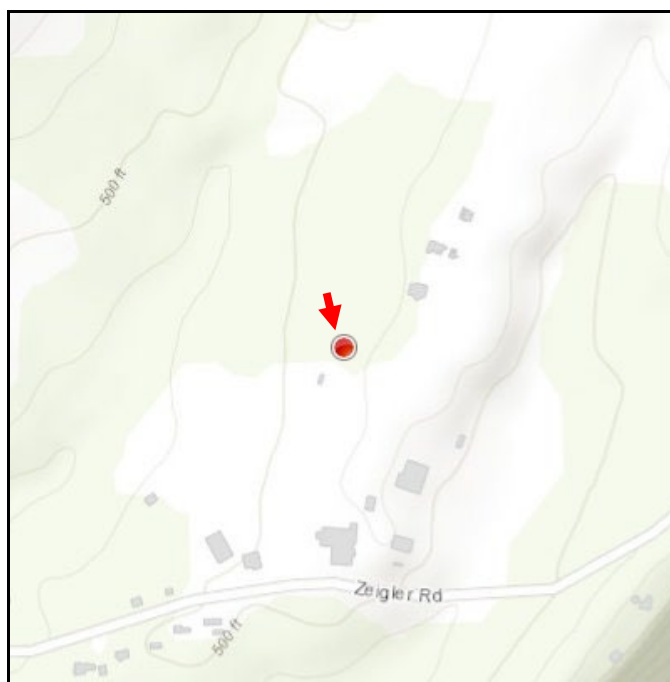
| Description | View, facing upgradient, of the unnamed tributary to Conewago Creek running along the northern border of the Facility. |

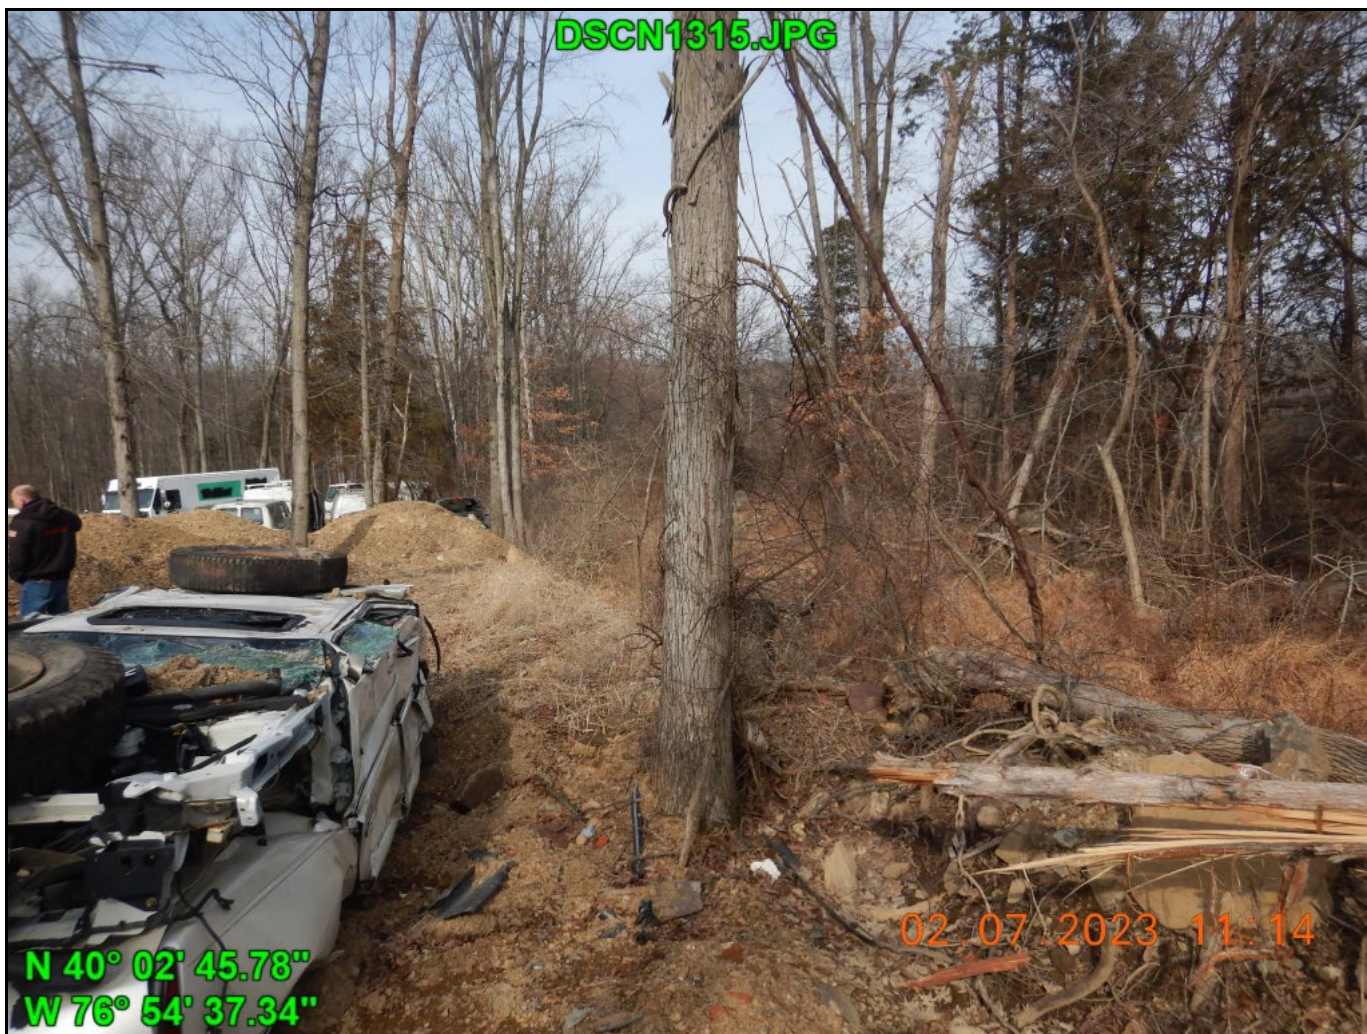
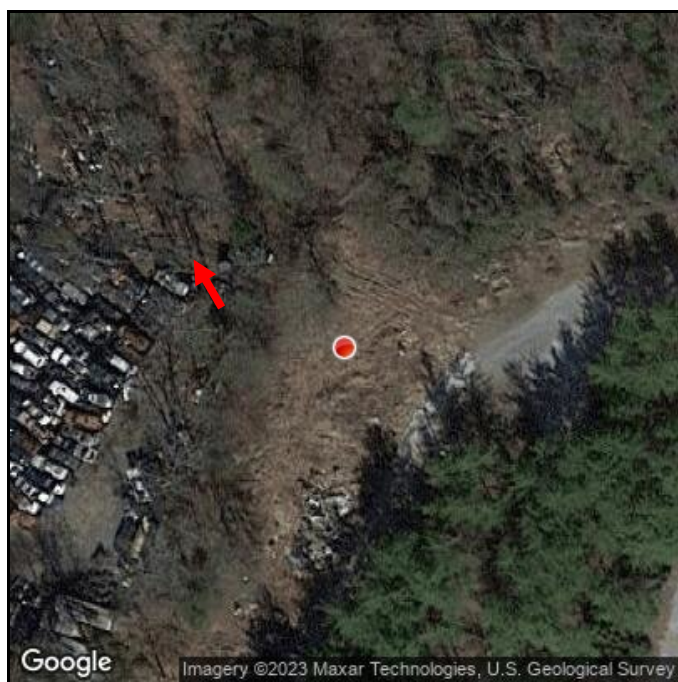
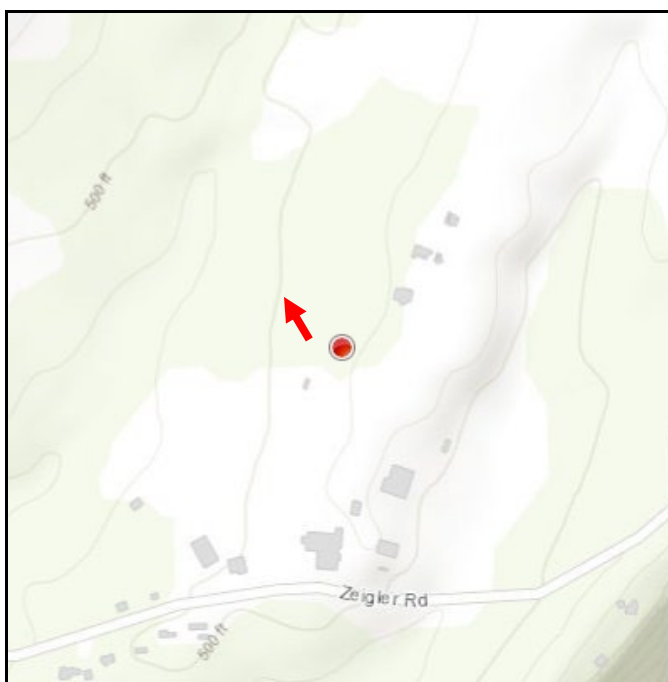
| Description | View of the Facility's north border, looking downgradient from the view in Photograph DSCN1314. |

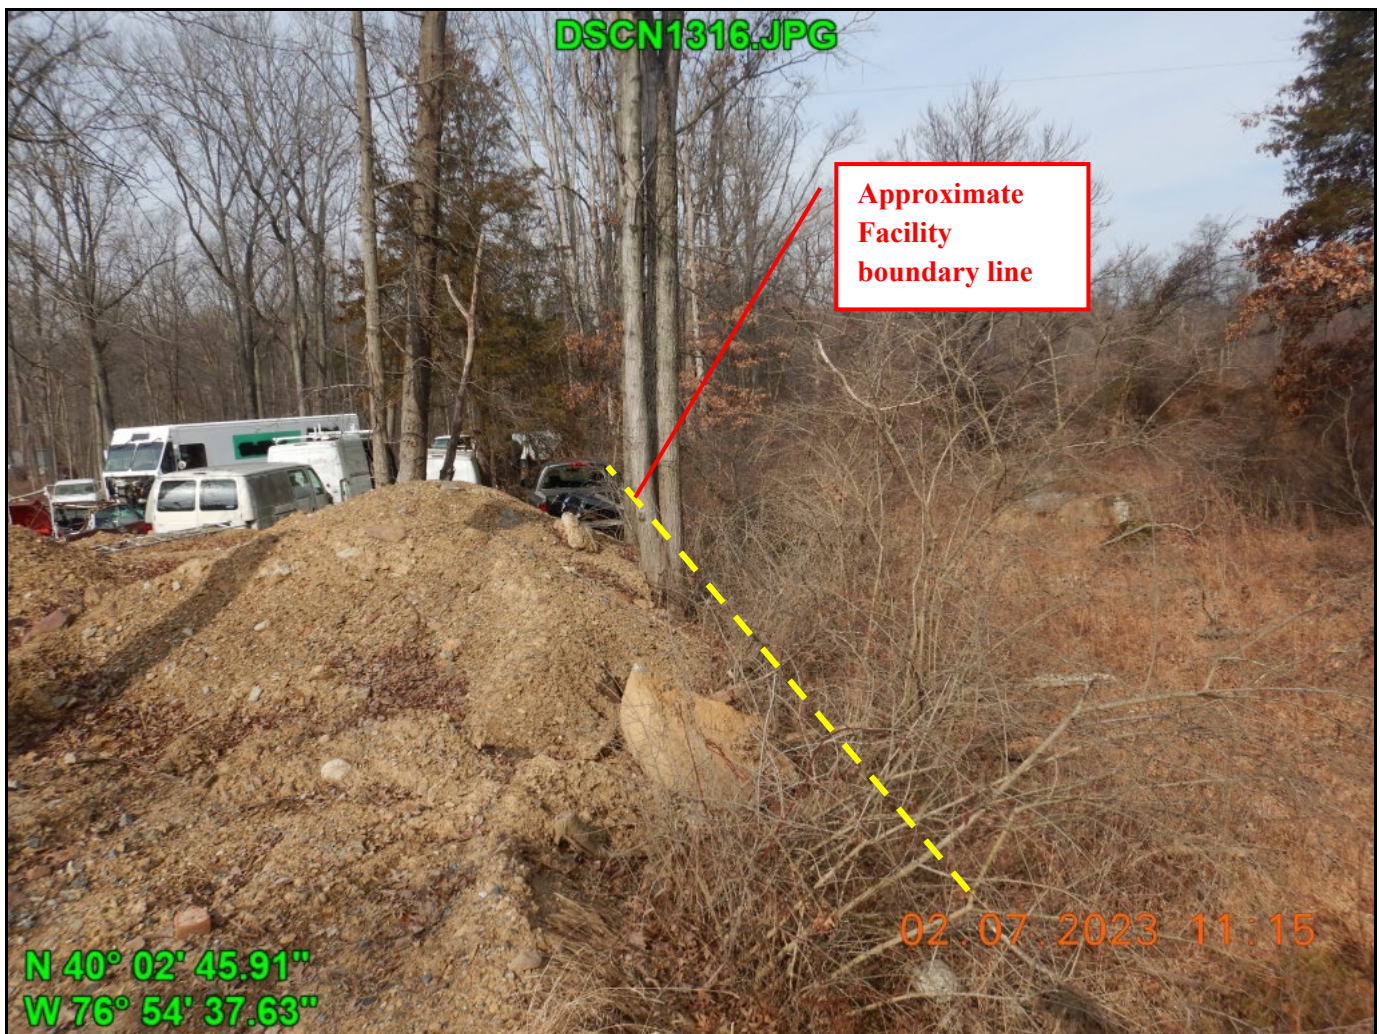
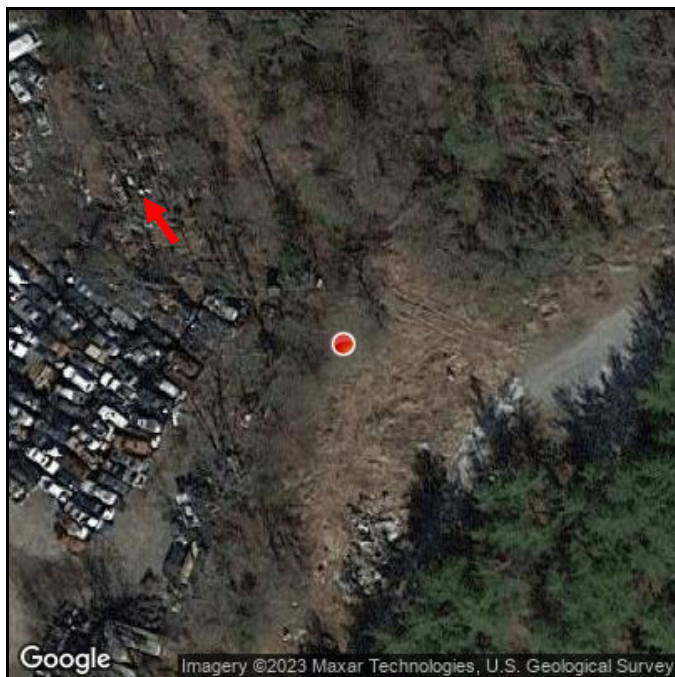
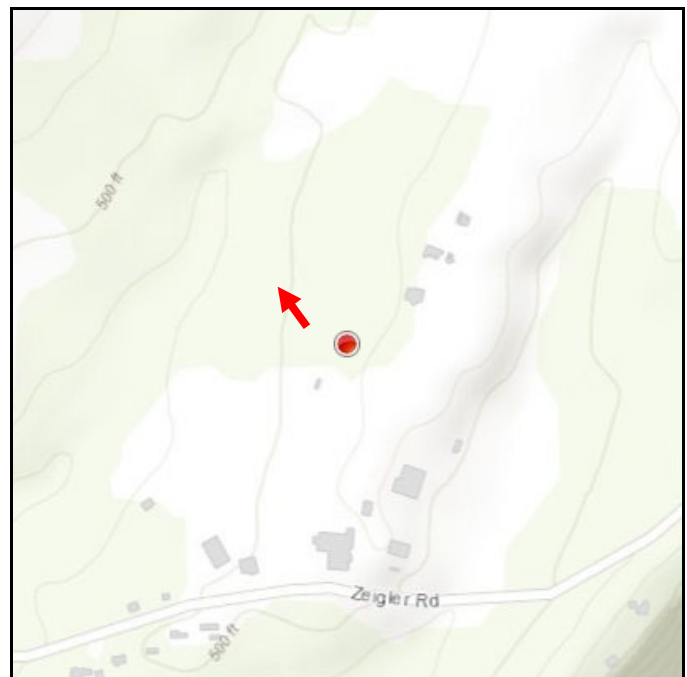
| Description | View of the Facility's north border. |

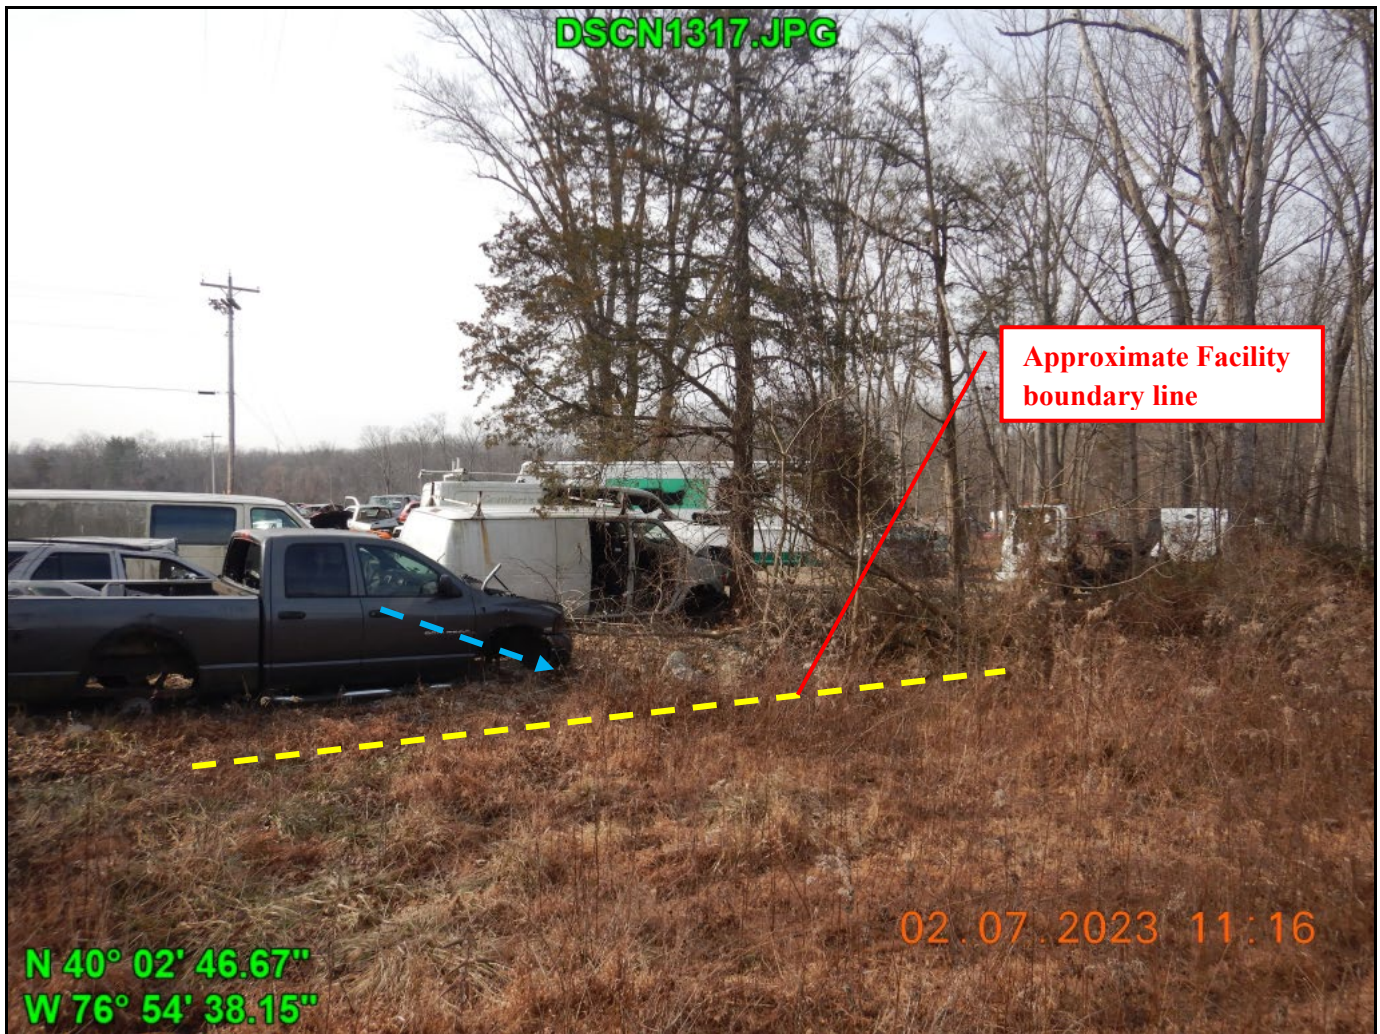
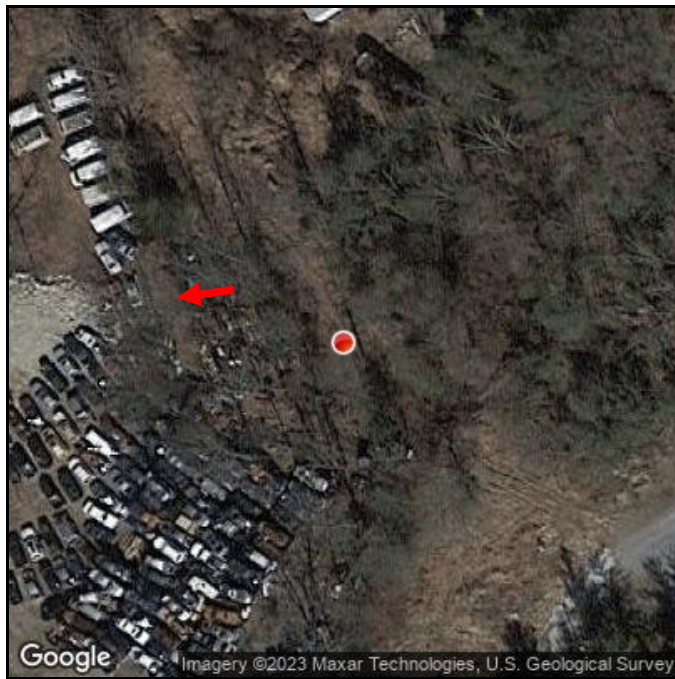
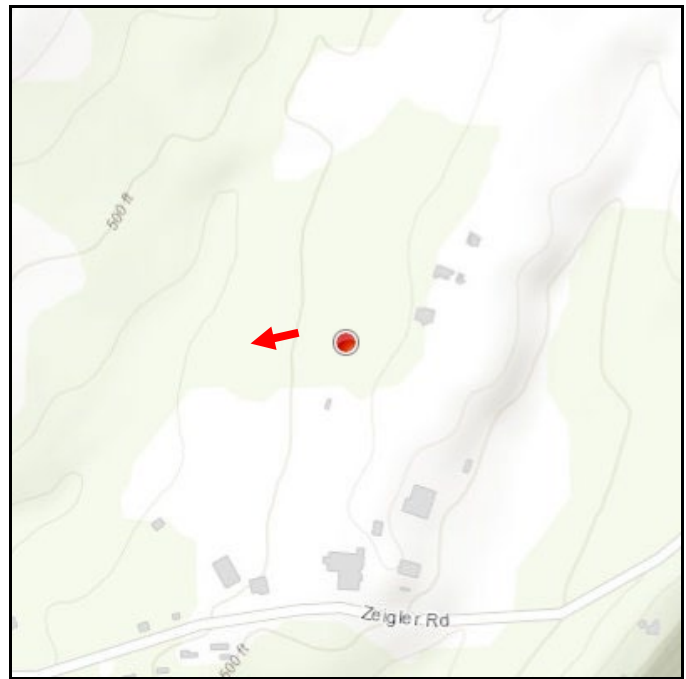
| Description | View, facing upgradient, of the Facility's north border. |

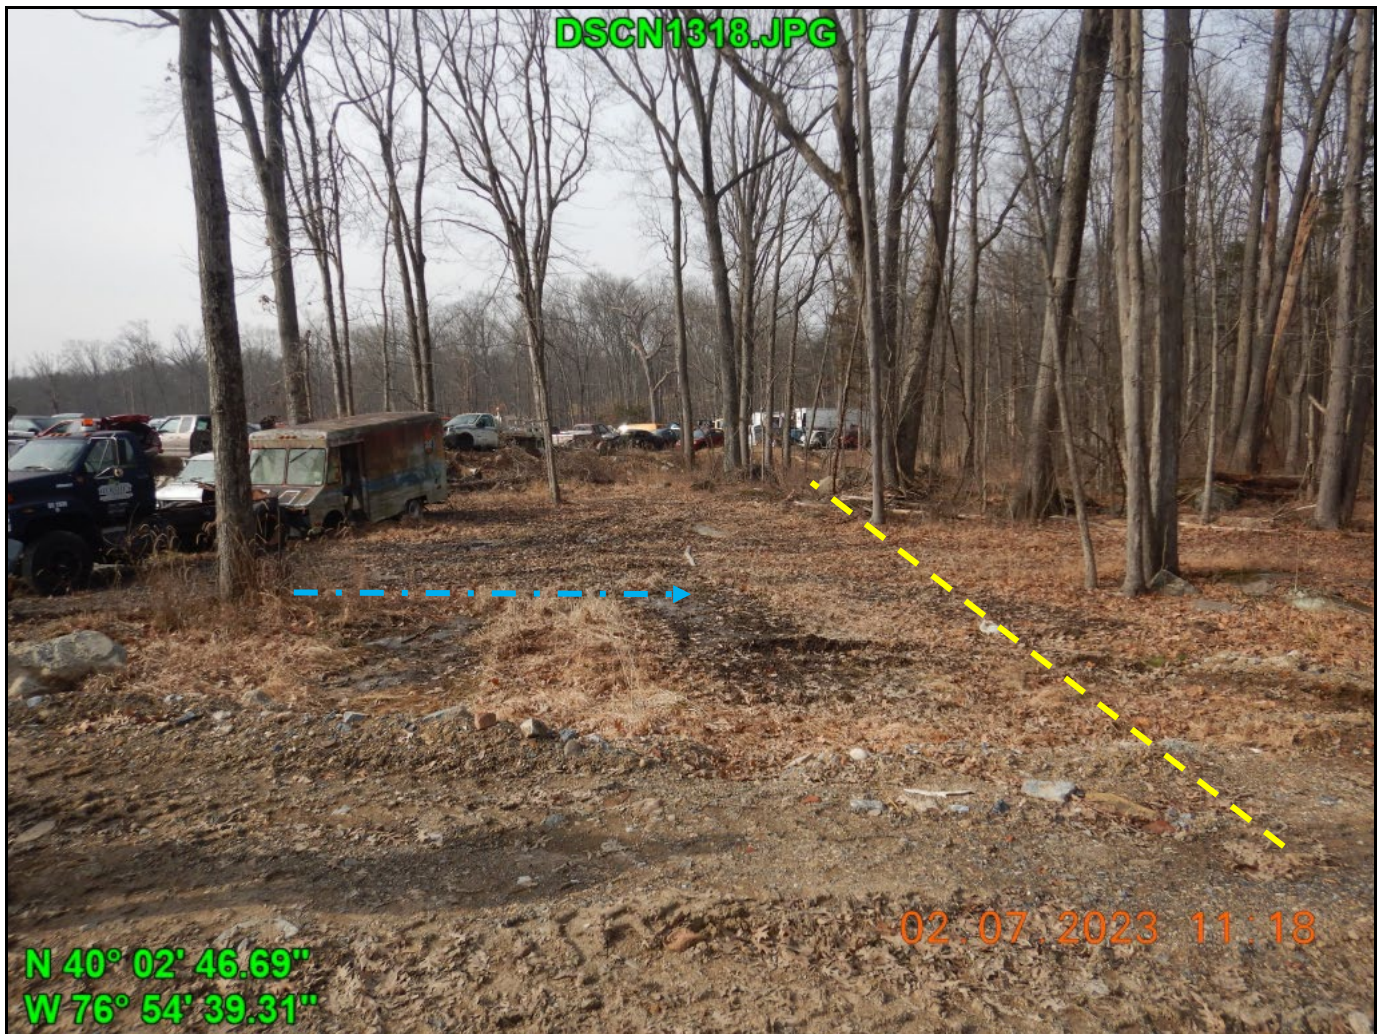
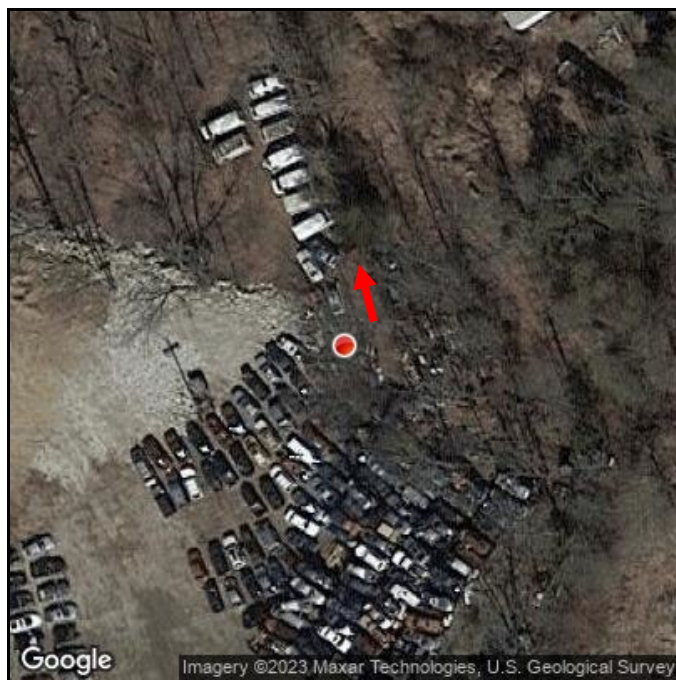
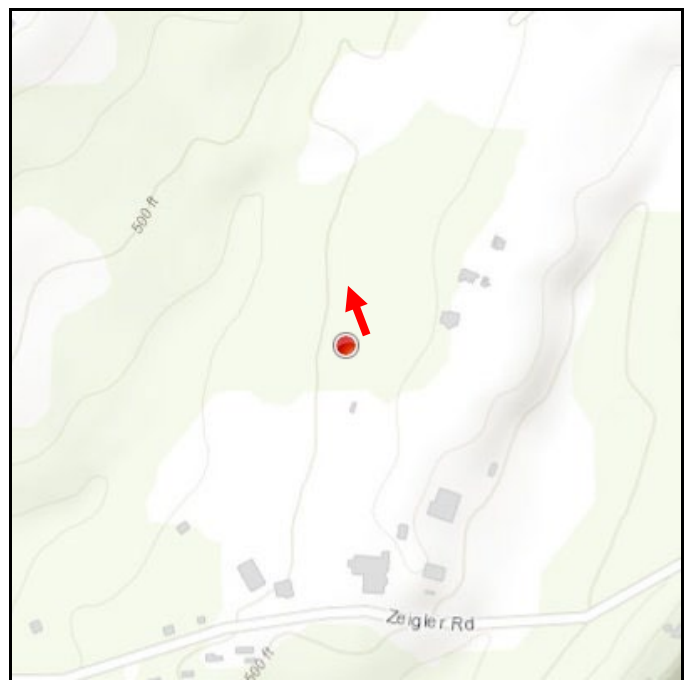
| Description | View, facing perpendicular to the gradient, of the Facility's north border. |
