## MULTI-SECTOR GENERAL PERMIT NON-FILER INSPECTION CHECKLIST

| <b>Inspection Date(s):</b> | 2/7/2023 | |
| <b>Operator Name:</b> | Lebarron's Auto Salvage | |

**Appendix A. Aerial Map**  
**Clean Water Act Inspection**  
**Lebarrons Auto Salvage**

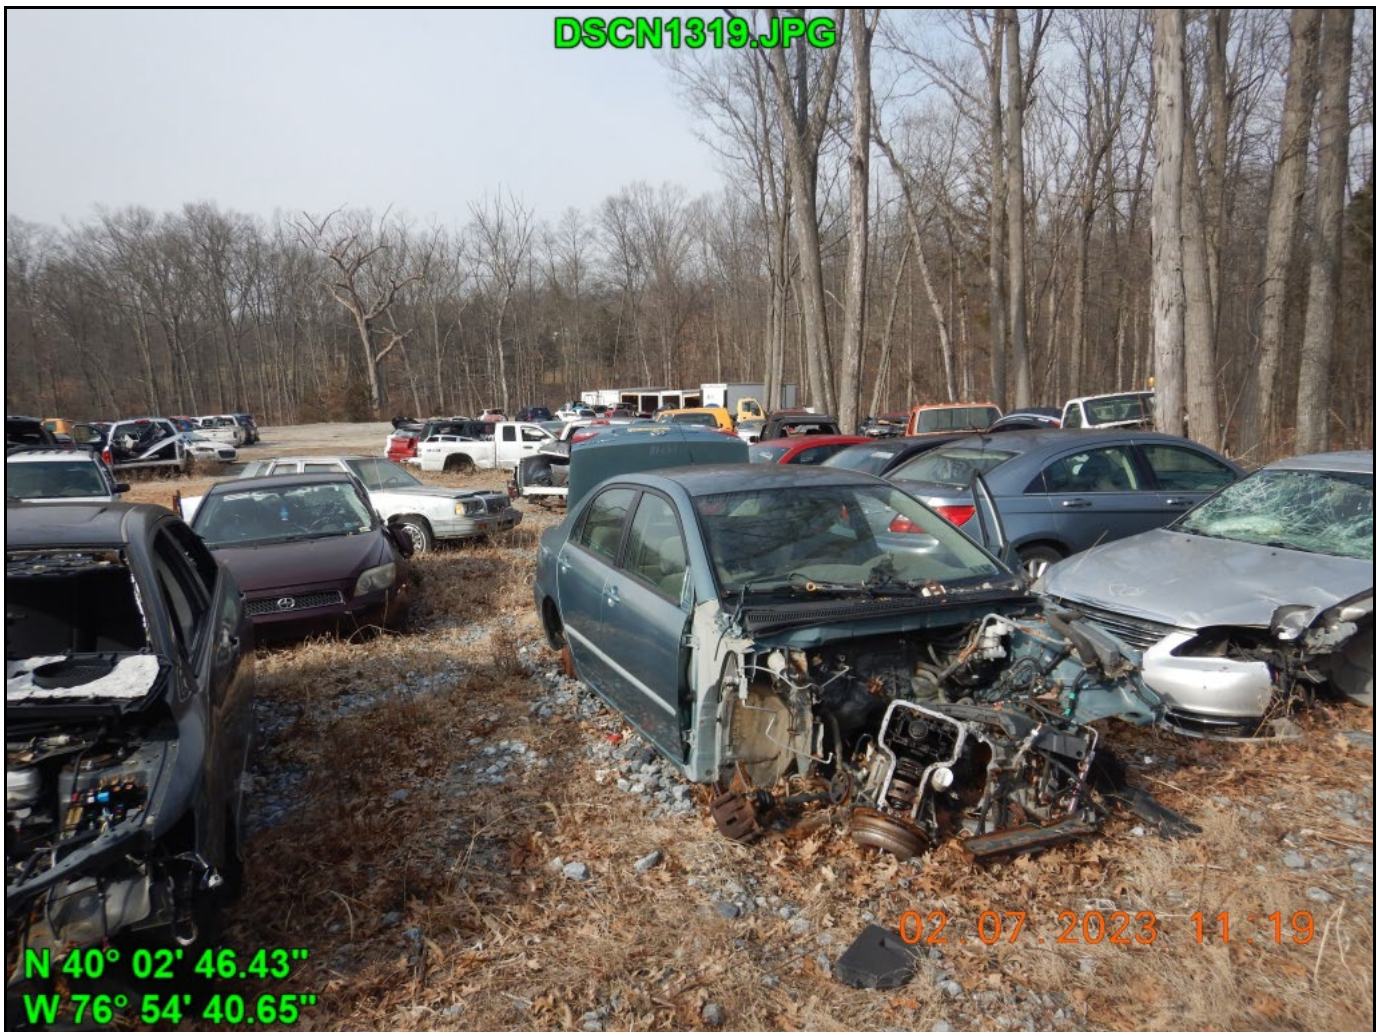
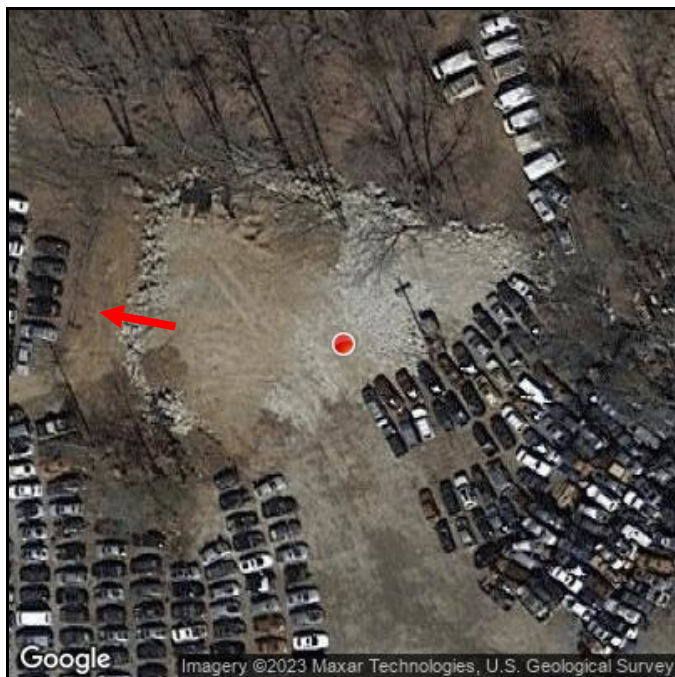
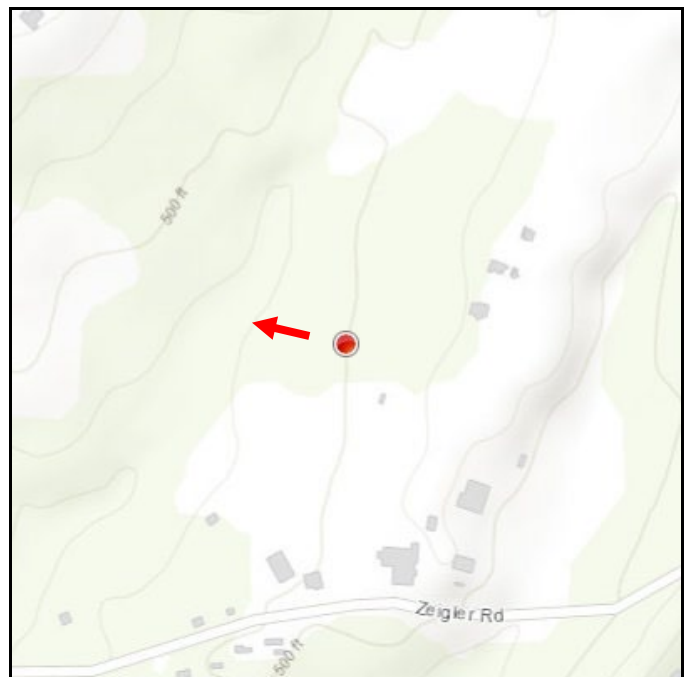
| Description | View of salvage vehicles stored on the pervious ground in the north area of the Facility. |

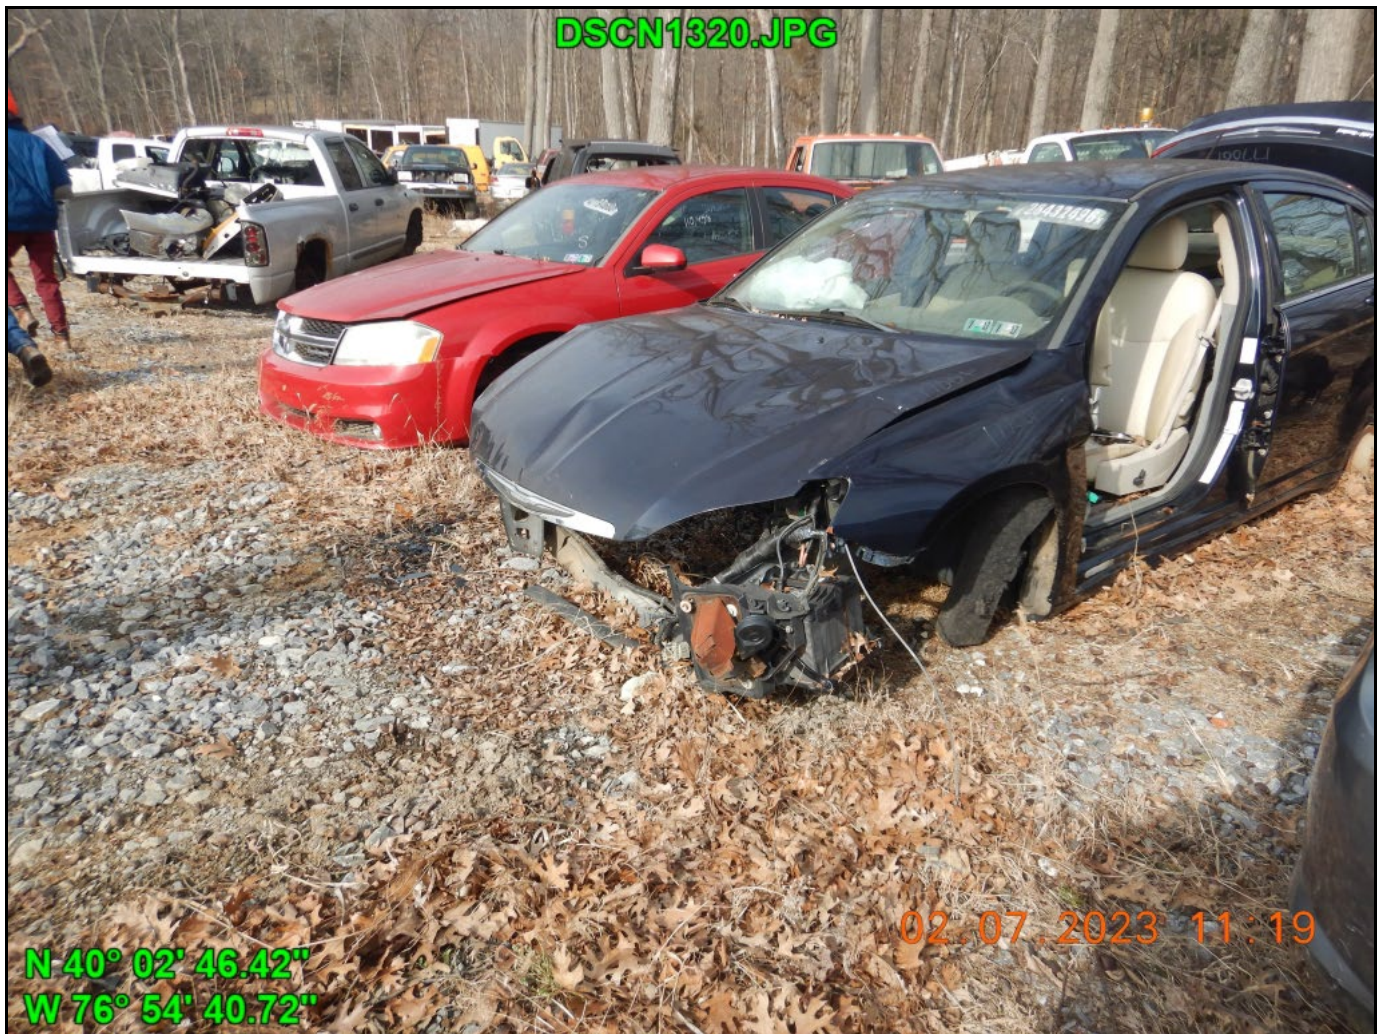
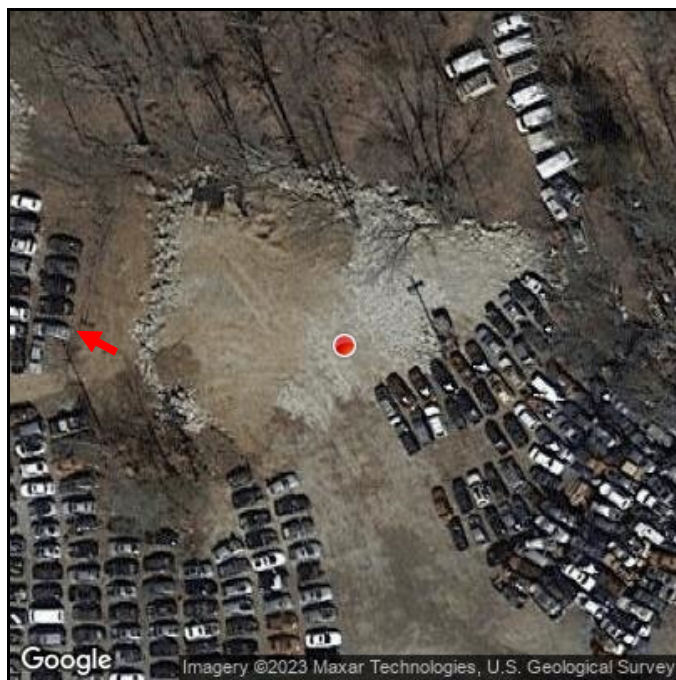
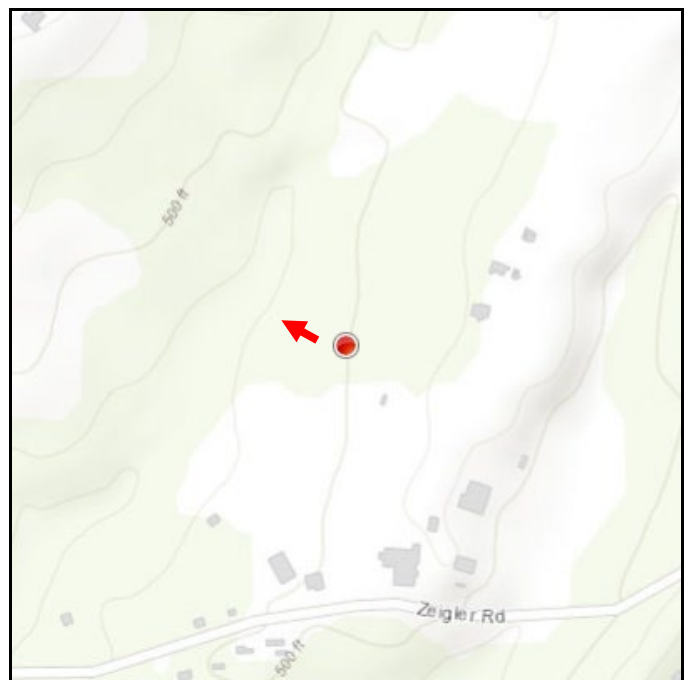
| Description | Additional view of salvage vehicles stored on the pervious ground in the north area of the Facility. |

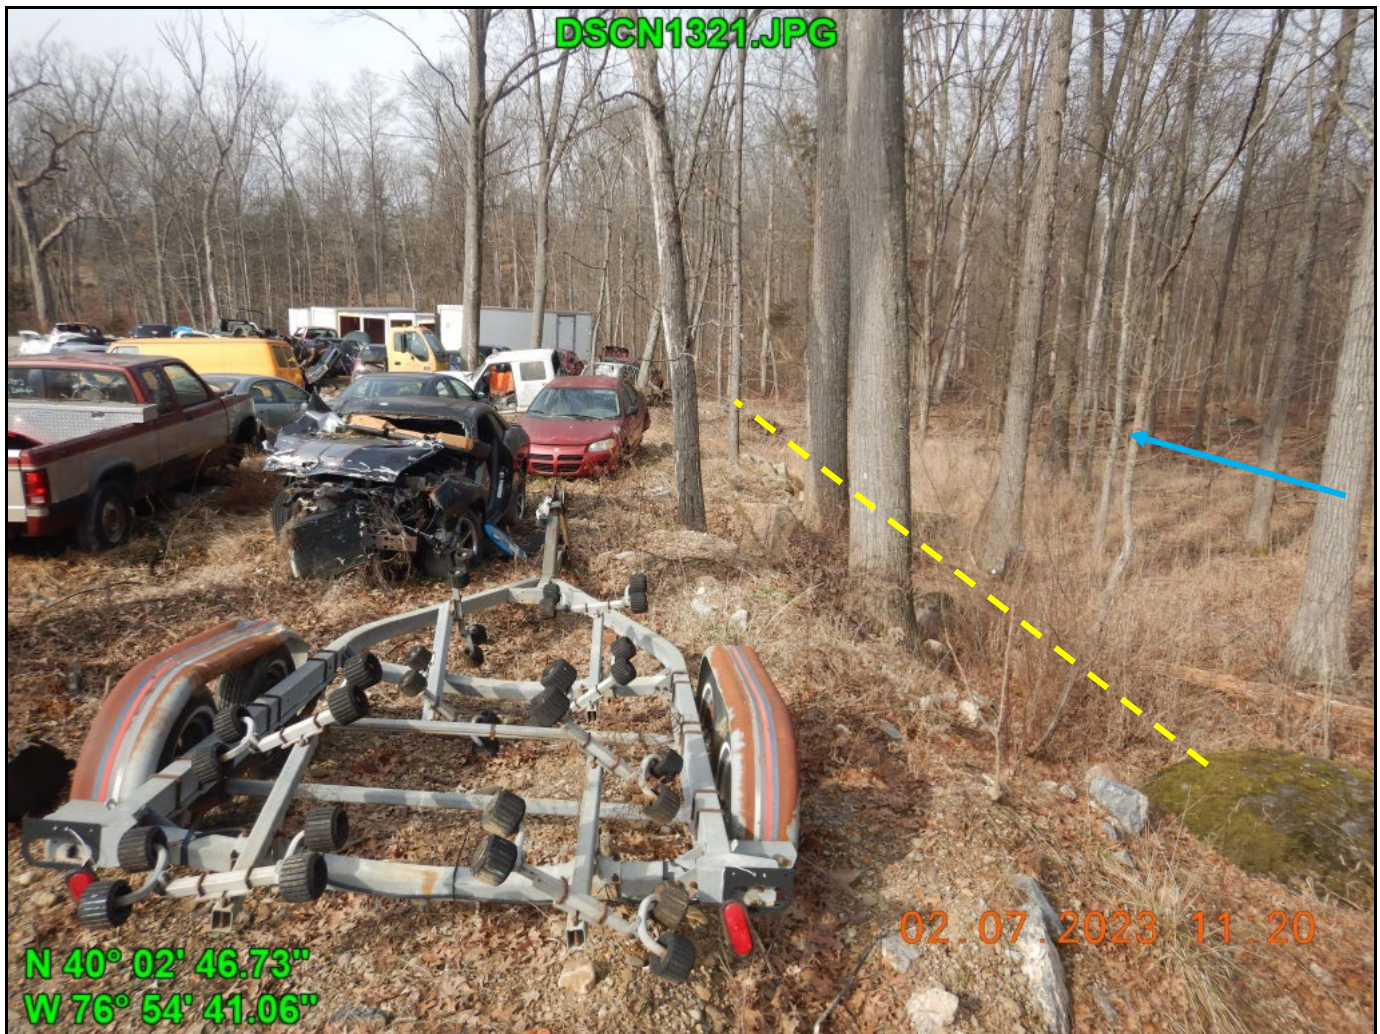
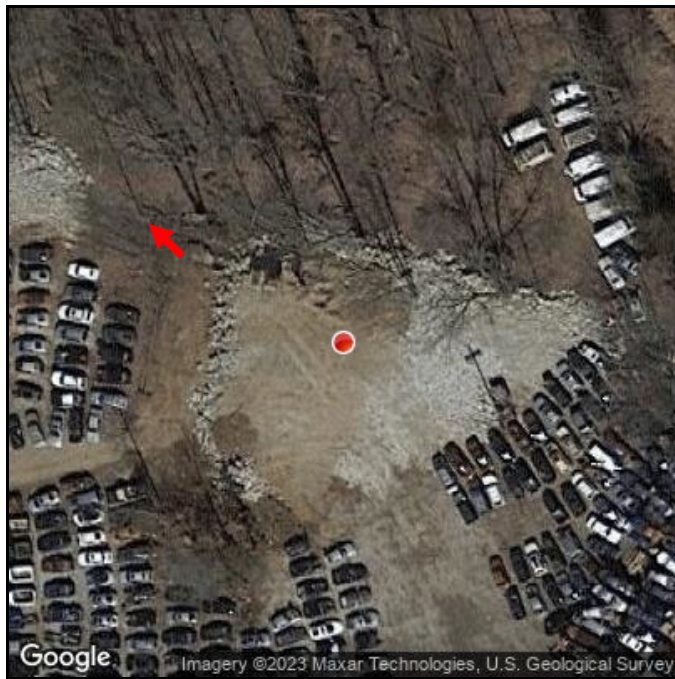
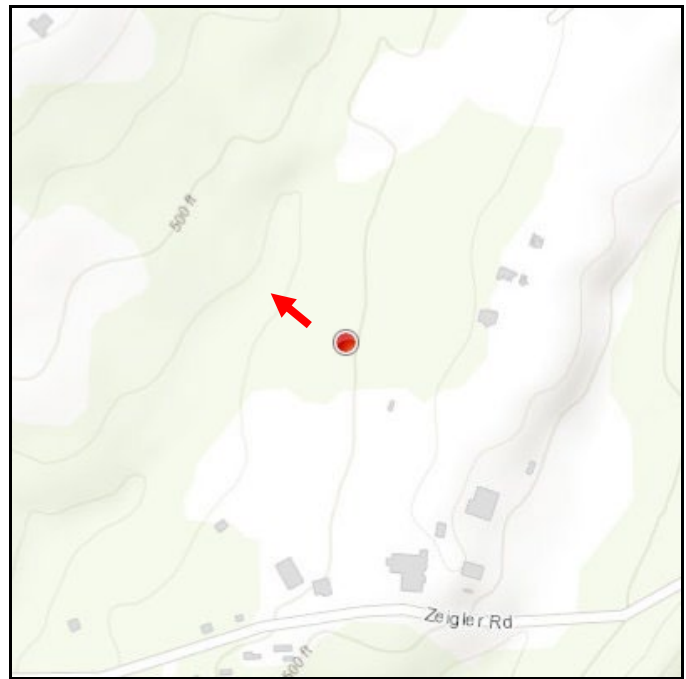
| Description | View of the northern Facility boundary. Note the unnamed tributary to Conewago Creek running along northern Facility boundary. |

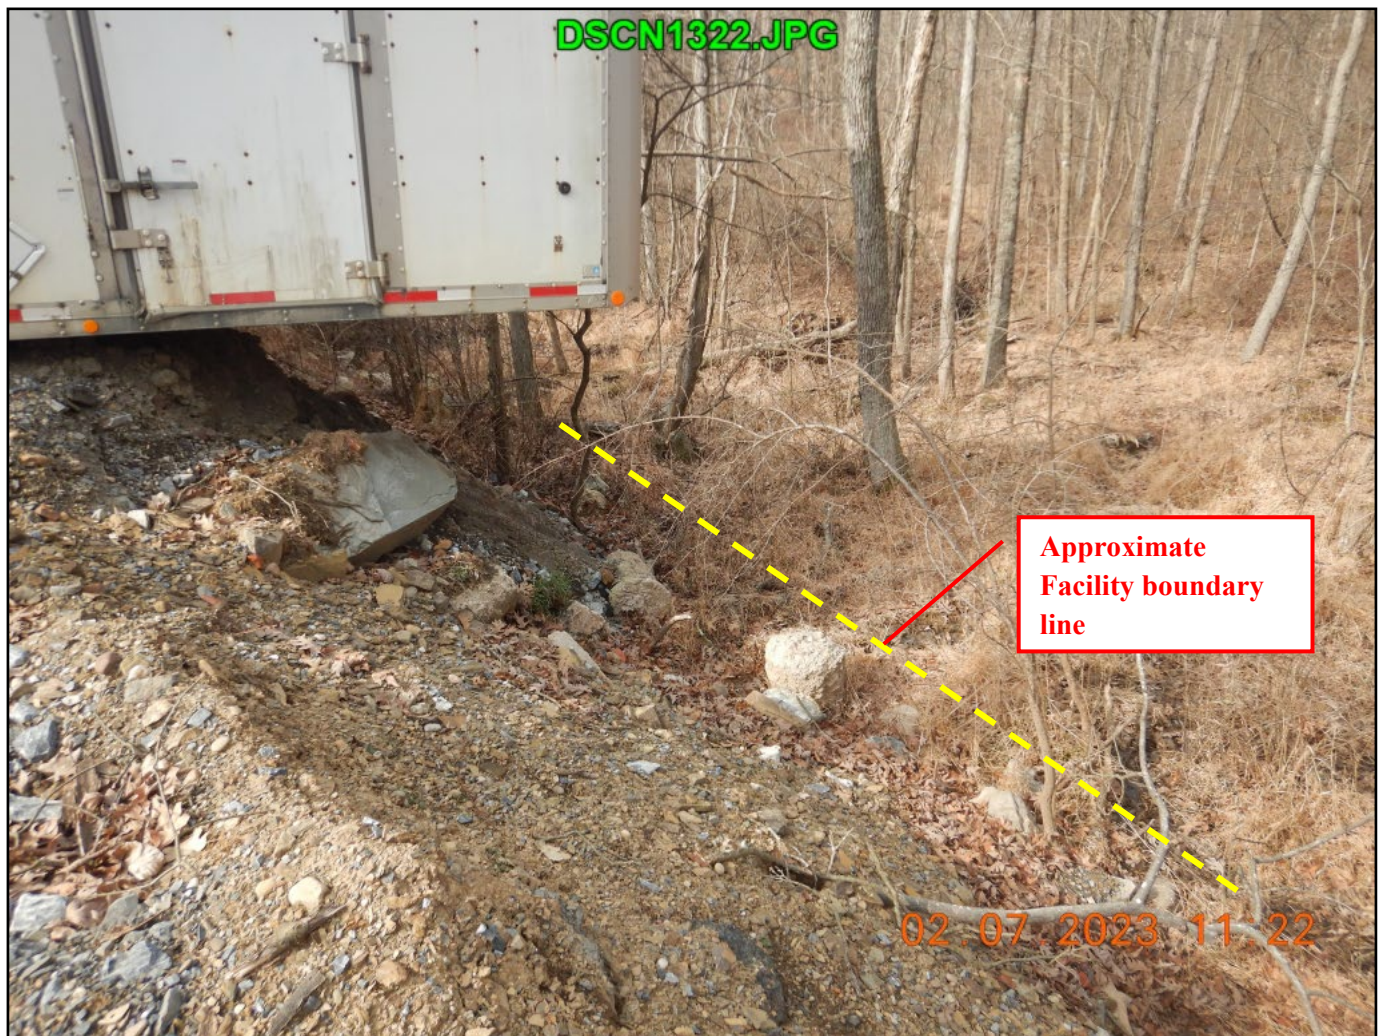
| Description | View of the of Facility's west boundary at northwest corner of the Facility's main office. |

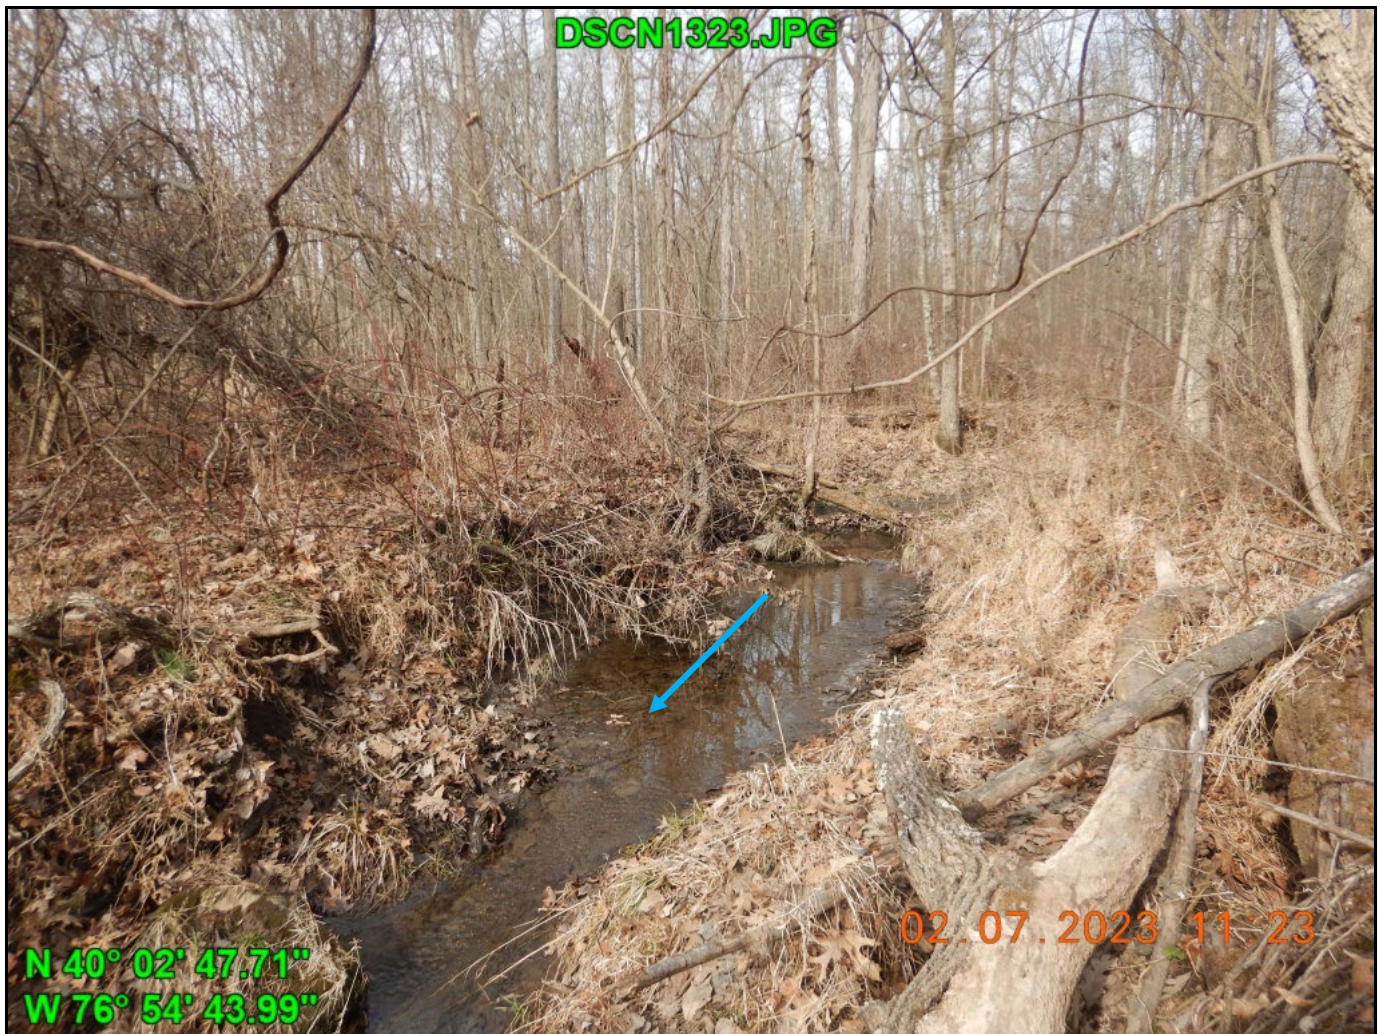
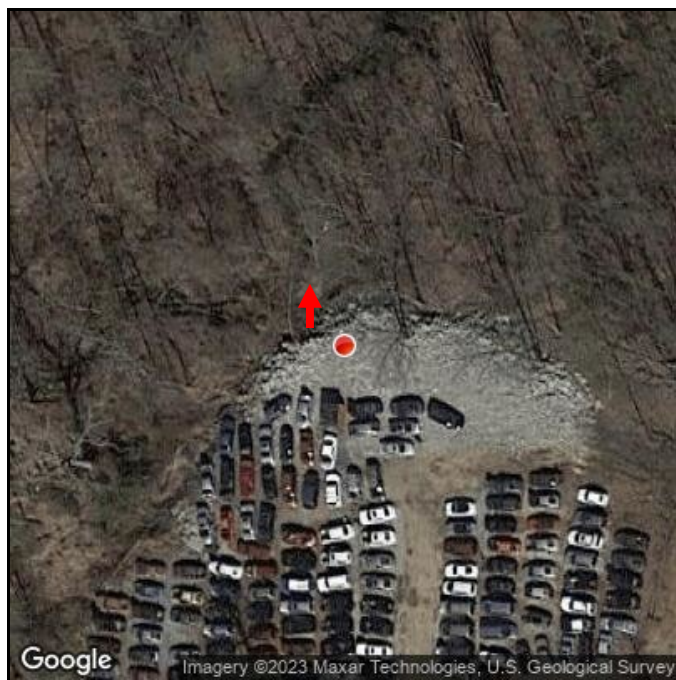
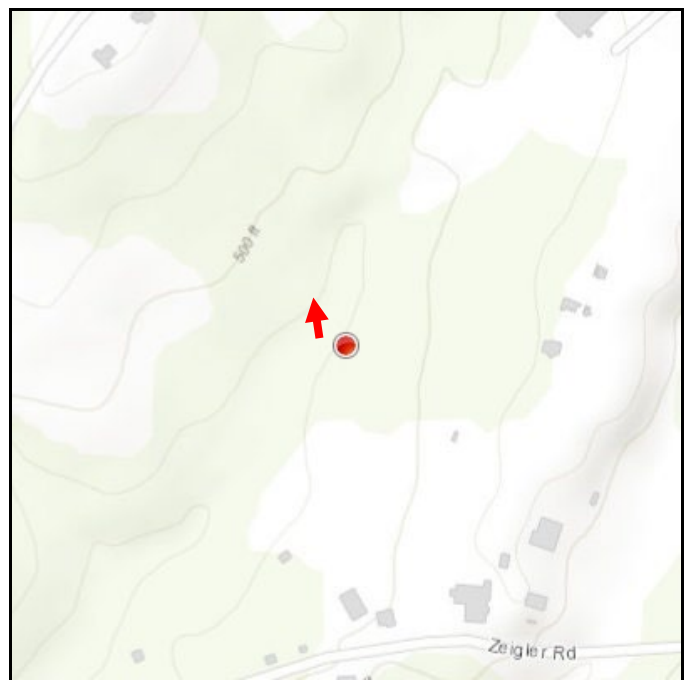
| Description | View of the unnamed tributary to Conewago Creek at the western Facility border. |

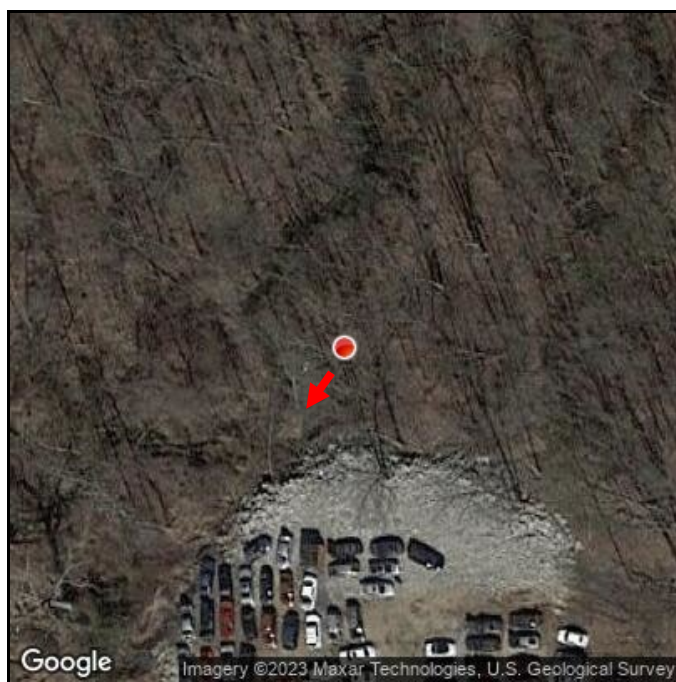
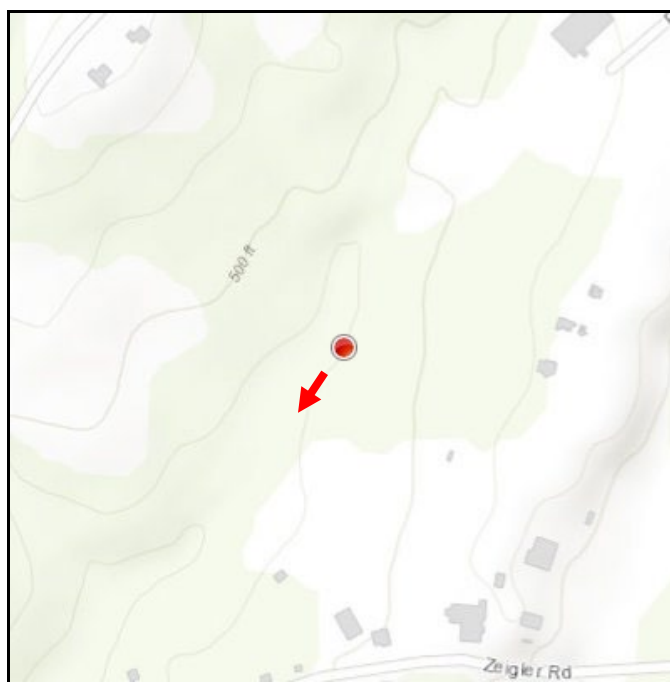
| Description | View of the unnamed tributary to Conewago Creek running along the Facility's western boundary. Note the salvage vehicles stored adjacent to the unnamed tributary. |

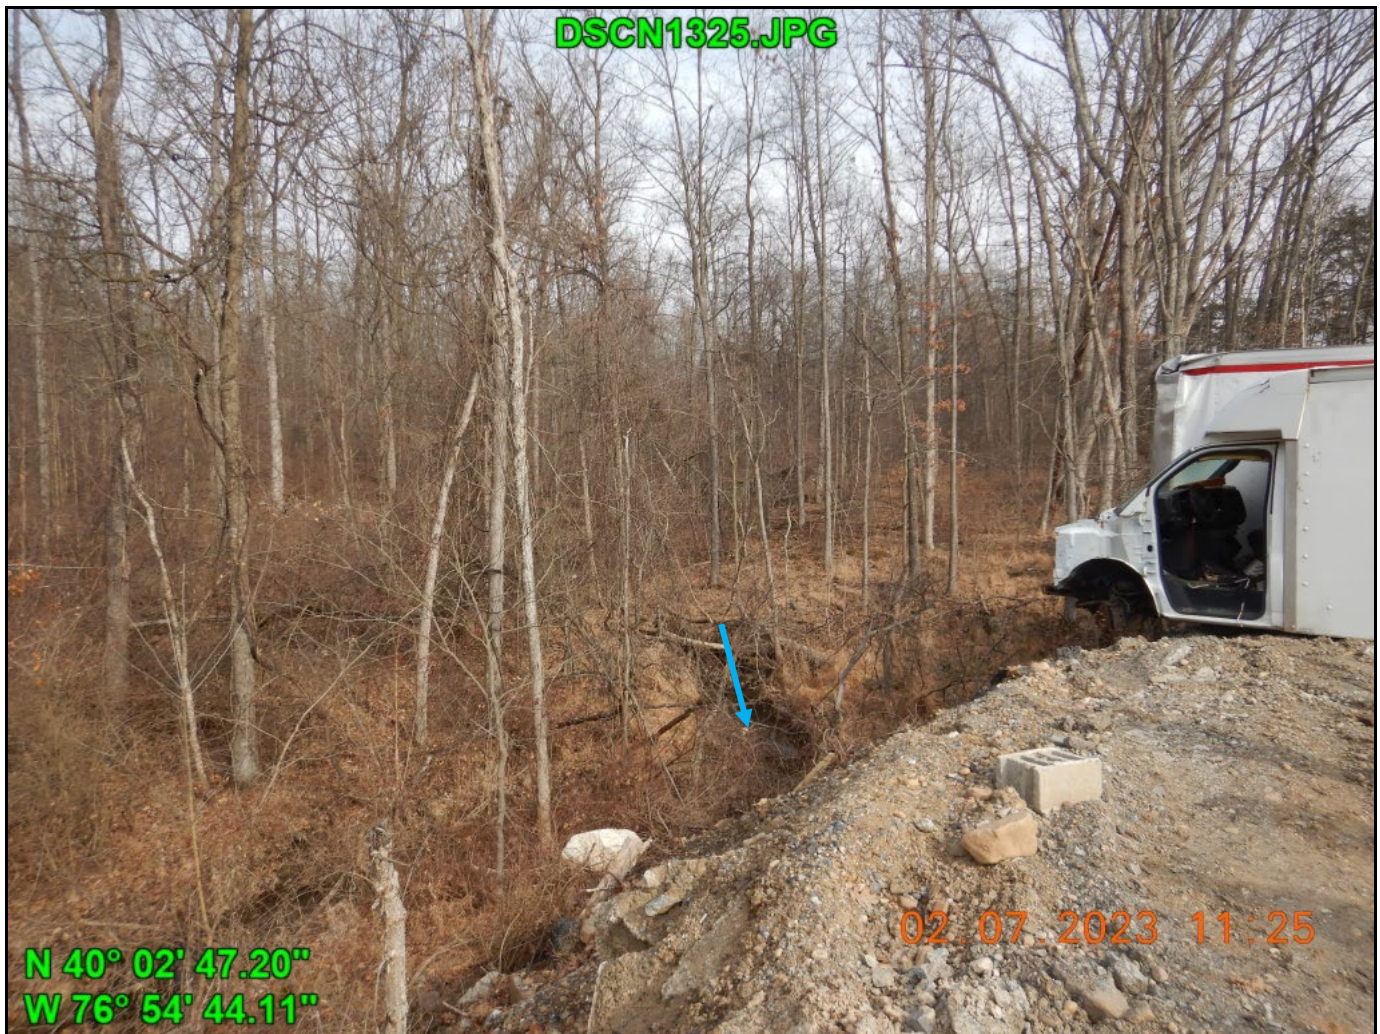
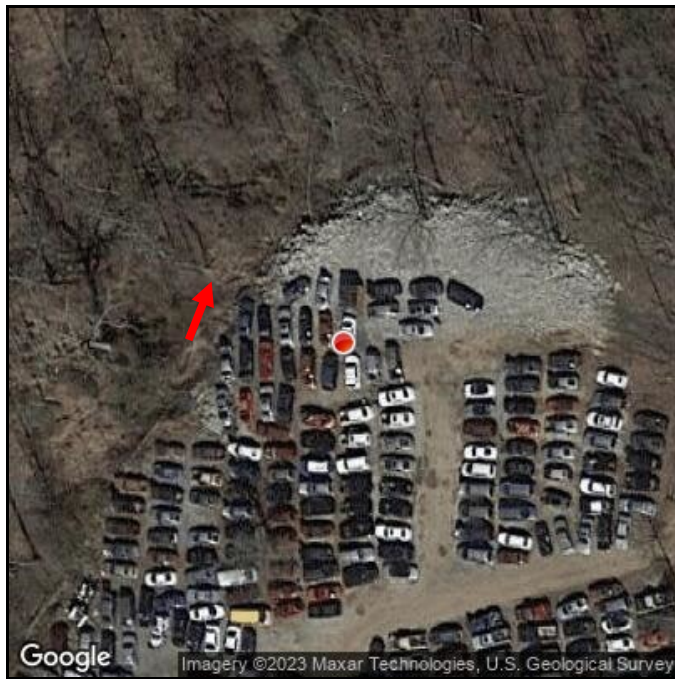
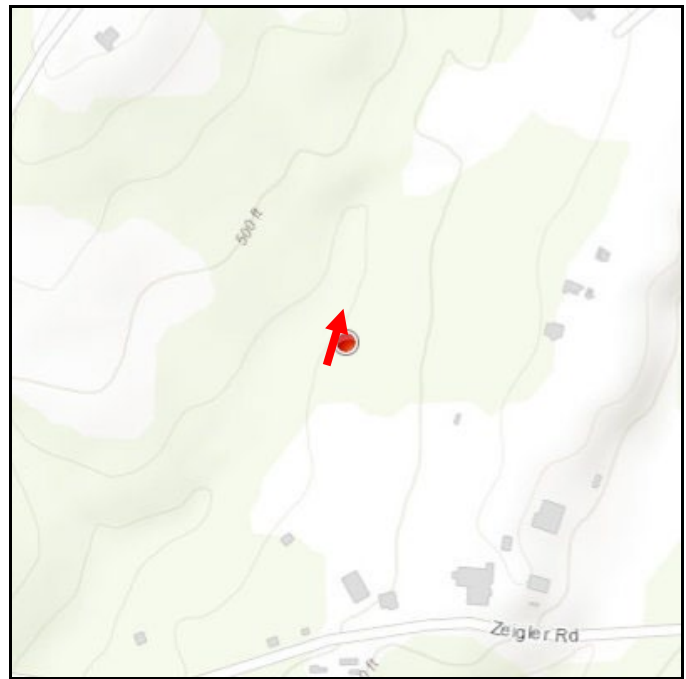
| Description | View of the unnamed tributary to Conewago Creek running along Facility's western boundary. Note the salvage vehicles stored adjacent to unnamed tributary. |

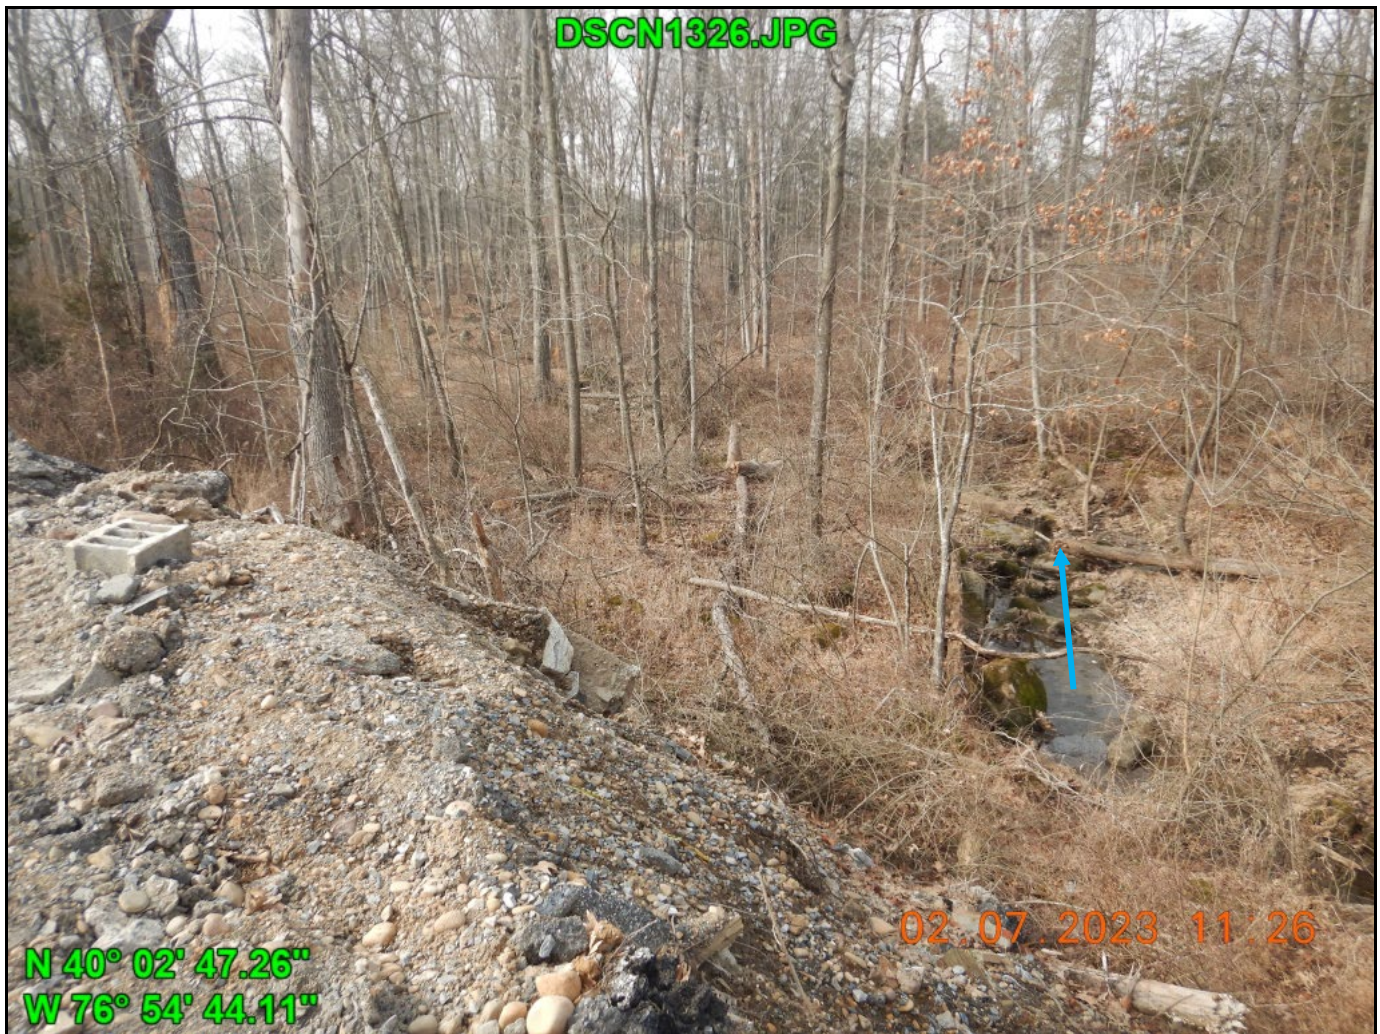
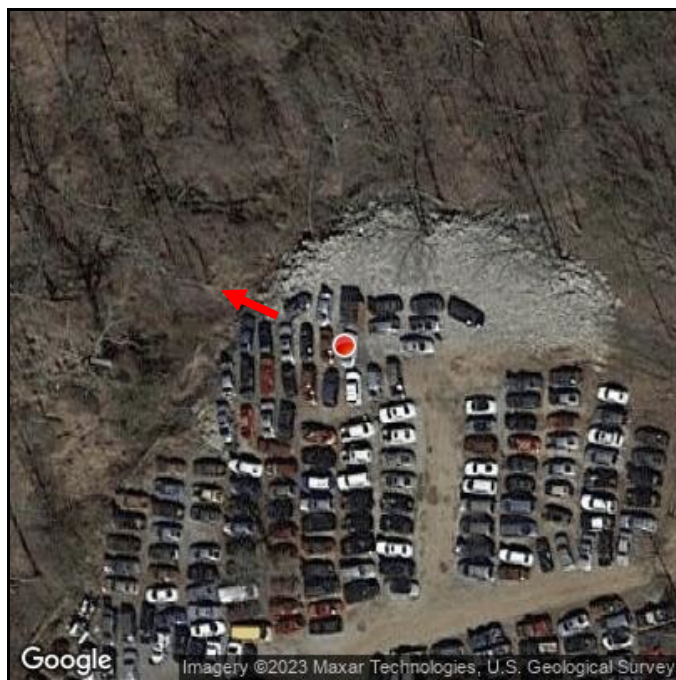
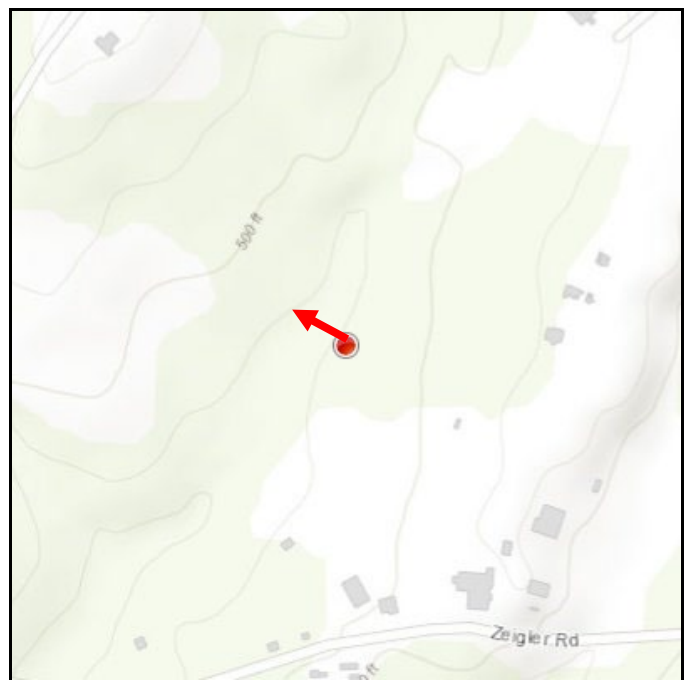
| Description | View of the unnamed tributary to Conewago Creek running along the Facility's western border. |

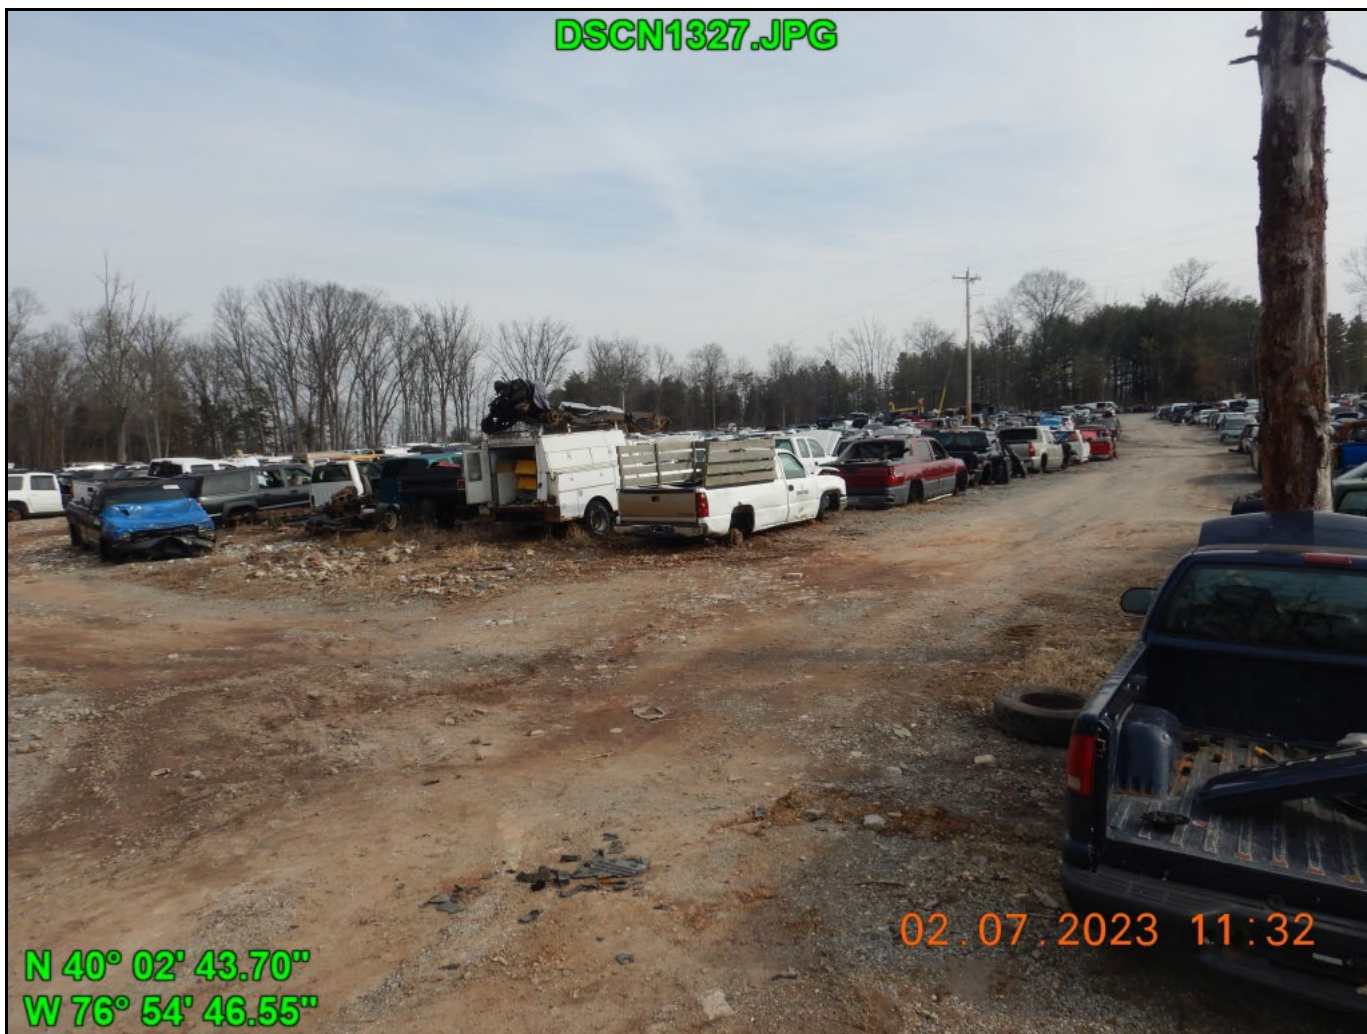
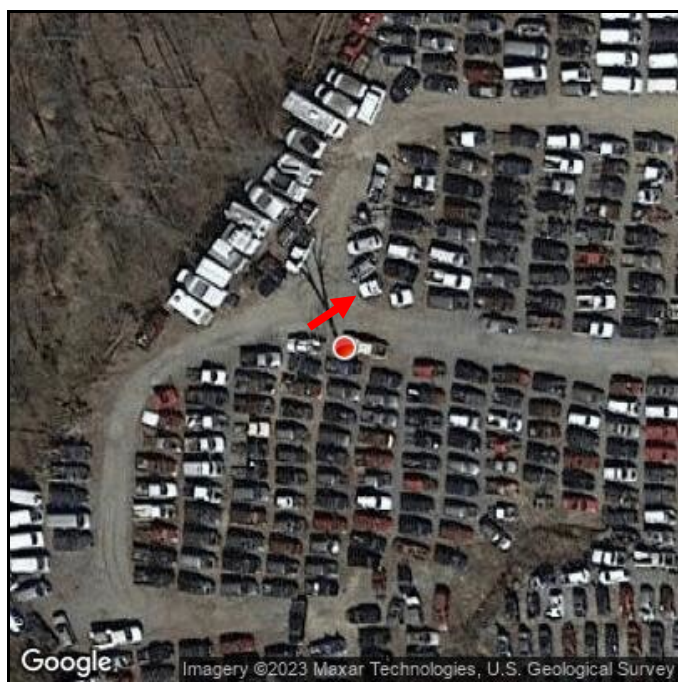
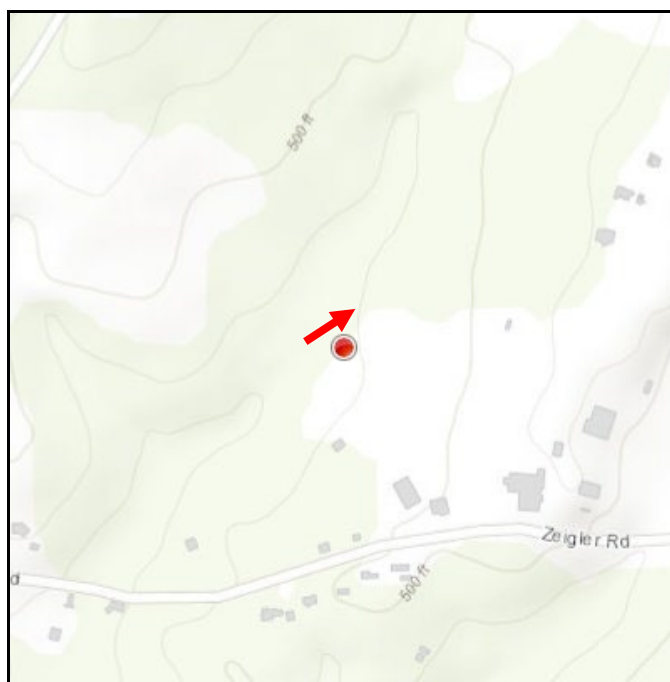
| Description | View, facing upgradient, of the salvage vehicle storage area in the central area of the Facility. |

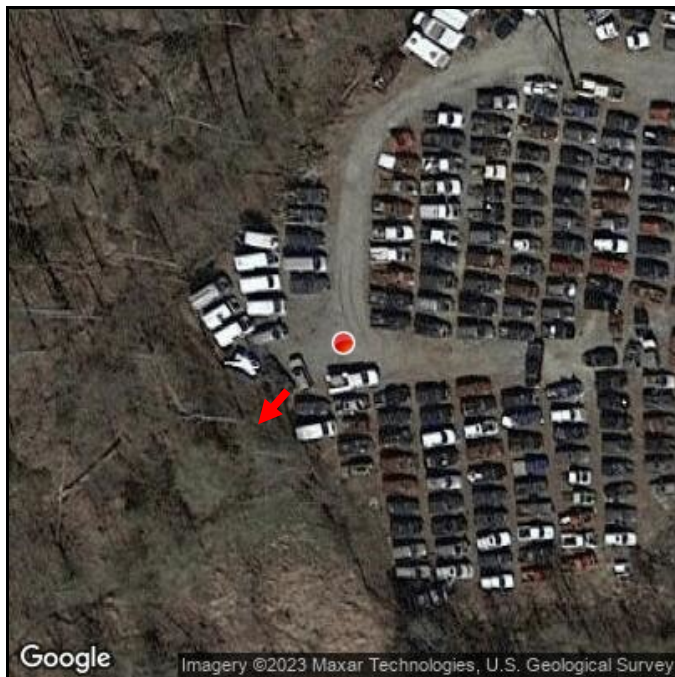
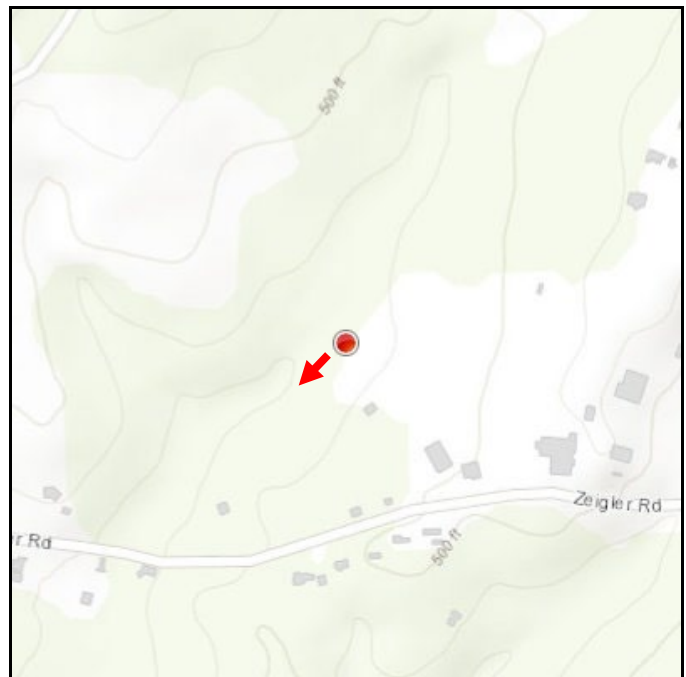
| Description | View of salvage vehicle scrap parts adjacent to the unnamed tributary to Conewago Creek running along the Facility's western boundary. |

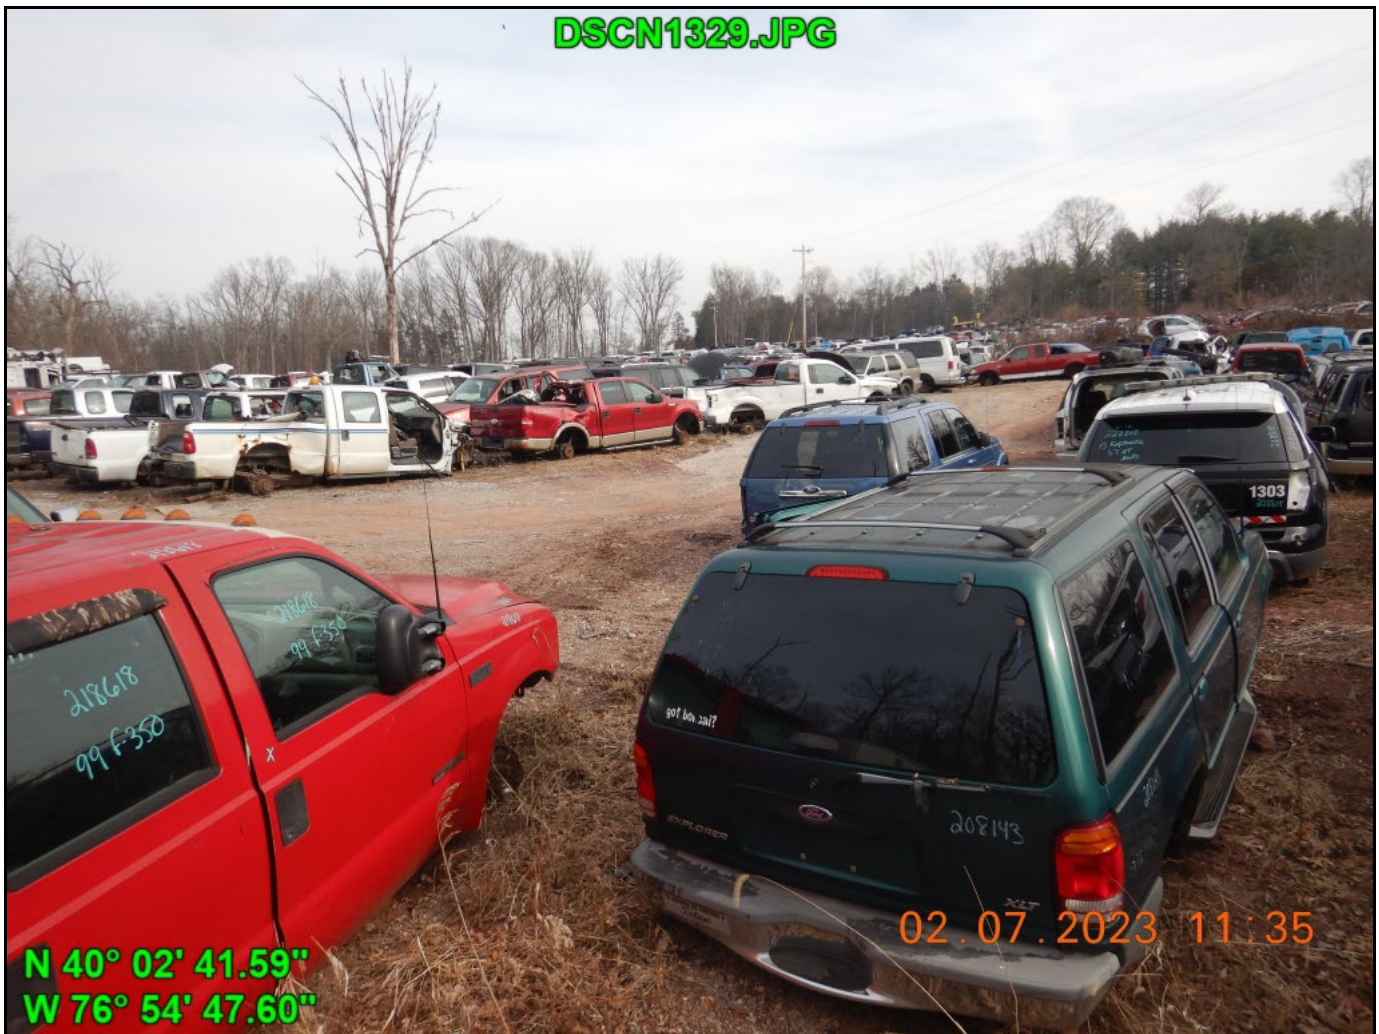
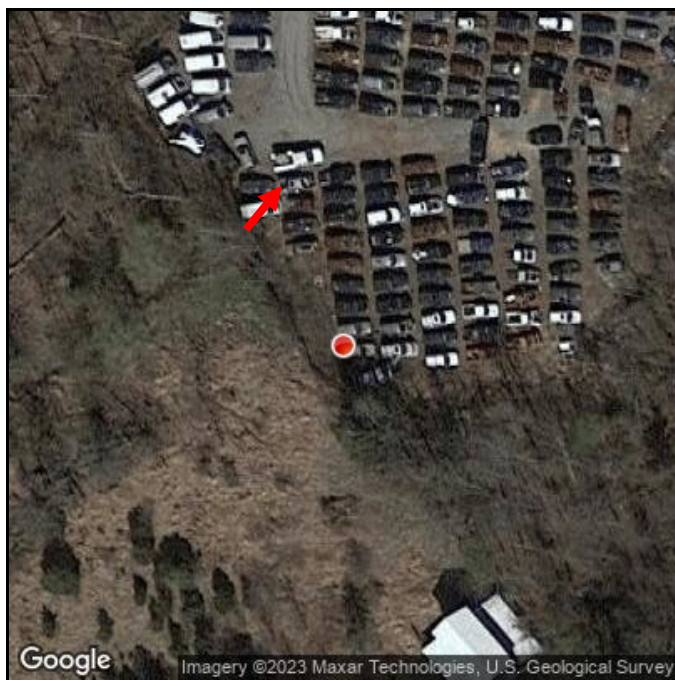
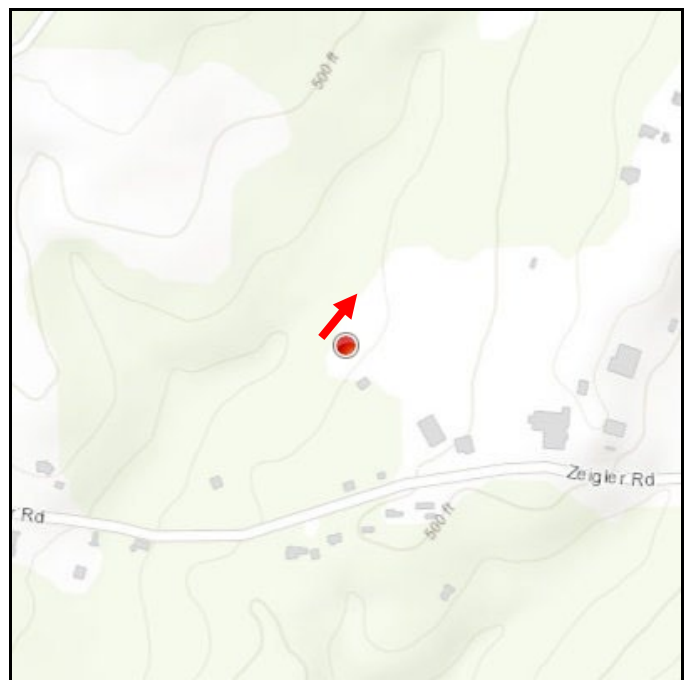
| Description | View, facing upgradient, of the salvage vehicle storage area in the central area of the Facility. |
