## MULTI-SECTOR GENERAL PERMIT NON-FILER INSPECTION CHECKLIST

| <b>Inspection Date(s):</b> | 2/7/2023 | |
| <b>Operator Name:</b> | Lebarron's Auto Salvage | |

**Appendix A. Aerial Map**  
**Clean Water Act Inspection**  
**Lebarrons Auto Salvage**

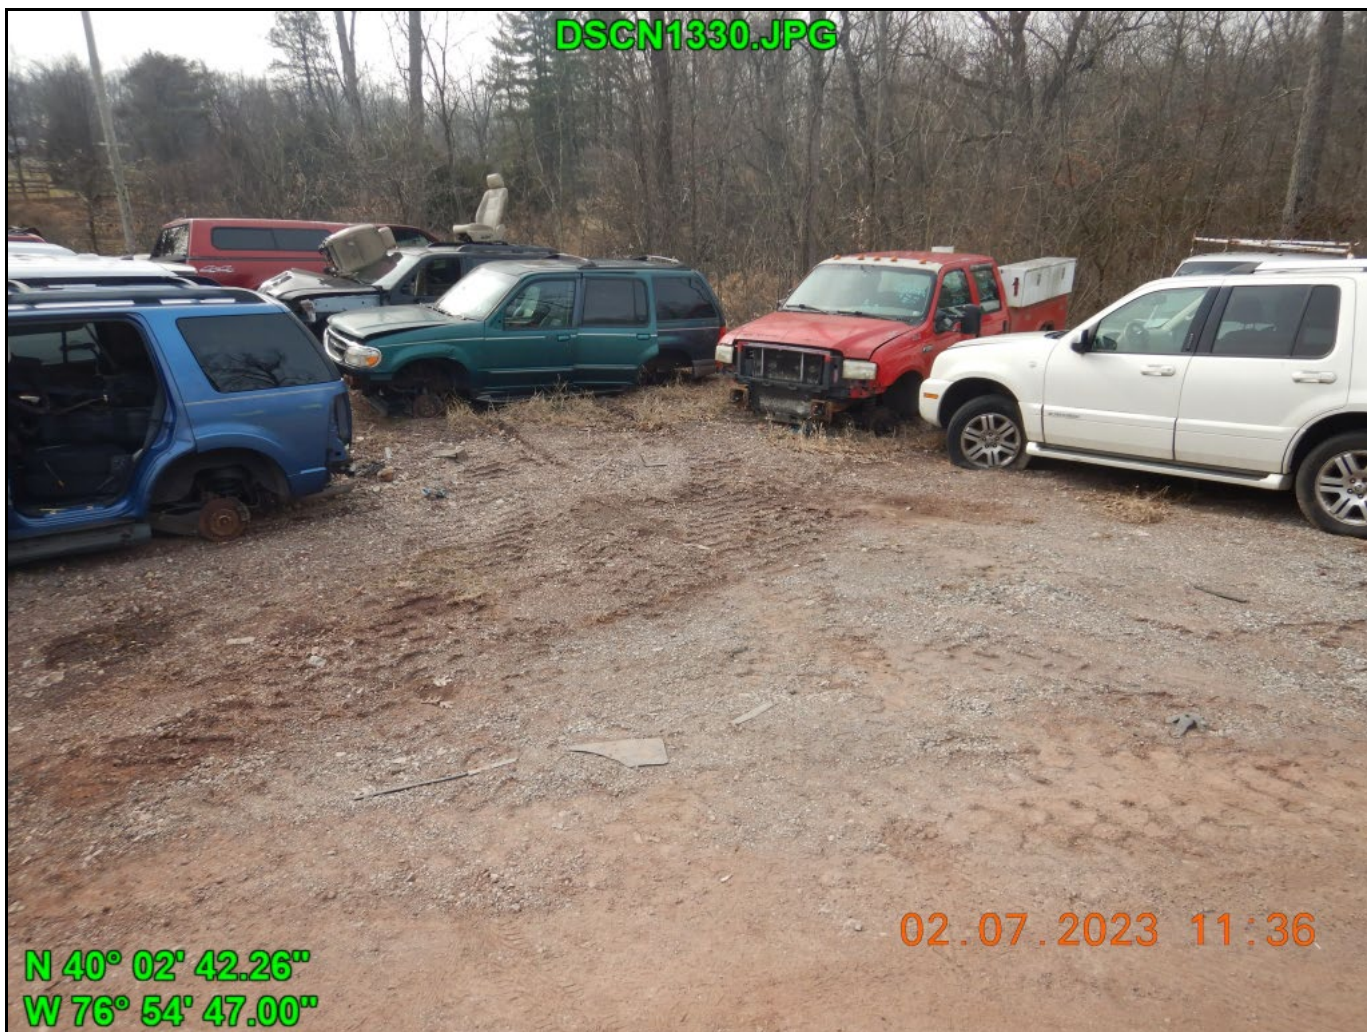
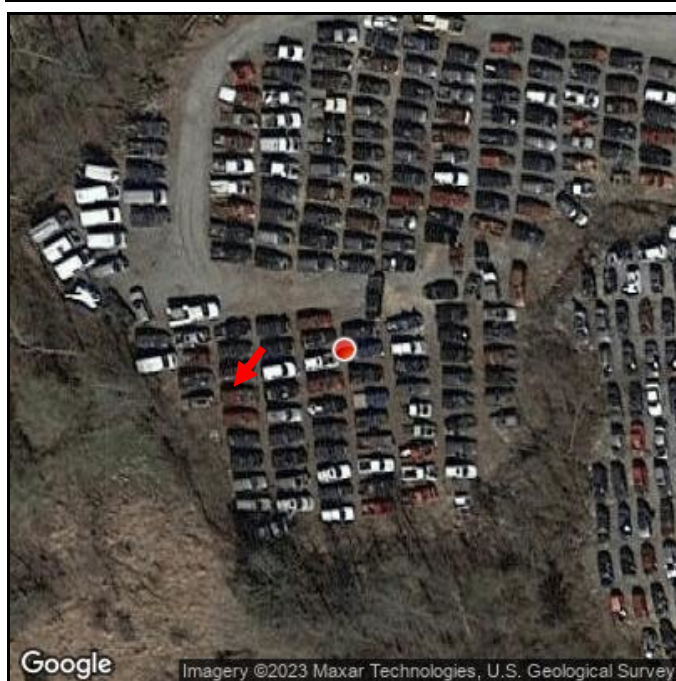
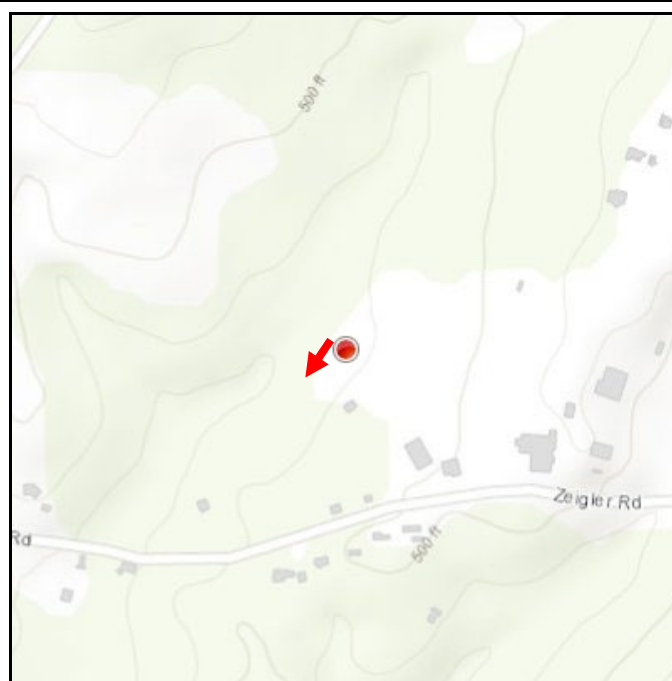
| Description | View, facing downgradient, of salvage vehicle storage area in the western area of the Facility. |

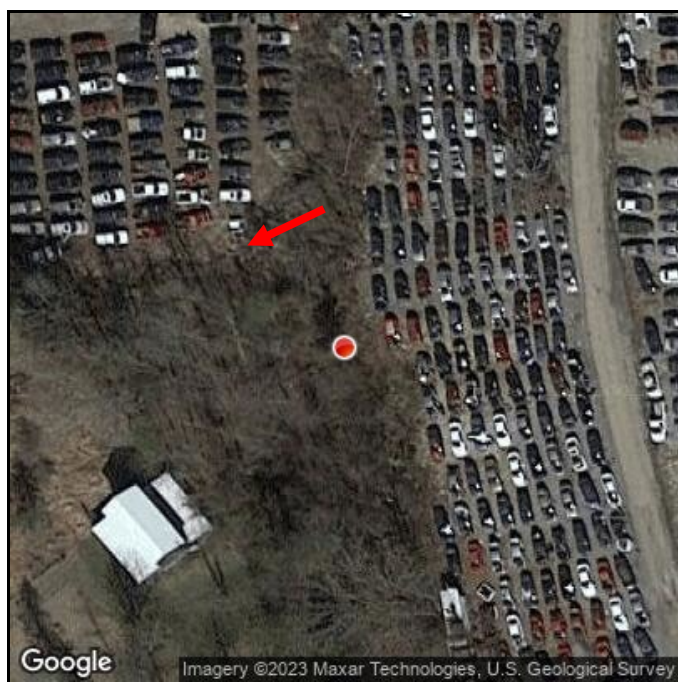
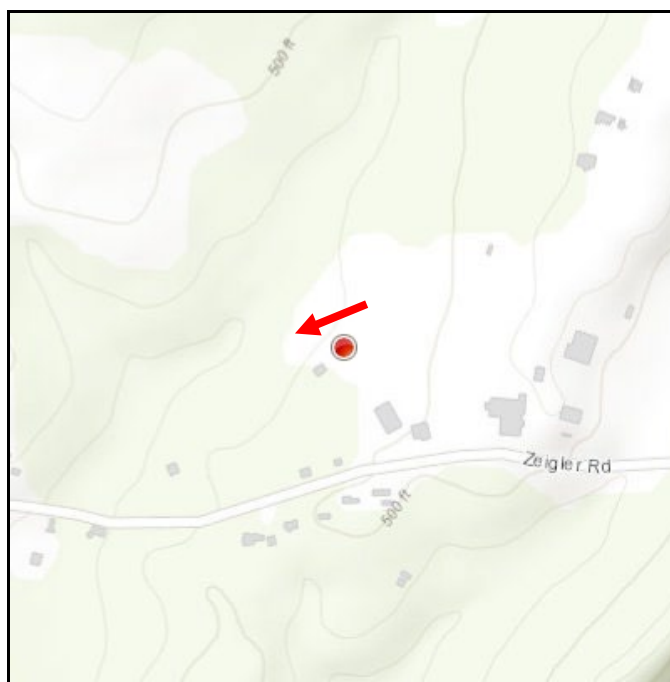
| Description | Point of concentrated discharge (red circle) to the unnamed tributary to Conewago Creek running along the southwest corner of the Facility. |

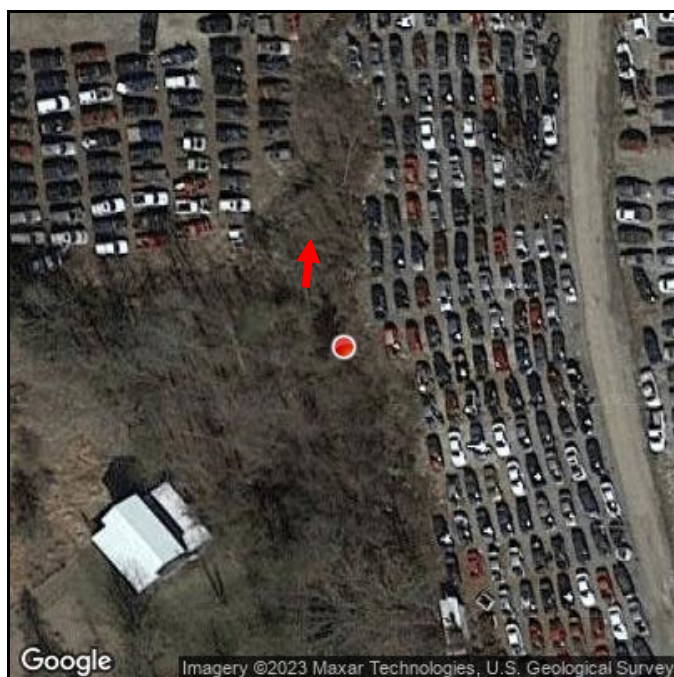
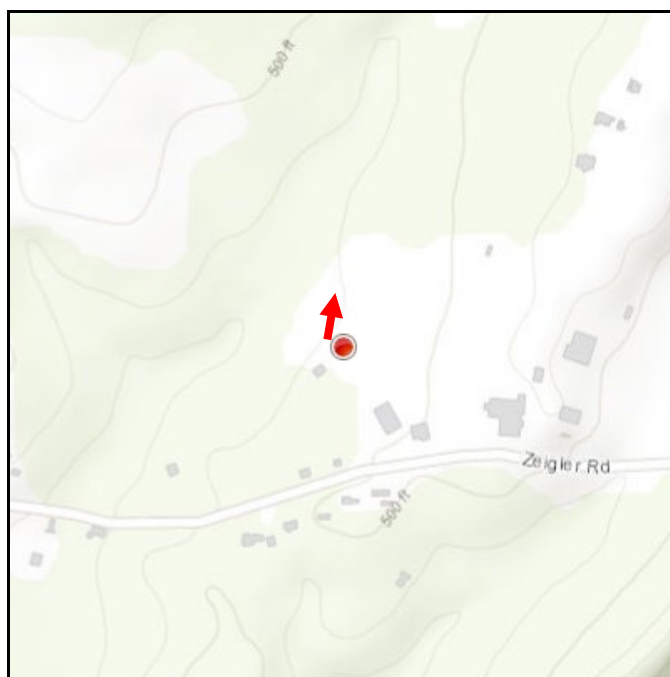
| Description | Point of concentrated discharge (red circle) to the unnamed tributary to Conewago Creek running through the Facility with a substantial collection of trash and debris along the bank. Salvage vehicles stored adjacent to unnamed tributary. |

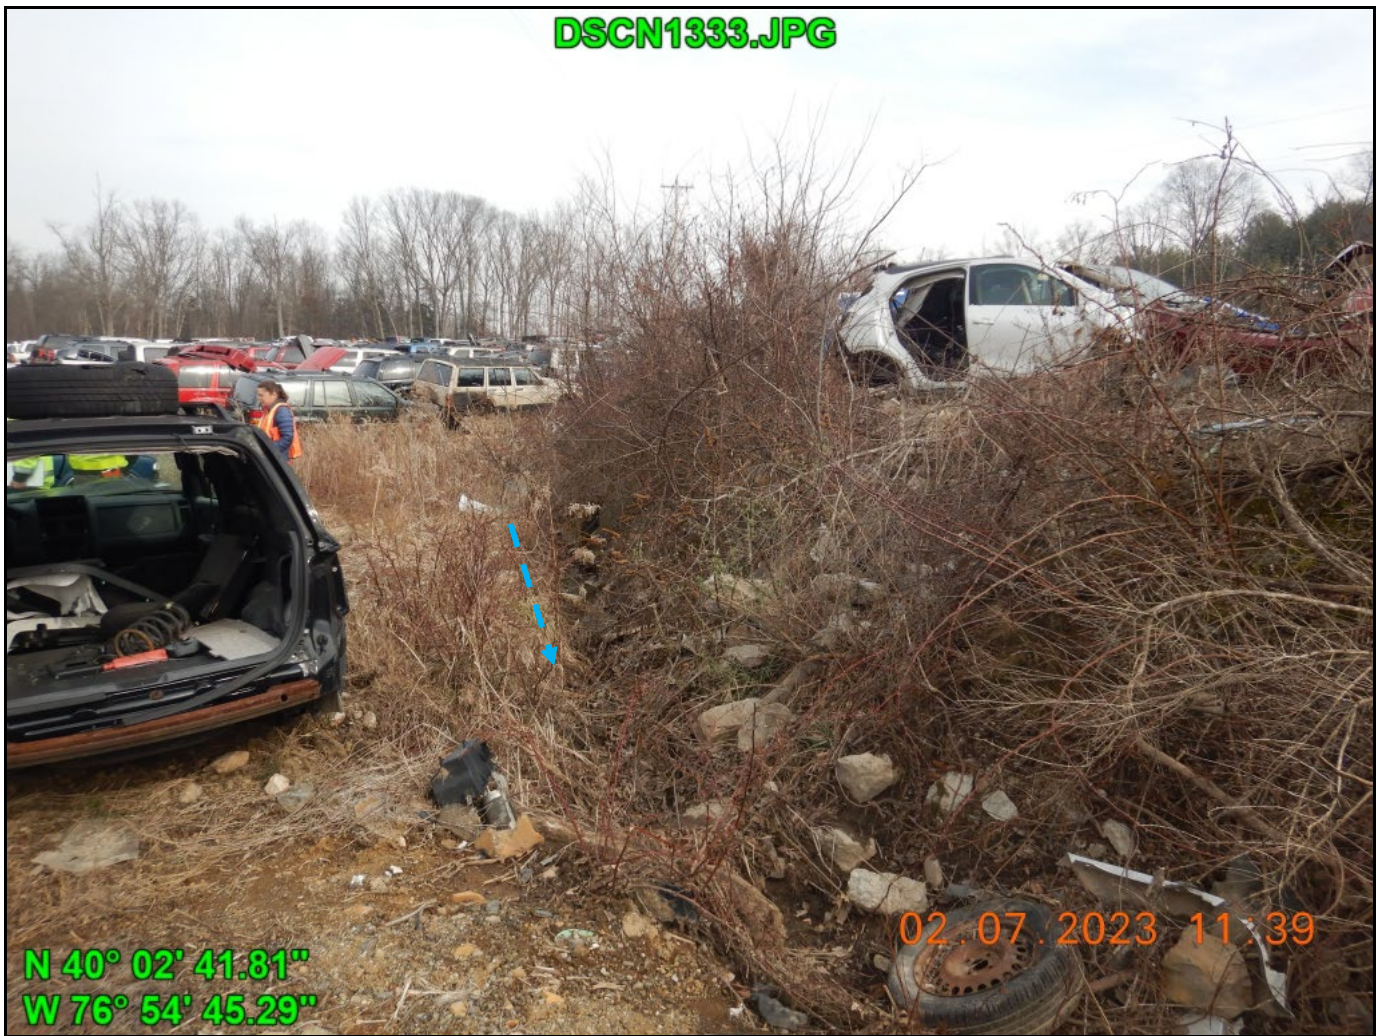
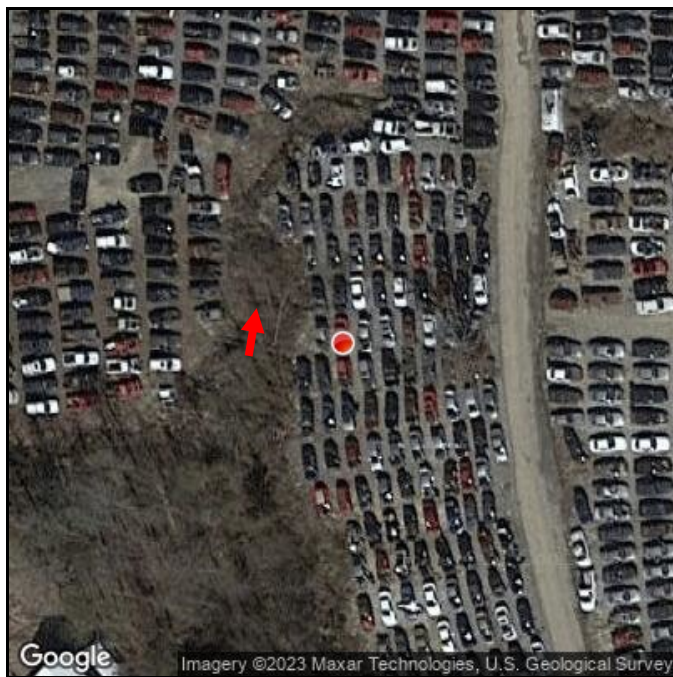
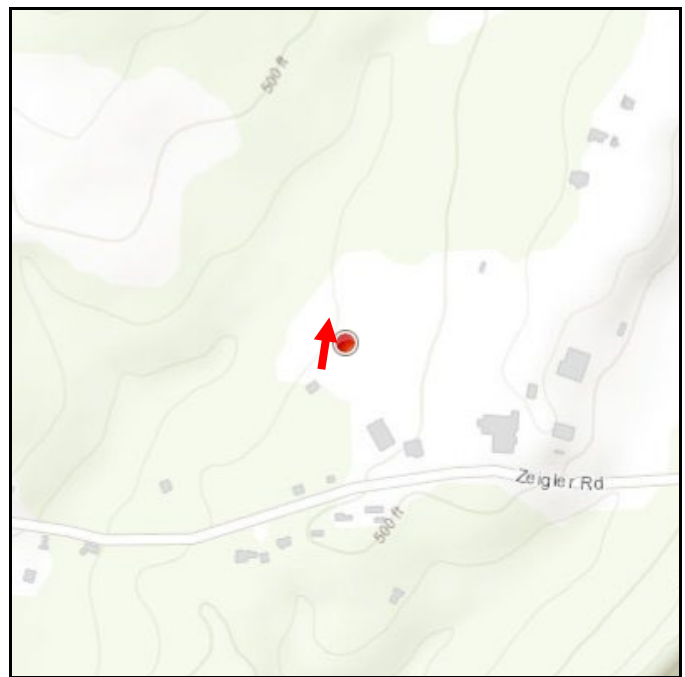
| Description | View of the unnamed tributary to Conewago Creek running through the Facility. Note the salvage vehicles stored adjacent to the unnamed tributary. |

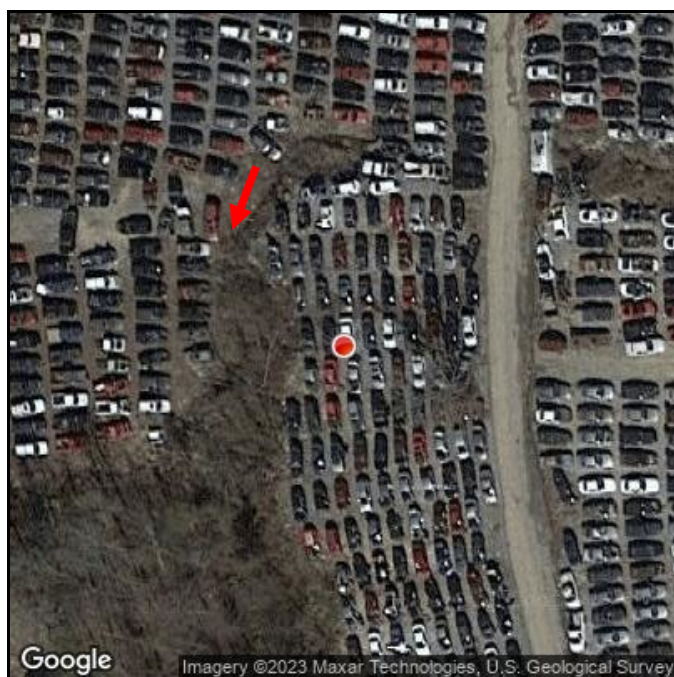
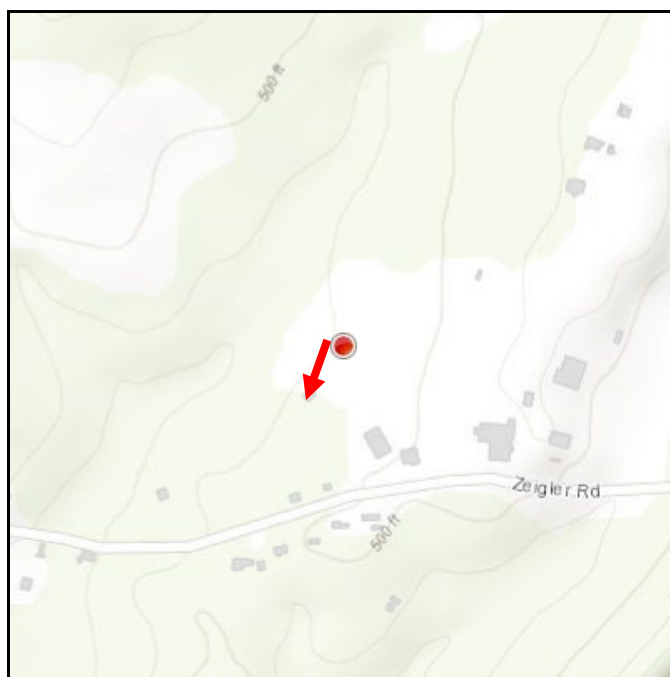
| Description | View of the unnamed tributary to Conewago Creek running through the Facility. Note the trash and debris in and around the tributary. Also note the salvage vehicles stored adjacent to the unnamed tributary. |

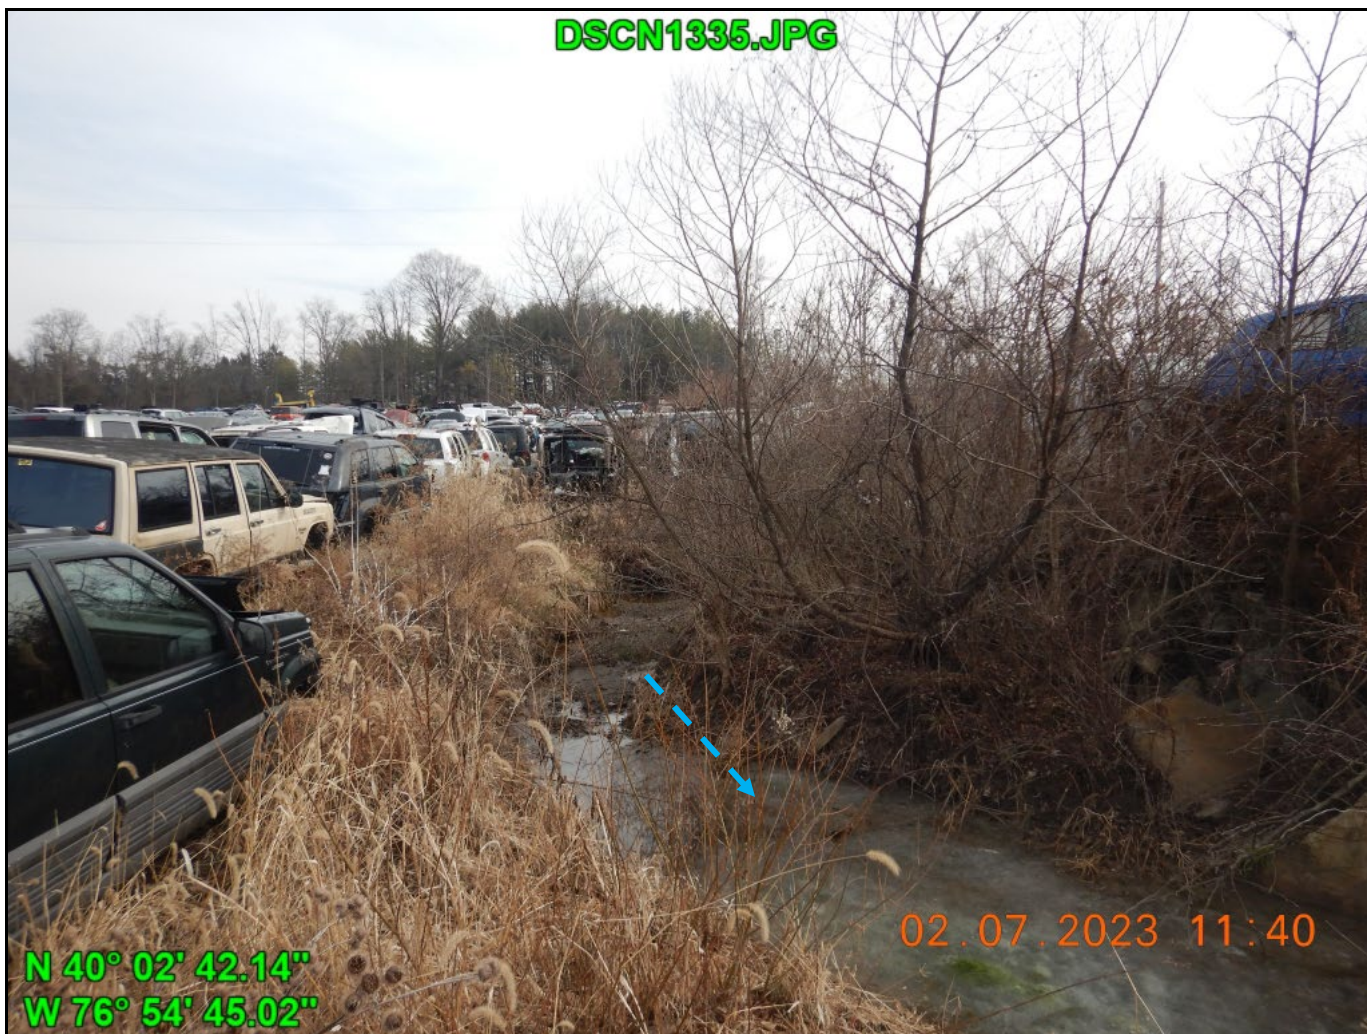
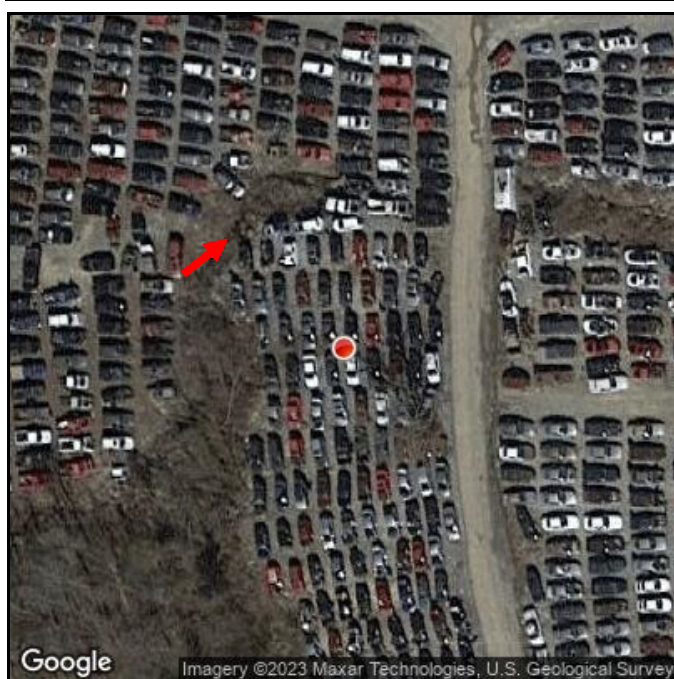
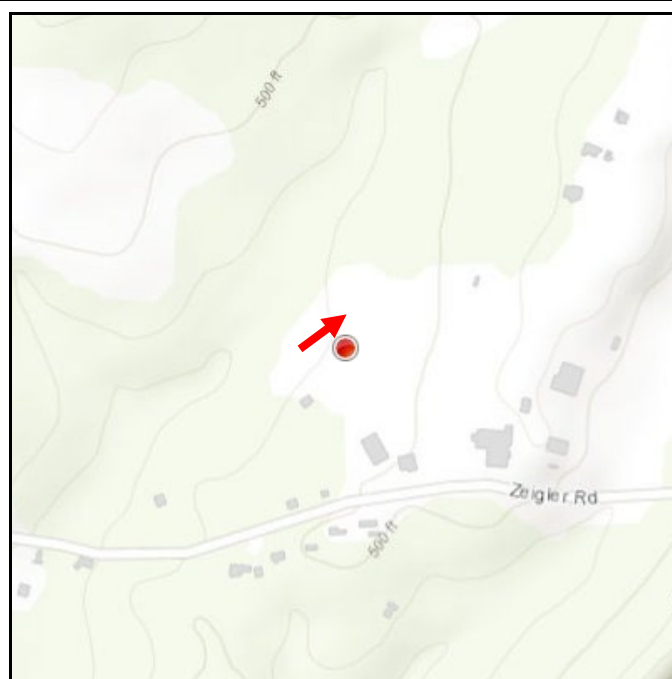
| Description | View of the unnamed tributary to Conewago Creek running through the Facility. Note the salvage vehicles stored adjacent to the unnamed tributary. |

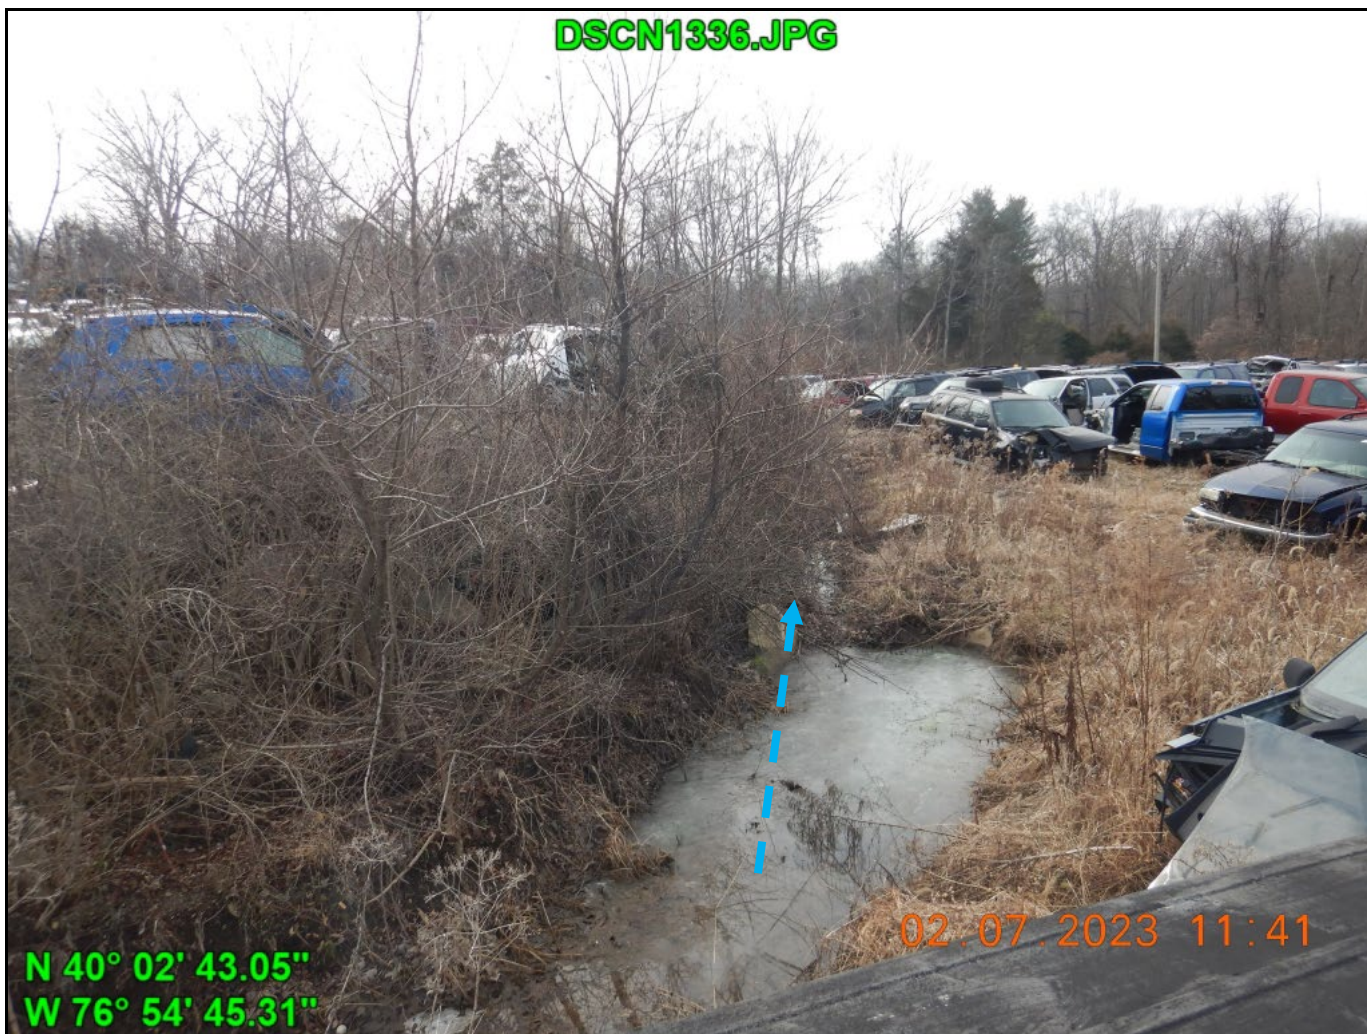
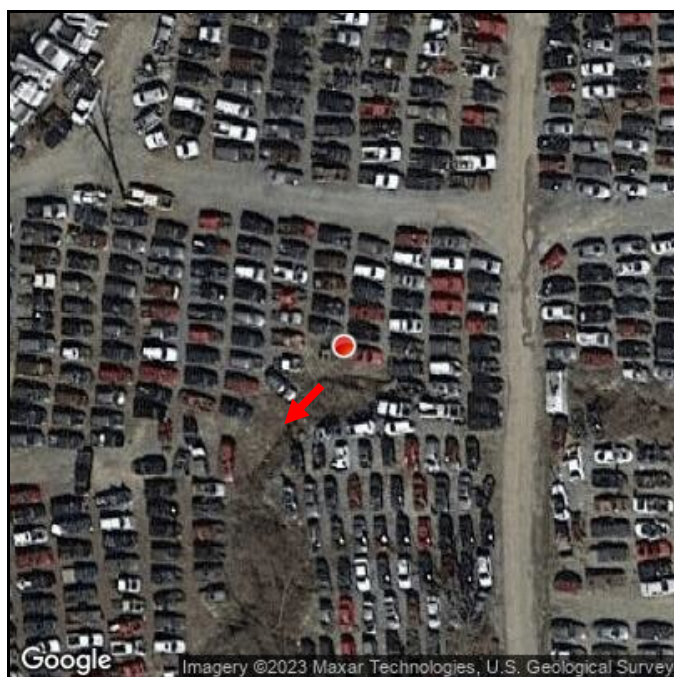
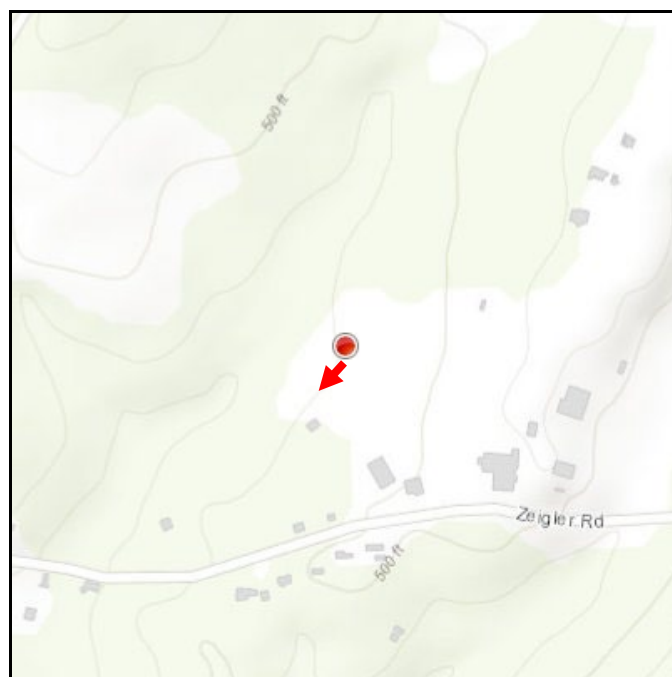
| Description | View of the unnamed tributary to Conewago Creek running through the Facility. Note the salvage vehicles stored adjacent to the unnamed tributary. |

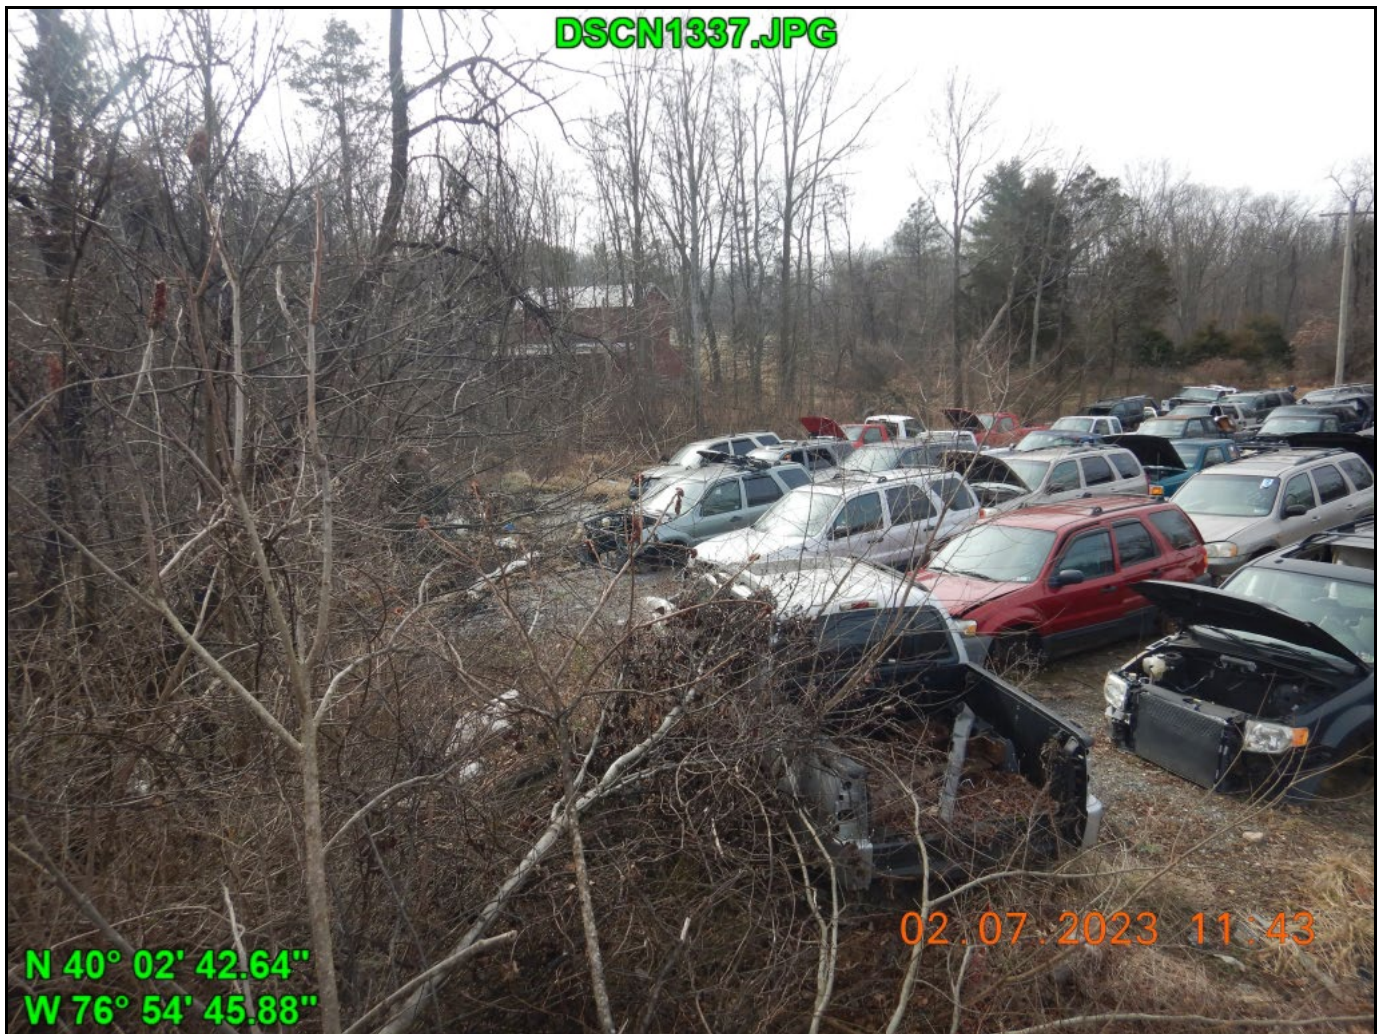
| Description | View of the unnamed tributary to Conewago Creek running through the Facility. Note the salvage vehicles stored adjacent to the unnamed tributary. |

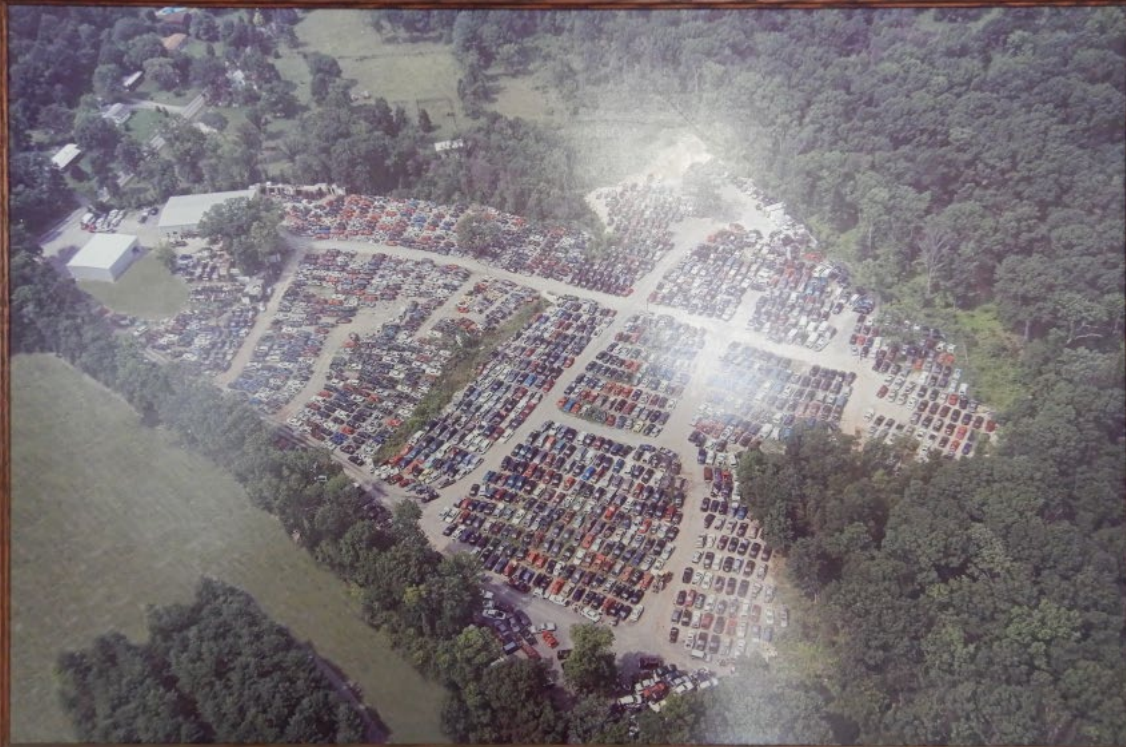
| Description | View of a picture of the Facility from 2006 posted inside main office. |

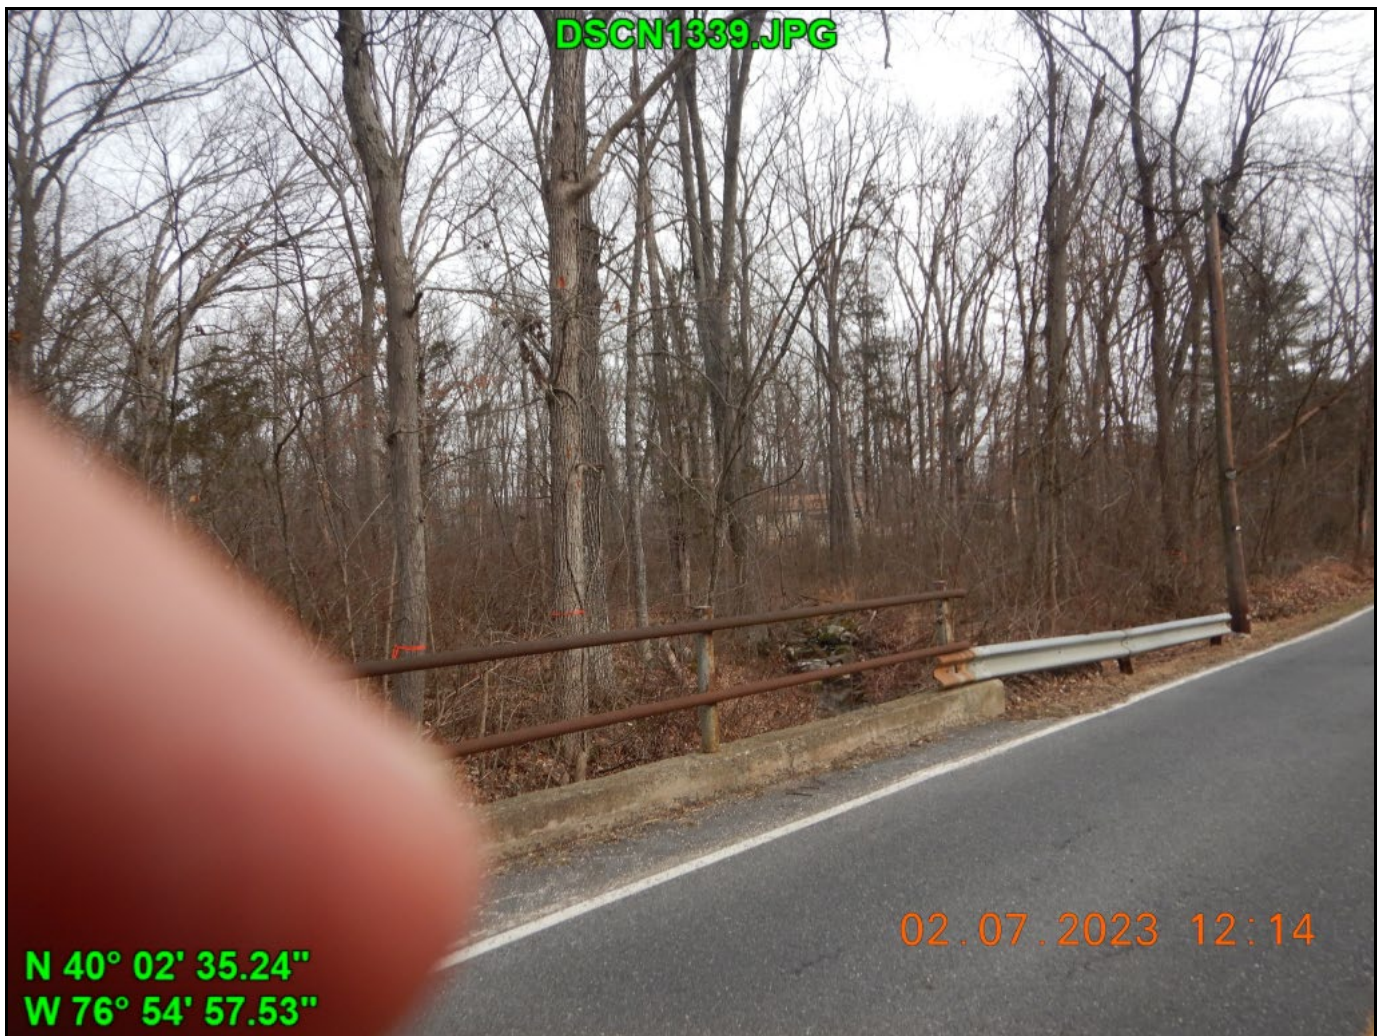
| Description | View, facing upstream, of the unnamed tributary to Conewago Creek approximately 400 yards west of the Facility running underneath Zeigler Road. |

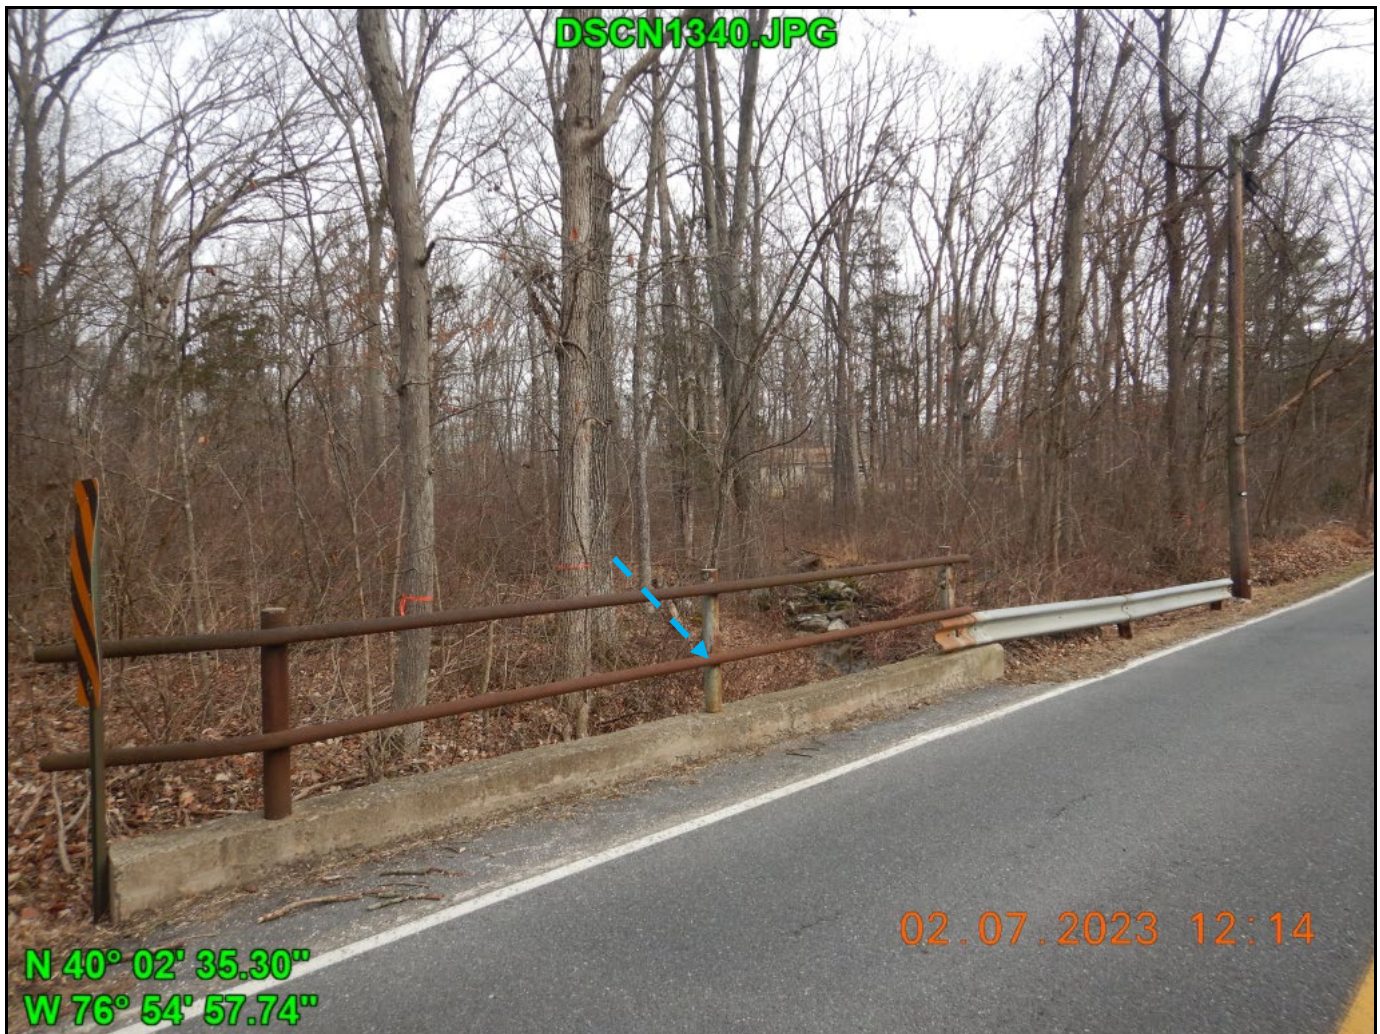
| Description | Additional view, facing upstream, of the unnamed tributary to Conewago Creek approximately 400 yards west of the Facility running underneath Zeigler Road. |

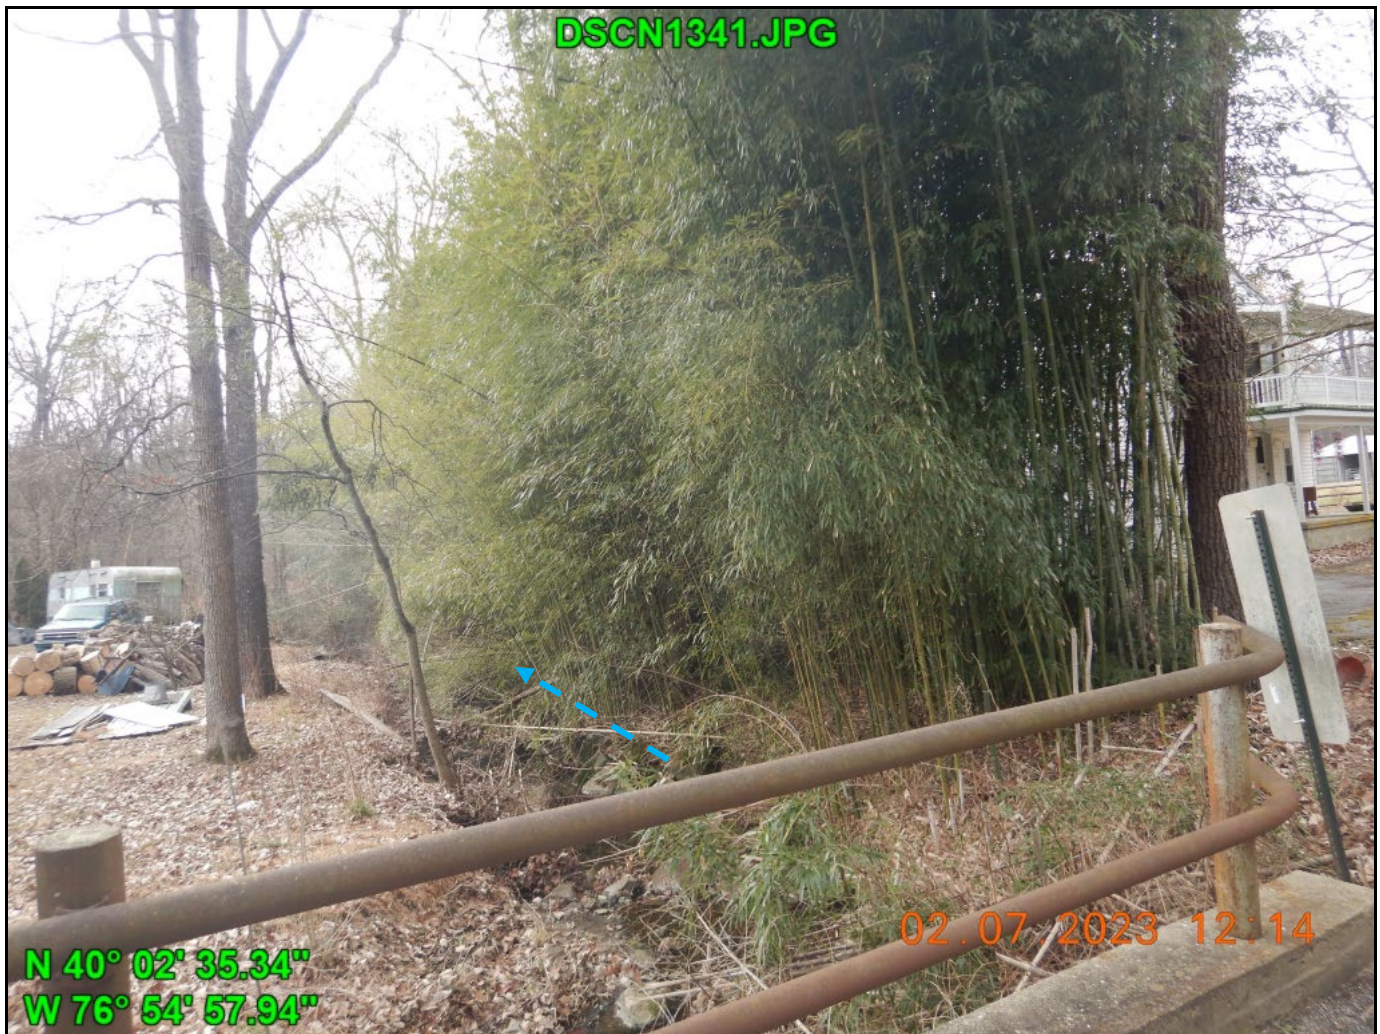
| Description | View, facing downstream, of the unnamed tributary to Conewago Creek approximately 400 yards west of the Facility running underneath Zeigler Road. |
