## Region 6 - Enforcement & Compliance Assurance Division

### INSPECTION REPORT

| Company Name: | <b>L.A. Look Auto Inc.</b> | |
| Facility Name: | <b>Alpha Auto Parts</b> | |

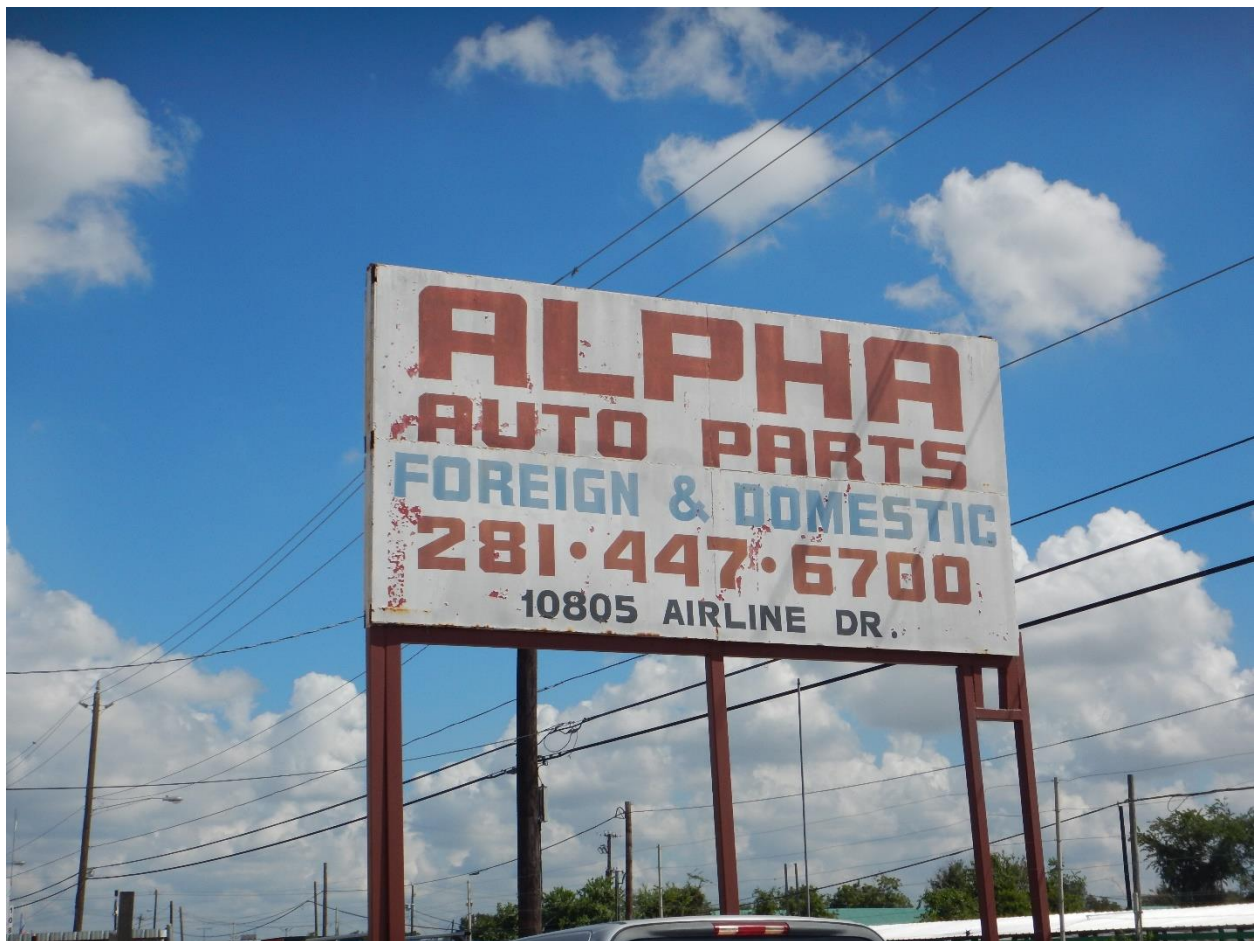
Photo No. 1

Description: View, of business signage for Alpha Auto Parts.

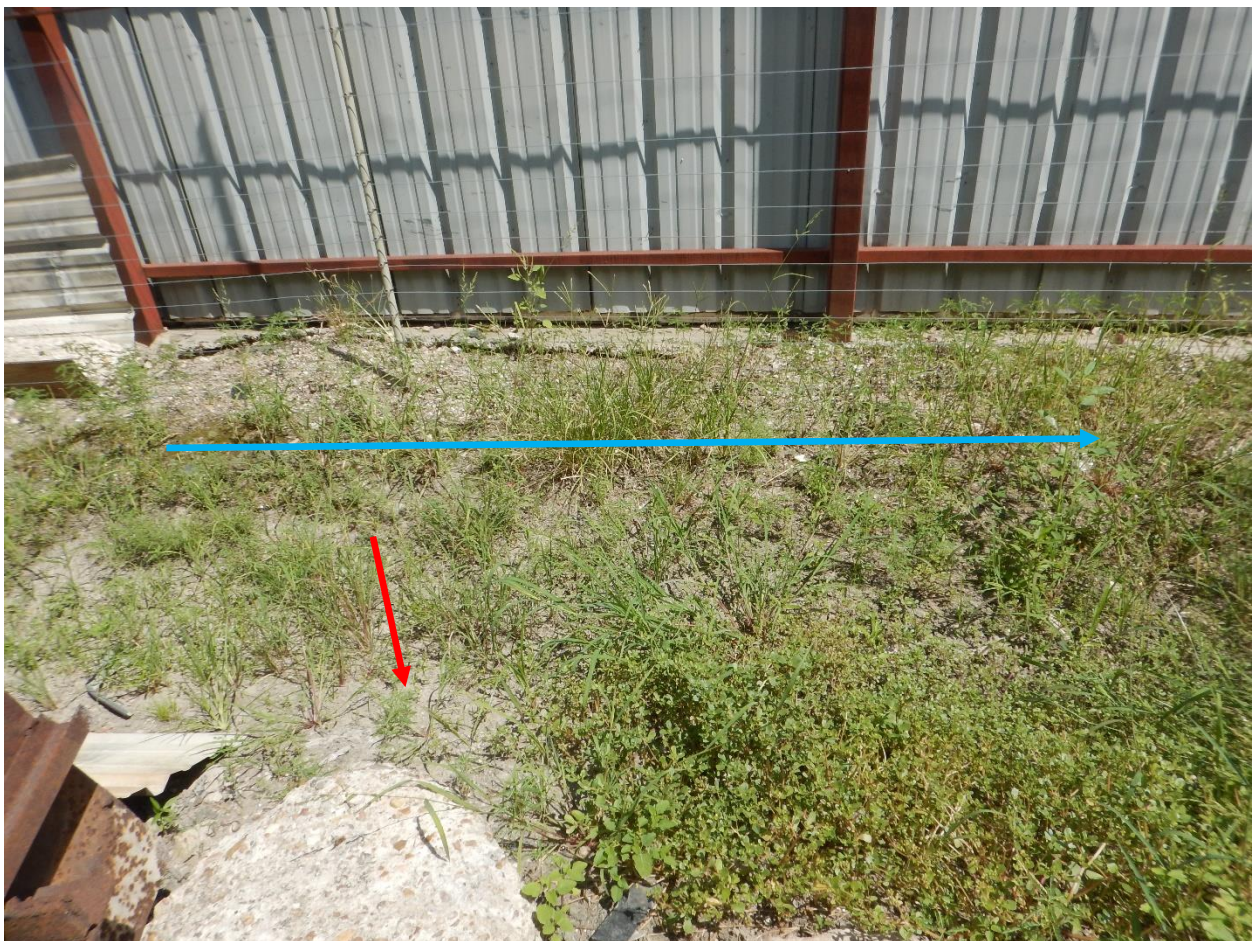
Description: Closer view, on the side of the Parts Warehouse, location of sample point reflected by red arrow. The blue arrow depicts the flow direction of stormwater from the site.
