REPORT OF COMPLIANCE EVALUATION INSPECTION  
(INDUSTRIAL STORMWATER)

**BMaKK Corporation**

1440 Red Street  
Omaha, Nebraska 68112

October 5, 2023

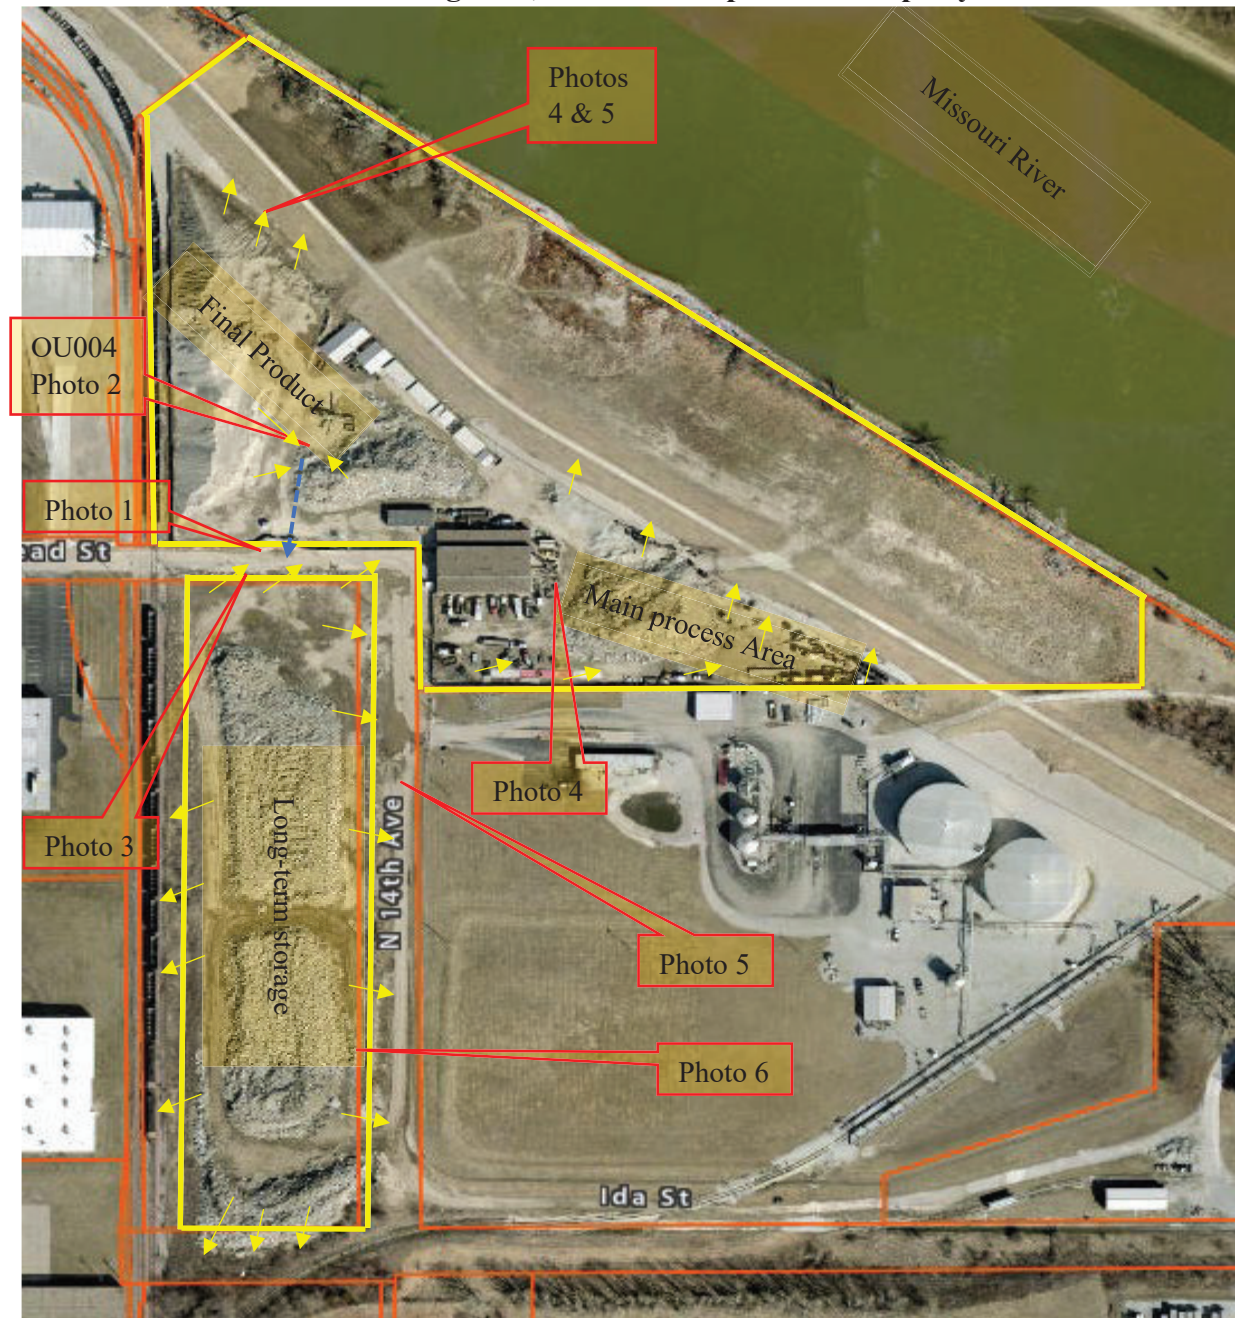
**Figure 1, BMaKK Corporation Property**

east section where the waste concrete is received and processed, and the west section where processed and final material is stockpiled for sale. The long-term waste concrete storage pile area is located south of the main processing area along N 14<sup>th</sup> Street. This area is used to store large amounts of waste concrete waiting to be processed. Crusher and equipment operators are hired contractors. The Facility consists of an office, a maintenance building, a fueling area, waste material truck unloading and storage areas, and final product storage areas. The Facility operates 8 hours per day, five days a week and employs approximately 15 people.
