**Employers Insurance of Wausau**

Safety and Health Consultant's Report

5333 Strawberry Lane  
Louisville, Kentucky

M. S. Freshwater, environmental health engineer; and  
J. Warble, senior safety consultant; on December 11, 1975

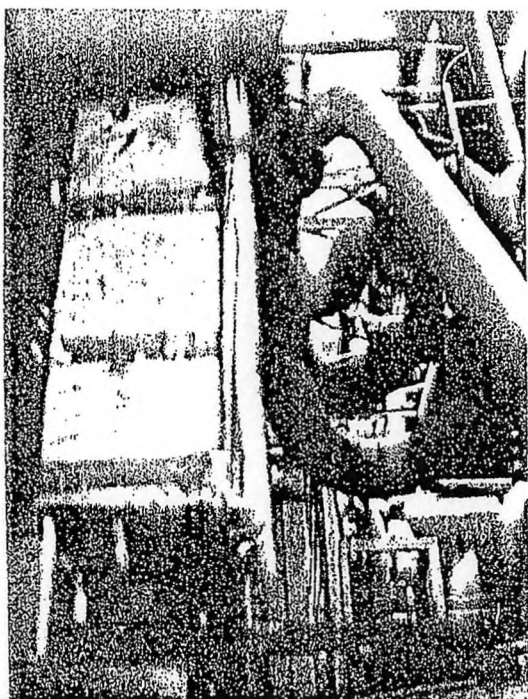
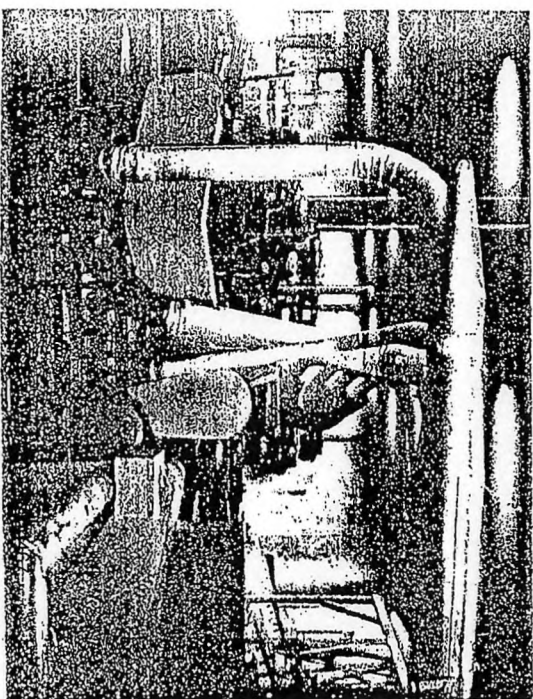
On M-67 Machine

- A. The Honeycomb Machine Saws are now on an American Air Filter "Bag" Unit discharging to the outside air.
- B. The M-67 Machine Saws are now on an "Unknown" brand filter unit discharging into the same room.
- C. Contact AAF in Louisville and have them send out a qualified Sales - Eng to look over the above and recommend how we should proceed to.
  1. Is the M-67 Machine Filter adequate?
  2. Should it be discharged outside the building?
  3. Could both the M-67 & Honeycomb Machine dusts be handled by the present AAF Unit?
  4. Is the present AAF Unit adequate for Asbestos to meet current regulation?
  5. If we add Saws to the SDNA line could we also tie it into this present AAF Unit?
  6. If Not these complete analysis & recommendations with pricing.

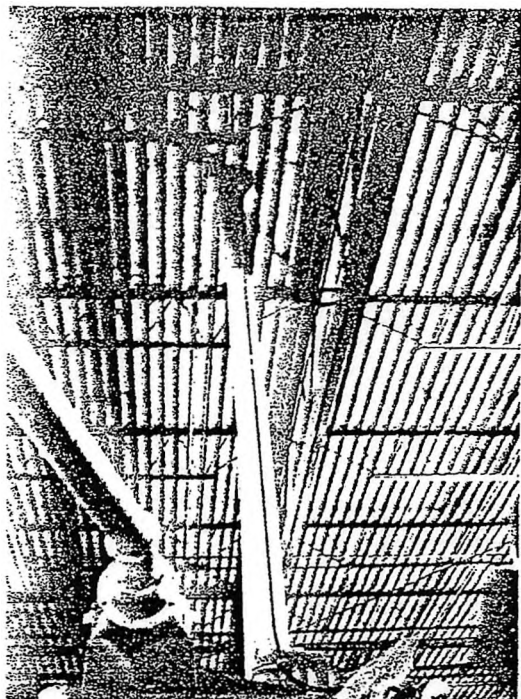
On  
 Horizontal  
 Machine

American Air Filter  
 Hummer - Size #10  
 Serial 561264  
 Astroglow - Size #10  
 961440
