INSPECTION REPORT

| <b>Inspection Date:</b> | May 31, 2023 | Inspection Announced: No |
| <b>Type of inspection:</b> | CEI - Compliance Evaluation Inspection | |
| <b>Facility or Site Name:</b> | American Crystal Sugar – Moorhead | |

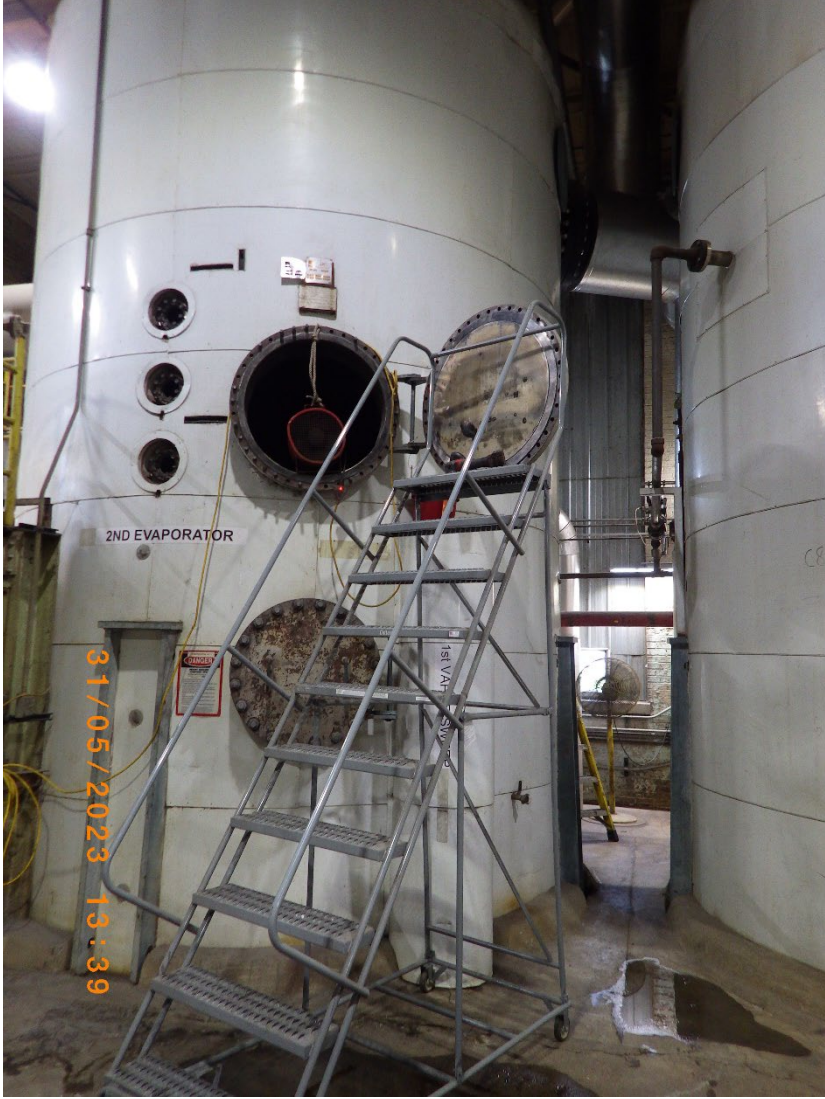
| <b>Photo No.: 1</b> | <b>Time:</b><br>1:39 PM | | |

| <b>Photo Description:</b><br>Evaporator tanks to remove water from the beats/sugar. | | | |

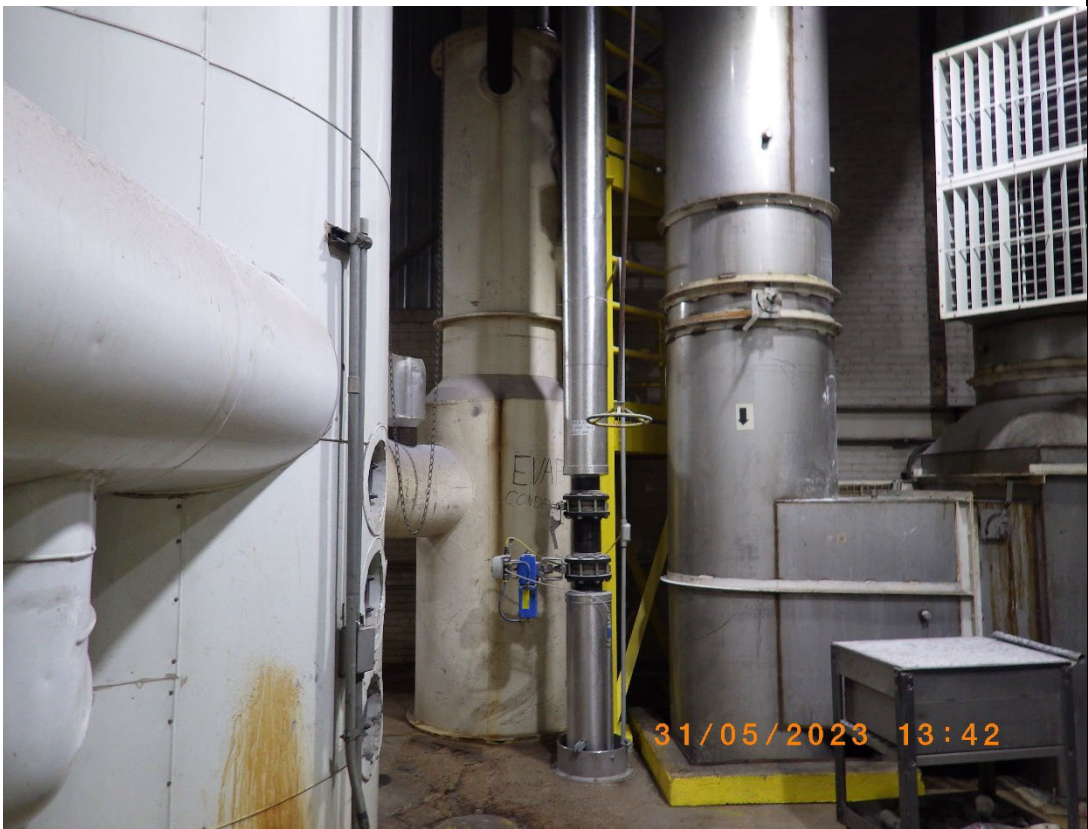
| <b>Photo No.: 2</b> | <b>Time:</b><br>1:42 PM | | |

| <b>Photo Description:</b><br>Pipe where cool water from the condenser pond is input into the system and used in the evaporators. | | | |

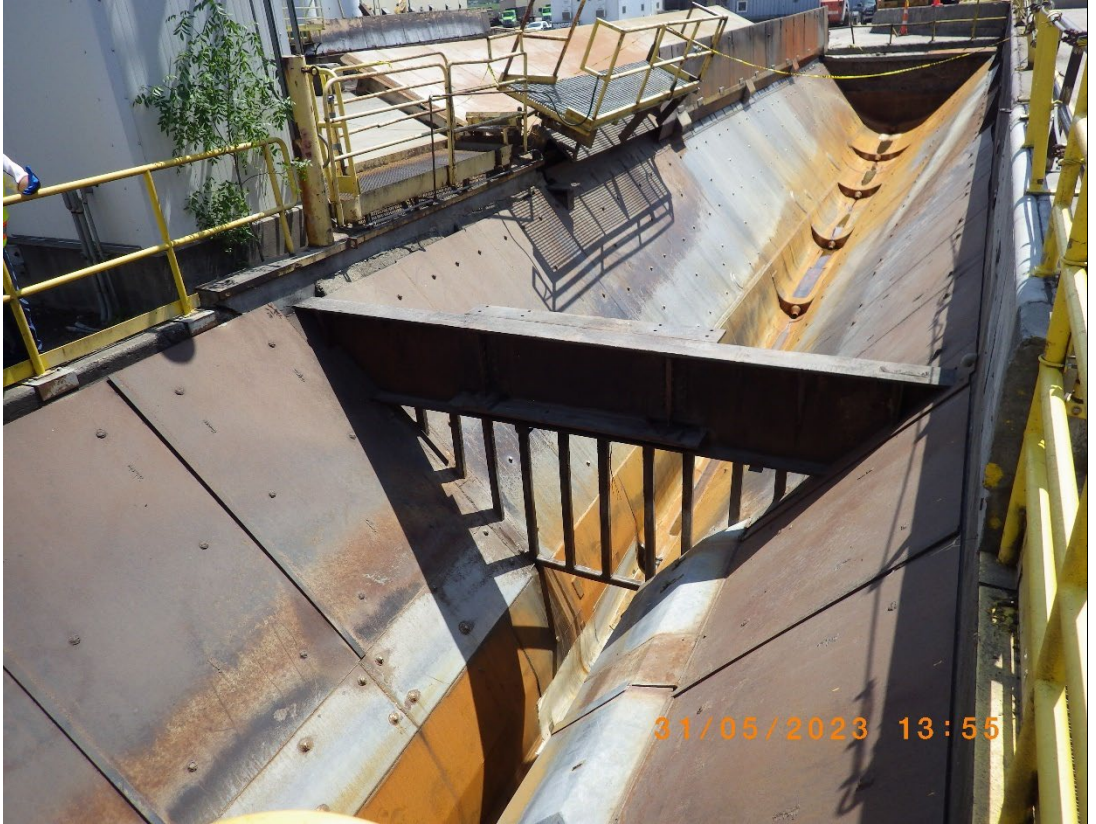
| <b>Photo No.:</b> 3 | <b>Time:</b><br>1:55 PM | | |

| <b>Photo Description:</b><br>Flume channel where beets enter the processing system. | | | |

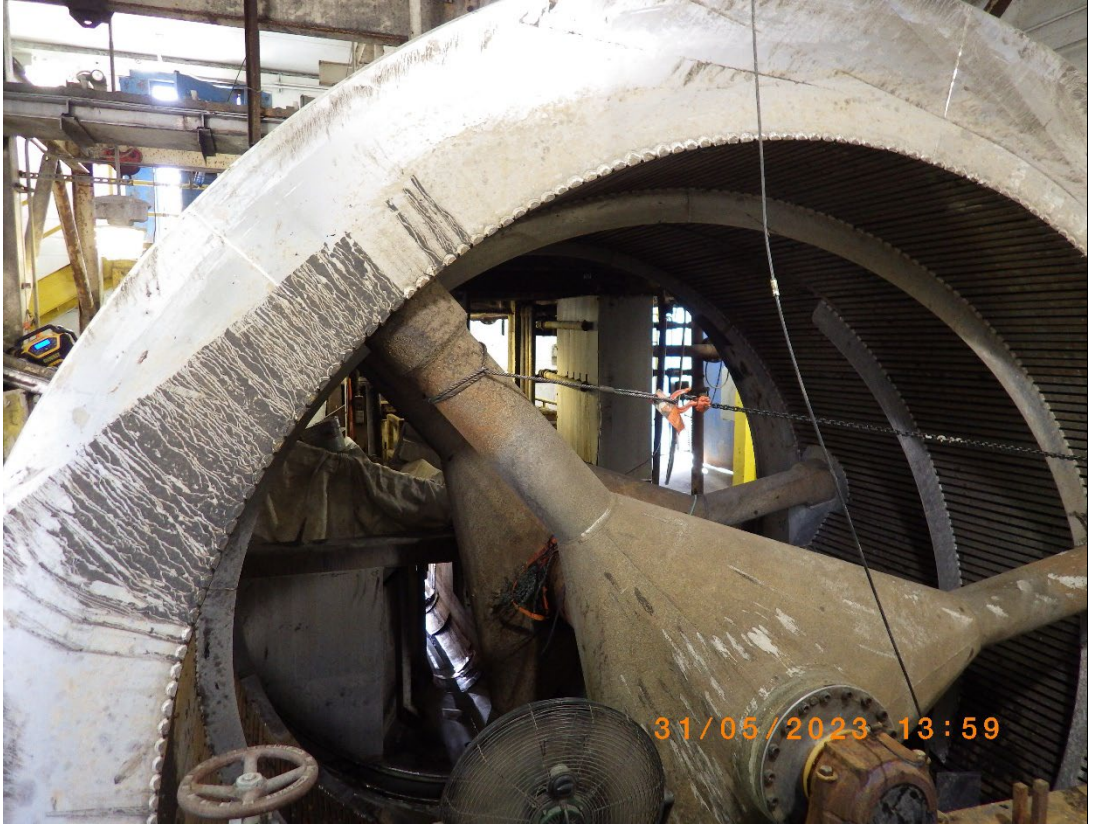
| <b>Photo No.:</b> 4 | <b>Time:</b><br>1:59 PM | | |

| <b>Photo Description:</b><br>Rock and dirt catcher. Where rocks and dirt are separated from the beets. | | | |

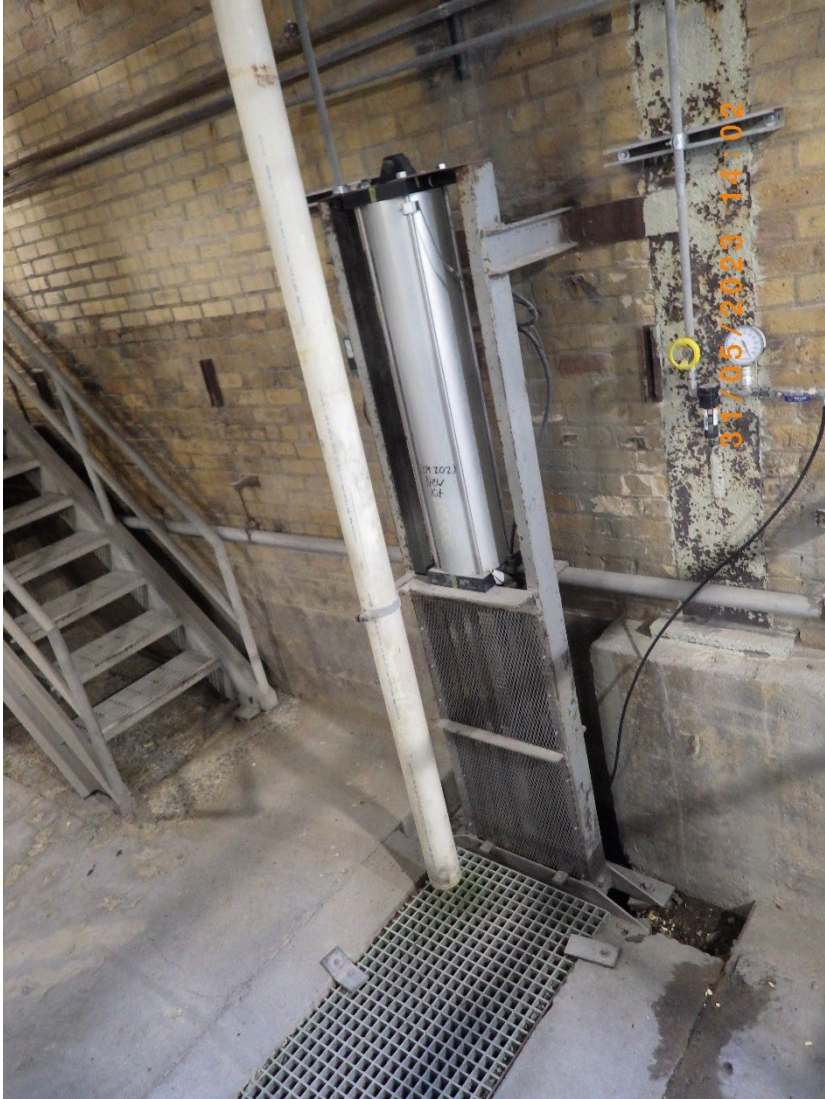
| <b>Photo No.:</b> 5 | <b>Time:</b><br>2:02 PM | | |

| <b>Photo Description:</b><br>"Panic" gate. Can be used to stop beets from entering Facility for processing. | | | |

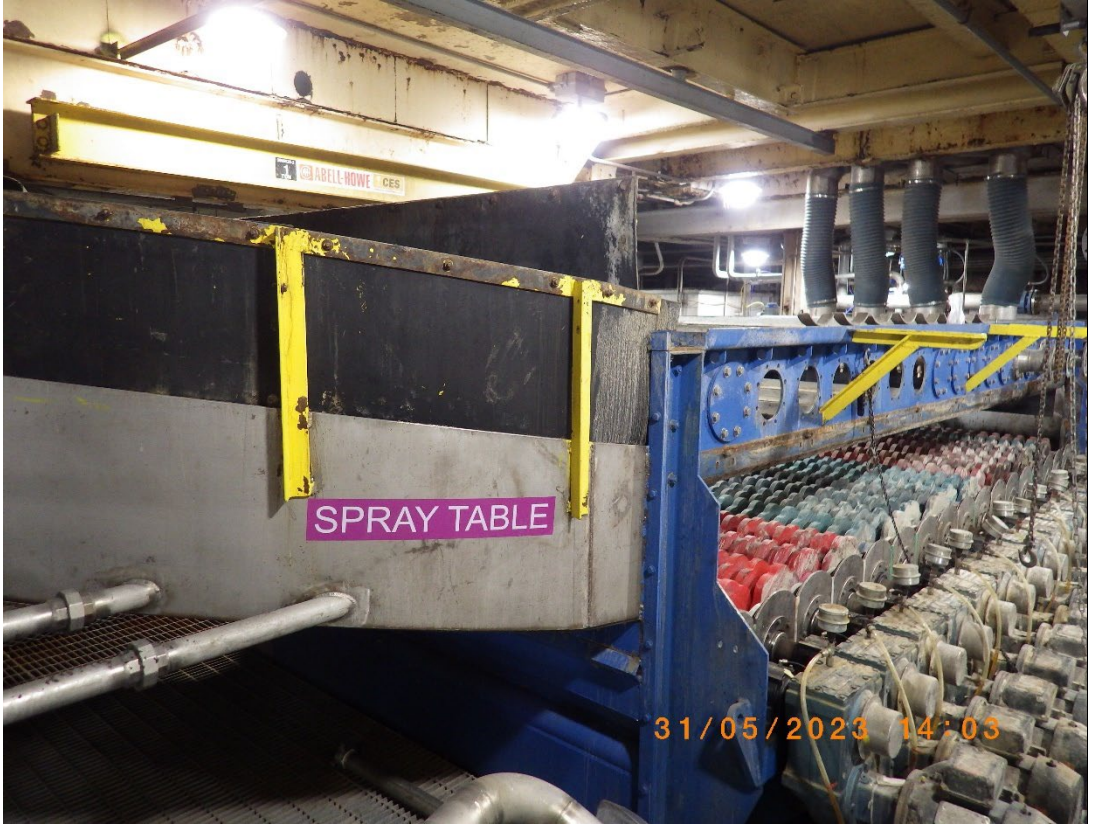
| <b>Photo No.:</b> 6 | <b>Time:</b> 2:03 PM | | |

| <b>Photo Description:</b><br>Spray table in the flume system. | | | |

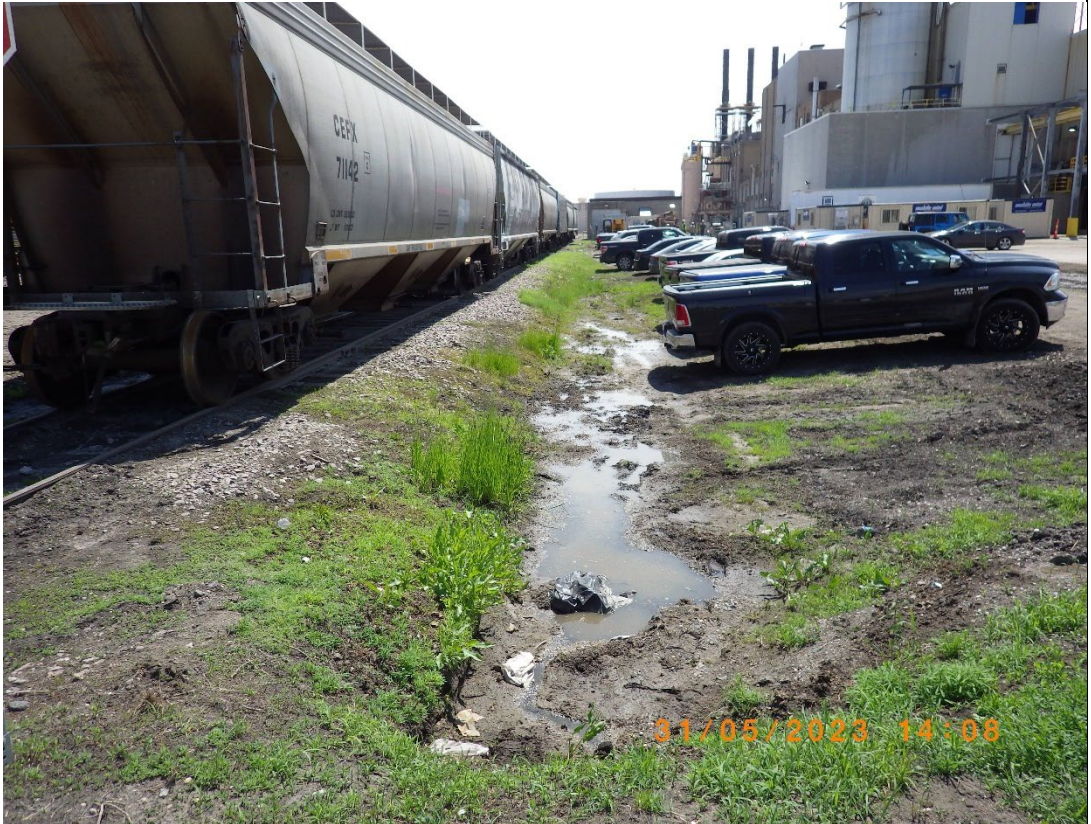
| <b>Photo No.:</b> 7 | <b>Time:</b><br>2:08 PM | | |

| <b>Photo Description:</b><br>Ditch west of primary clarifier. | | | |

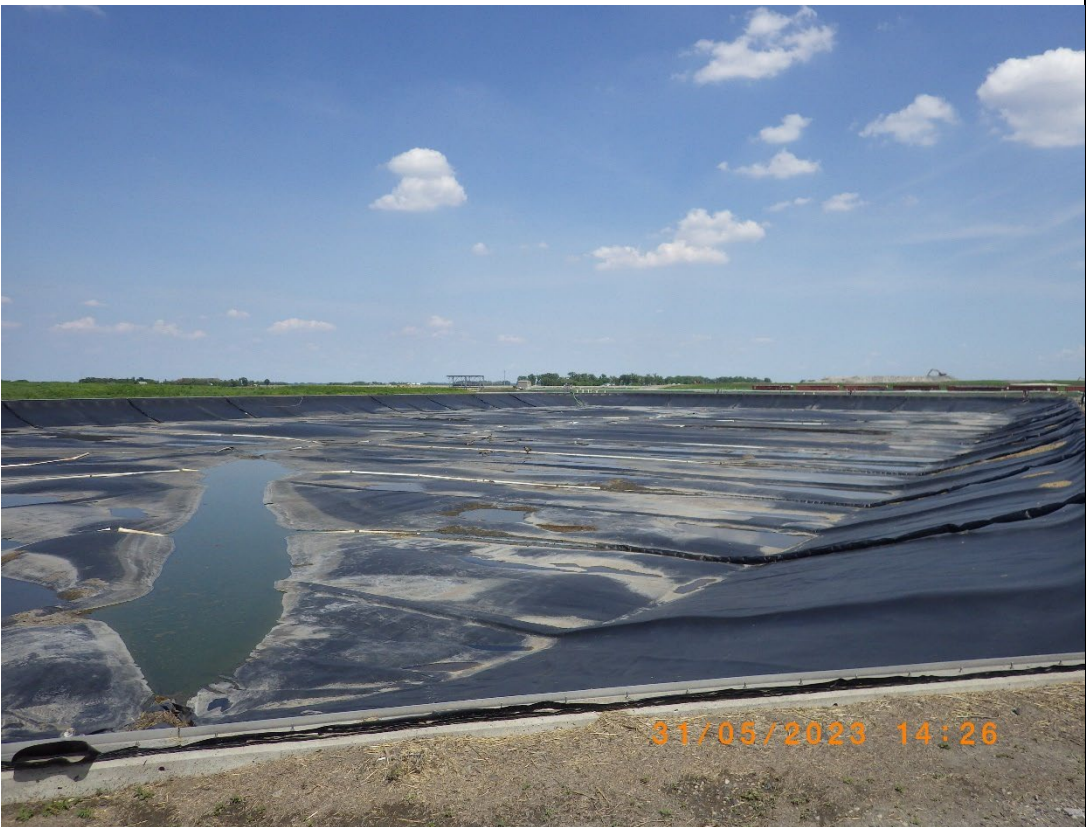
| <b>Photo No.:</b> 9 | <b>Time:</b><br>2:26 PM | | |

| <b>Photo Description:</b><br>EQ Pond (covered). | | | |

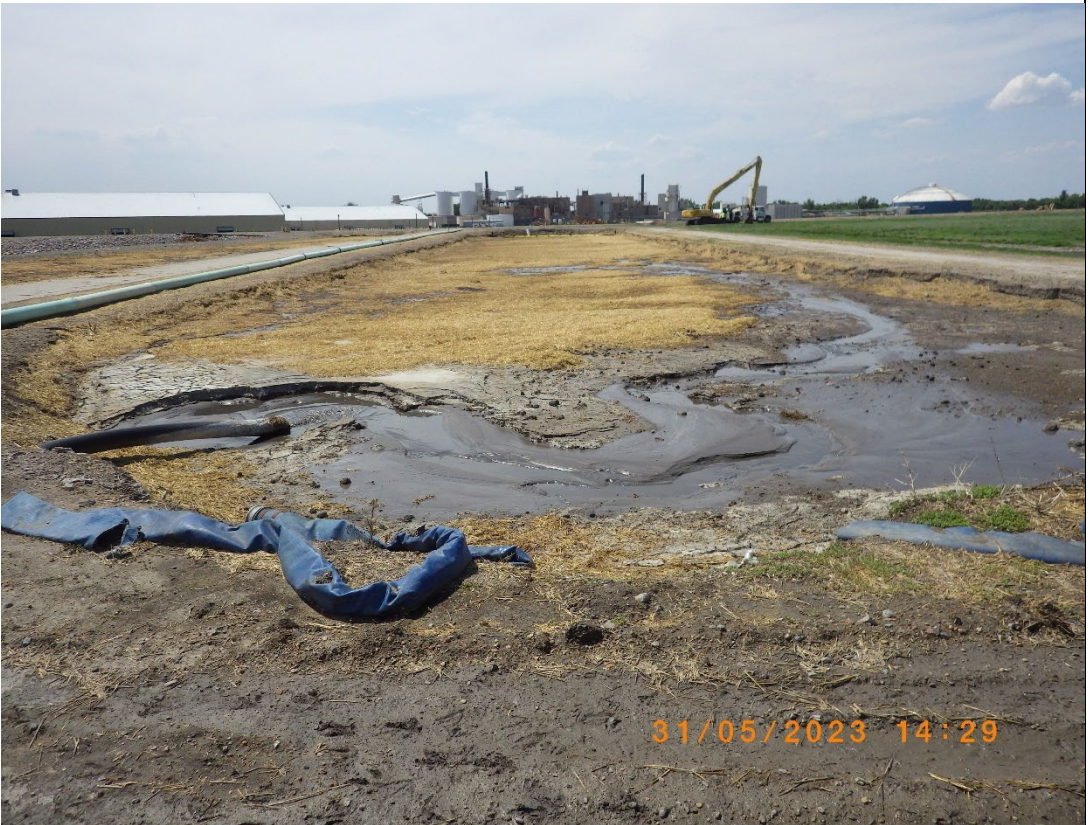
| <b>Photo Description:</b><br>Mud ditch. Water flowing in from primary clarifier. Straw on top of ditches to manage odors. Mud ditches receive mud from the mud presses. | | | |

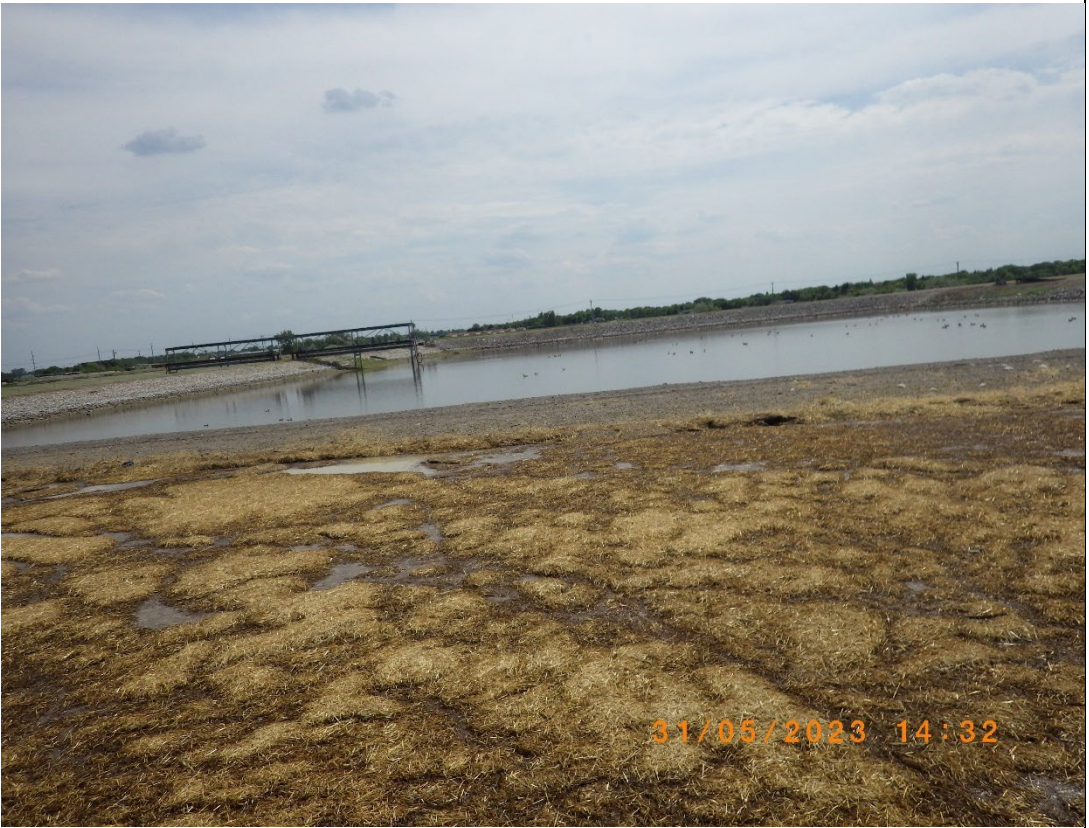
| <b>Photo No.: 11</b> | <b>Time:</b><br>2:32 PM | | |

| <b>Photo Description:</b><br>Low strength stormwater pond. | | | |

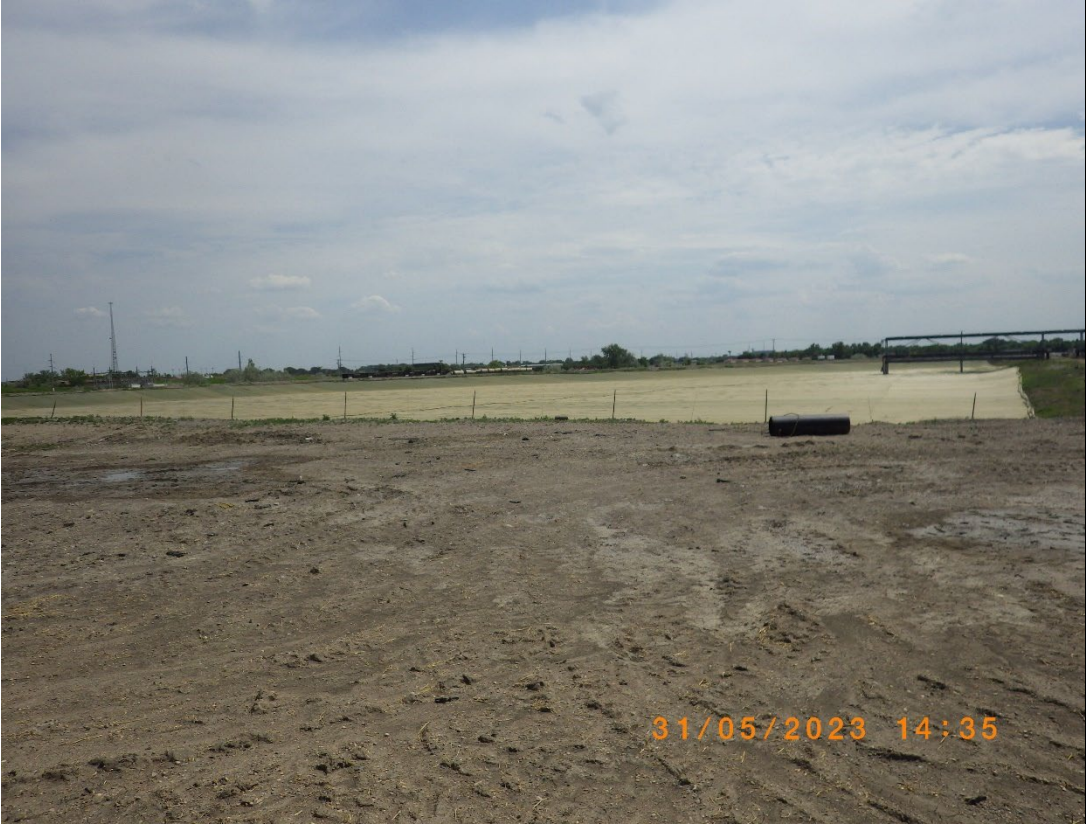
| <b>Photo No.: 12</b> | <b>Time:</b><br>2:35 PM | | |

| <b>Photo Description:</b><br>High strength stormwater pond.<br>Covered with permeable material (thermogreen). | | | |

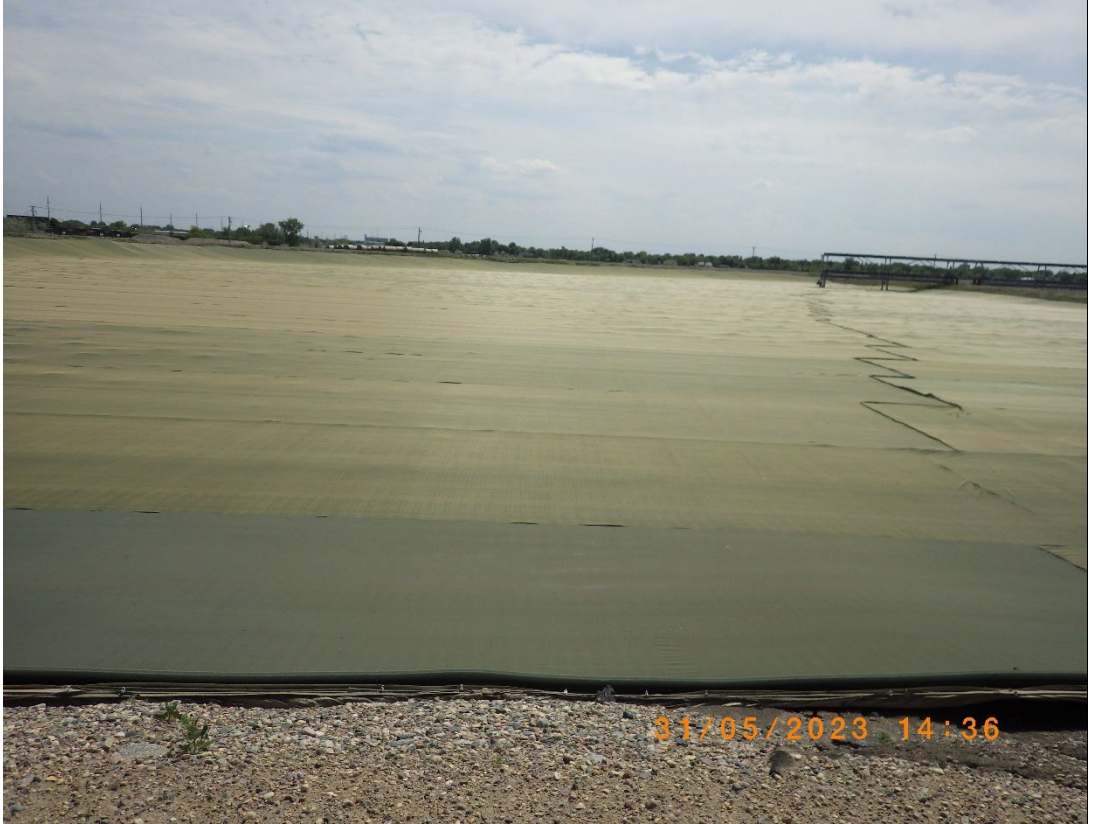
| <b>Photo No.: 13</b> | <b>Time:</b><br>2:36 PM | | |

| <b>Photo Description:</b><br>High strength stormwater pond.<br>Covered with permeable material (thermogreen). | | | |

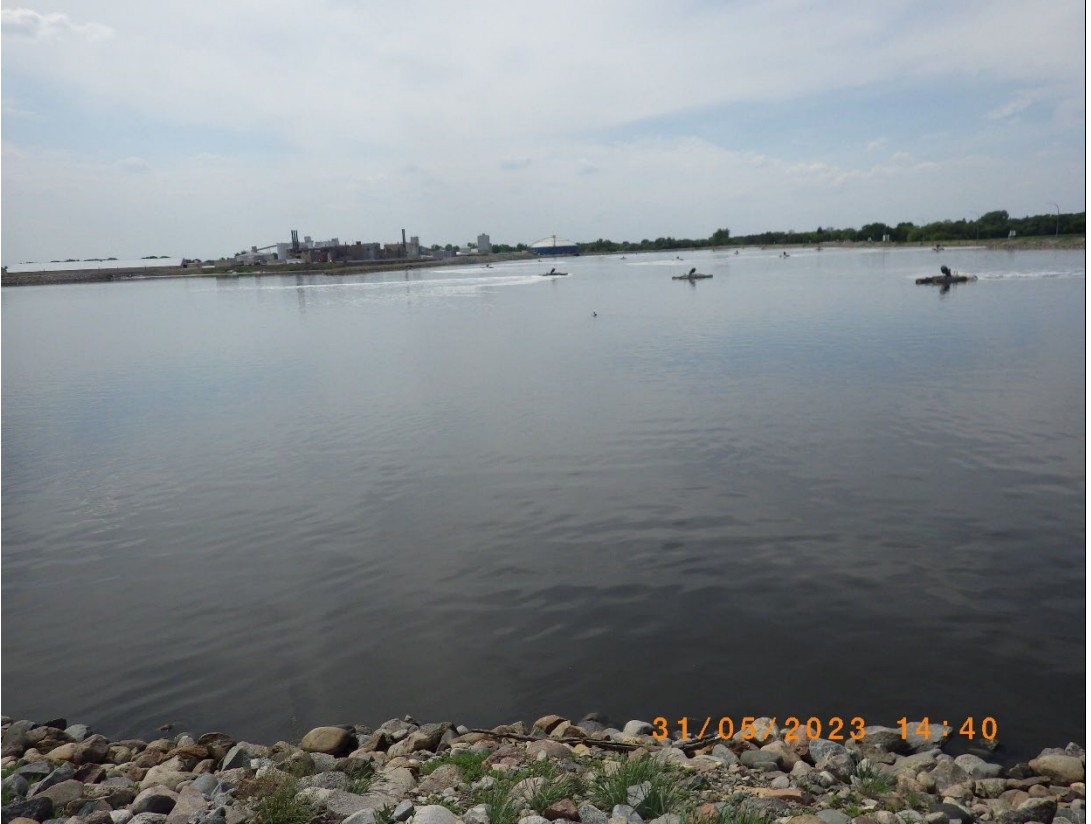
| <b>Photo No.: 14</b> | <b>Time:</b><br>2:40 PM | | |

| <b>Photo Description:</b><br>Condenser pond with floating aerators in its surface. | | | |

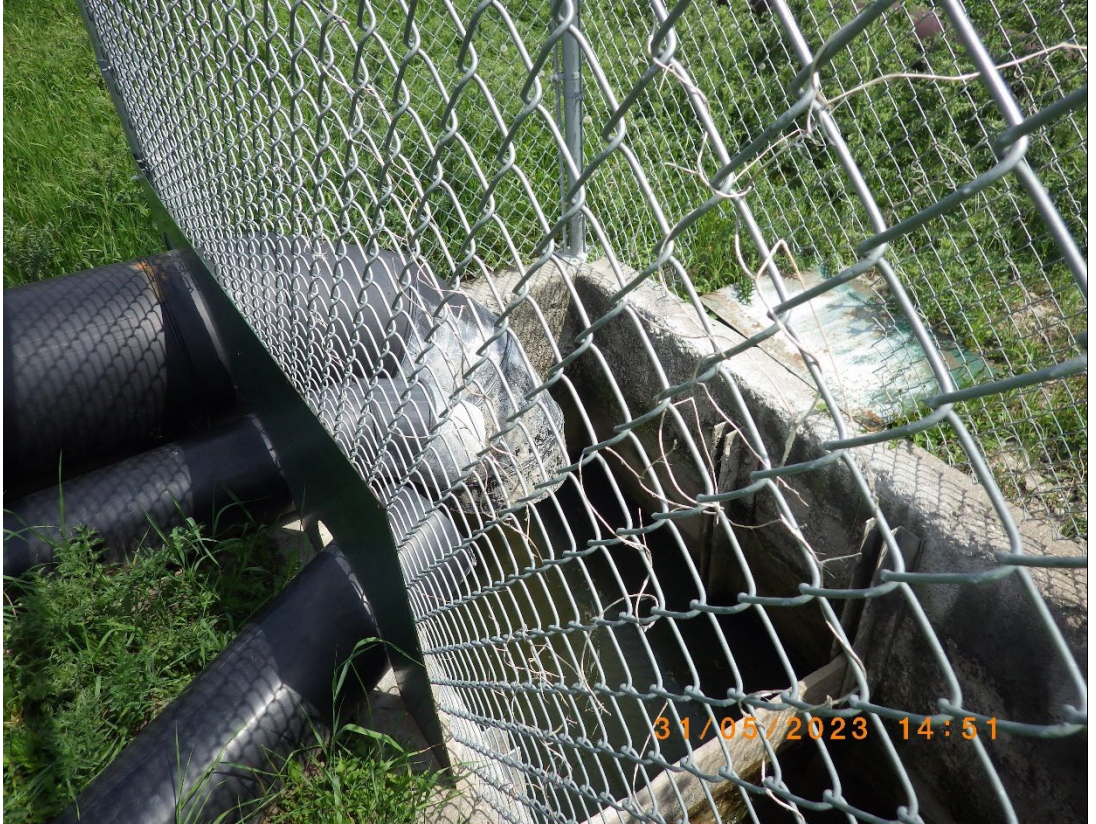
| <b>Photo No.:</b> 16 | <b>Time:</b> 2:51 PM | | |

| <b>Photo Description:</b><br>Final Effluent<br>sampling station.<br>Outfall SD001. | | | |

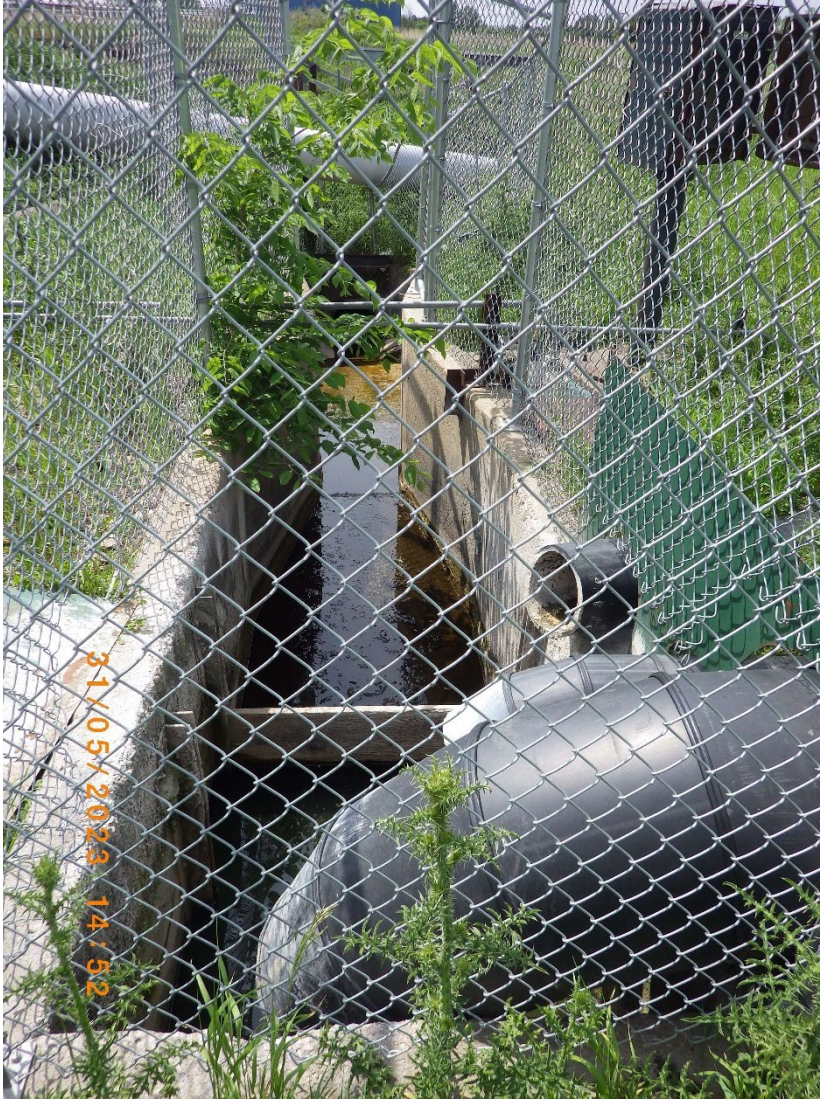
| <b>Photo No.:</b> 17 | <b>Time:</b><br>2:52 PM | | |

| <b>Photo Description:</b><br>Final Effluent<br>sampling station.<br>Outfall SD001. | | | |

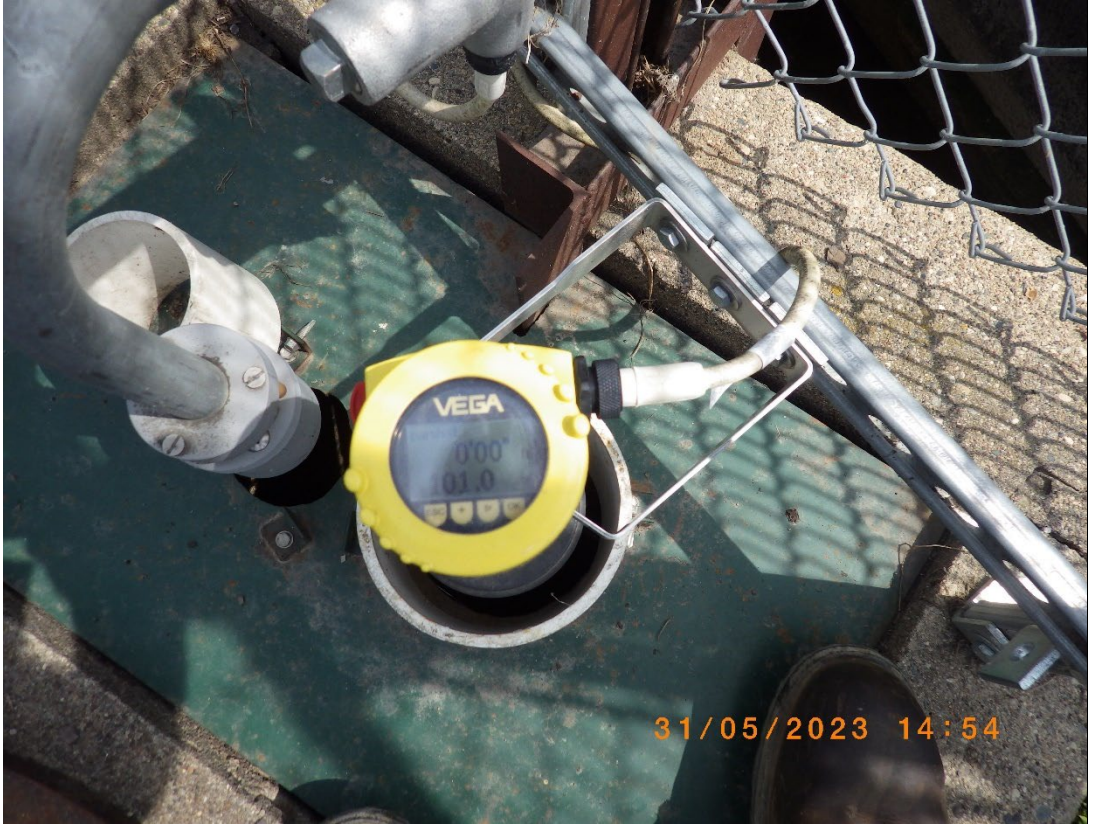
| <b>Photo No.: 18</b> | <b>Time:</b><br>2:54 PM | | |

| <b>Photo Description:</b><br>Parshall flume meter for SD001. | | | |

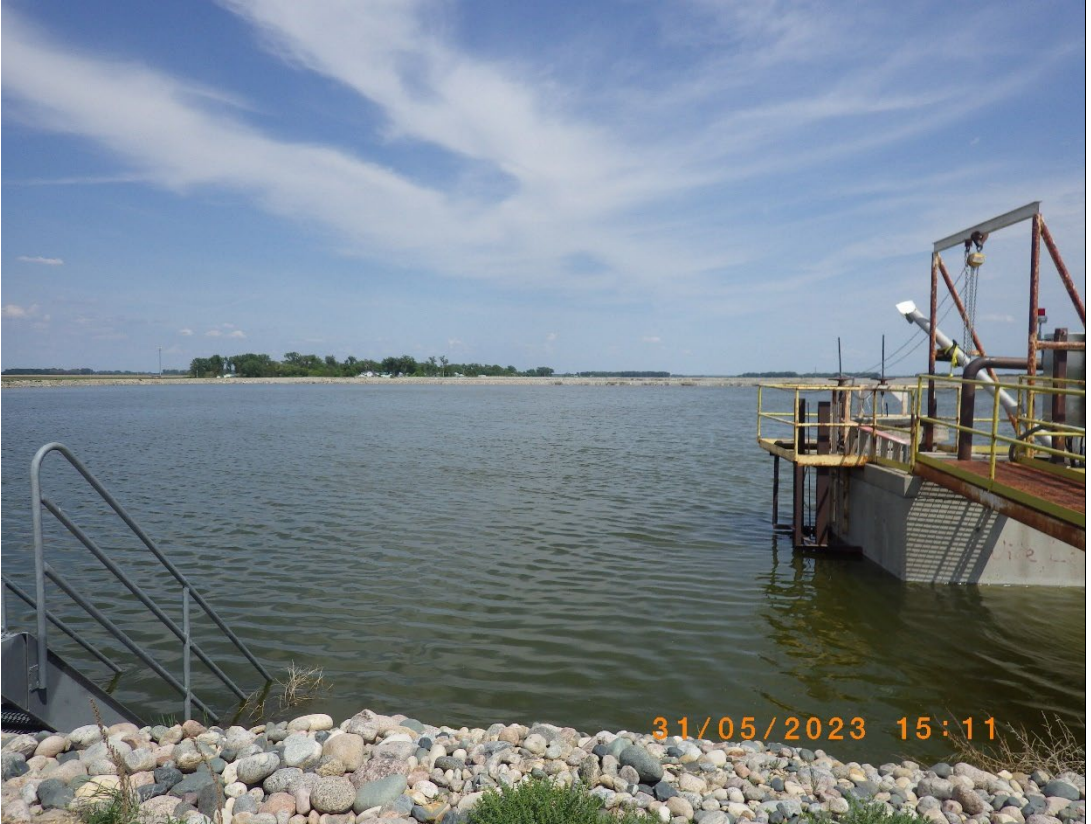
| <b>Photo No.: 19</b> | <b>Time:</b><br>3:11 PM | | |

| <b>Photo Description:</b><br>West game pond where final treated is stored before being discharged. | | | |

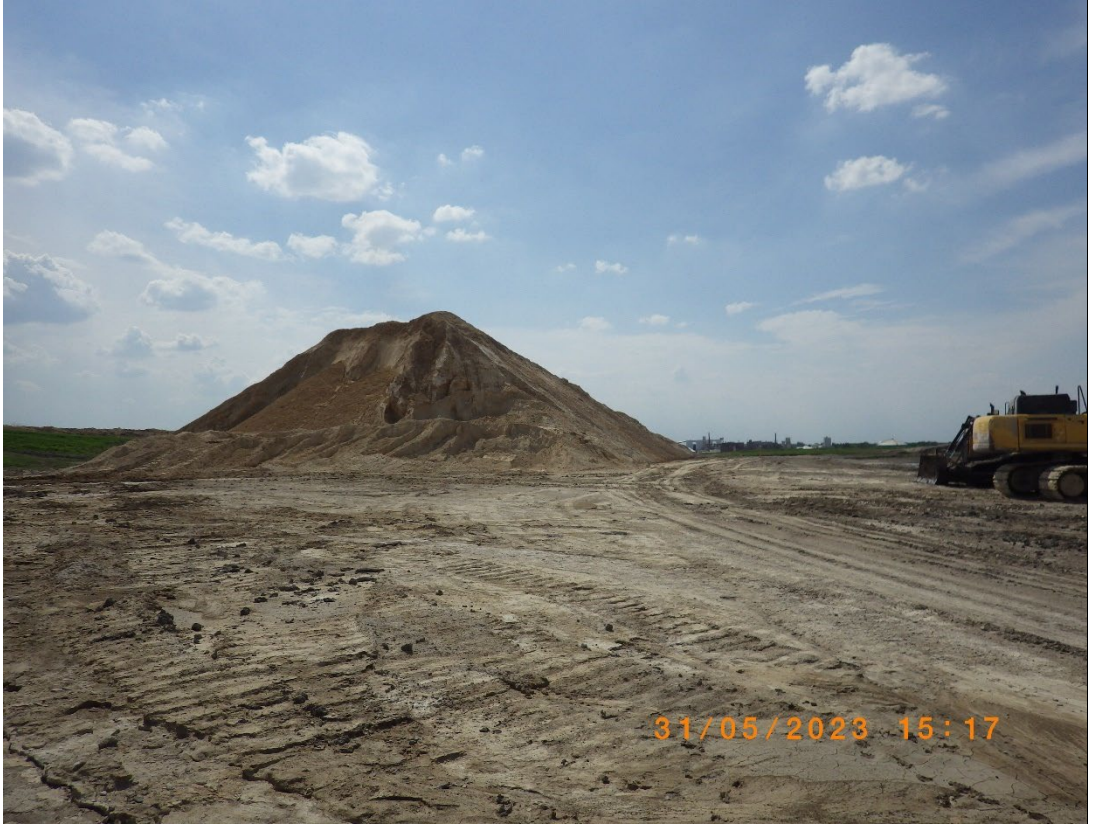
| <b>Photo No.: 20</b> | <b>Time:</b><br>3:17 PM | | |

| <b>Photo Description:</b><br>Precipitated Calcium Carbonate (PCC) lime pile stored on east side of facility. | | | |

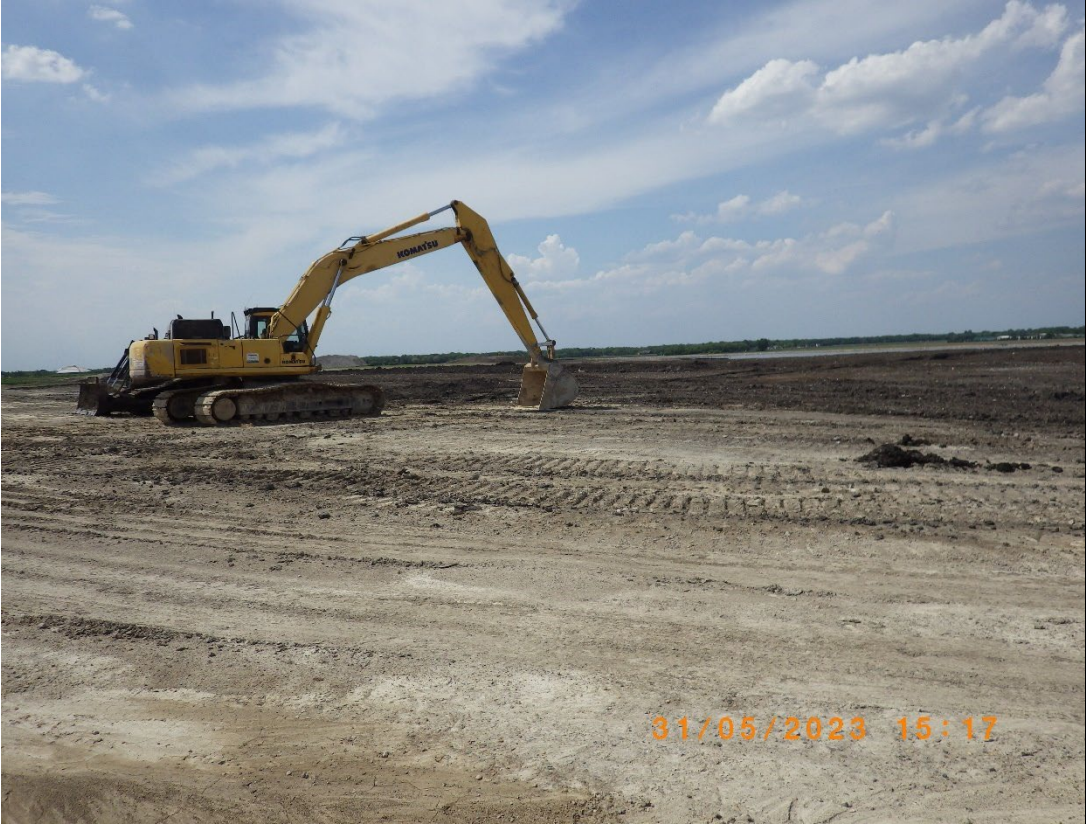
| <b>Photo No.:</b> 21 | <b>Time:</b><br>3:17 PM | | |

| <b>Photo Description:</b><br>Rocks and dirt from the rock catchers.<br>The area drains into the game ponds. | | | |
