**Region 6 - Enforcement & Compliance Assurance Division**  
**INSPECTION REPORT**

| <b>Inspection Dates:</b> | 7/28/2025 and 7/29/2025 | |
| <b>Company Name:</b> | <b>Duncan Public Utilities Authority – Public Water System</b> | |
| <b>Facility Name:</b> | <b>Duncan Public Utilities Authority</b> | |

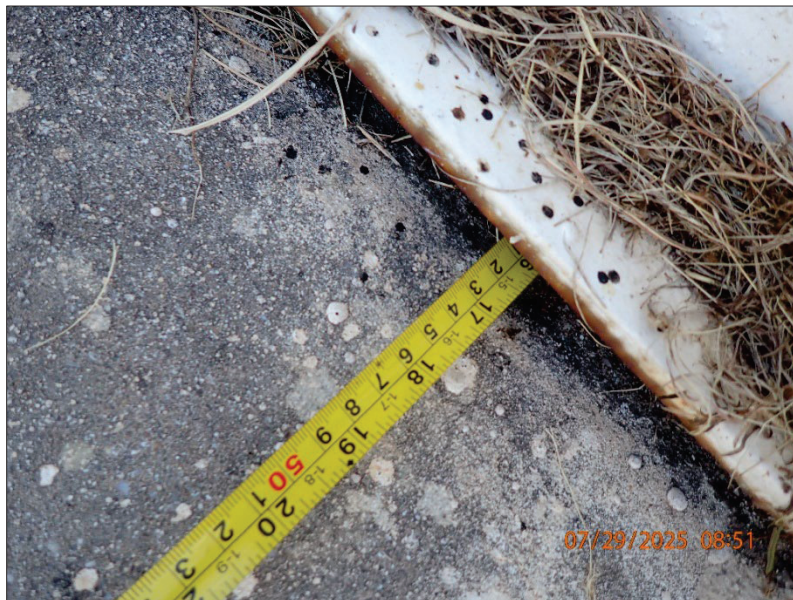
**Area of Concern 33.** The EPA Inspection Team observed the designed seal between the tank ring and concrete foundation to be missing at the WTP backwash supply tank, where exposed gaps extended 17 in. beneath the tank's base in one area (Photograph 2), and at the El Rancho Tower (Photograph 59).

**Photograph 2. 7/29/2025 08:51 P7290252.JPG Duncan WTP Backwash Supply Tank**  
**Description:** Gap between the base of the WTP backwash supply tank and the concrete tank pad.

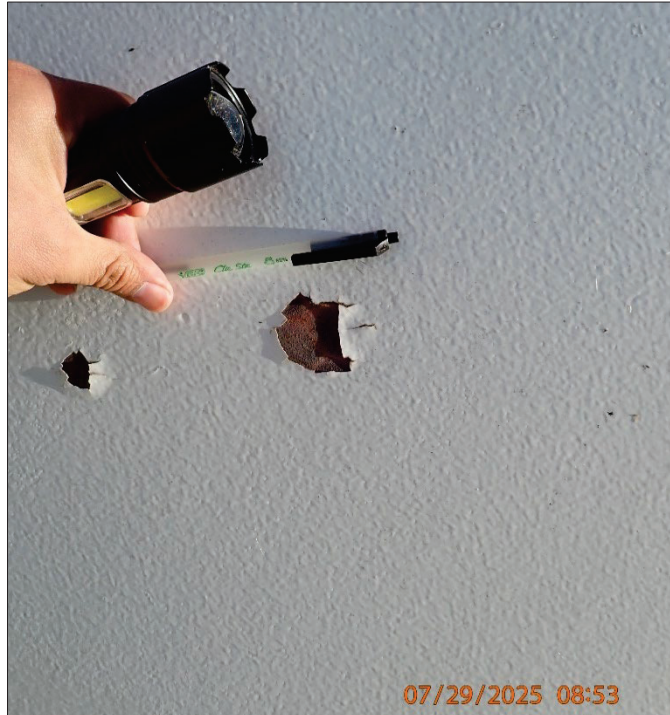
**Area of Concern 36.** The EPA inspection team observed thinning, peeling, or corroded surface coating at the WTP Backwash Tank (Photograph 3), 10<sup>th</sup> and Elk South Storage Tank (Photograph 68 and Photograph 69), 10<sup>th</sup> and Elk N.E. Tank (Photograph 70), and 10<sup>th</sup> and Elk N.W. Tank (Photograph 71).

**Photograph 3. 7/29/2025 08:53 P7290254.JPG Duncan WTP Backwash Supply Tank**  
**Description:** Chipping paint on the WTP backwash supply tank.

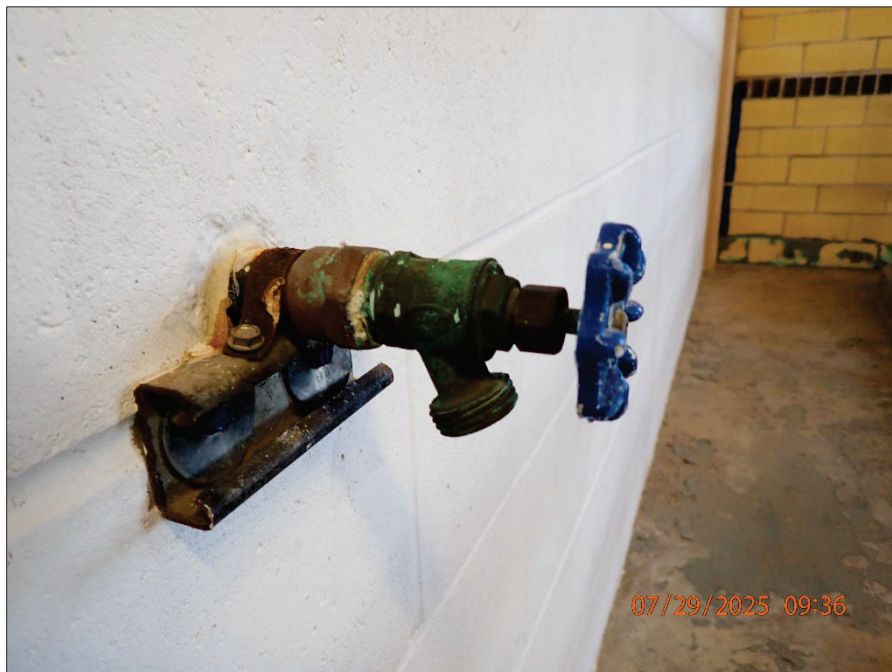
**Area of Concern 31.** The EPA inspection team observed garden hoses without vacuum breakers at the South Plant filter (Photograph 9), WTP polymer storage and feed room (Photograph 50), and WTP Caustic and ACH storage building (Photograph 46). The System also had threaded hose-bibs without vacuum breakers at the Northwest Sector Tower (Photograph 76) and the rest of the South Plant filters.

**Photograph 10. 7/29/2025 09:36 P7290328.JPG WTP South Plant Filter**

**Description:** Hose bib in the Water Treatment Facility without a hose bib vacuum breaker.

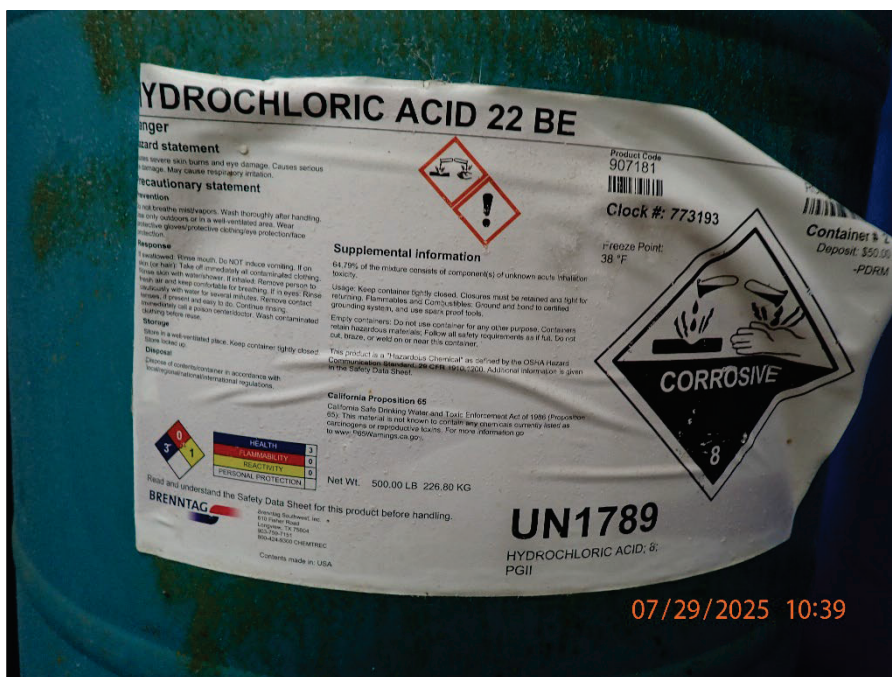
**Photograph 23. 7/29/2025 09:40 100\_0101.JPG Ammonia Storage Room**  
**Description:** Hydrochloric acid drums located in the anhydrous ammonia storage room at the Water Treatment Facility, without secondary containment, that are bulging due to increased pressure.

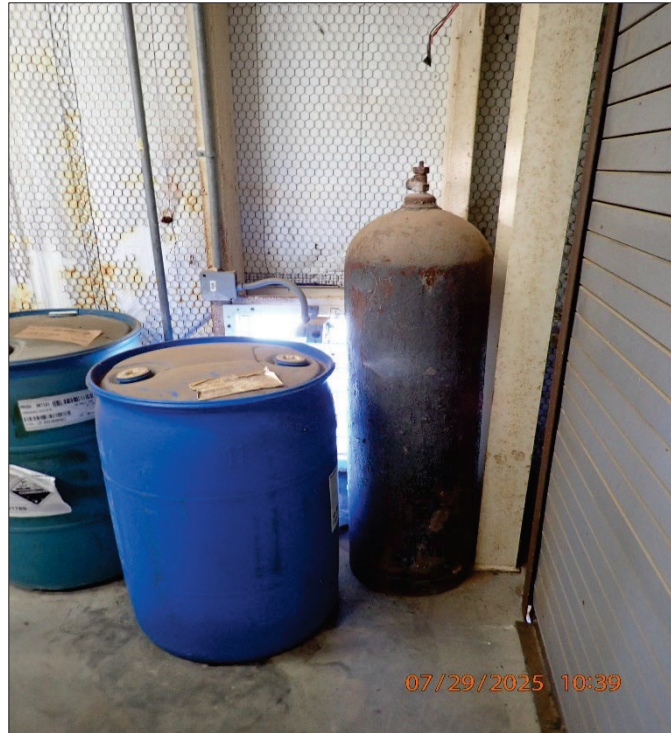
- Area of Concern 39.** The EPA inspection team observed chlorine gas detectors for the chlorine storage room and the chlorinator room that were not labeled to distinguish between one and the other (Photograph 47).
- Area of Concern 40.** The EPA inspection team observed a lack of chemical labeling identifying the chemicals housed in the WTP ammonia storage room (Photograph 31).
- Area of Concern 41.** Seven ammonia pressure tanks were improperly chained, secured only with a single chain tied loosely around the necks of the tanks and a single pillar in the storage room (Photograph 26).
- Area of Concern 42.** One propane tank in the corner of the ammonia storage room and an ammonia tank were not chained (Photograph 28 and Photograph 29). System representatives stated that they were uncertain if the tanks were empty.
-

**Photograph 28. 7/29/2025 10:43 P7290465.JPG Ammonia Storage Room**  
**Description:** A single propane tank located in the anhydrous ammonia storage room at the Water Treatment Facility.

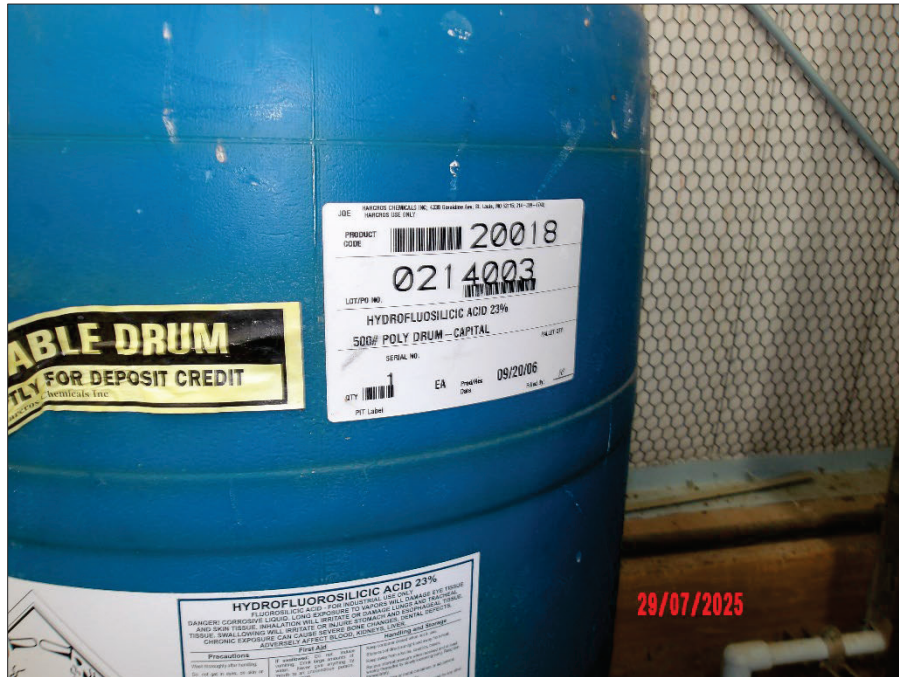
**Photograph 40. 7/29/2025 10:27 100\_0172.JPG Polyphosphate Storage Room**  
**Description:** Storage of poly-orthophosphate, 23 percent hydrofluosilicic acid, and 12 percent sodium hypochlorite drums in the Polyphosphate Storage Room.

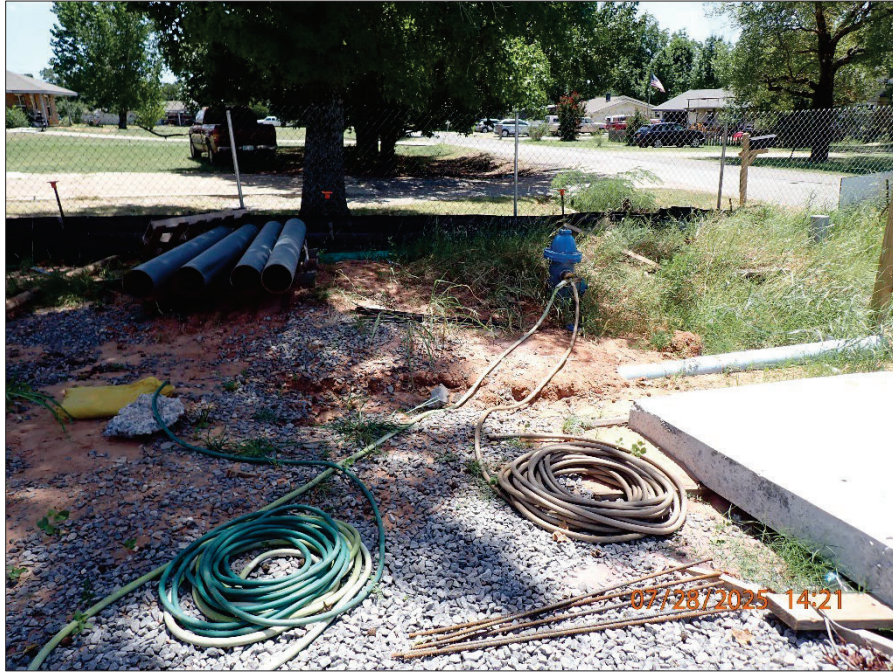
**Area of Concern 30.** The EPA inspection team observed multiple hoses without backflow prevention devices connected directly to a fire hydrant at the El Rancho Tower (Photograph 54). The hoses were used by the construction crew building the new El Rancho Tower located at the same site as the existing El Rancho Tower.

**Photograph 54. 7/28/2025 14:21 P7280077.JPG El Rancho Tower**  
**Description:** Hydrant tap used by the El Rancho Tower construction company without a backflow prevention device.

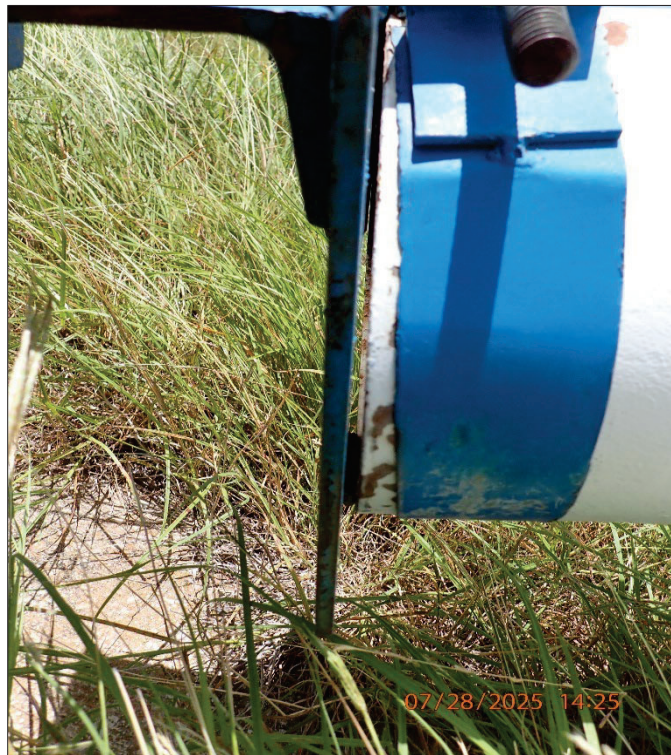
**Photograph 57. 7/28/2025 14:29 P7280096.JPG El Rancho Tower**

- Area of Concern 25.** The EPA inspection team observed vegetation growth along lengths of the perimeter fence that covered the existing barbed wiring at the El Rancho Tower (Photograph 57) and Industrial Tower #2 (Photograph 73).
-

**Description:** Vegetation growth around the El Rancho Tower base and on the security fencing.

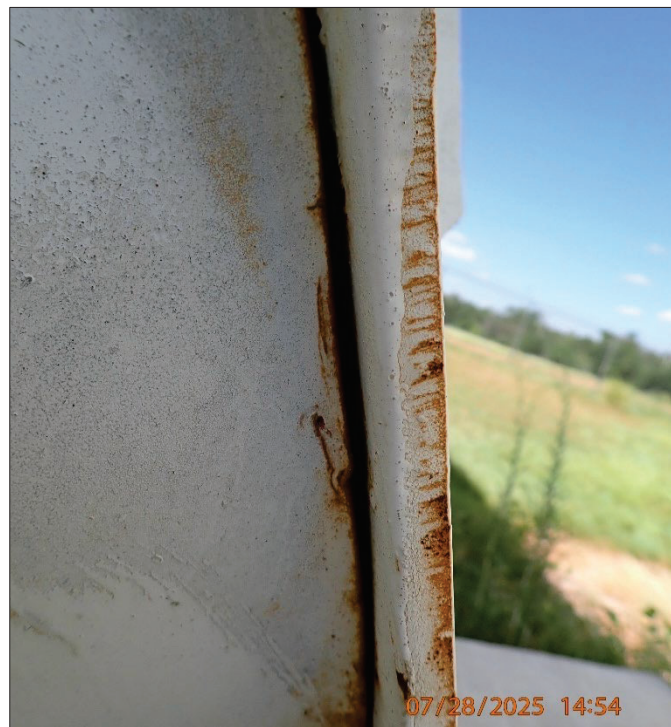
**Photograph 65. 7/28/2025 15:02 P7280156.JPG 10<sup>th</sup> and Elk South Tank**

- Area of Concern 20.** The EPA inspection team observed solid metal flappers on the overflows of all the finished water storage tanks. The solid flappers did not form a tight seal around the overflow pipe at the WTP backwash supply tank (Photograph 1), El Rancho Tower (Photograph 58), 10<sup>th</sup> and Elk South Tank (Photograph 65), 10<sup>th</sup> and Elk N.W Tank (Photograph 66), 10<sup>th</sup> and Elk N.E Tank (Photograph 67), and Industrial #2 Tower (Photograph 75). None of the inspected finished water storage tanks had screens installed inside the overflow pipe.
-

**Description:** Metal flapper on the end of an overflow line for the 10<sup>th</sup> and Elk South Tank that does not create a proper seal.

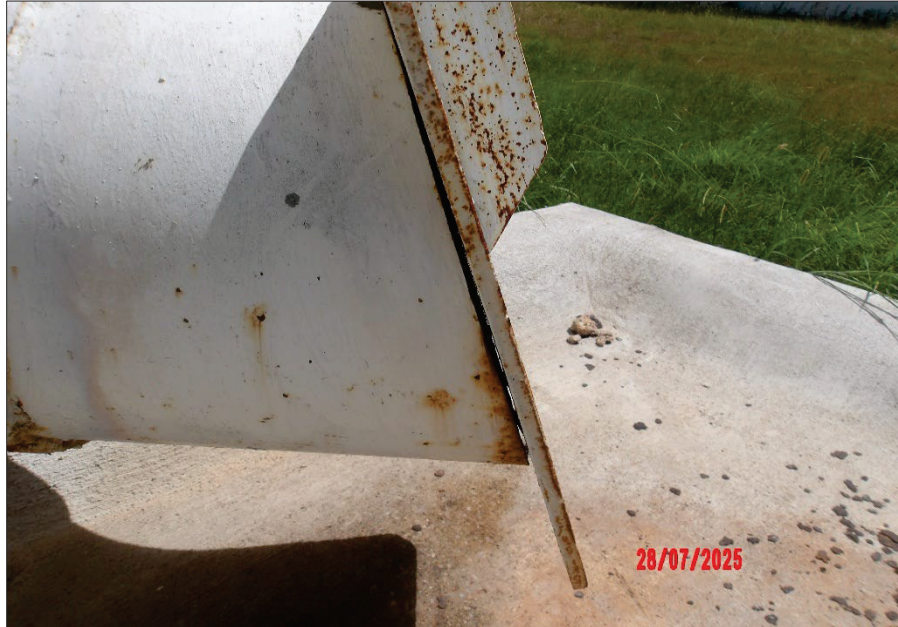
**Photograph 66. 7/28/2025 14:54 P7280135.JPG 10<sup>th</sup> and Elk N.W Tank**

**Description:** A metal flapper at the end of the overflow line on the 10<sup>th</sup> and Elk N.W Tank that does not create a proper seal.
